Division of Oil, Gas and Mining

Inspection Report

Permit Number:	C0070039
Inspection Type:	PARTIAL
Inspection Date:	Wednesday, November 01, 2017
Start Date/Time:	11/1/2017 7:30:00 AM
End Date/Time:	11/1/2017 2:00:00 PM
Last Inspection:	Monday, October 16, 2017

Permitee: **CANYON FUEL COMPANY**
 Operator: **CANYON FUEL COMPANY**
 Site: **DUGOUT CANYON MINE**
 Address: **PO BOX 1029, WELLINGTON UT 84542**
 County: **CARBON**
 Permit Type: **PERMANENT COAL PROGRAM**
 Permit Status: **ACTIVE**

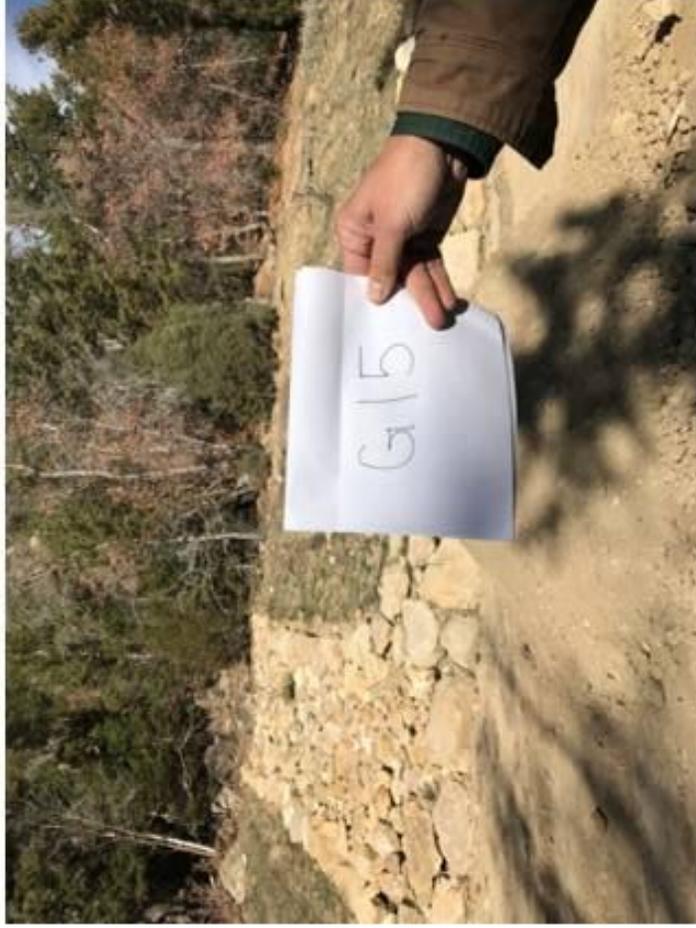
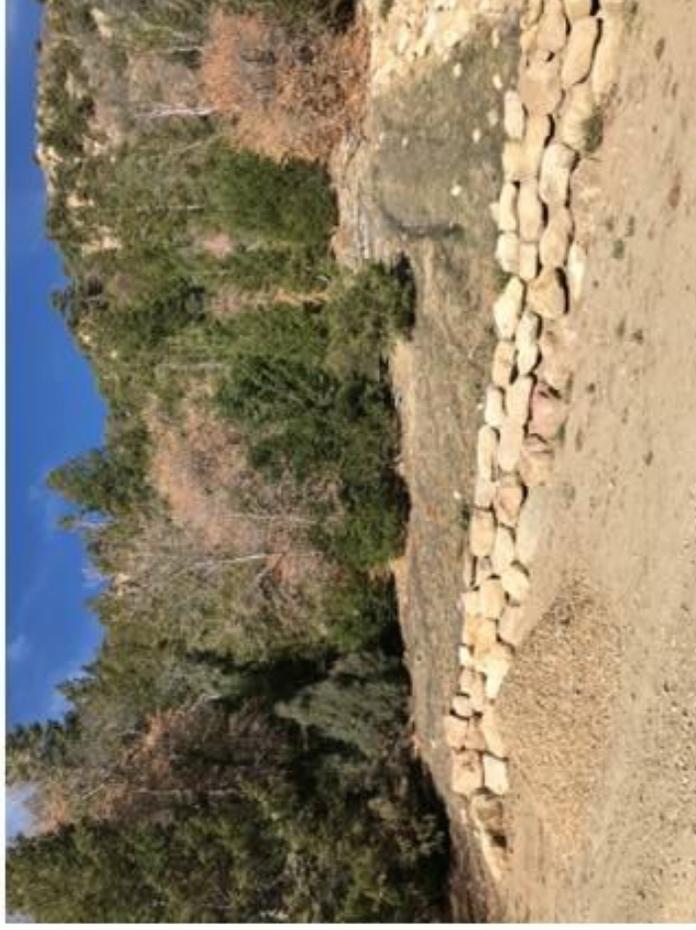
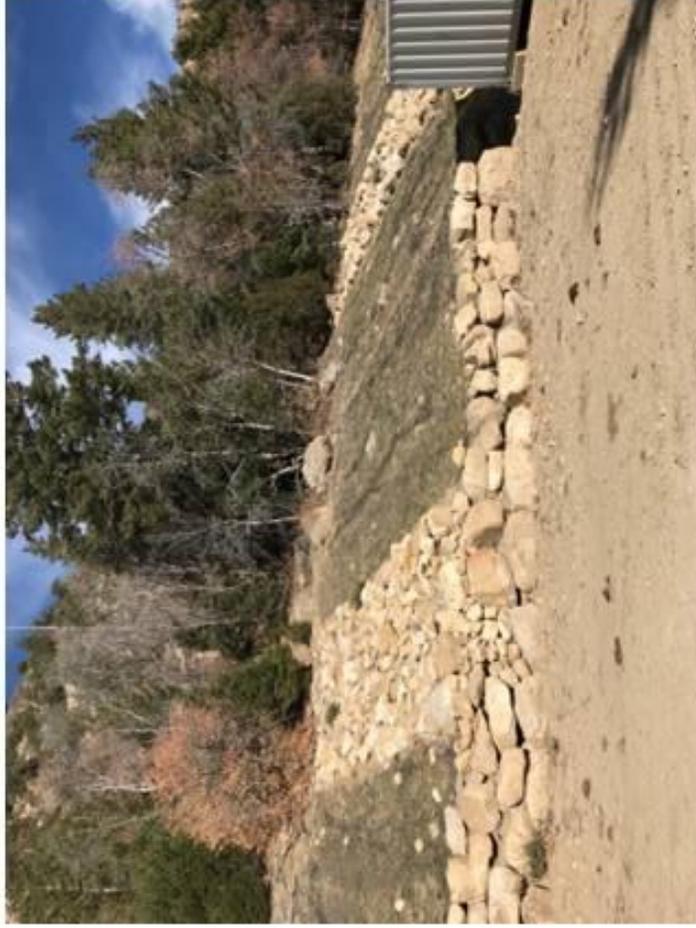
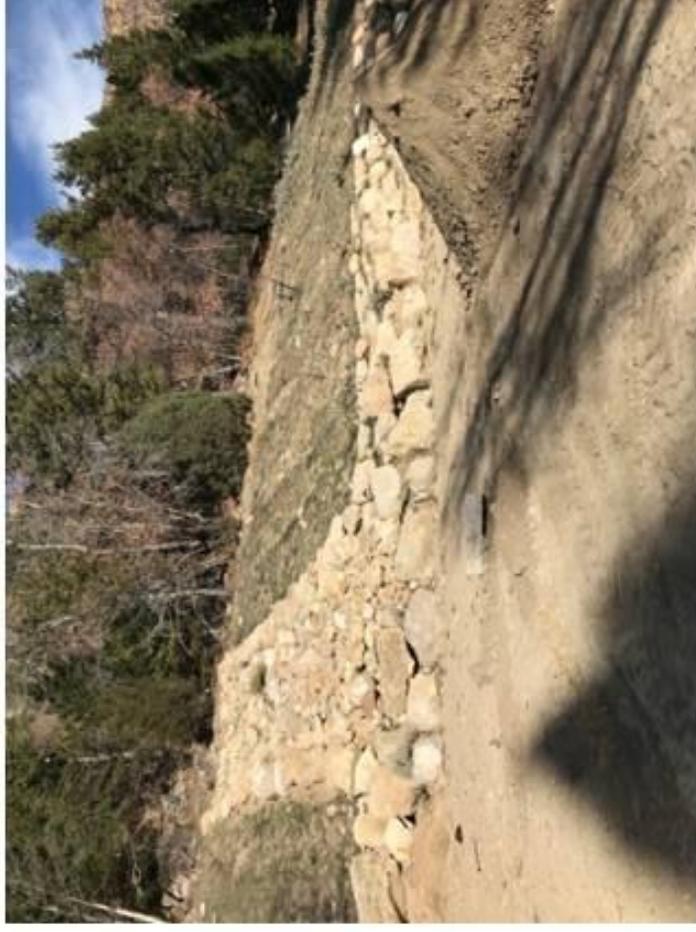
Site G-15

G-15: Final reclamation of the site was achieved in June of 2015. Bond release has not been sought by the Permittee for this degas site. The pad was constructed, but the gob gas vent hole was never drilled. The pad is located directly adjacent to the pre-existing main access road. Excelsior matting is in place and is breaking down. The dark lines seen in the photos are the netting from the Excelsior matting. A rock wall and rock channels have been constructed at the request of the land owner. No evidence of instability or off-site impacts was noted during inspection. The Permittee was reminded to provide revised as-built drawings as well as supporting hydrologic calculations that the rock-lined channels have been designed to safely pass a 100-year, 6-hour event as required per R645-301-742.323.

G-15: This site was reclaimed in 2015. It is fenced and stable. The vegetation is just starting to show through the netting and appears to be doing well at this stage of reclamation.

a.Rock Wall Terrace- Permittee needs to submit an as-built drawing showing the rock wall terrace. This drawing is expected to be submitted by June 30, 2018.

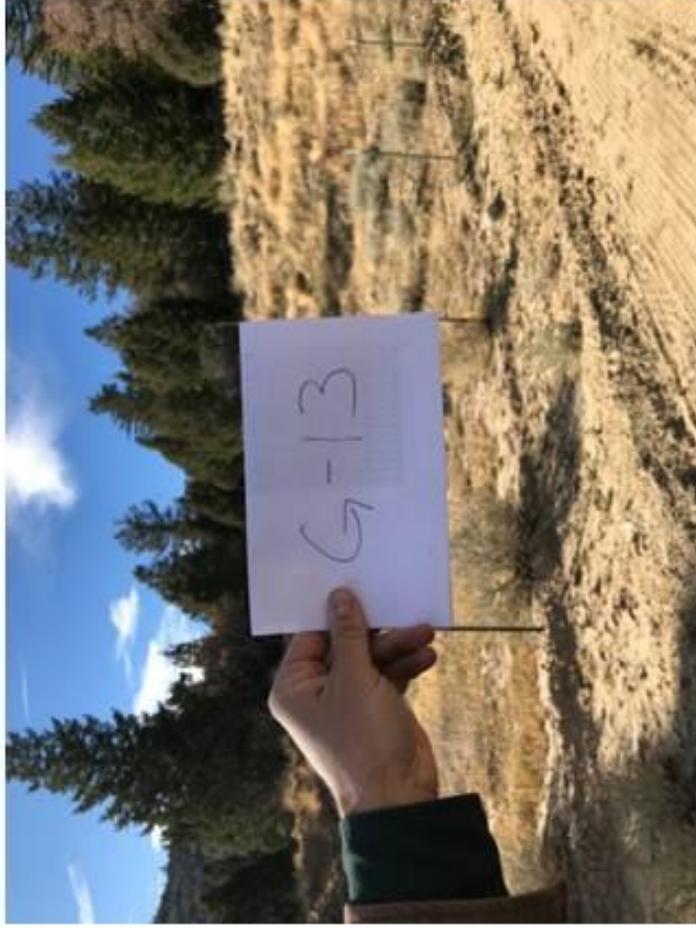
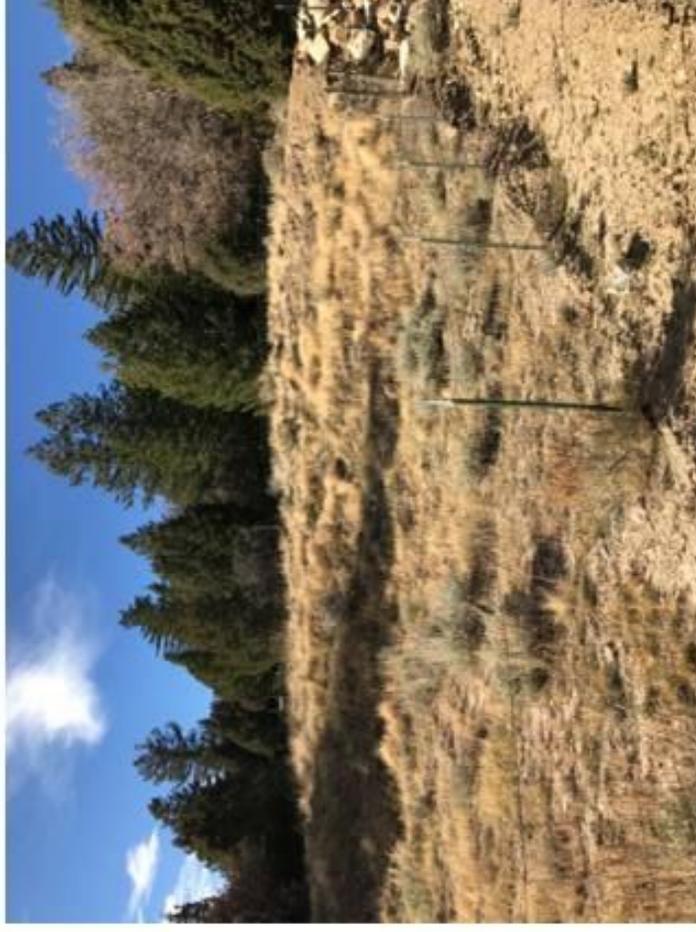
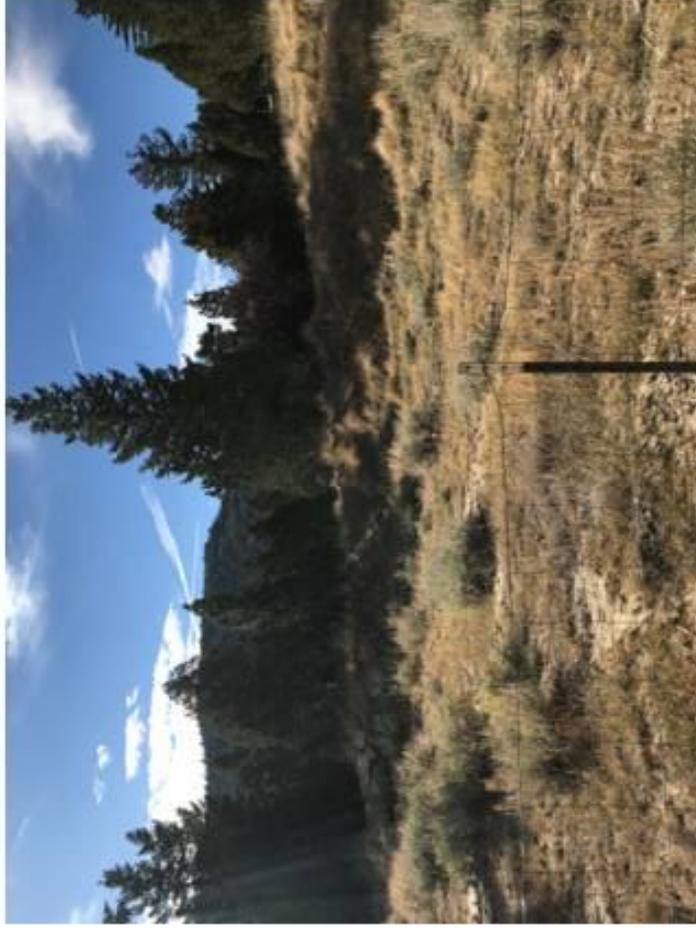
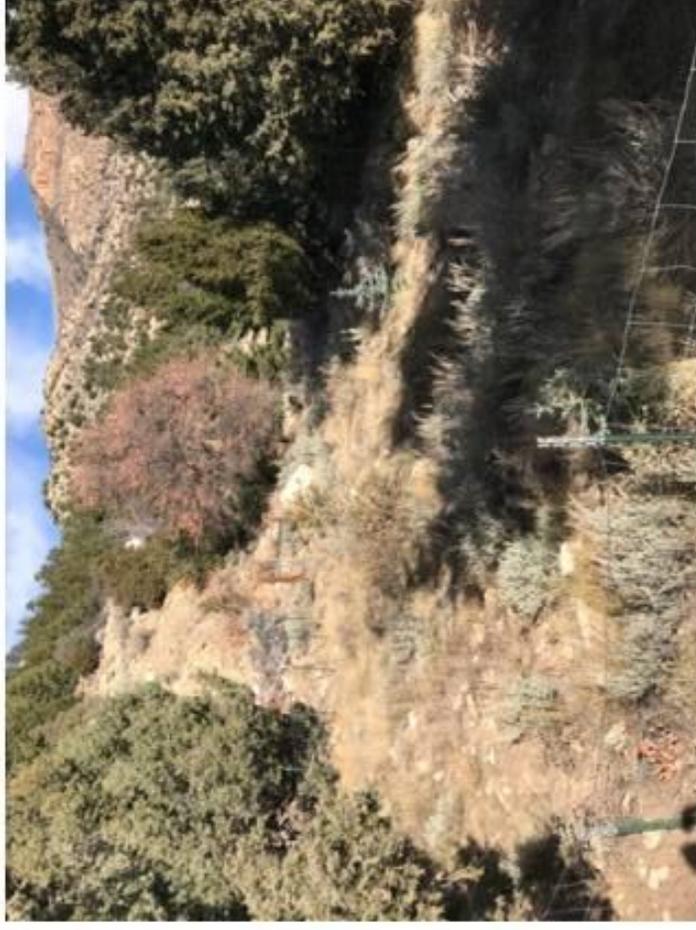
Site G-13

G-13: The site was reclaimed in 2009 and received Phase II bond release in 2014.

The site had been pre-disturbed by logging activities so the AOC was set to that configuration. The site is bisected by the road and therefore consists of two fenced-off areas on either side of the road. No evidence of off-site impacts or instability was observed during the inspection.

G-13: This site is fenced, stable and well vegetated. The sagebrush is also well established as it was reclaimed in 2009.

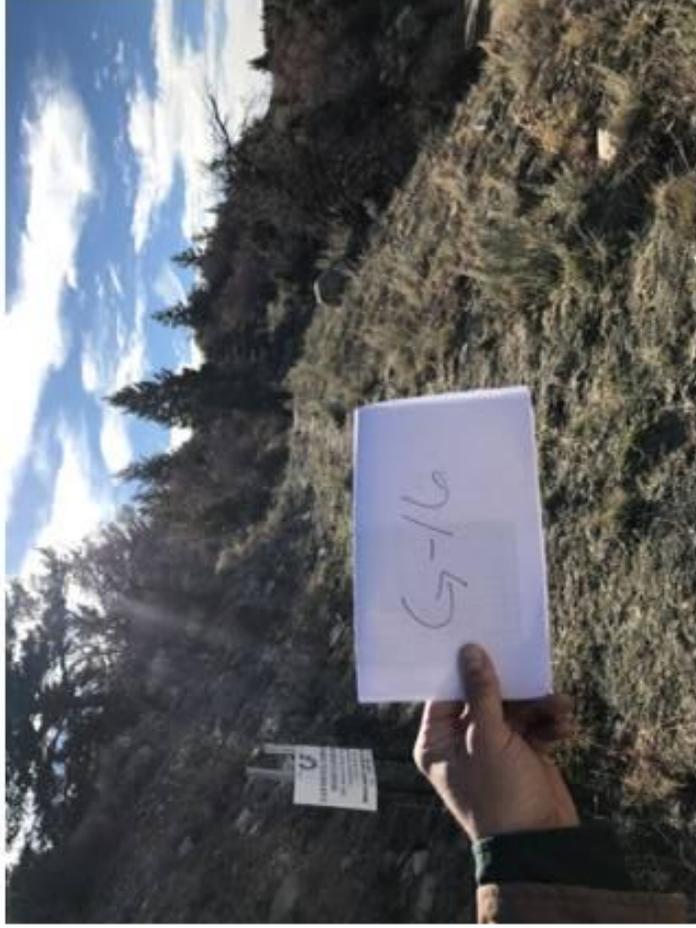
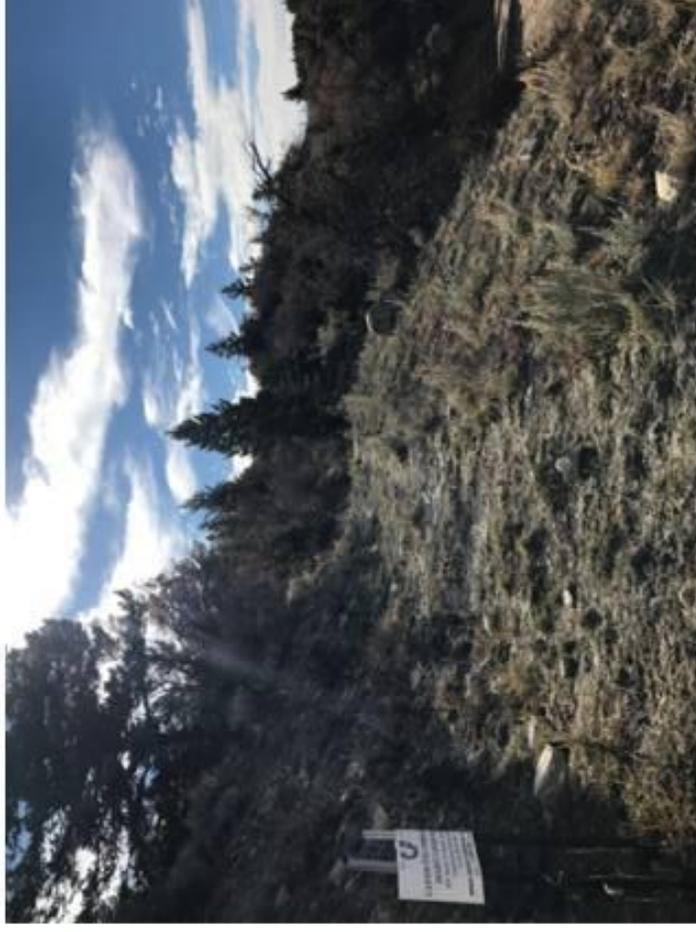
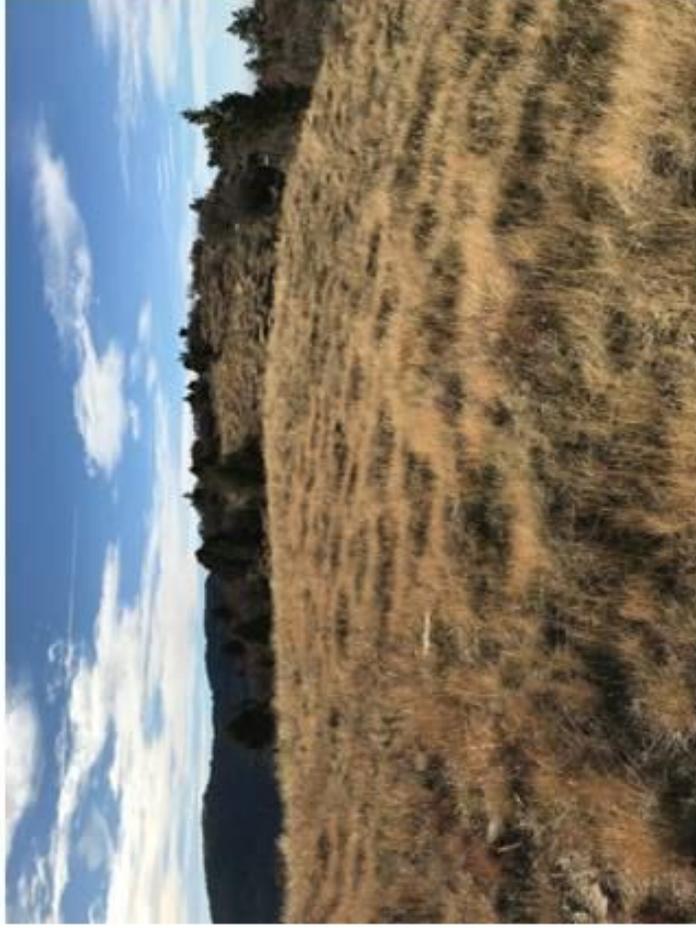
Site G-16

G-16: The degas pad was reclaimed in June of 2013. The access road to the pad was reclaimed in 2014. Phase I bond release was approved in 2014. The reclaimed access road was found to be stable with no sign of off-site impacts. The degas pad was found to be stable with no off-site impacts and strong vegetation growth.

G-16: This site is fenced, stable and well vegetated. This site is located on a knoll of predominately conifer and juniper interspersed with pockets of sagebrush and serviceberry. The reclaimed site is mainly a grass/forb vegetative community.

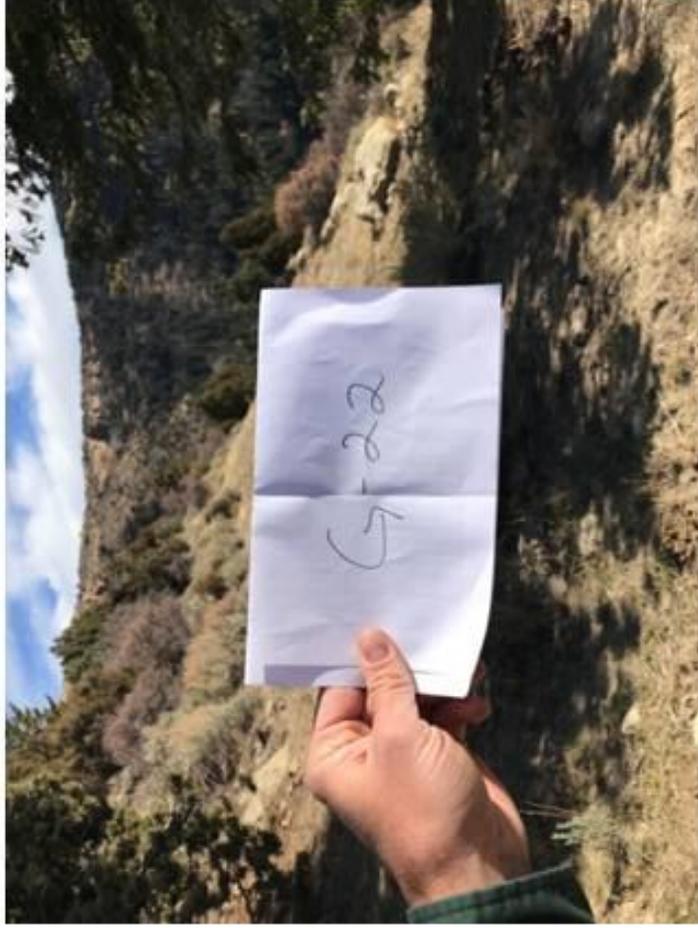
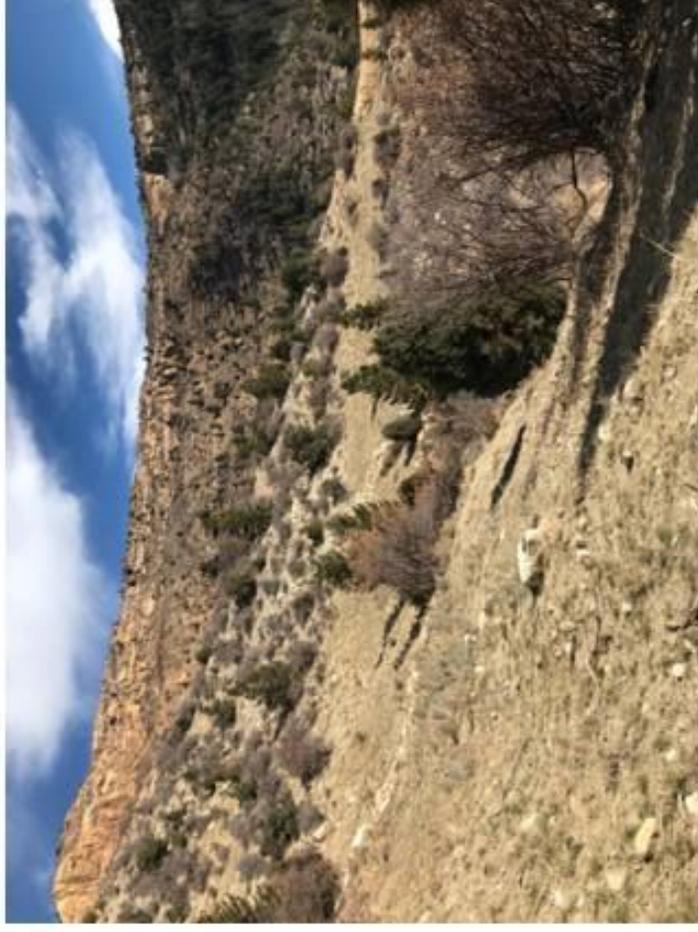
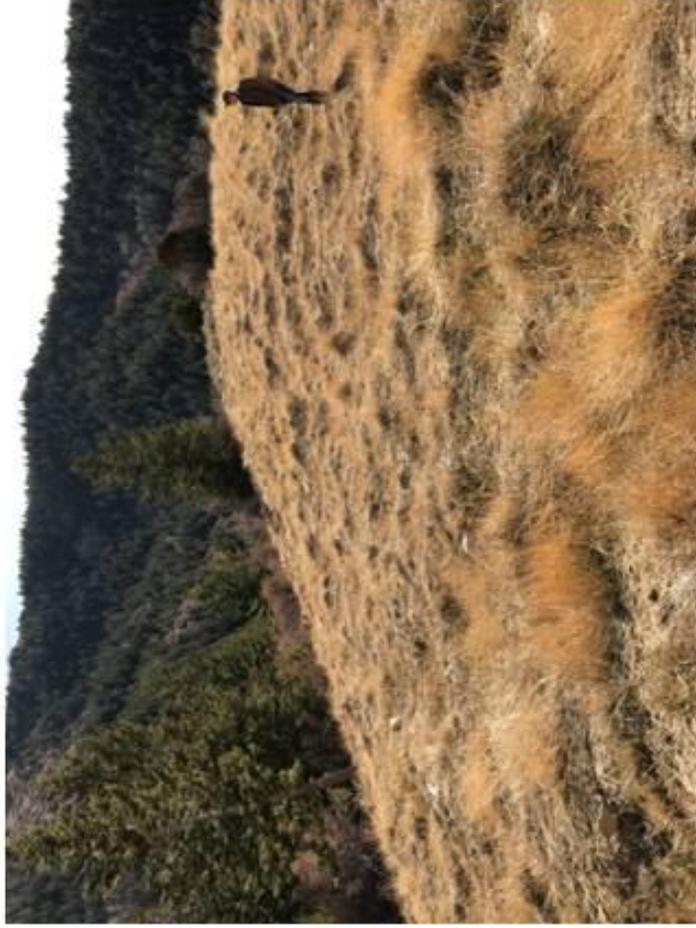
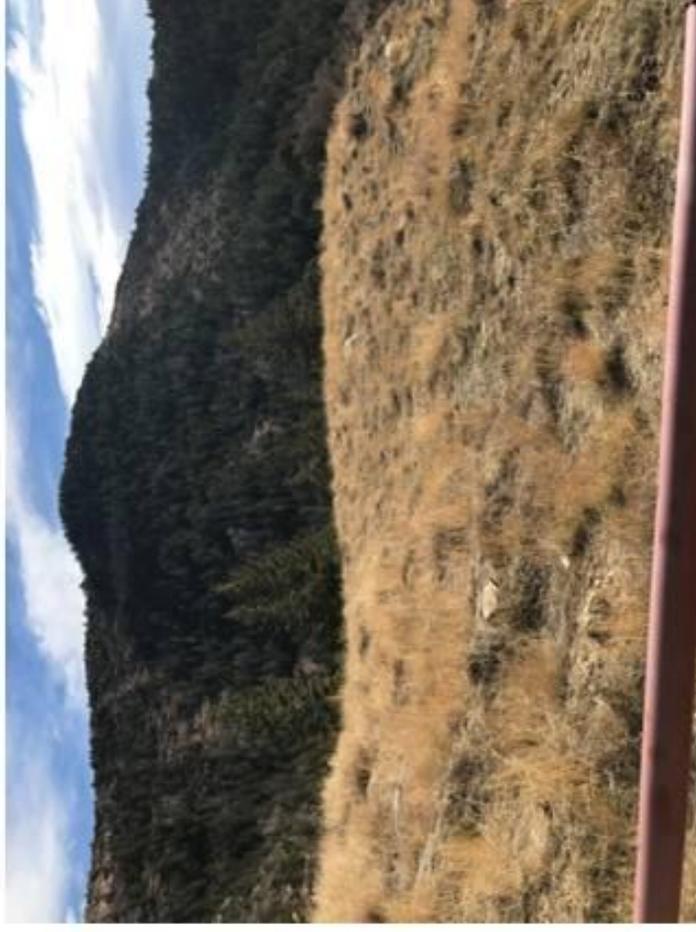
Site G-22

G-22: The access road between G-16 and G-22 has been reclaimed and showed no erosion impacts. The vegetation on the road was heavily grazed but the site itself has been relatively well protected from grazing and is growing well. No signs of erosion or off-site impacts were noted during the field inspection.

G-22: This site is fenced, stable and well vegetated. This site is also located on a knoll of predominately conifer and juniper interspersed with pockets of sagebrush and serviceberry. The reclaimed site is mainly a grass/forb vegetative community. The access road to these two sites (16 & 22) has been reclaimed and is fairly heavily grazed by comparison to the fenced pads.

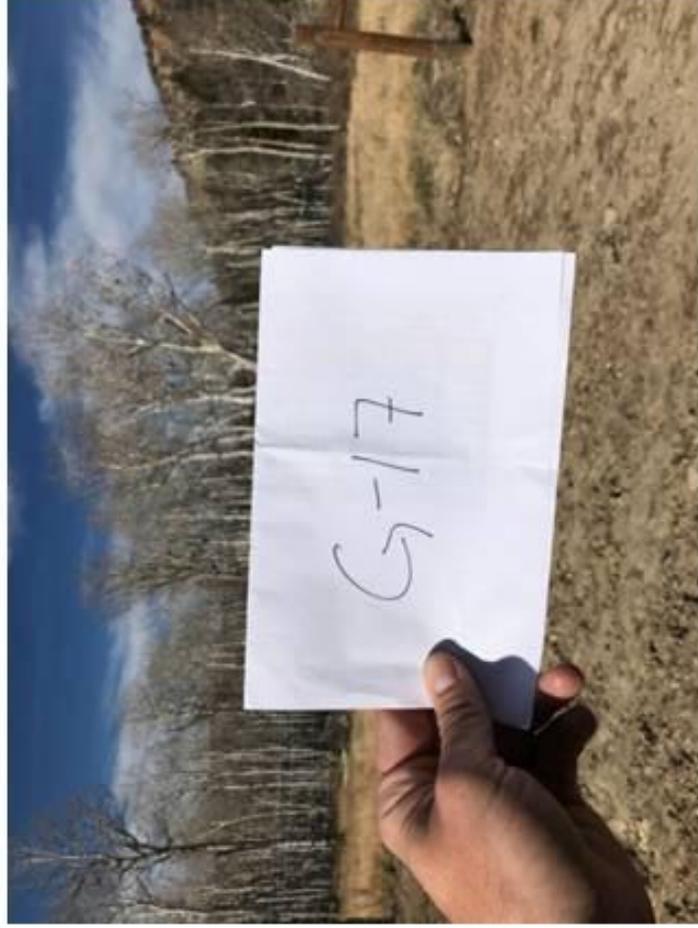
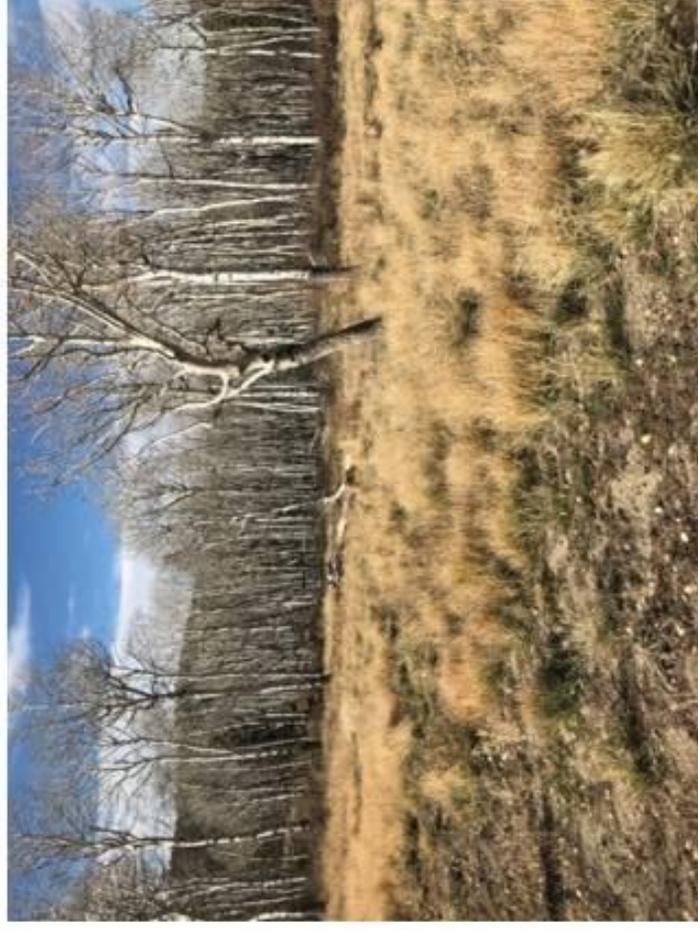
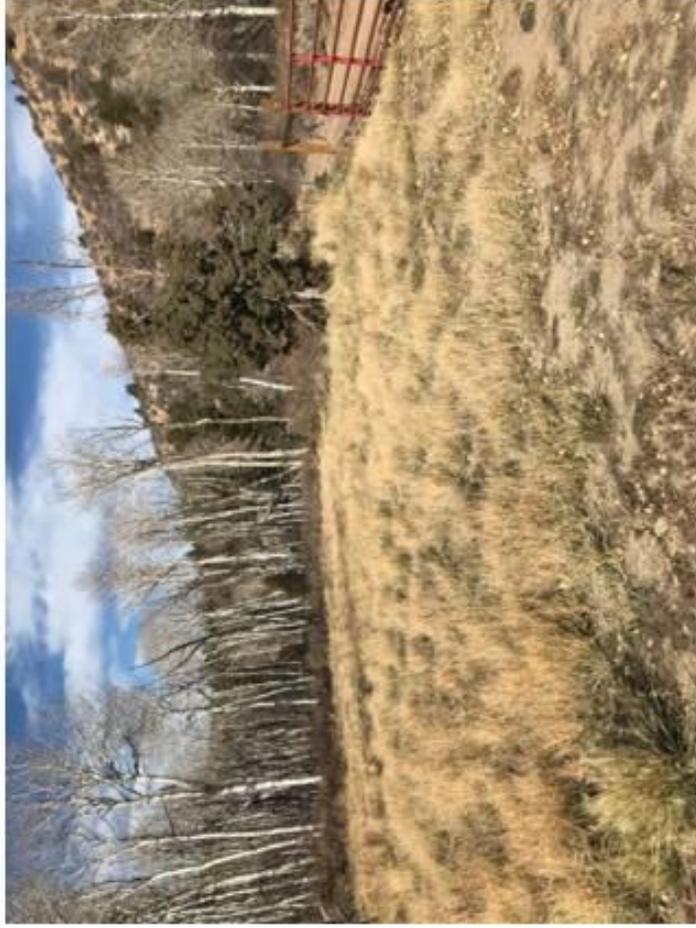
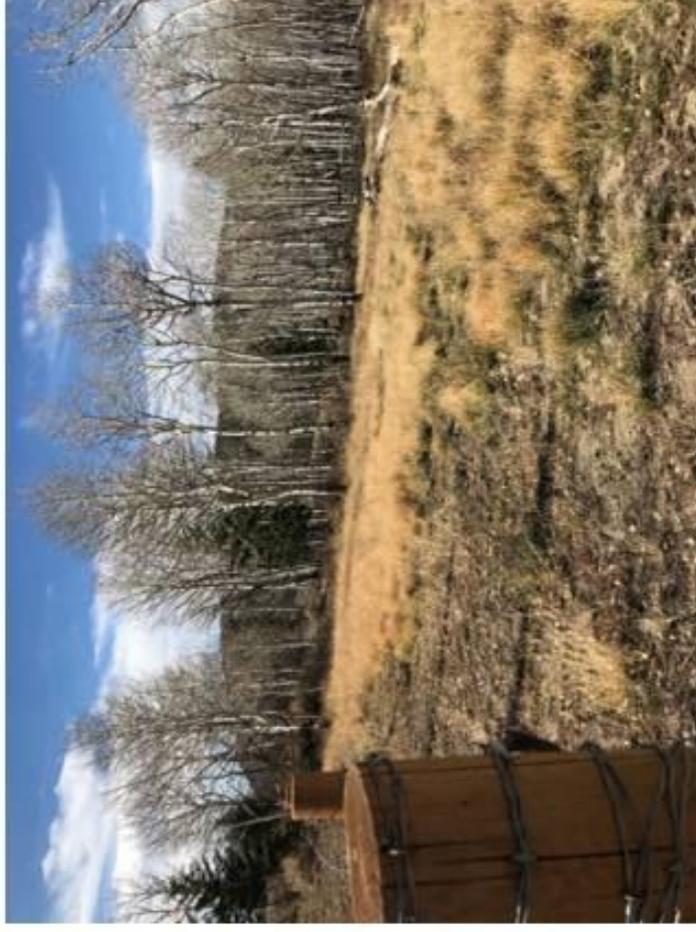
Site G-17

G-17: The site was fully reclaimed in October of 2014. The site has not received any bond release. The site has been utilized as a storage area for topsoil from degas pad G-22. The site was observed to be in stable condition and was well-vegetated with no off-site impacts noted.

G-17: This site is fenced, stable and well vegetated. This is a sagebrush/grass community mostly in the understory of a stand of aspen.

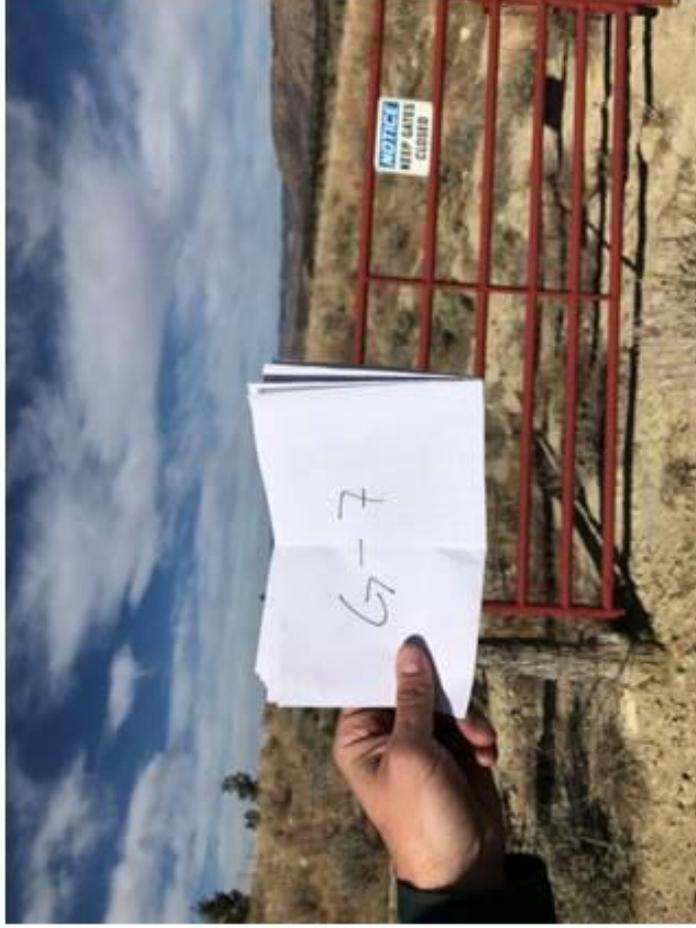
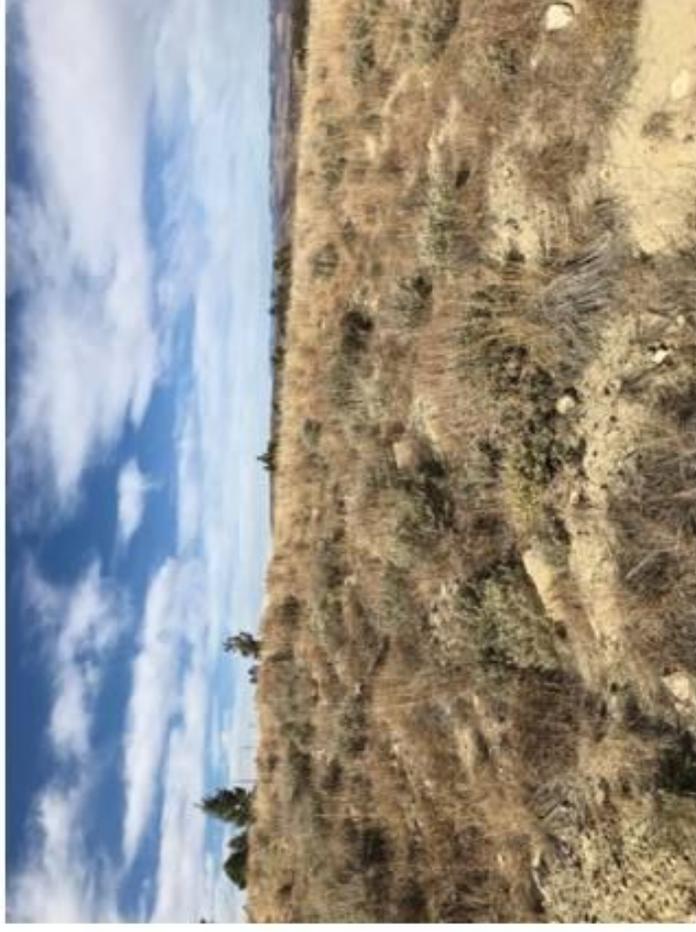
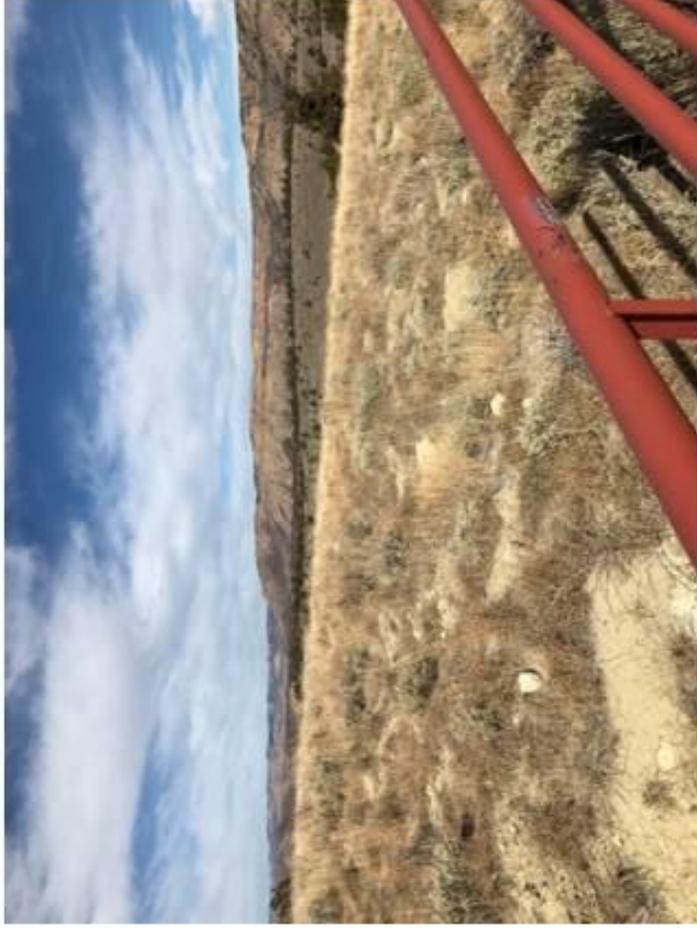
Site G-7

G-7: The site was reclaimed in 2009 and received Phase II bond release in 2014. No evidence of off-site impacts was observed during the field inspection. The site is well-vegetated.

G-7: This site is fenced, stable and well vegetated. This site is predominately grass/sagebrush. The outlying vegetative community is mixed conifer sagebrush with some grasses and forbs in the understory.

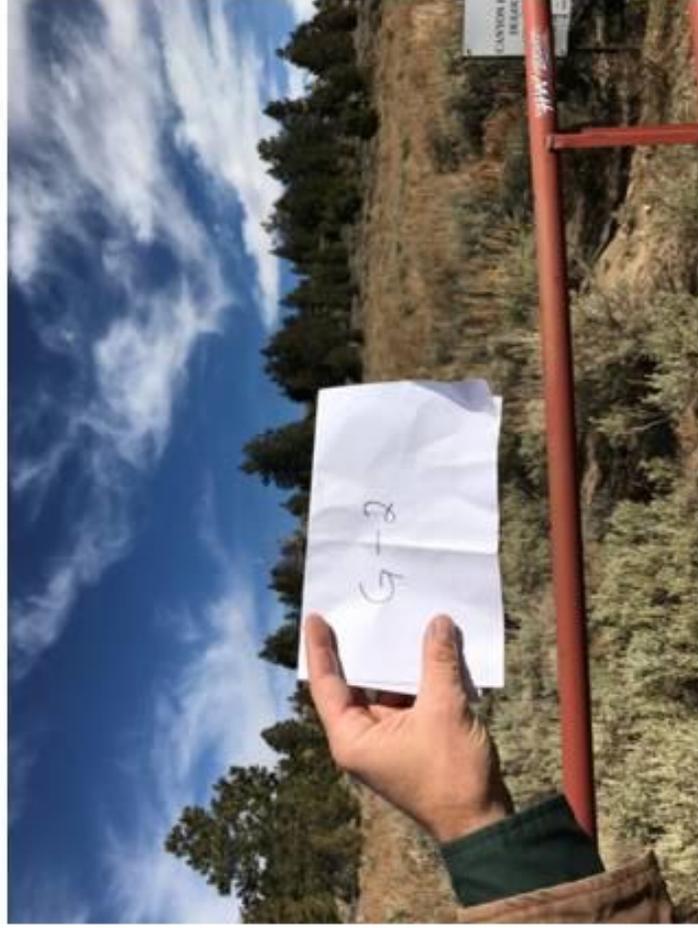
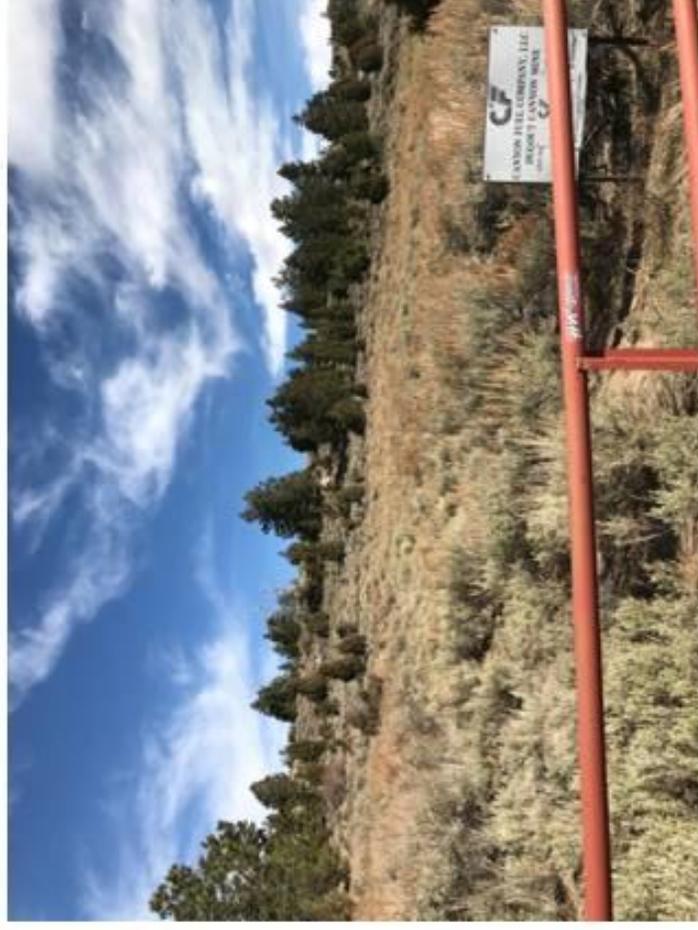
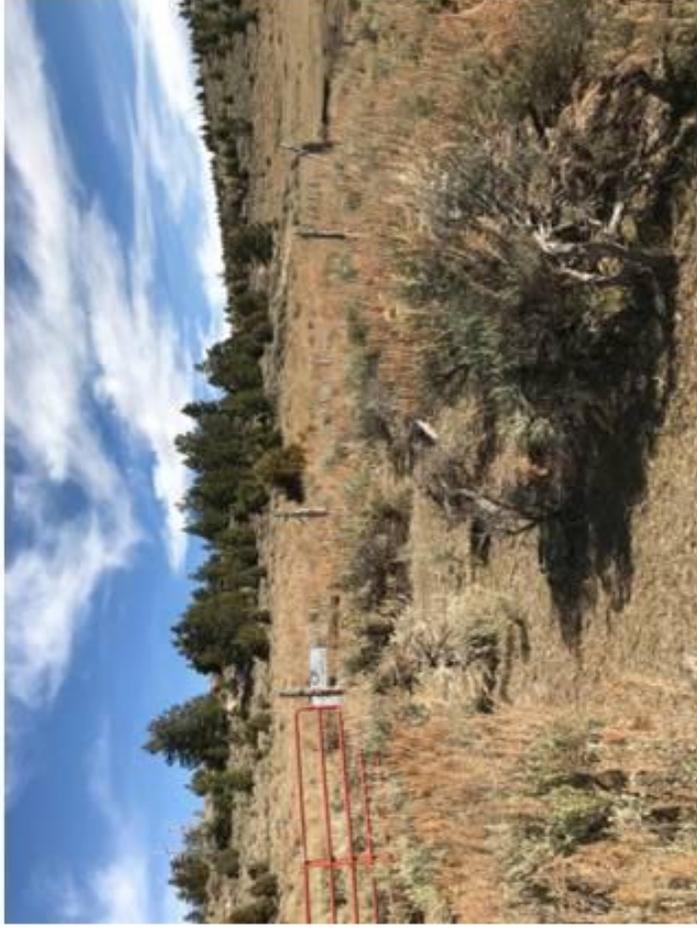
Site G-2

G-2: The site was reclaimed in June of 2009. No evidence of off-site impacts was observed during the field inspection. Musk thistle had been an issue at this site in years past. However, during the field inspection, no evidence of musk thistle was observed. The site was noted to be in stable condition with no evidence of erosion or off-site impacts. There is a wash adjacent to the site that may, in the future, impact the site especially if a heavy flooding event were to come through the area. As of this inspection, however, there is no impact to the site from the wash.

G-2: This site is fenced, stable and well vegetated. This site is also predominately grass/sagebrush. The outlying vegetative community is mixed conifer sagebrush with some grasses and forbs in the understory.

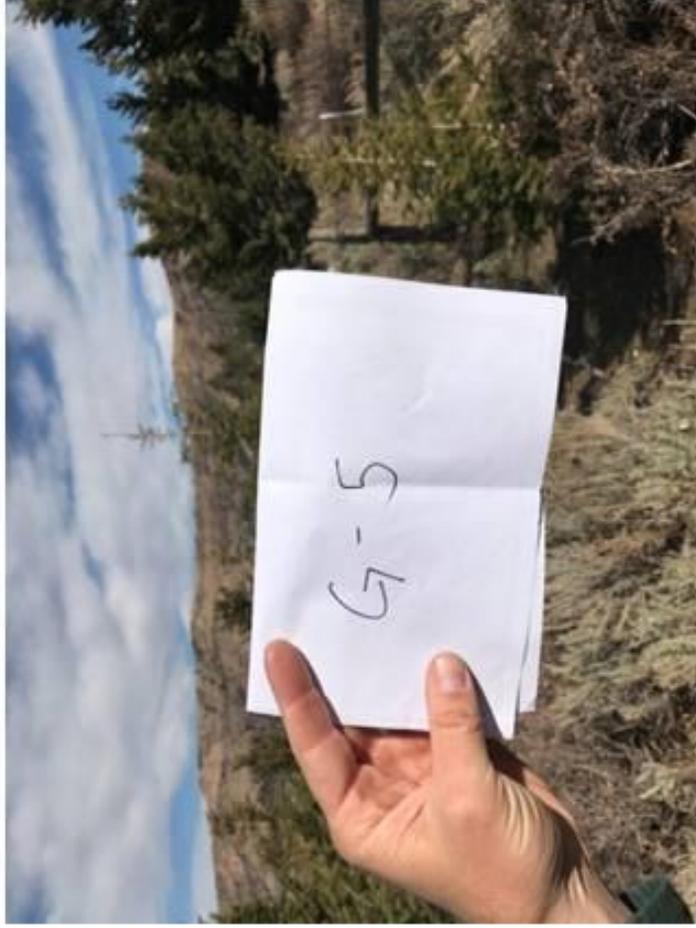
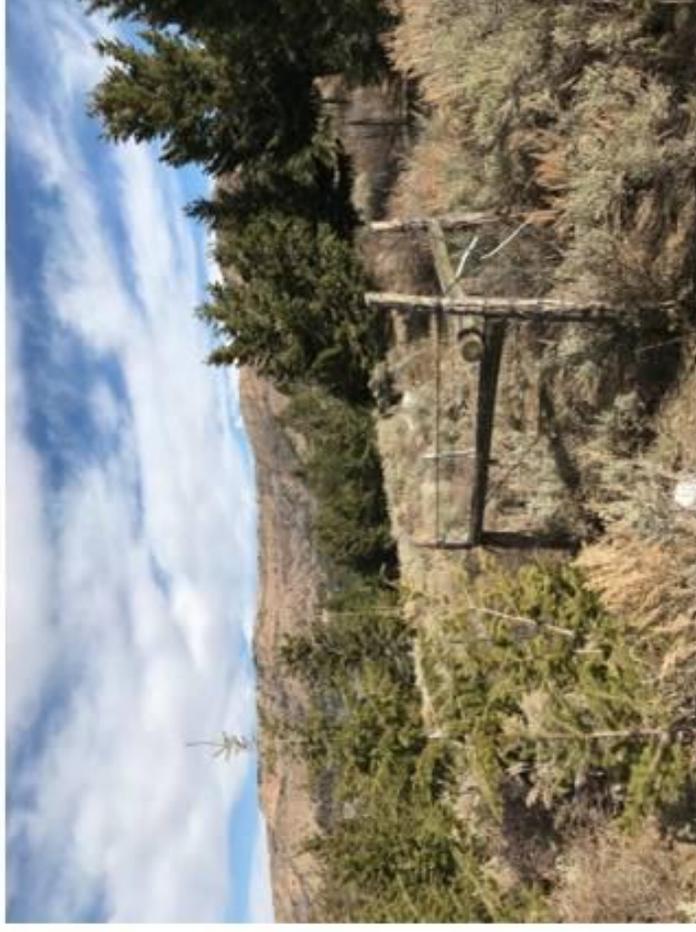
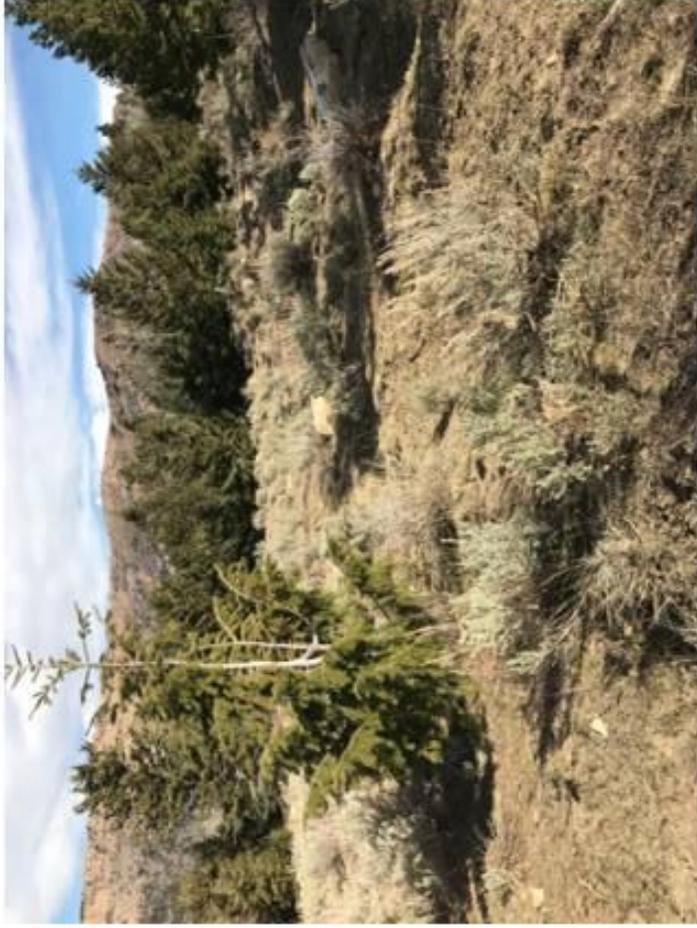
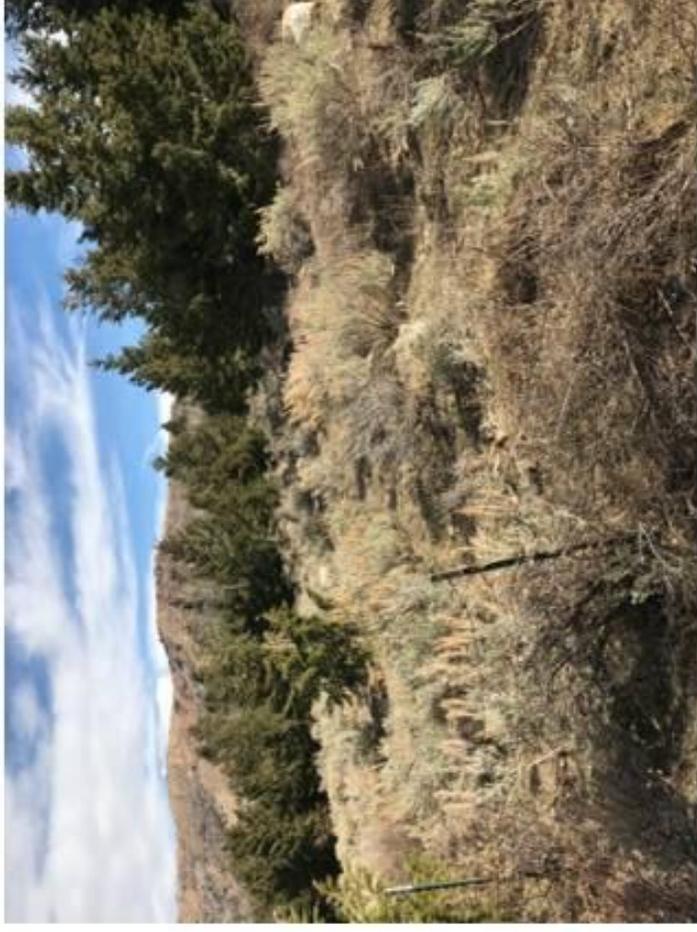
Site G-5

G-5: The site was reclaimed in June of 2009. Phase II bond release was approved in 2014. No evidence of erosion or instability was observed during the field inspection. The fence has been knocked down in some areas leading to grazing within the site. The site, however, is dominated by sagebrush and the impacts of the grazing are relatively low.

G-5: This site is fenced, stable and well vegetated. This site is predominately a mature sagebrush snowberry vegetative community with some grass/forb understory perhaps due to some grazing. The shrubs are approximate 4' tall. The outlying vegetative community is conifer with a grass/forb understory.

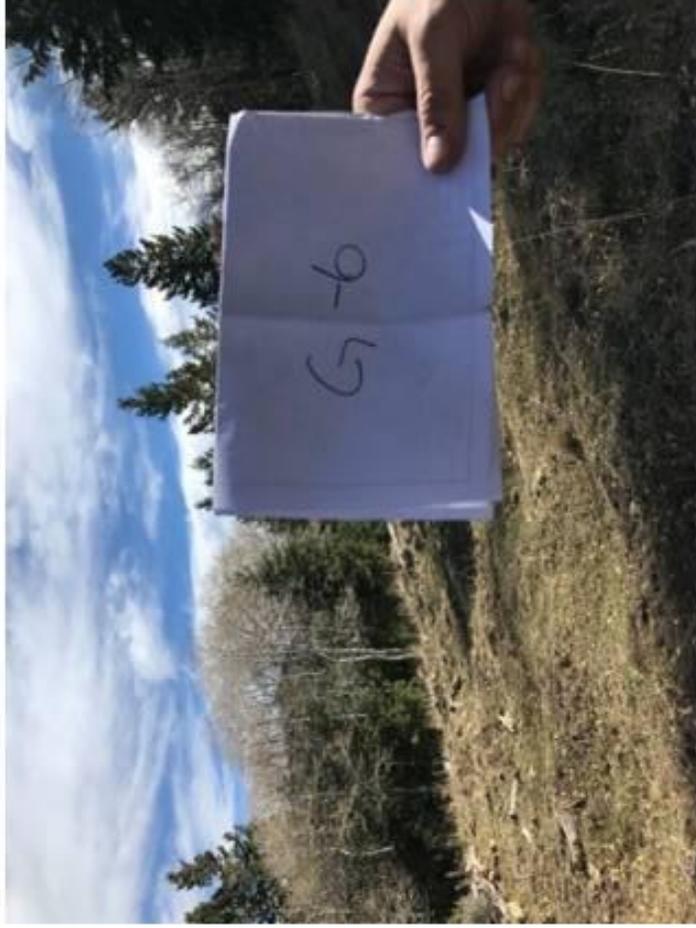
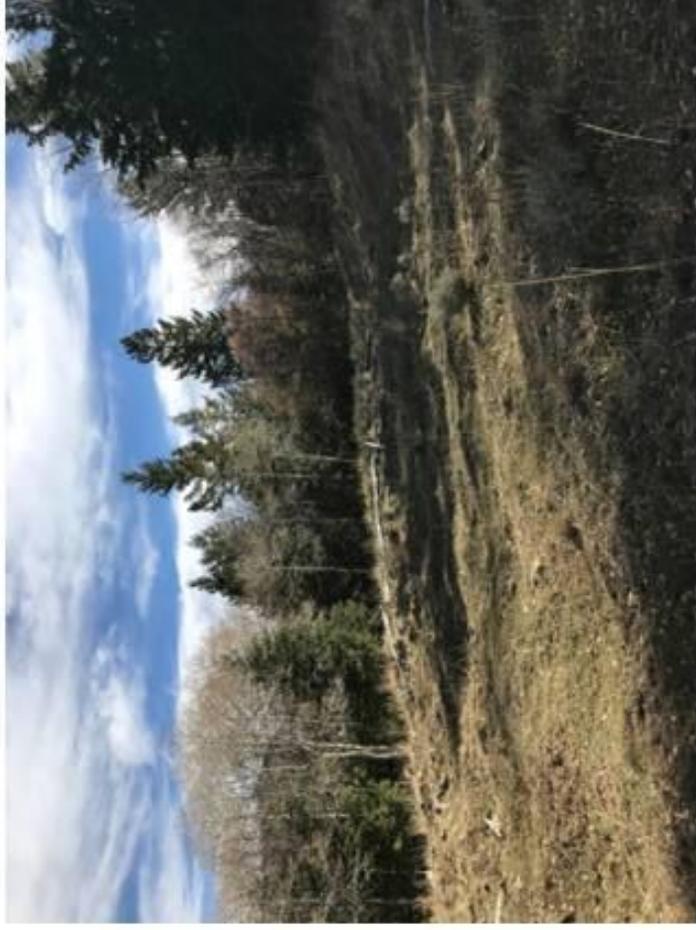
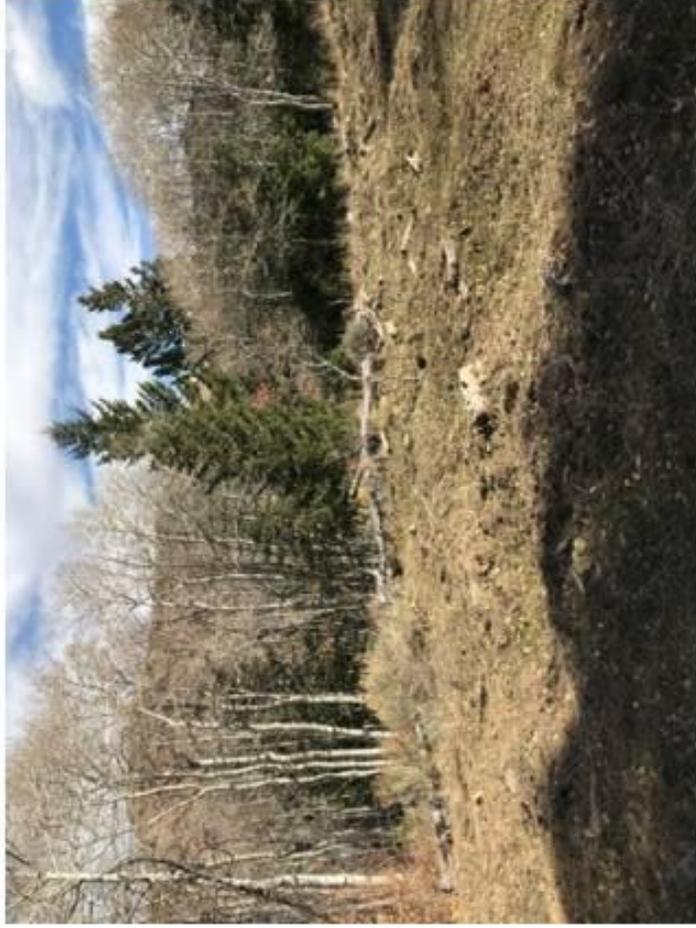
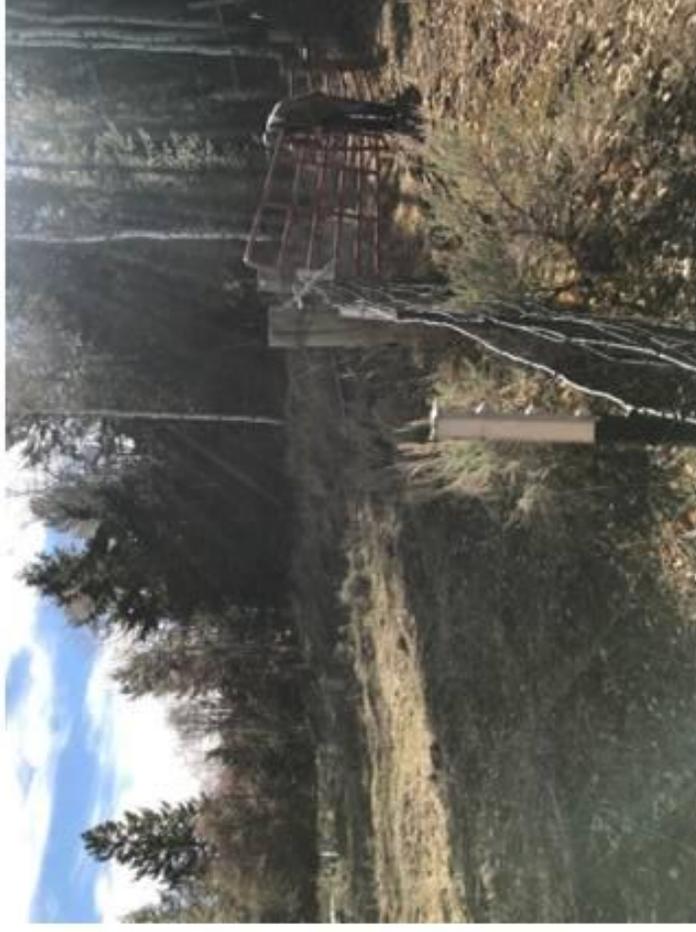
Site G-6

G-6: The site was reclaimed in June of 2007. Phase II bond release was granted in 2014. The fence has been knocked down in one place which has allowed heavy grazing to occur within the site. No evidence of instability or erosion was observed during the field inspection.

G-6: This site is fenced, stable and well vegetated. It is currently a sagebrush grass

vegetative community with some evidence of forbs. Volunteer trees (conifer & aspen) and shrubs (snowberry & service berry) may add to the species composition during the remaining portion of the liability period. The outlying vegetative community is mixed conifer aspen with a grass/forb understory.
