# Inspection Report

Permit Number:	<b>C0070039</b>
Inspection Type:	PARTIAL
Inspection Date:	Tuesday, December 3, 2019
Start Date/Time:	12/3/2019 10:30:00 AM
End Date/Time:	12/3/2019 12:30:00 PM
Last Inspection:	Wednesday, November 6, 2019

Permitee: **CANYON FUEL COMPANY**  
 Operator: **CANYON FUEL COMPANY**  
 Site: **DUGOUT CANYON MINE**  
 Address: **PO BOX 1029, WELLINGTON UT 84542**  
 County: **CARBON**  
 Permit Type: **PERMANENT COAL PROGRAM**  
 Permit Status: **ACTIVE**

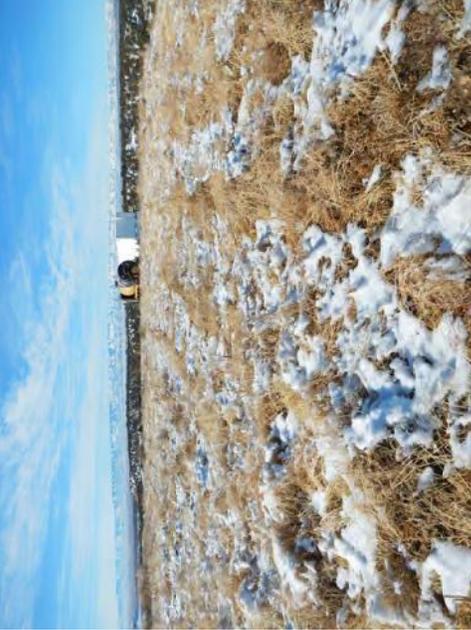
The top of the waste rock site was surface roughened to incorporate straw before seeding. A small, approximately 0.65 acre, 2-foot-cover-test-plot on the North face of the waste rock pile was also seeded and blanketed in January 2018. The 2-foot-cover-test-plot was observed to have vegetative and snow cover. The reclaimed surface on the East face (3.5 feet of cover) was likewise vegetated, but without snow cover.

<p>Looking North at the reclaimed portion of the East face</p>

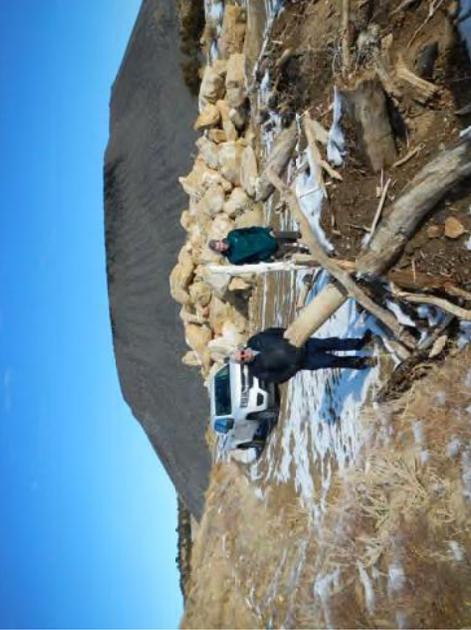
The slopes of the waste rock site were graded smooth and covered with mulch blanket after seeding in January 2018. In total, 1.9 acres were contemporaneously reclaimed in stage 1 of the Phase II expansion. The contemporaneous reclamation area includes the top of the waste rock pile at the North end (final height 5,996 ft.) and a portion of the North and East facing slopes.

<p>Looking West across reclaimed portion of the top of the refuse</p>
