Division of Oil, Gas and Mining

Inspection Report

Permit Number:	C0070039
Inspection Type:	COMPLETE
Inspection Date:	Tuesday, August 4, 2020
Start Date/Time:	8/4/2020 6:30:00 AM
End Date/Time:	8/5/2020 10:00:00 PM
Last Inspection:	Wednesday, July 15, 2020

Permitee: **CANYON FUEL COMPANY**
 Operator: **CANYON FUEL COMPANY**
 Site: **DUGOUT CANYON MINE**
 Address: **PO BOX 1029, WELLINGTON UT 84542**
 County: **CARBON**
 Permit Type: **PERMANENT COAL PROGRAM**
 Permit Status: **ACTIVE**

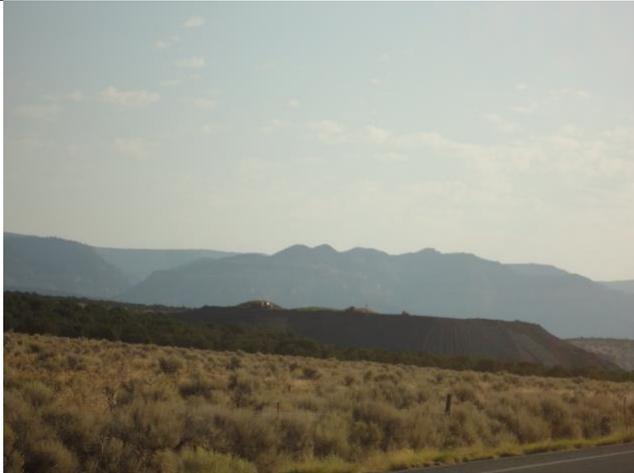
PHOTO 1

The waste rock pile is well graded, compacted and sloped. The site was not active at the time of the complete inspection and has been inactive for about two weeks. Reclamation of the out slopes and partial top of the pile is temporarily suspended.

Dugout Waste Rock Site Overview

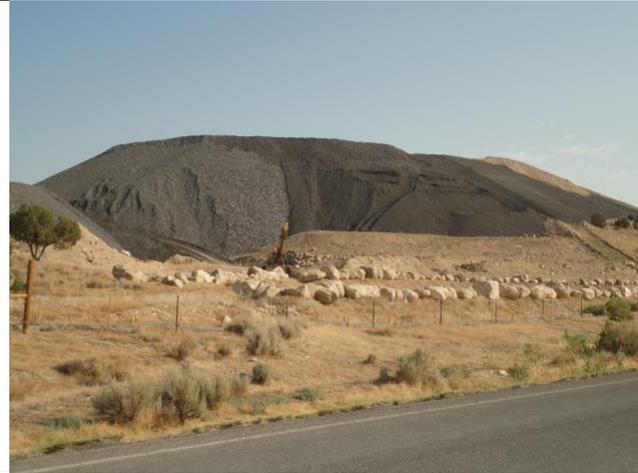
PHOTO 2

Dugout Waste Rock Site Overview

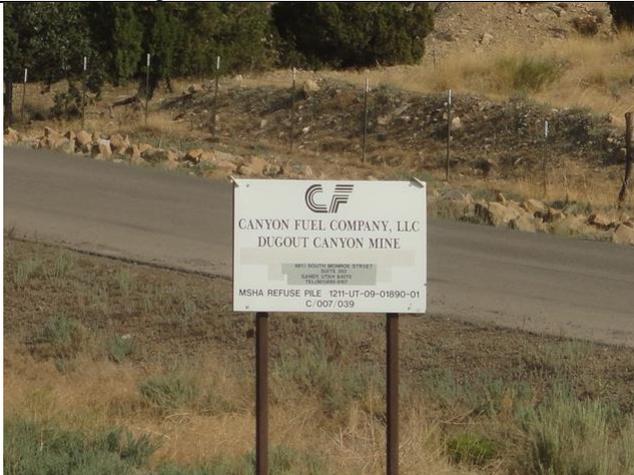
PHOTO 3

The identification signs leading into the permit areas associated with the Dugout Mine were checked at numerous places. Signs were posted at the mine site, waste rock site, topsoil storage pile area, Pace Canyon Port/Fan Shaft Area, Degas Sites. The signs post the name Address, phone number and mining permit number for the Dugout Operations. The signs are in compliance.

Dugout Waste Rock Site Identification Sign

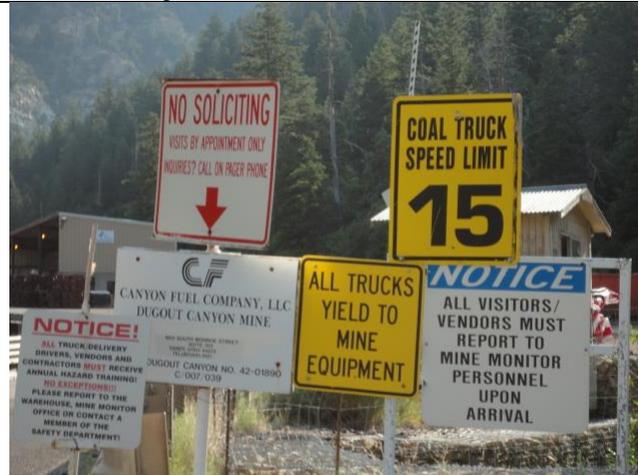
PHOTO 4

Dugout Mine Site Identification Sign

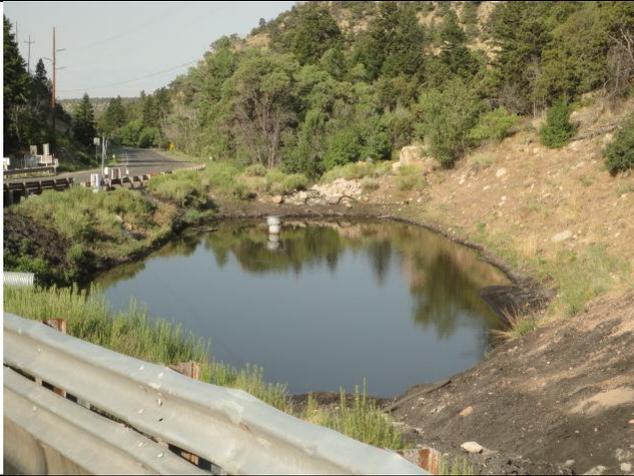
PHOTO 5

The main sediment pond located at the mine site contained water. The two sediment ponds located at the waste rock site were dry. Embankments at all sediment ponds were checked and found to be stable.

Dugout Sediment Pond

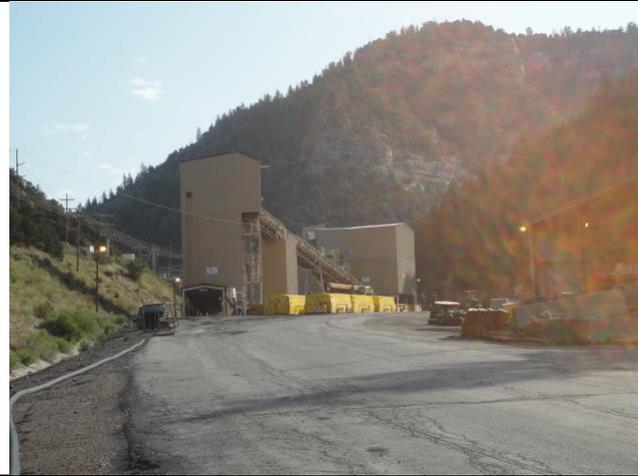
PHOTO 6

Dugout Mine Overview

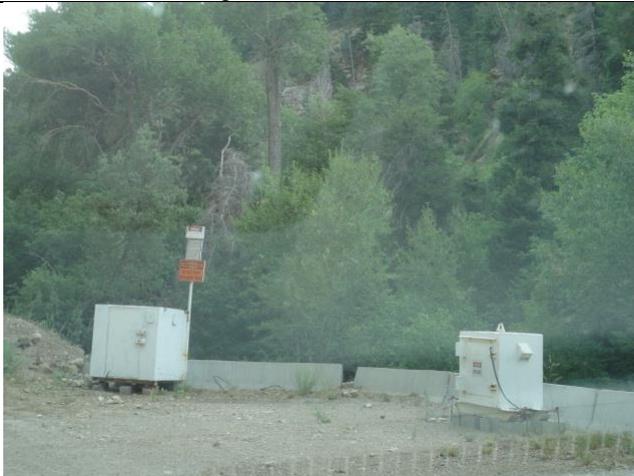
PHOTO 7

The explosive storage area was checked during the complete inspection. The area has proper signs posted in accordance with the regulations and the magazines are grounded against a lightning strike.

Dugout Explosive Storage Area

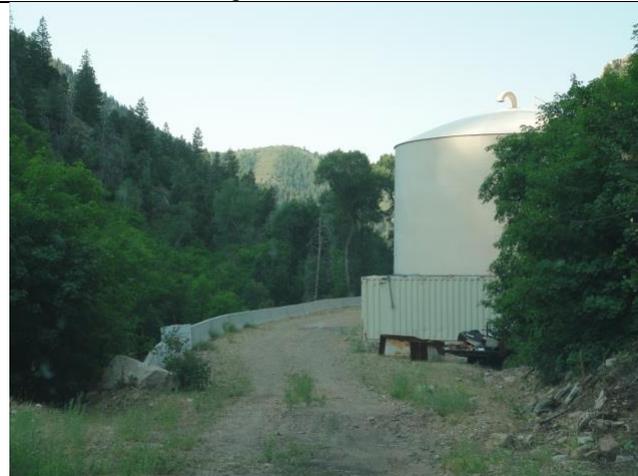
PHOTO 8

Dugout Water Tanks

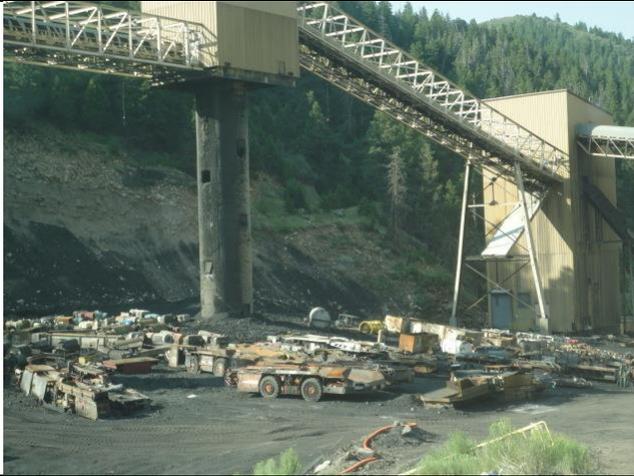
PHOTO 9

Dugout Mine Overview

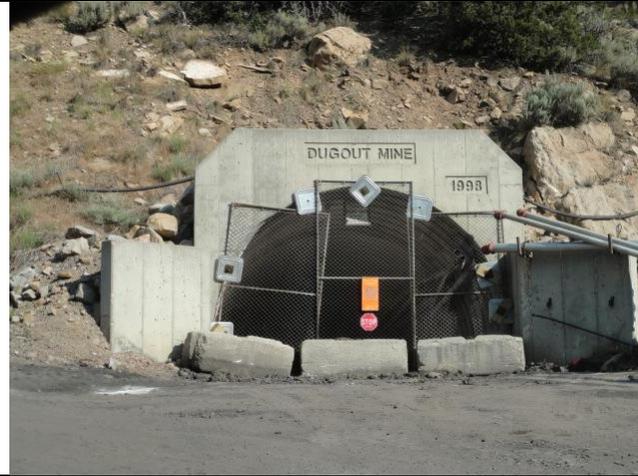
PHOTO 10

The underground water pumps have been shut off and the portal entrances at the Dugout Mine are covered with gating.

Dugout Travel Portal Closure

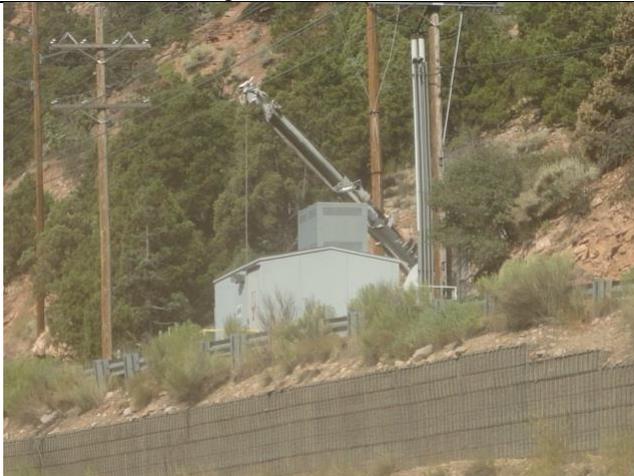
PHOTO 11

The mine fan has been shut down. The sub-station that provided power to the fan is being disassembled and removed from the mine site. This sub-station is sub-station number two, which is the smaller of the sub-stations.

Dugout Sub-Station Removal (#2 Smaller Sub-Station for Fan)

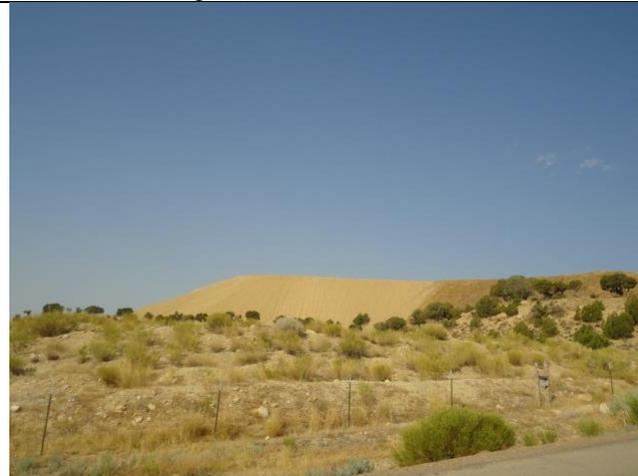
PHOTO 12

Dugout Waste Rock Site Overview

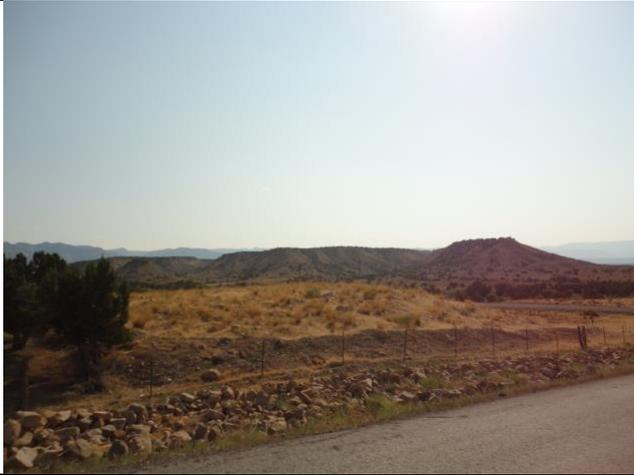
PHOTO 13

Dugout Waste Rock Site Topsoil Pile

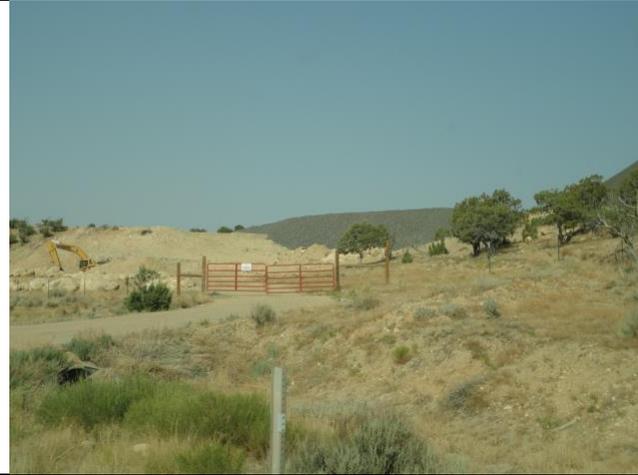
PHOTO 14

Dugout Waste Rock Site Overview

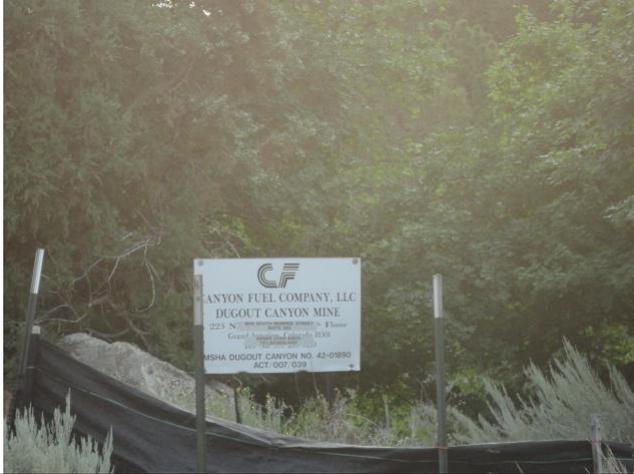
PHOTO 1

Dugout Degas Identification Sign

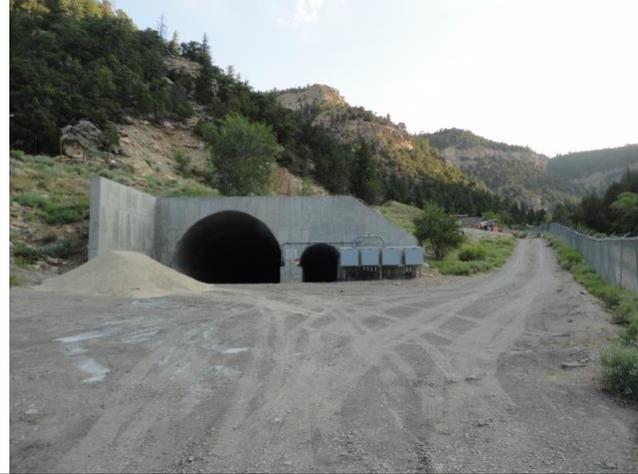
PHOTO 2

Pace Canyon Portal

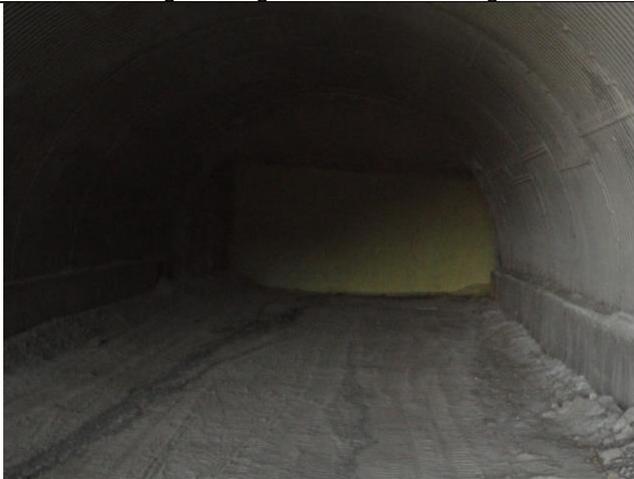
PHOTO 3

The Pace Canyon Portal has a permanent seal installed in accordance with MSHA design and approval. The fan shaft at Pace Canyon has been completely filled/plugged and then a concrete cap has been poured over top of the shaft in accordance with BLM requirements.

Pace Canyon Portal Seal

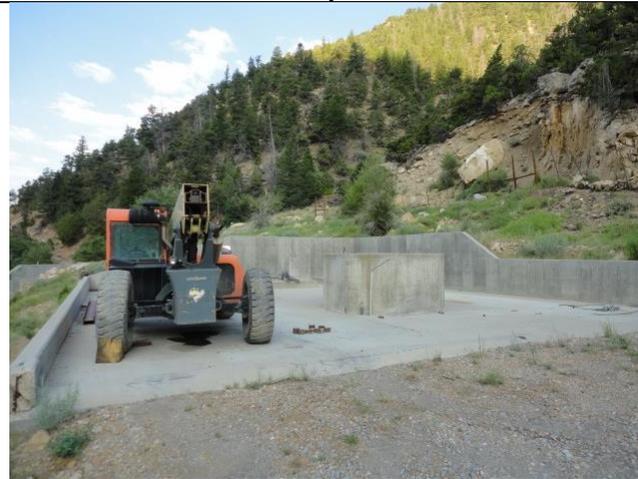
PHOTO 4

Pace Canyon Generator Pad

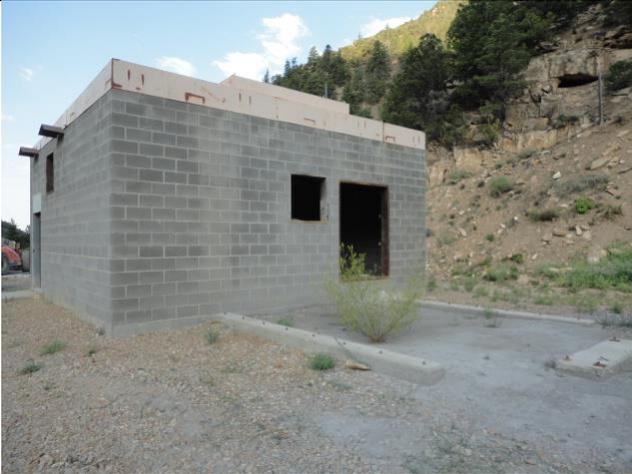
PHOTO 5

Pace Canyon Fan Motor House

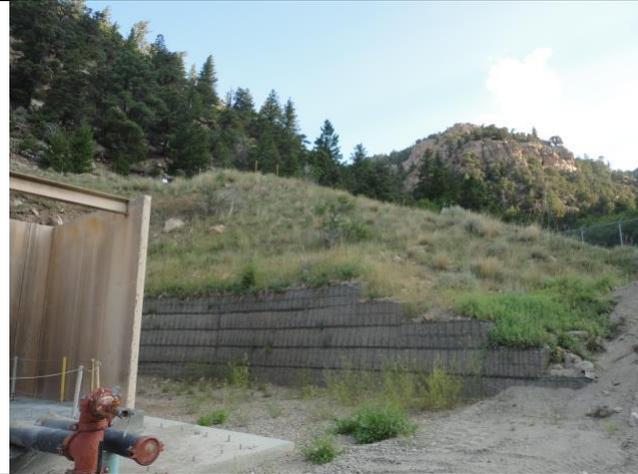
PHOTO 6

Pace Canyon Topsoil Pile

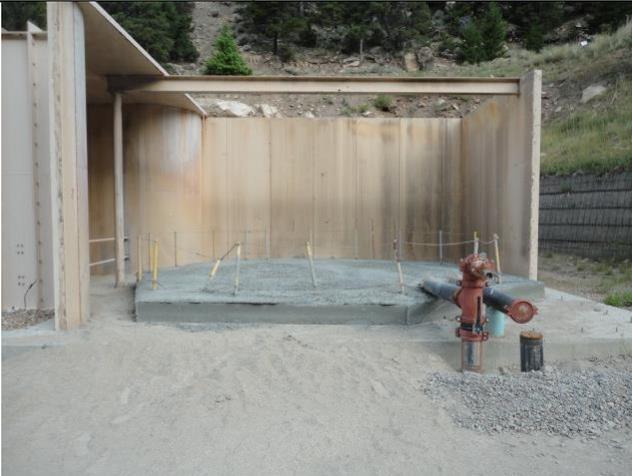
PHOTO 7

Pace Canyon Fan Shaft Concrete Cap

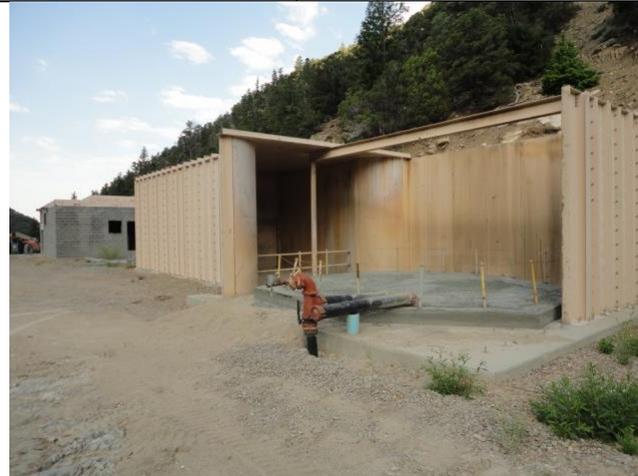
PHOTO 8

Pace Canyon Fan Shaft Concrete Cap/Fan Housing

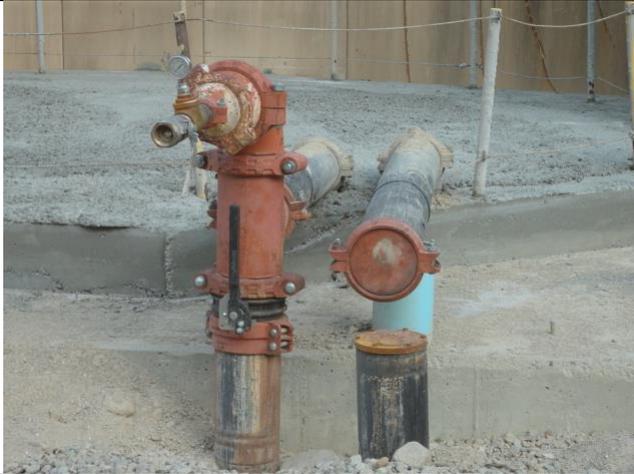
PHOTO 9

Pace Canyon Fan Shaft Monitoring Pipes (Pressure & Depth)

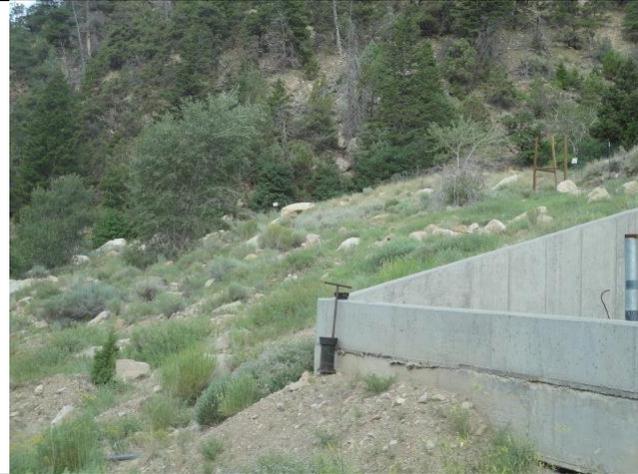
PHOTO 10

Pace Canyon Additional Topsoil Pile

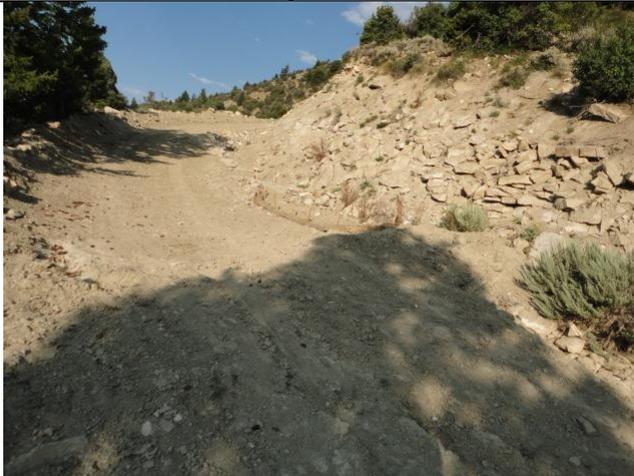
PHOTO 15

One portion of the AMV road was not traversed do to the depth of the water bar and potential to high center and/or damage the vehicle.

Degas Road Water Bar To Deep To Pass Through

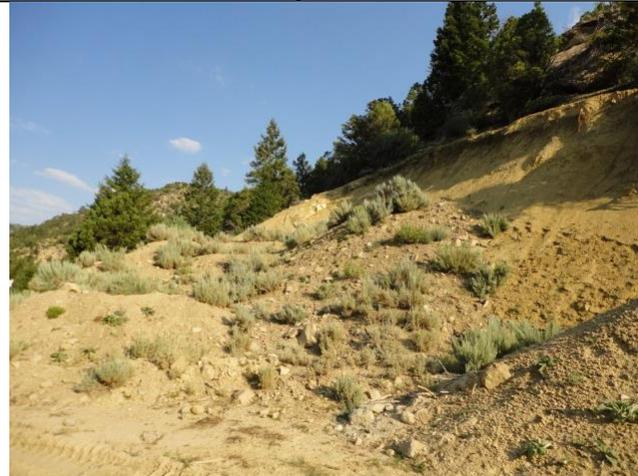
PHOTO 16

G-11 Site (No Hole/Topsoil & Subsoil Storage)

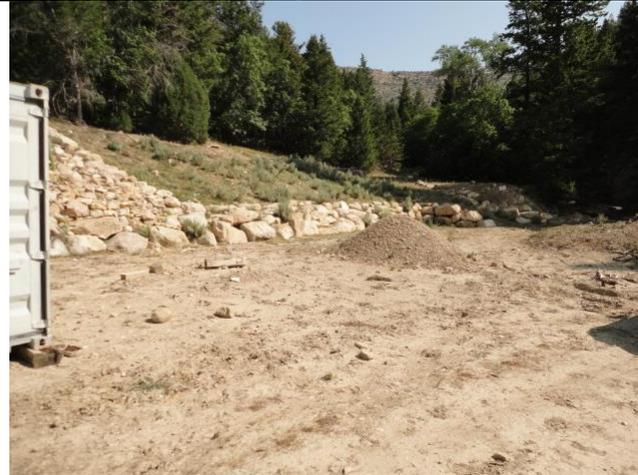
PHOTO 24

Degas G-15 (Never Drilled/Reclaimed)

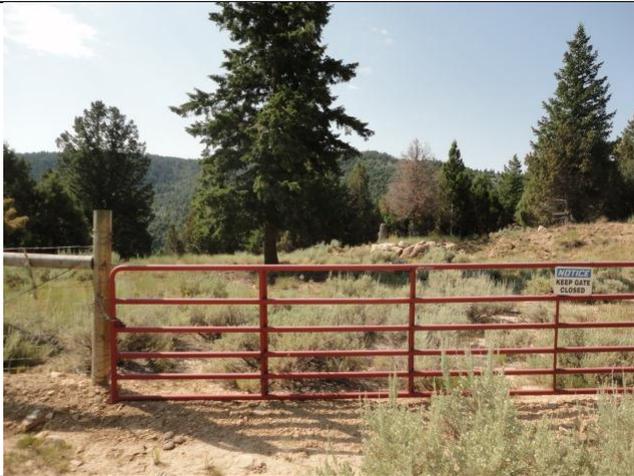
PHOTO 25

Degas G-13
(Road Dissects. Left Side Looking Up Canyon)

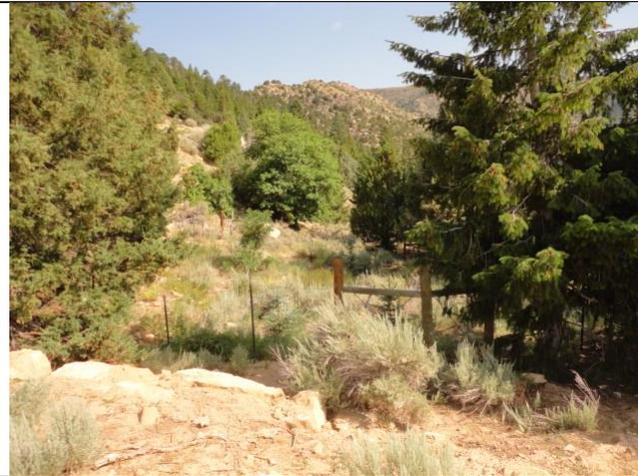
PHOTO 26

Degas G-13
(Road Dissects. Right Side Looking Up Canyon. Blue Spruce)

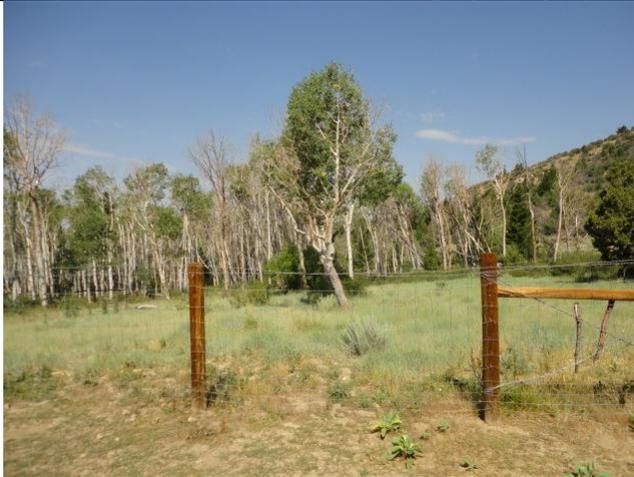
PHOTO 27

Degas G-17
(Aspen Trees Were Left during Construction and Operation)
