Inspection Report

Permit Number: C0070041
Inspection Type: TECHNICAL
Inspection Date: Thursday, July 12, 2007
Start Date/Time: 07/12/2007 7:00:00 AM
End Date/Time: 07/12/2007 4:00:00 PM
Last Inspection: Friday, June 22, 2007

Permittee: **WEST RIDGE RESOURCES**
Operator: **WEST RIDGE RESOURCES**
Site: **WEST RIDGE MINE**
Address: **PO BOX 1077, PRICE UT 84501**
County: **CARBON**
Permit Type: **PERMANENT COAL PROGRAM**
Permit Status: **ACTIVE**

The purpose of the site visit was to inspect the condition of the Bear Canyon drainage following undermining by longwall mining that began in November 2006 for panel #8, and April 2007 for panel #9. The ephemeral stream channel is approximately 325 feet above panel #8 at the point of shallowest cover. As a condition of the West Ridge MRP, noted in chapter 7, page 7-12C, the Permittee must visually inspect the stream channel following undermining and mitigate any adverse impacts to the hydrologic balance caused by subsidence. In addition, the Permittee must conduct a pre- and post-mining subsidence survey of the canyon bottom. A report is to be submitted to the Division within 30 days of the inspection. The pre and post-mining subsidence su

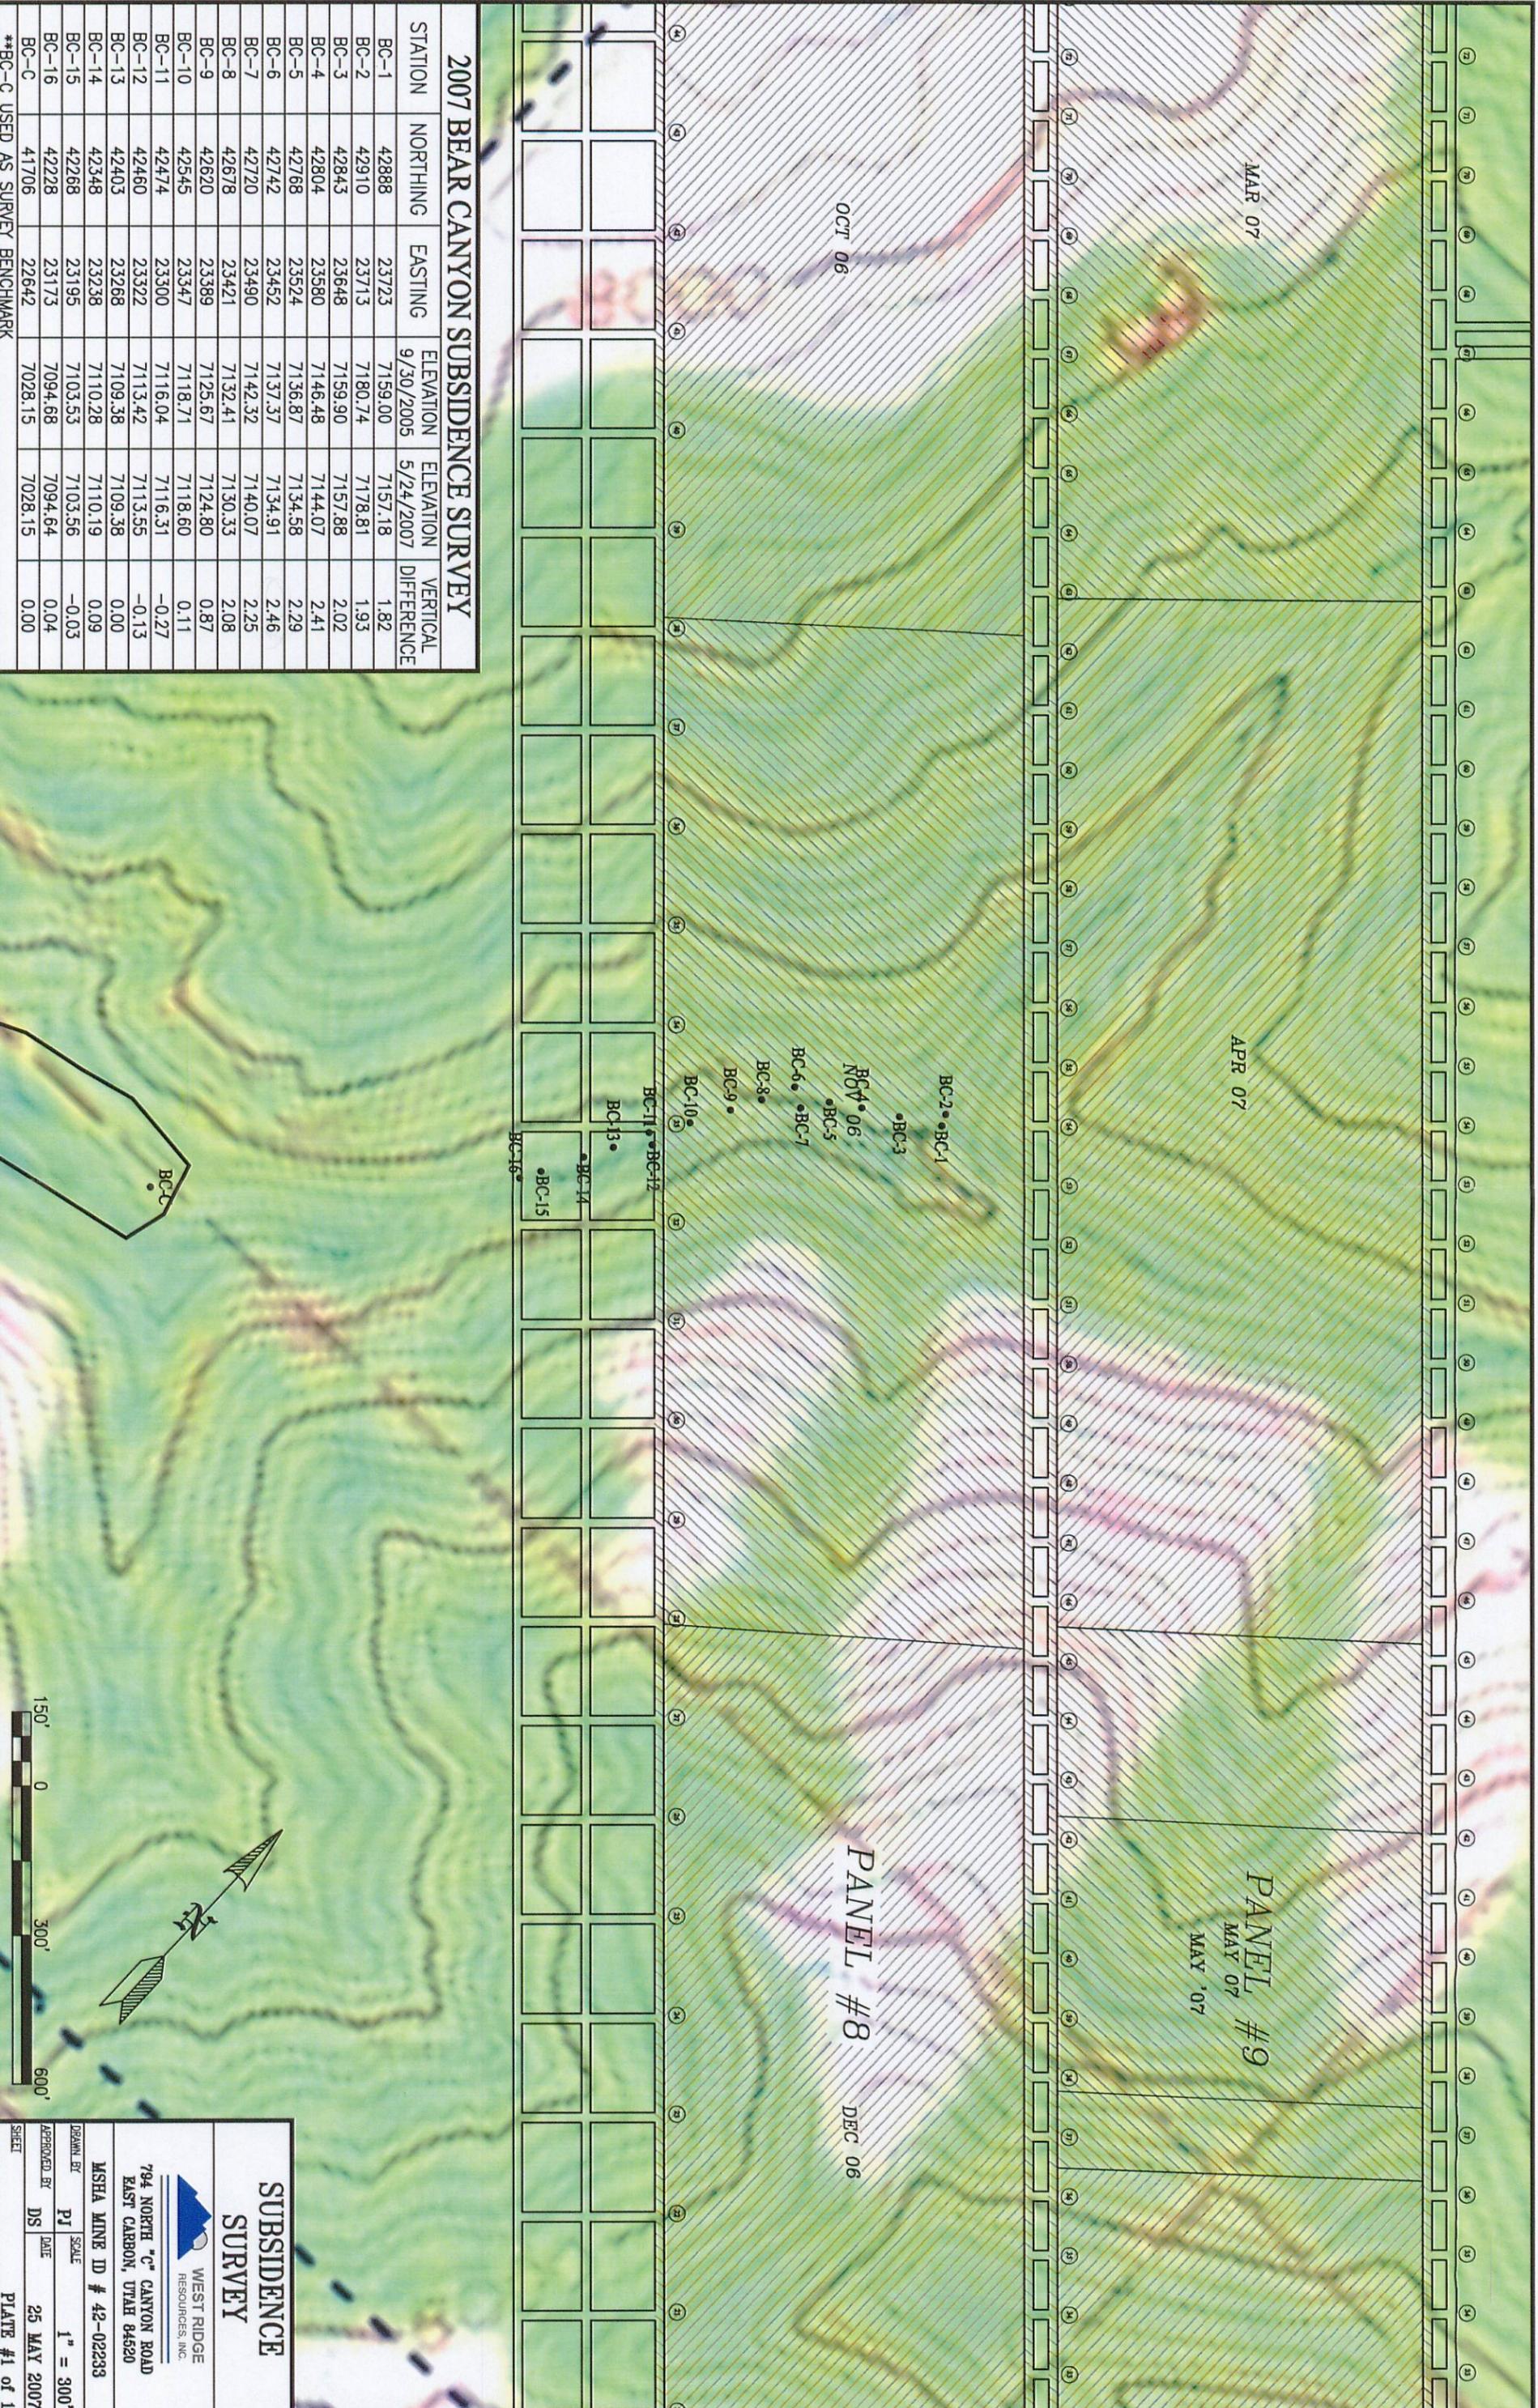
SUBSIDENCE SURVEY	
WEST RIDGE RESOURCES, INC.	794 NORTH "C" CANYON ROAD EAST CARBON, UTAH 84520
MSHA MINE ID # 42-02233	
DRAWN BY PJ	SCALE 1" = 300'
APPROVED BY DS	DATE 25 MAY 2007
SHEET	PLATE #1 of 1

During the July 5, 2005 site visit with Pat Collins from Mt. Nebo Scientific the consensus regarding riparian vegetation was that there was some evidence of riparian vegetative communities near the mouth of the right and left forks of Bear Canyon. During the recent site visit, 7/12/07, there did not appear to be any noticeable change in the plant life for this community as a result of mining and mine related subsidence. After the site visit Mr. Collins and the undersigned met at the mine office with Dave Shaver. The group discussed the observations made in Bear Canyon and the results of the subsidence survey. The pre and post subsidence surveys were completed on 9/30/05 and 5/24/07 for panel # 8. The average displacement was 1.14' with a maximum of 2.46' near the center of the panel at survey point BC-6.

2007 BEAR CANYON SUBSIDENCE SURVEY					
STATION	NORTHING	EASTING	ELEVATION 9/30/2005	ELEVATION 5/24/2007	VERTICAL DIFFERENCE
BC-1	42888	23723	7159.00	7157.18	1.82
BC-2	42910	23713	7180.74	7178.81	1.93
BC-3	42843	23648	7159.90	7157.88	2.02
BC-4	42804	23580	7146.48	7144.07	2.41
BC-5	42768	23524	7136.87	7134.58	2.29
BC-6	42742	23452	7137.37	7134.91	2.46
BC-7	42720	23490	7142.32	7140.07	2.25
BC-8	42678	23421	7132.41	7130.33	2.08
BC-9	42620	23389	7125.67	7124.80	0.87
BC-10	42545	23347	7118.71	7118.60	0.11
BC-11	42474	23300	7116.04	7116.31	-0.27
BC-12	42460	23322	7113.42	7113.55	-0.13
BC-13	42403	23268	7109.38	7109.38	0.00
BC-14	42348	23238	7110.28	7110.19	0.09
BC-15	42268	23195	7103.53	7103.56	-0.03
BC-16	42228	23173	7094.68	7094.64	0.04
BC-C	41706	22642	7028.15	7028.15	0.00
