WATER QUALITY MEMORANDUM

Utah Coal Regulatory Program

RE: 2007 Second Quarter Water Monitoring, West Ridge Resources, Inc, West Ridge Mine, C/007/0041-WQ07-2, Task ID #2732

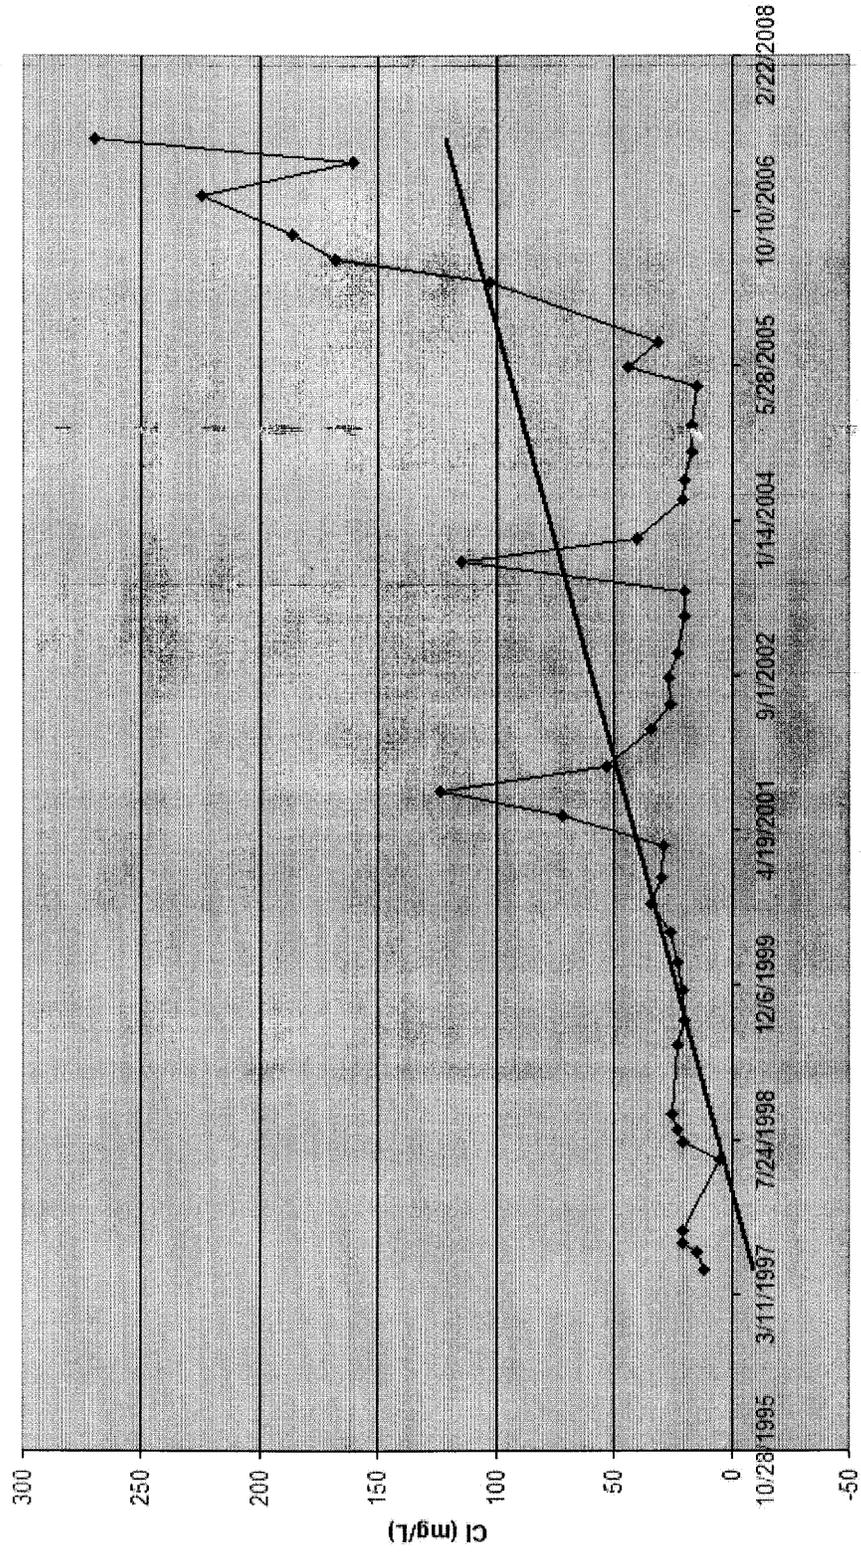
Chloride

There is a weak upward trend in the chloride at DH-86-2, however it has a sharp increase in the last two years. The drinking water criterion for chloride is 250 mg/L. This is the first time that has been exceeded, but this well is not used for drinking water, and regardless of the origin, the chloride levels are not of concern at this time.

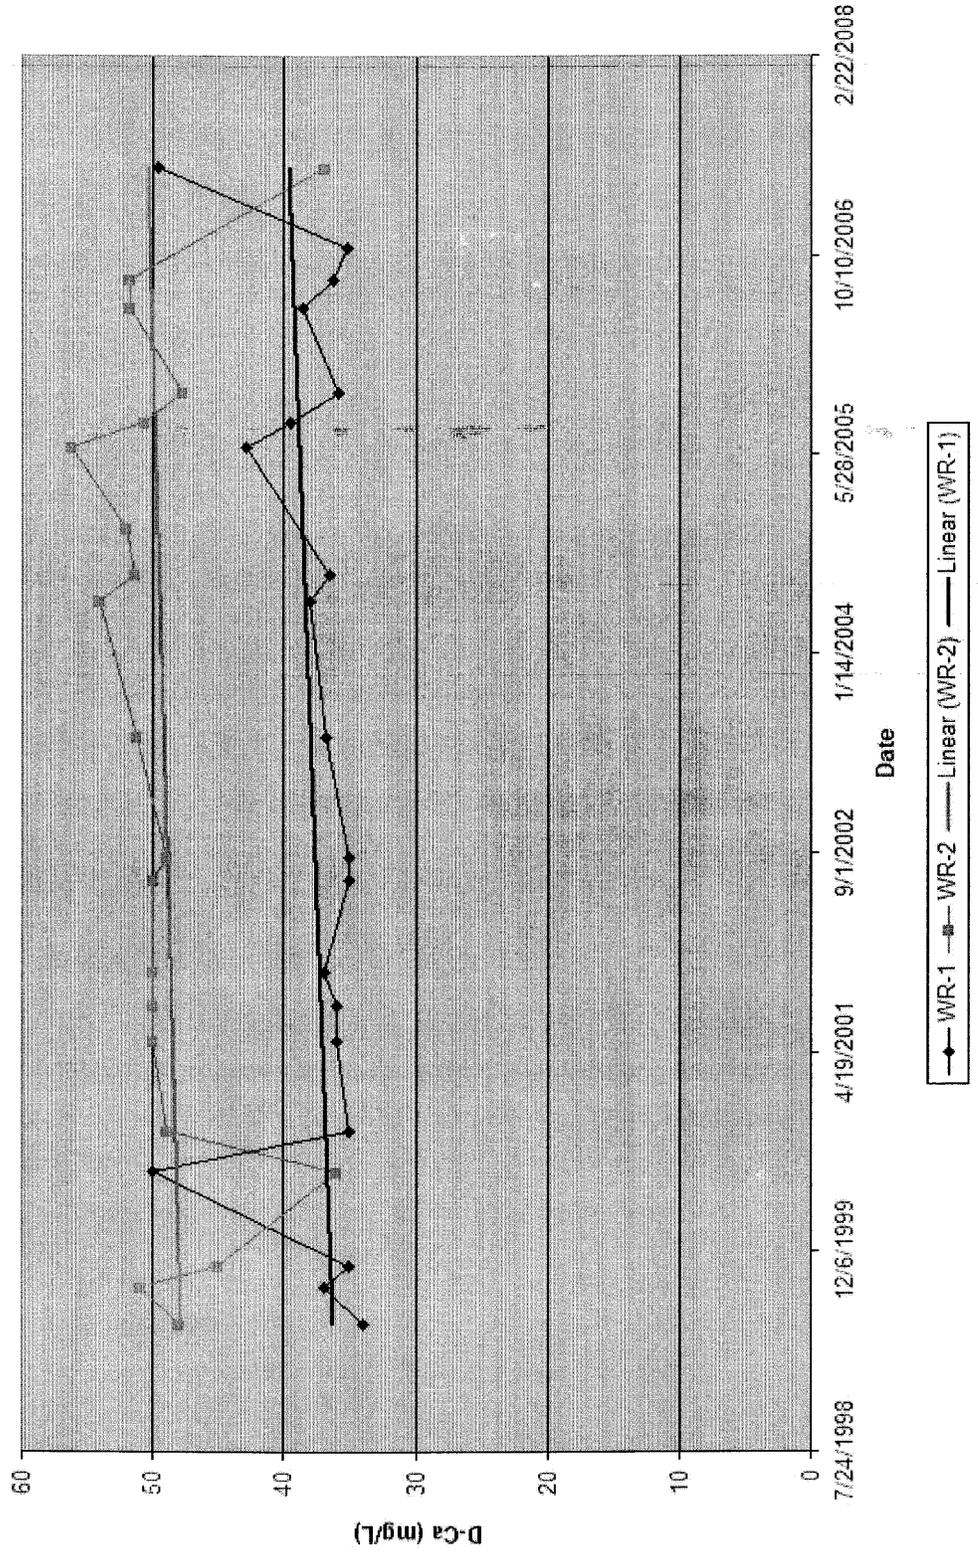
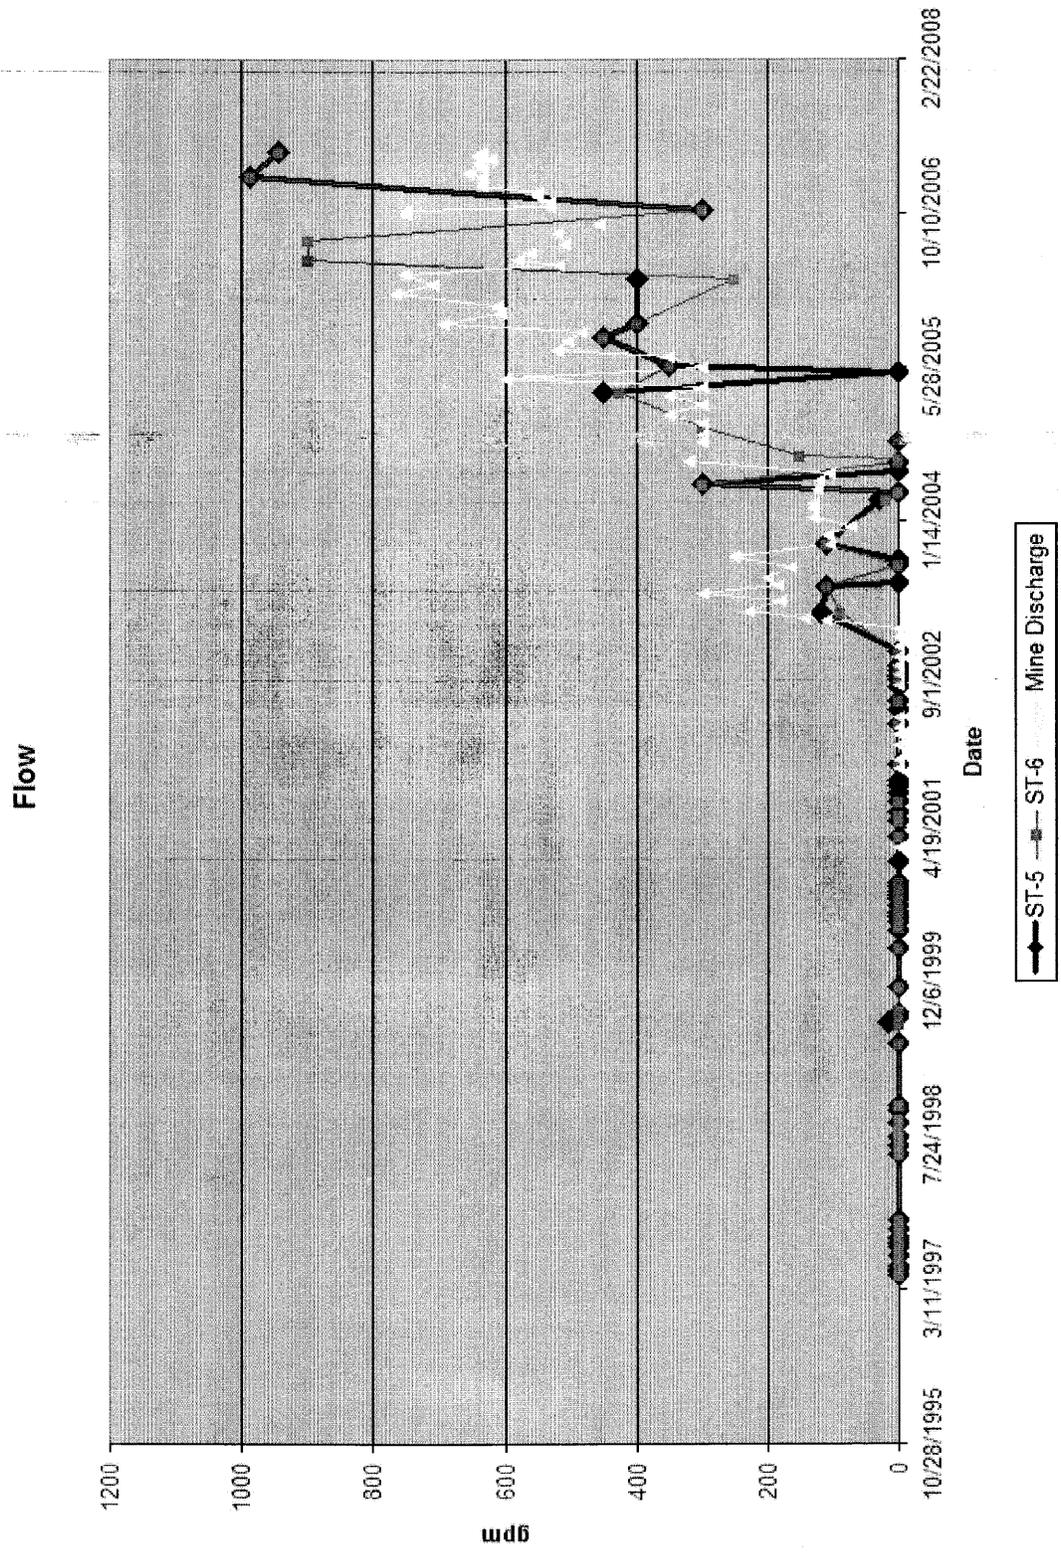
Dissolved Calcium

There is no trend in dissolved calcium at WR-1, or WR-2 ($R^2 = 0.0621$ and

0.0286, respectively).

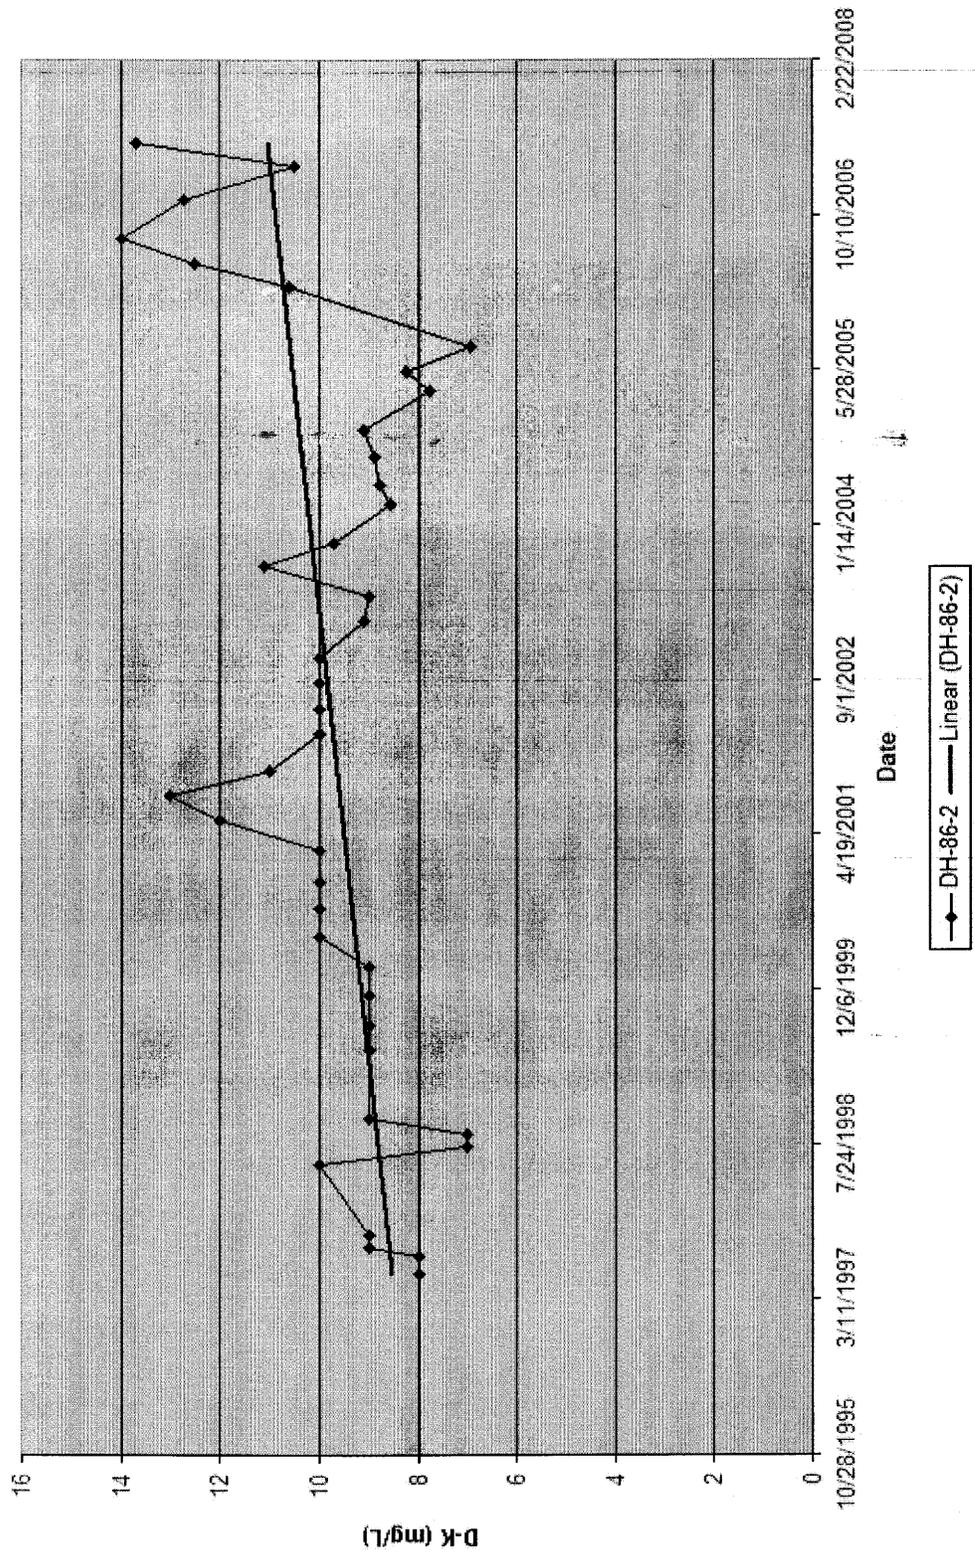
Dissolved Potassium

There is no trend in dissolved potassium at DH-86-2 ($R^2 = 0.1971$).

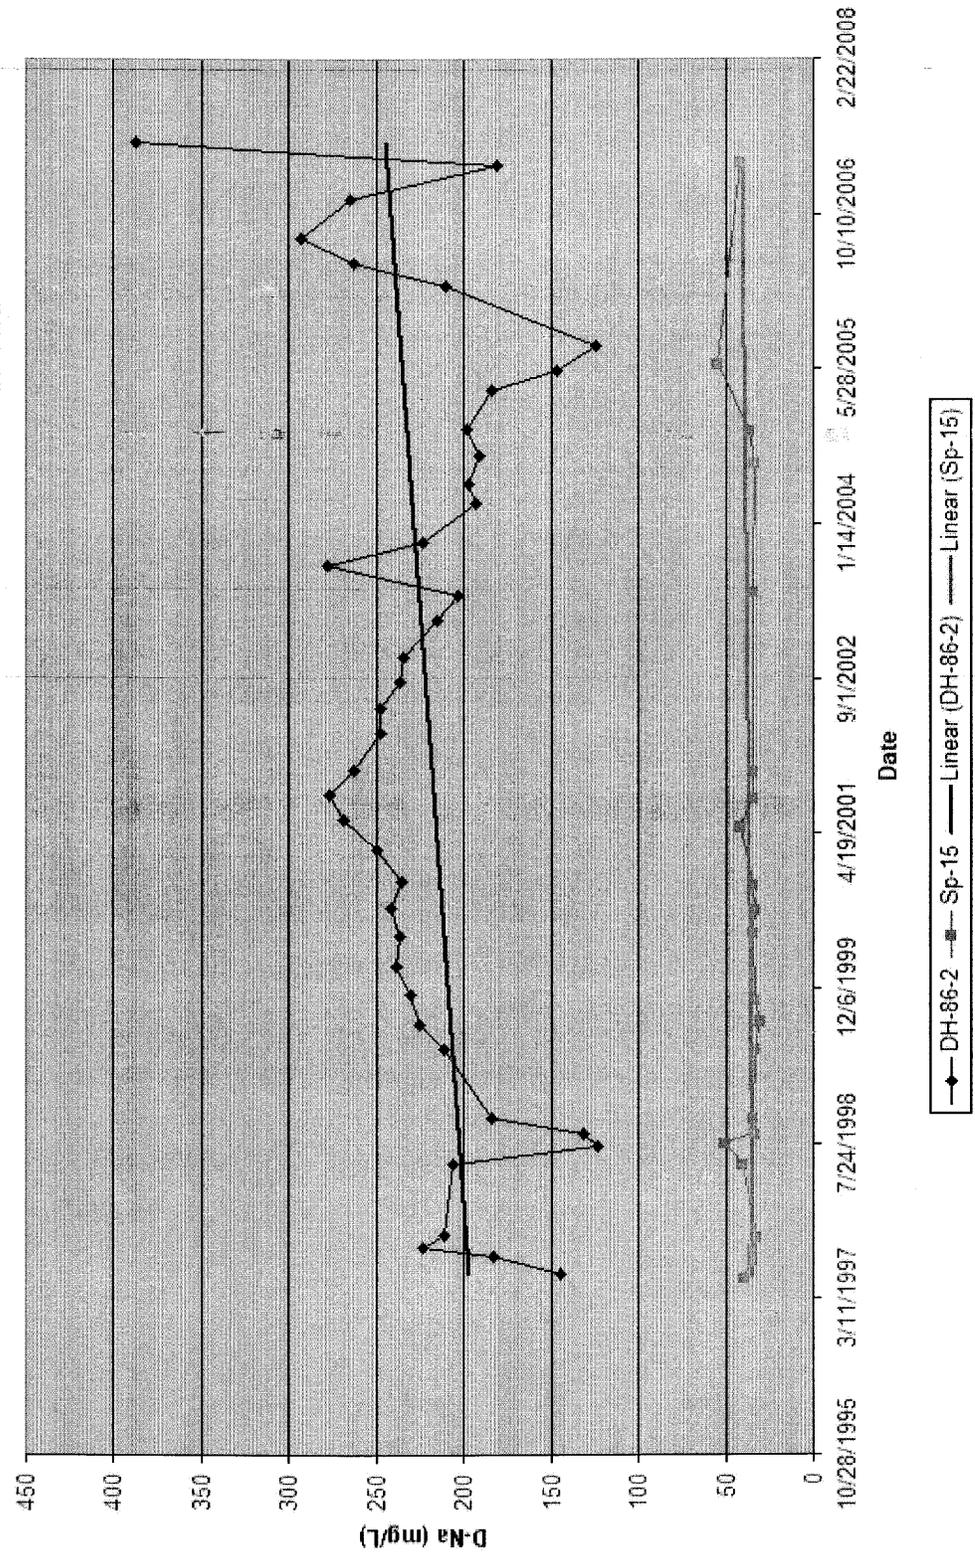
Dissolved Sodium

There is no trend in dissolved sodium at DH-86-2, or SP-15 ($R^2 = 0.0794$ and 0.09 , respectively).
