Division of Oil, Gas and Mining

Inspection Report

Permit Number:	C0070041
Inspection Type:	PARTIAL
Inspection Date:	Tuesday, October 11, 2016
Start Date/Time:	10/11/2016 9:00:00 AM
End Date/Time:	10/11/2016 2:30:00 PM
Last Inspection:	Wednesday, September 21, 2016

Permitee: **WEST RIDGE RESOURCES**
 Operator: **WEST RIDGE RESOURCES**
 Site: **WEST RIDGE MINE**
 Address: **PO BOX 910, EAST CARBON UT 84520-0910**
 County: **CARBON**
 Permit Type: **PERMANENT COAL PROGRAM**
 Permit Status: **ACTIVE**

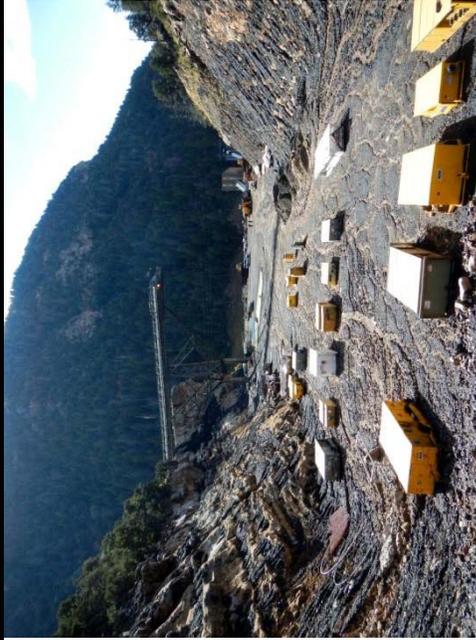
Sheet flow across the coal storage yard has eroded approximately 2-3 inches of soil from the surface. It is recommended that sediment cleanout (currently stockpiled on the coal pad) be used to create water bars along the contour of the coal pad to reduce overland flow velocity.

PHOTO 1 coal storage yard

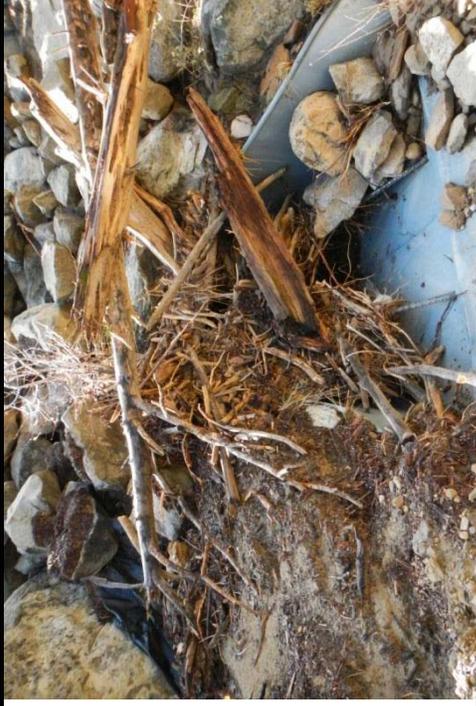
PHOTO 2 clogged coal stockyard undisturbed bypass inlet

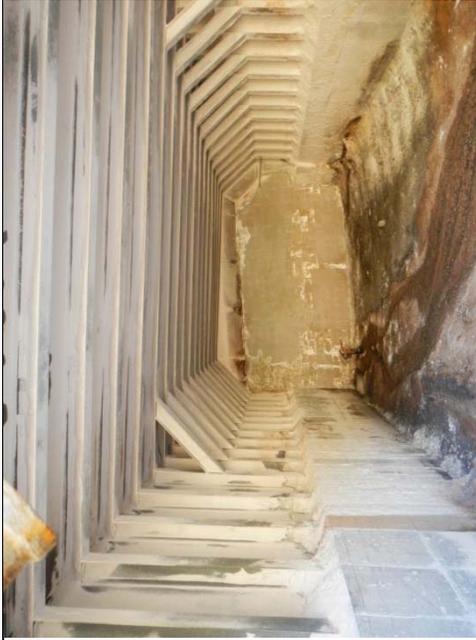
PHOTO 3 sealed man portal

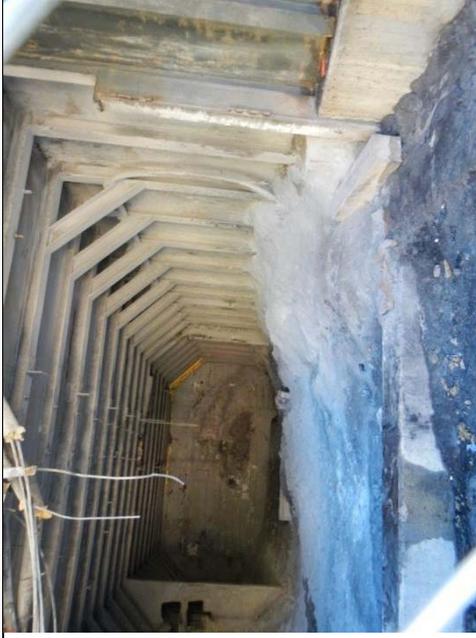
PHOTO 4 sealed conveyor portal

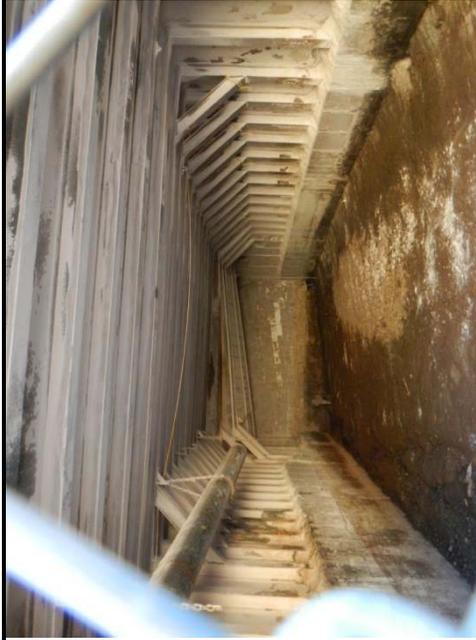
PHOTO 5 sealed man portal

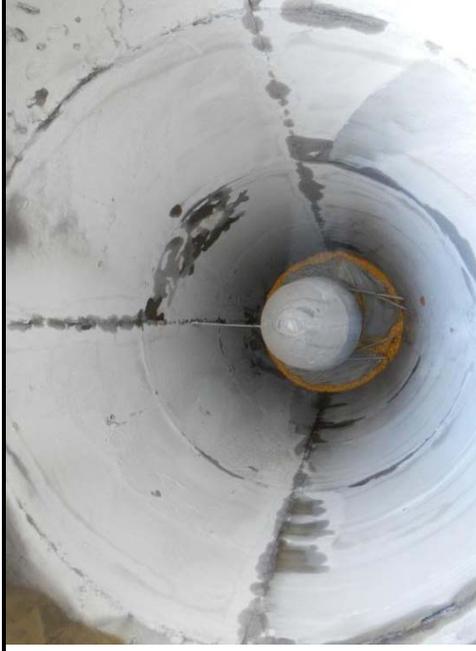
PHOTO 6 fan sealed with foam

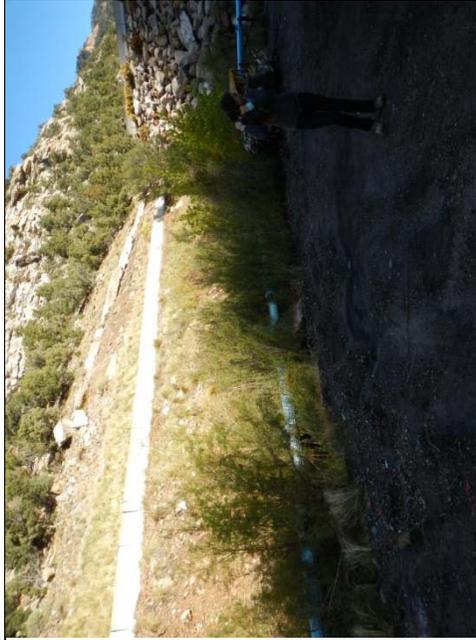
Tamarisk was noted near the fan portal and along ditches in the disturbed area. Tamarisk is a Utah Class 3 noxious weed and must be removed. Tamarisk was also noted at the catchment A site. Tamarisk in this location should also be controlled. However, it was noted that tamarisk is prevalent throughout the Grassy trail drainage, the management of which is under the direction of the BLM.

PHOTO 7
Tamarisk and willows along DD4-A

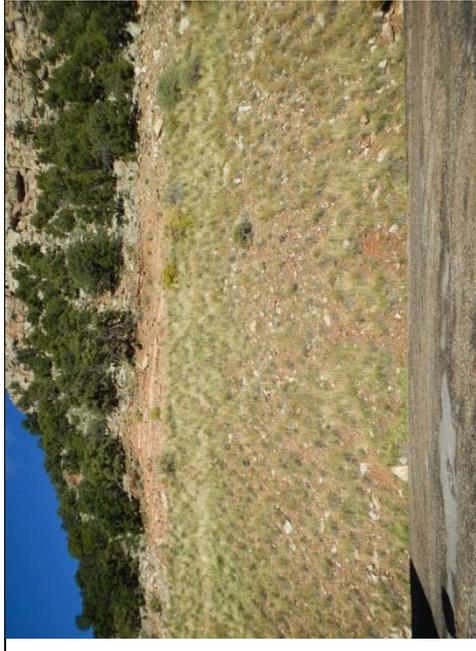
PHOTO 8
Interim reclamation on slope above DD4

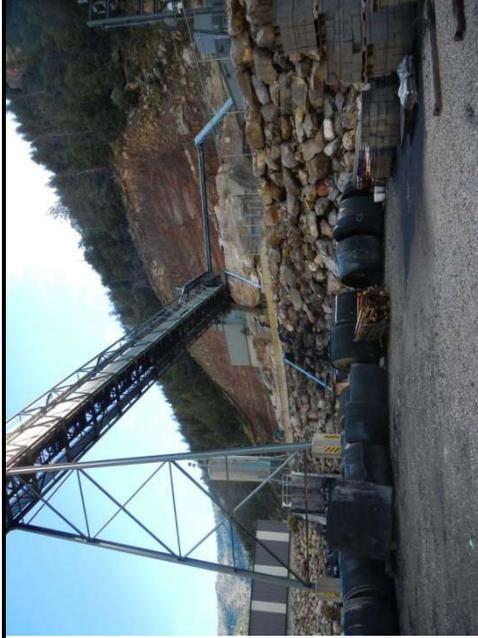
PHOTO 9

High wall and conveyor with belting removed

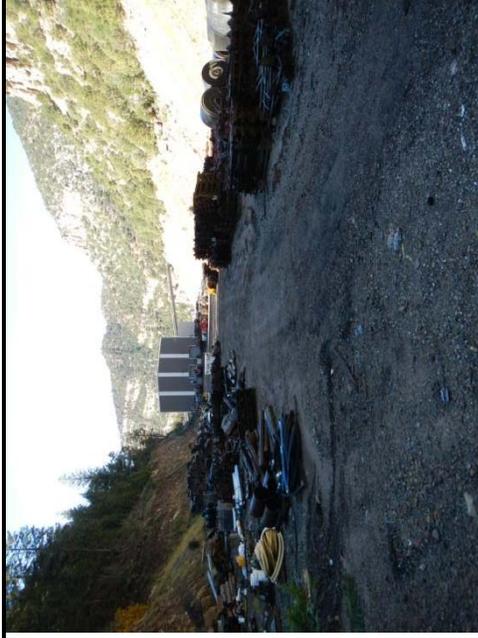
PHOTO 10

Warehouse shop at the end of the Materials storage yard

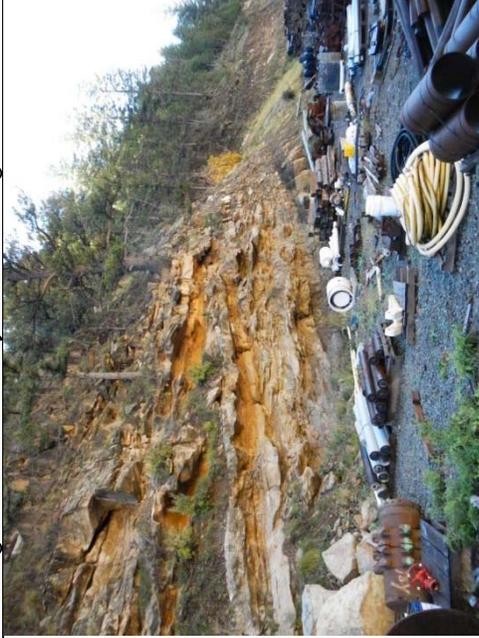
PHOTO 11

North facing cut slope by the explosives storage

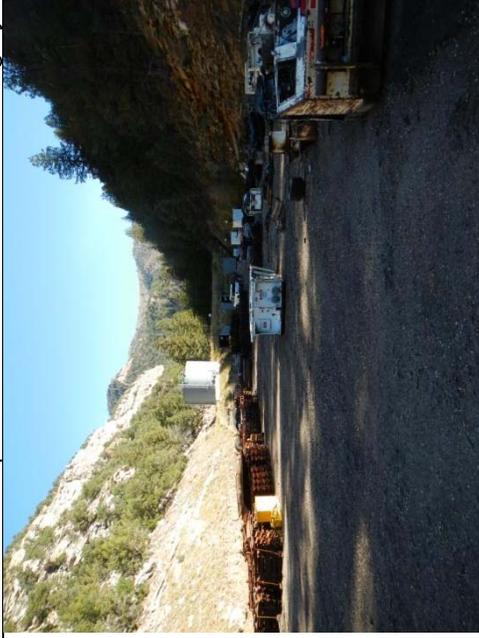
PHOTO 12

Water tank and topsoil stockpile at the East end of the Materials storage yard

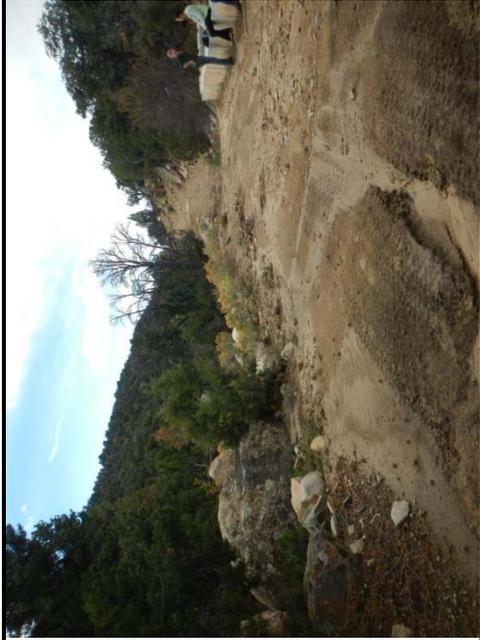
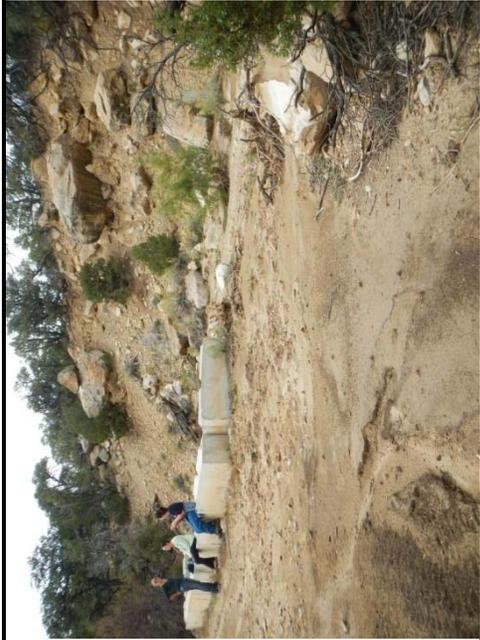
Catch Basin A was observed to be full of sediment and non-functional. Some flow in the channel now bypasses the catch basin and flows over the road or the flow by passes the weir of the catch basin, so that sedimentation no longer occurs. The catch basin should either be maintained or reclaimed. The catch basin is on BLM land. The catch basin was inspected by the BLM in the last six months. The Division agreed to contact the BLM about the possibility of reclaiming this catch basin.

<p style="text-align: center;">PHOTO 14 Jersey barriers form Catchment A</p>
<p style="text-align: center;">PHOTO 13 Flow exiting creek before Catchment A crosses road</p>

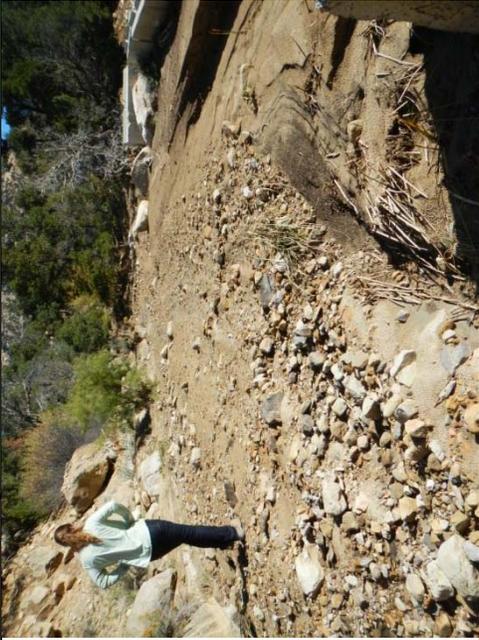
<p style="text-align: center;">PHOTO 15 Catchment A silted in.</p>

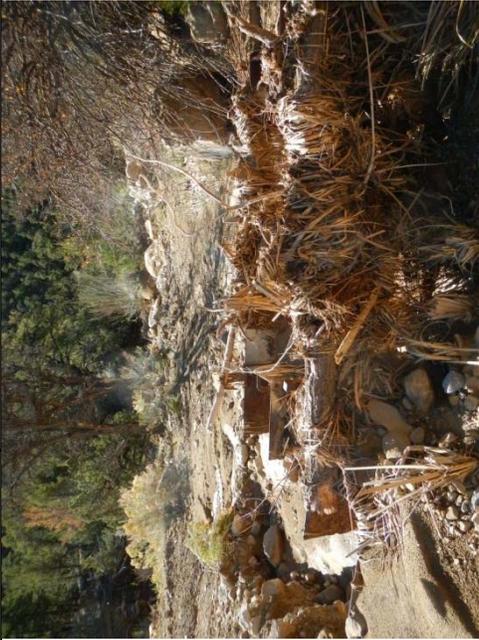
<p style="text-align: center;">PHOTO 16 Catchment A wier is no longer functional and should be reclaimed.</p>

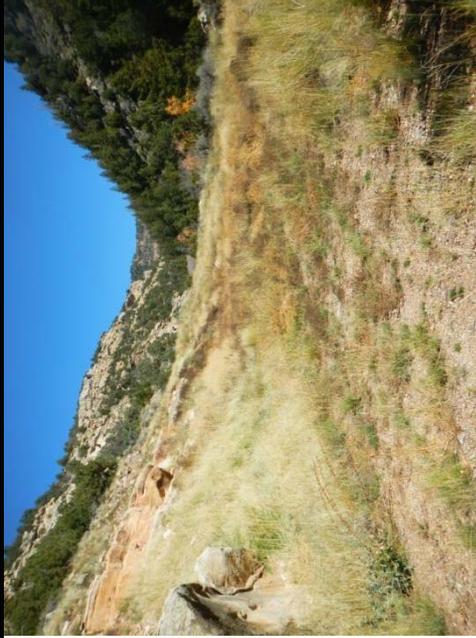
PHOTO 17

We hiked to the abandoned mine portal in B Canyon that was briefly re-opened for ventilation and access in 2012. The B Canyon work is described in App. 5-19. The area was reclaimed and seeded two years ago (2014). There was good cover, although some of the cover was weedy. A small vertical air monitoring pipe was placed in the backfill.

B Canyon reclamation was completed in 2014.

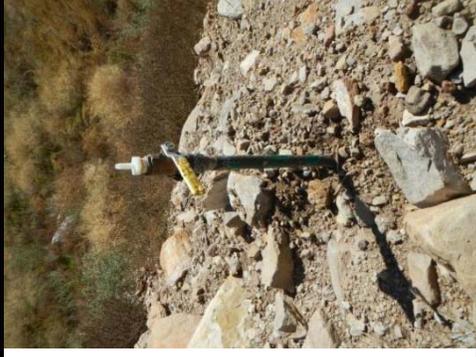
PHOTO 18

Stand pipe at the B Cyn reclaimed portal.
