Re: West Ridge Mine C/007/041
WR17-001 Seismic Monitoring

RB&G
ENGINEERING, INC.

OCTOBER 2016 TO OCTOBER 2017

**MINING-INDUCED SEISMICITY
NEAR GRASSY TRAIL DAM AND RESERVOIR**
Carbon County, Utah

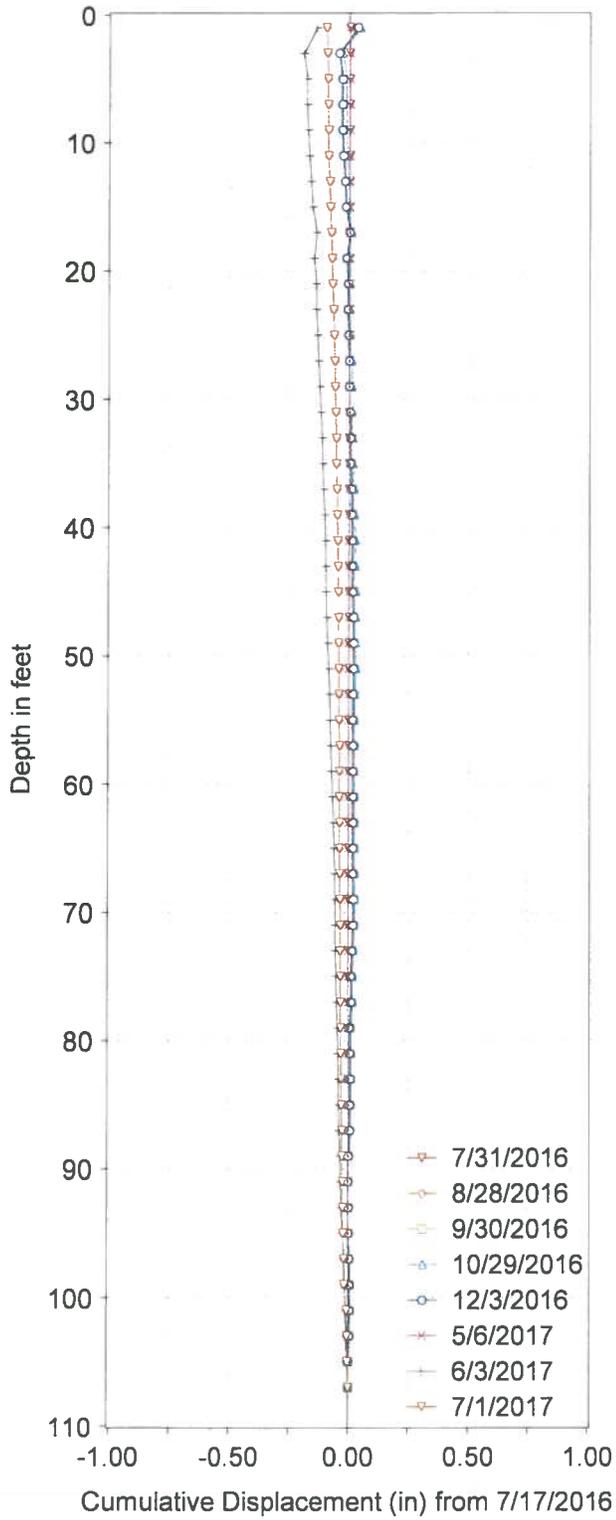
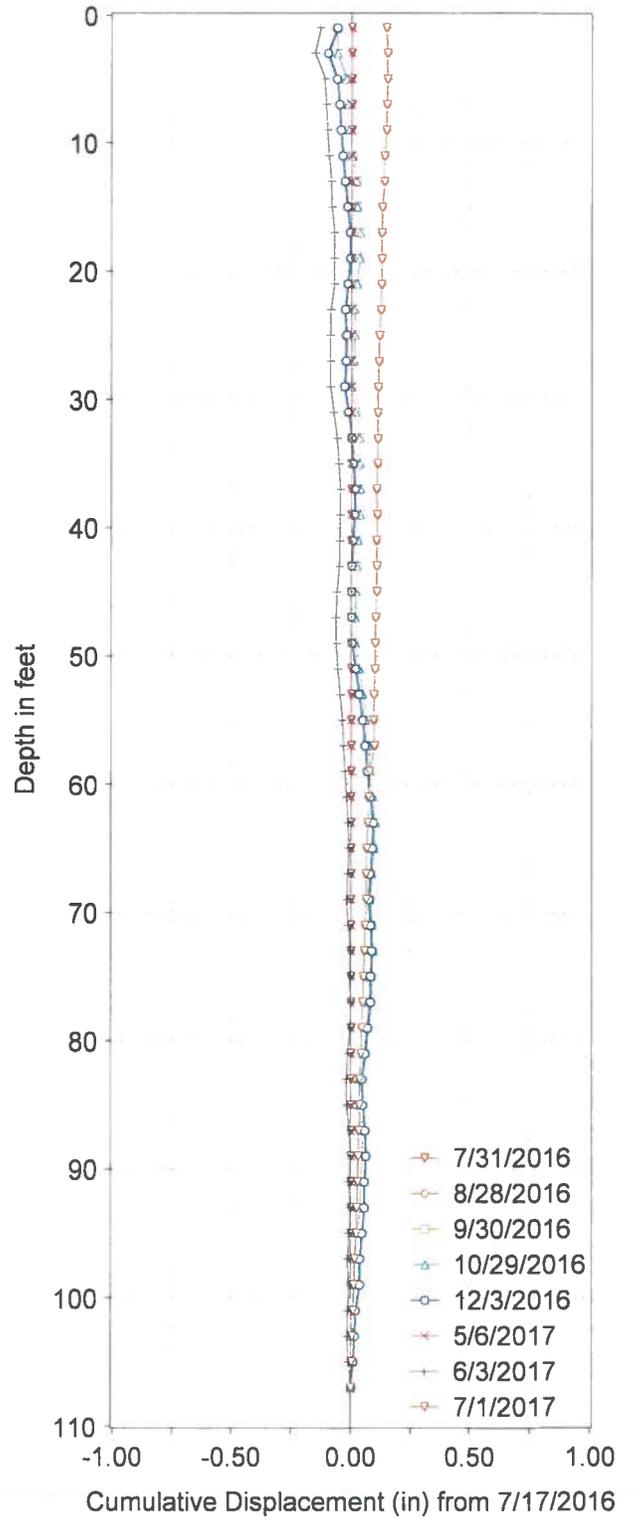
Figure B-1
Inclinometer 1 -Deflection Profiles
Grassy Trail Dam, Carbon County, Utah

No significant movement observed

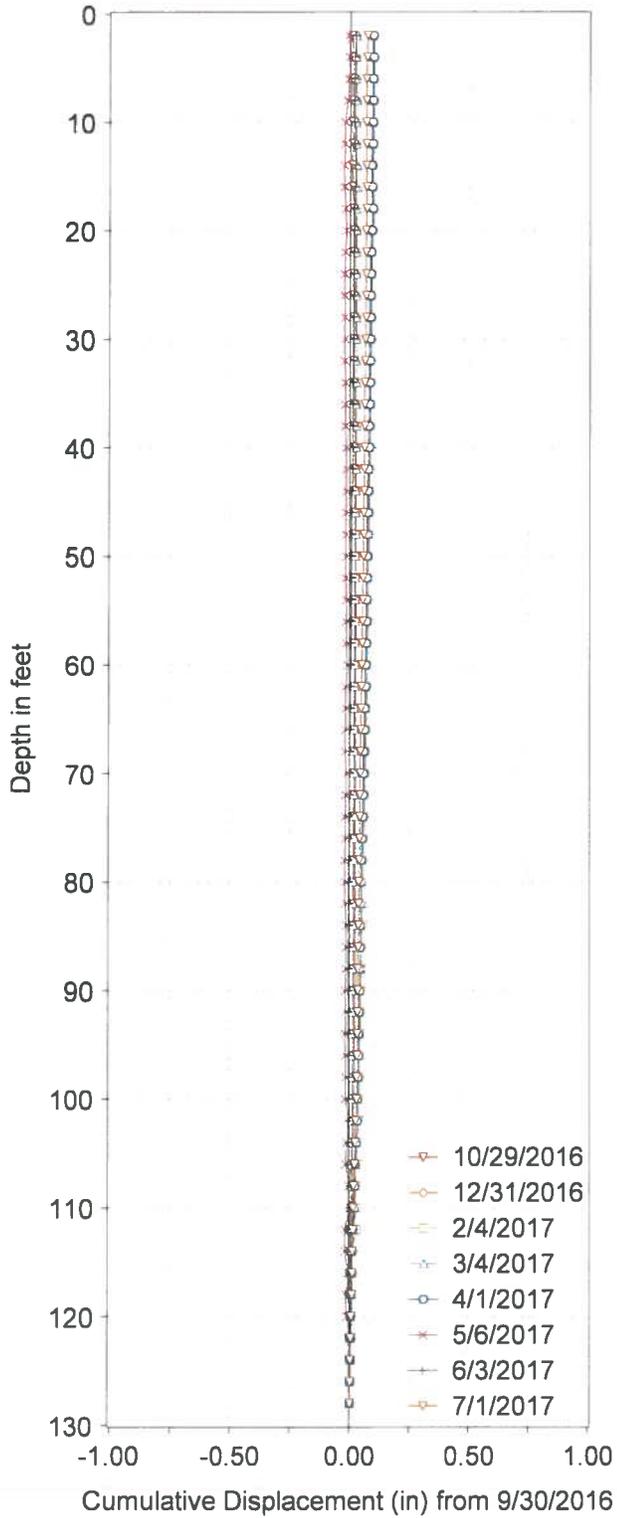
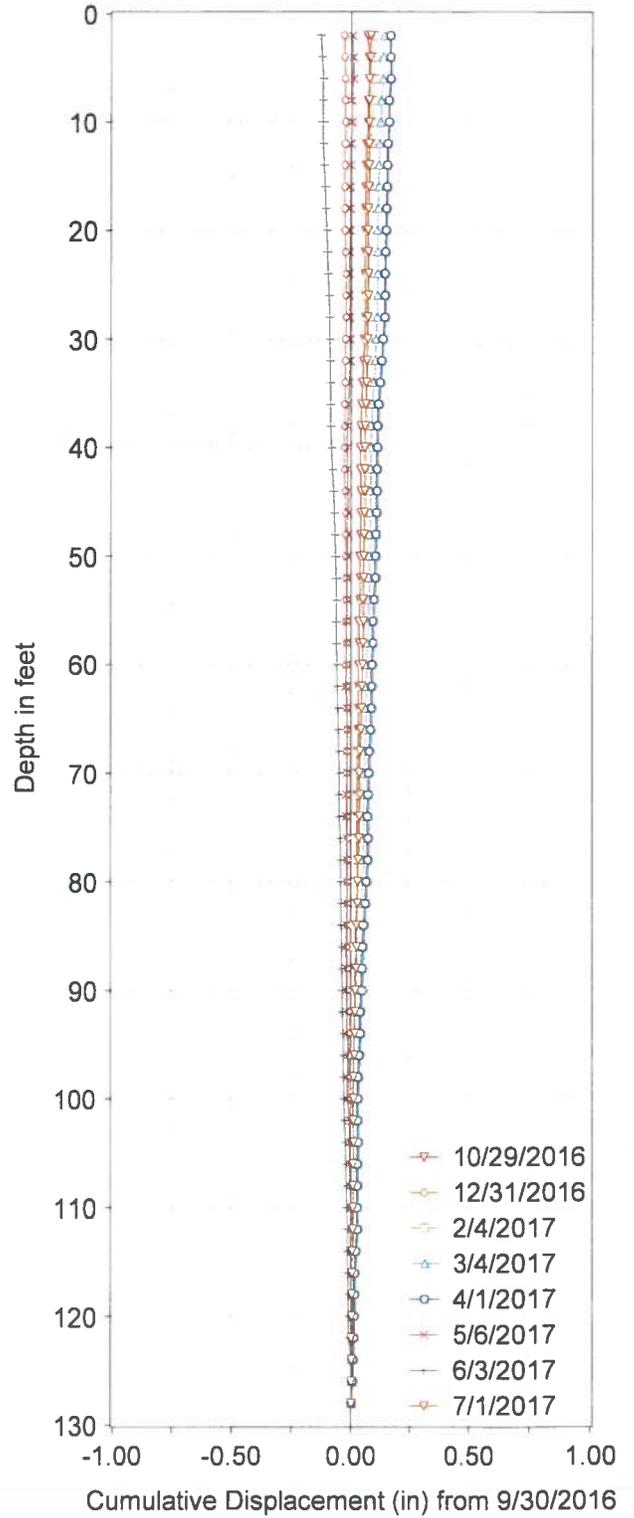
Figure B2
Inclinometer 2 - Deflection Profile
Grassy Trail Dam, Carbon County, Utah

readings. It is likely that this inclinometer did not extend deep enough into the bedrock to fix the tip below the slide. Based on the movement which occurred during mining, it was determined that Inclinometer I-2 should be replaced with new inclinometer casing which has not been strained, and that Inclinometer I-3 should be replaced with an inclinometer extending deeper into the bedrock.

-15 degree skew
Bias-shift correction

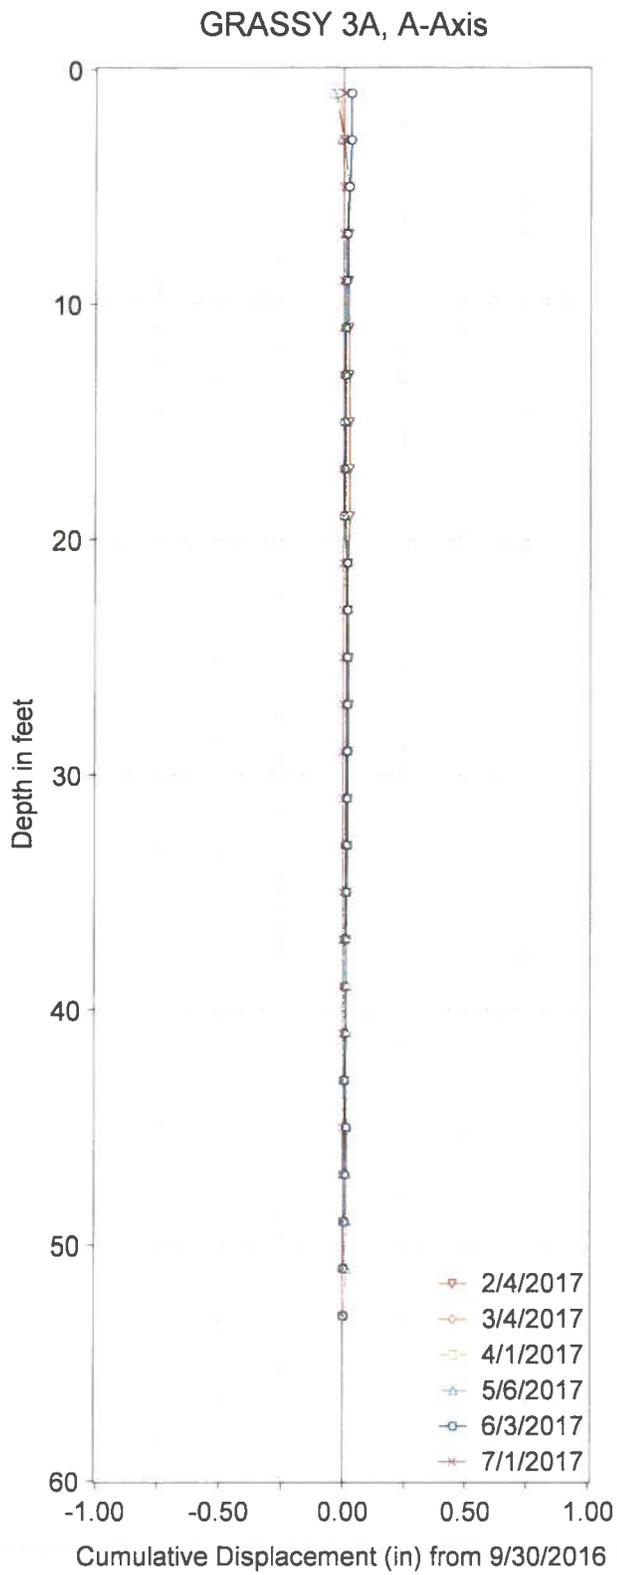
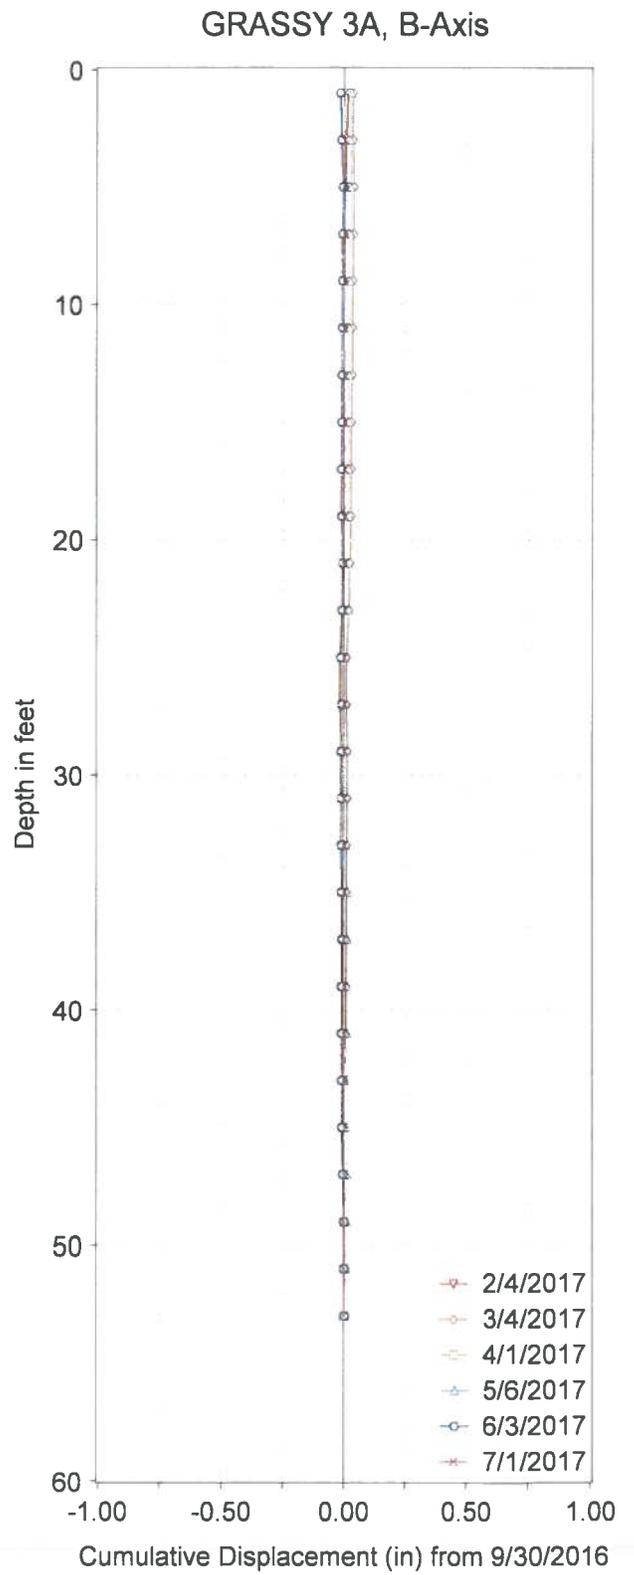
Figure B-3
 Inclinometer 3 - Deflection Profile
 Grassy Trail Dam, Carbon County, Utah

-30 degree skew

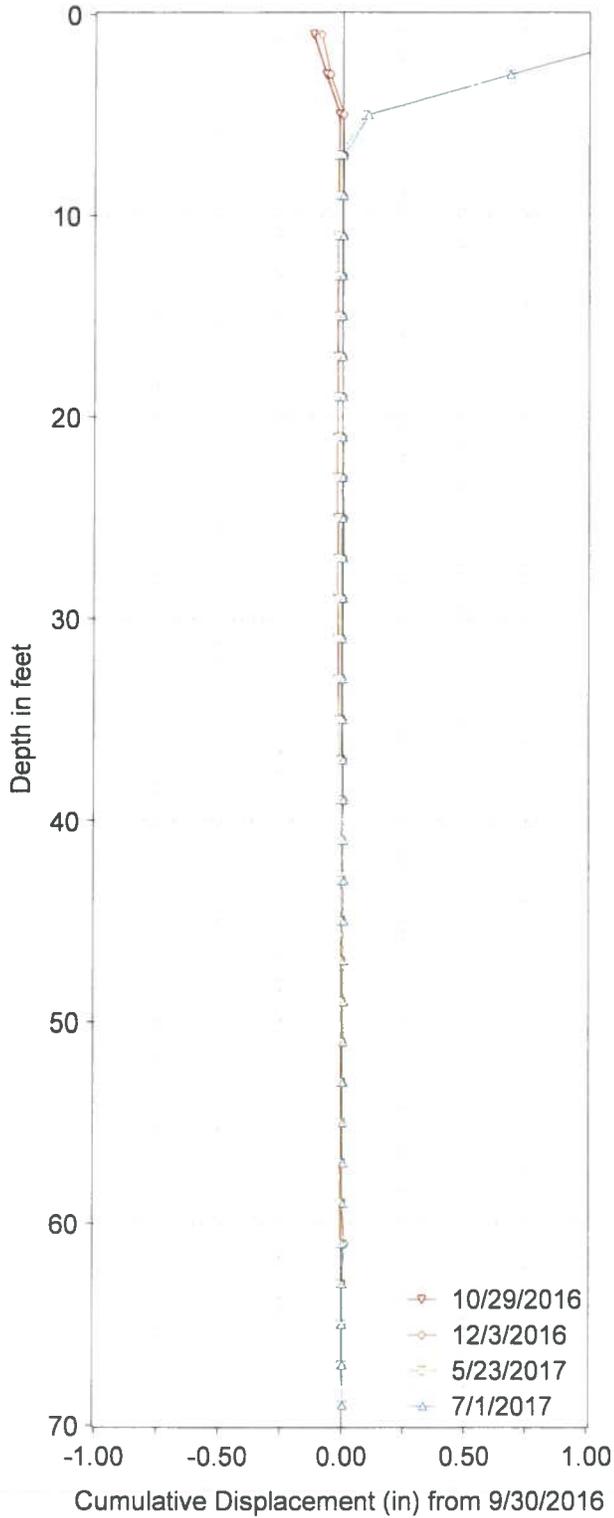
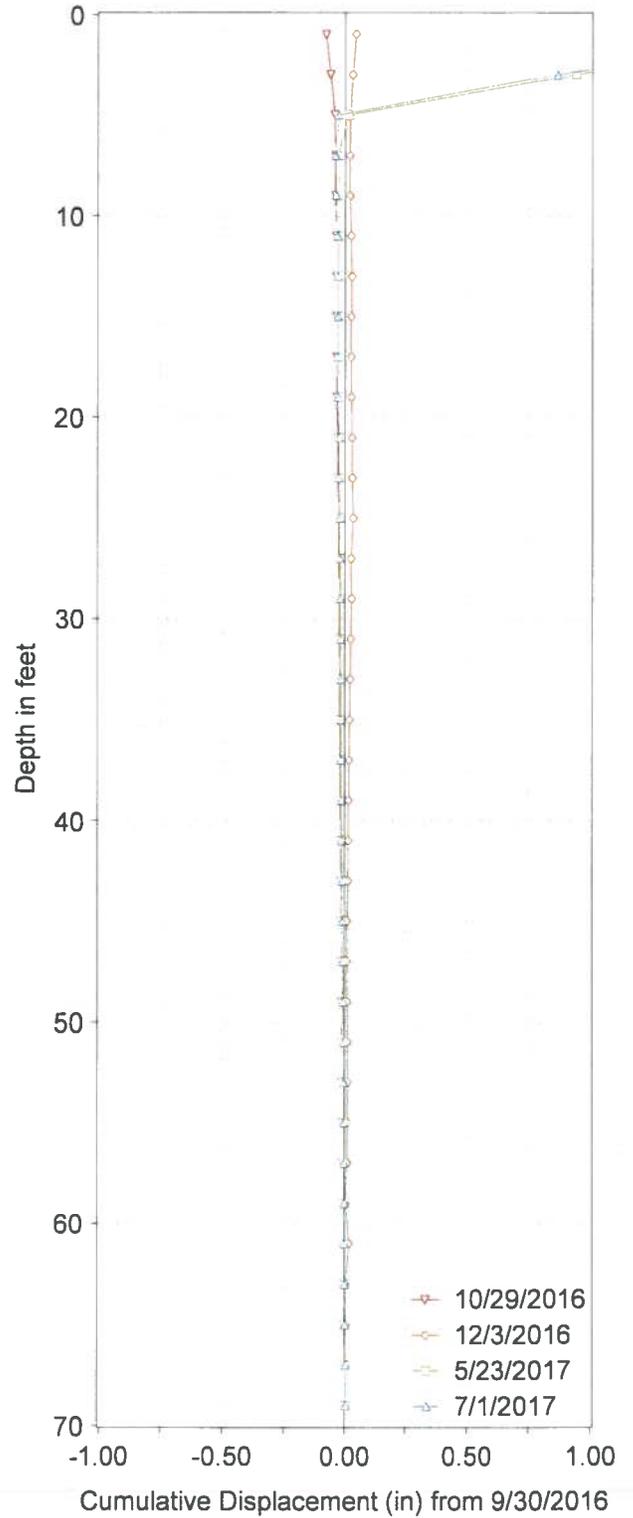
Repairs made 5/26/10 new survey
may not match true with old surveys

Top few feet of pipe were loose

Deflection profiles for Inclinator 4 are shown on Figure B-8. This figure shows relative movement compared to a base line reading taken in June, 2010. The larger displacements shown in the upper 4 feet indicate that the top of the pipe is loose and is moving during the readings.

Taking into account the possible reading error due to the damage, the inclinometer does not show any significant movement since 2007. Some additional repairs are advisable to secure and protect the top of the instrument.

- Inclinator 4 was damaged and then buried by a surficial landslide. This slide was triggered by a road cut made to widen the roadway along the west side of the dam. We recommend stabilizing and protecting the top of this inclinometer. It is recommended that modifications to the existing slopes not be performed without considering hillside stability.

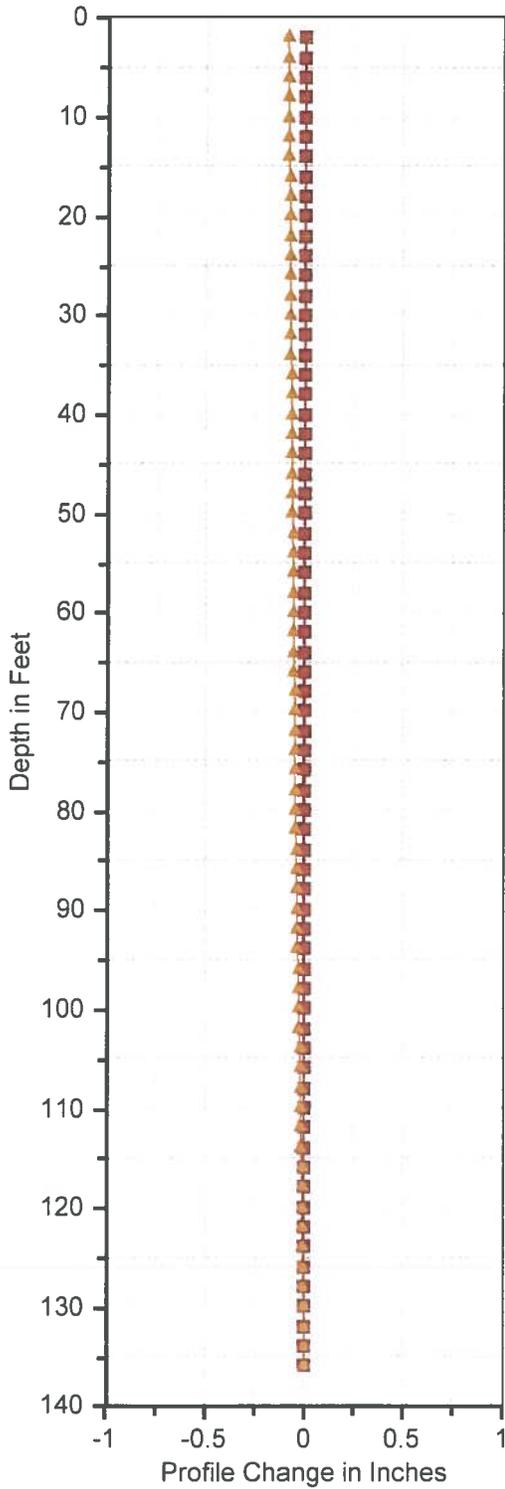
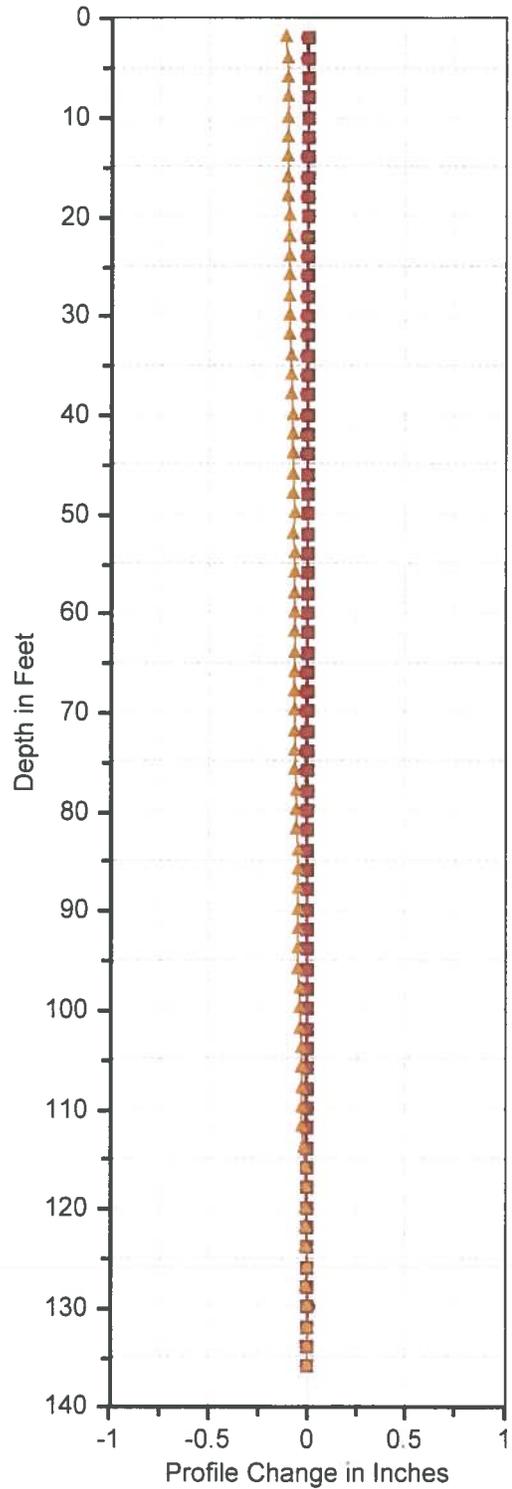
Figure B-9 GrassyTrail 17-I-2 A

The new inclinometers have been installed and the instrumentation monitoring during the past year has not identified any mining-induced seismicity dam safety issues. No MIS events have been recorded on the dam, inclinometer readings have shown negligible movement, and piezometers, observation wells, and seepage monitoring has been within expected ranges. It is recommended that the MIS monitoring be terminated.

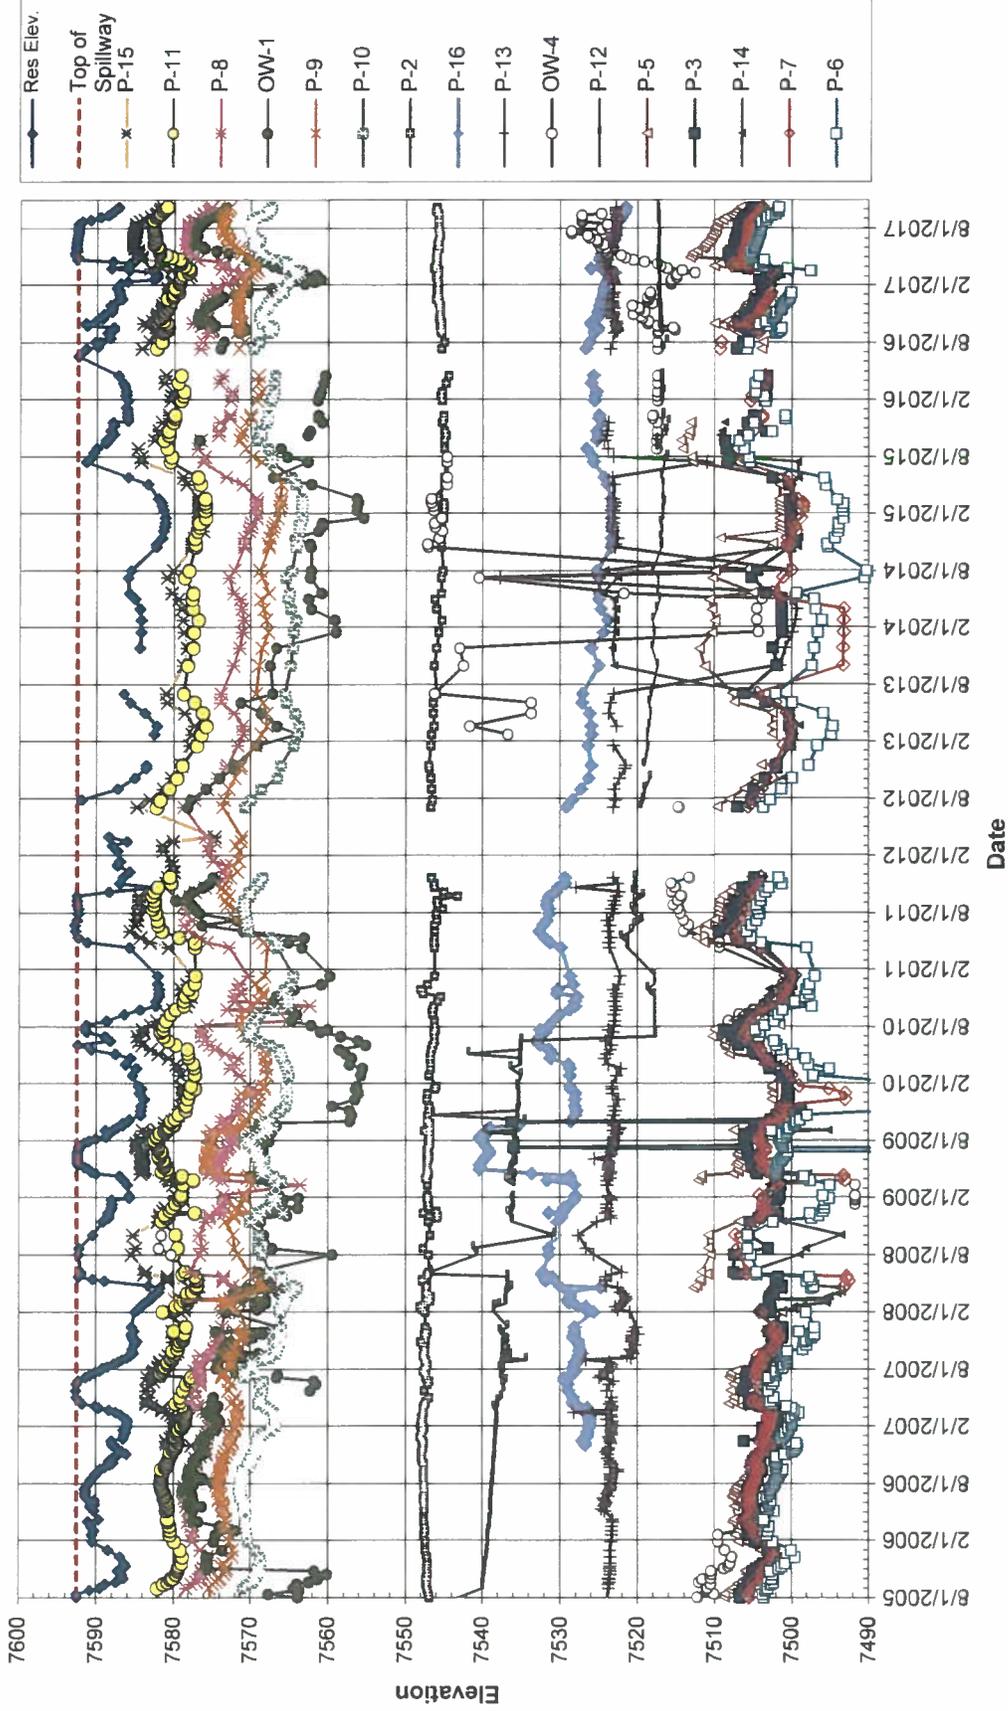
Figure C-1A Reservoir Elevation and Piezometer Readings
August 2005 to Oct 7, 2017

Water levels recorded in piezometers and observation wells appear to be functioning normally with respect to the elevation of the water in the reservoir. No evidence of internal erosion has been observed in seepage collected and monitored downstream of the dam and abutments. Seepage rates coincide with changes in reservoir water elevation. The highest seepage rates occur when the reservoir is near full, above elevation 7590 feet. Seepage rates in excess of 20 gallons per minute were recorded in 2007 and 2008. The highest level recorded between October 2016 and October 2017 was 15 gallons per minute.

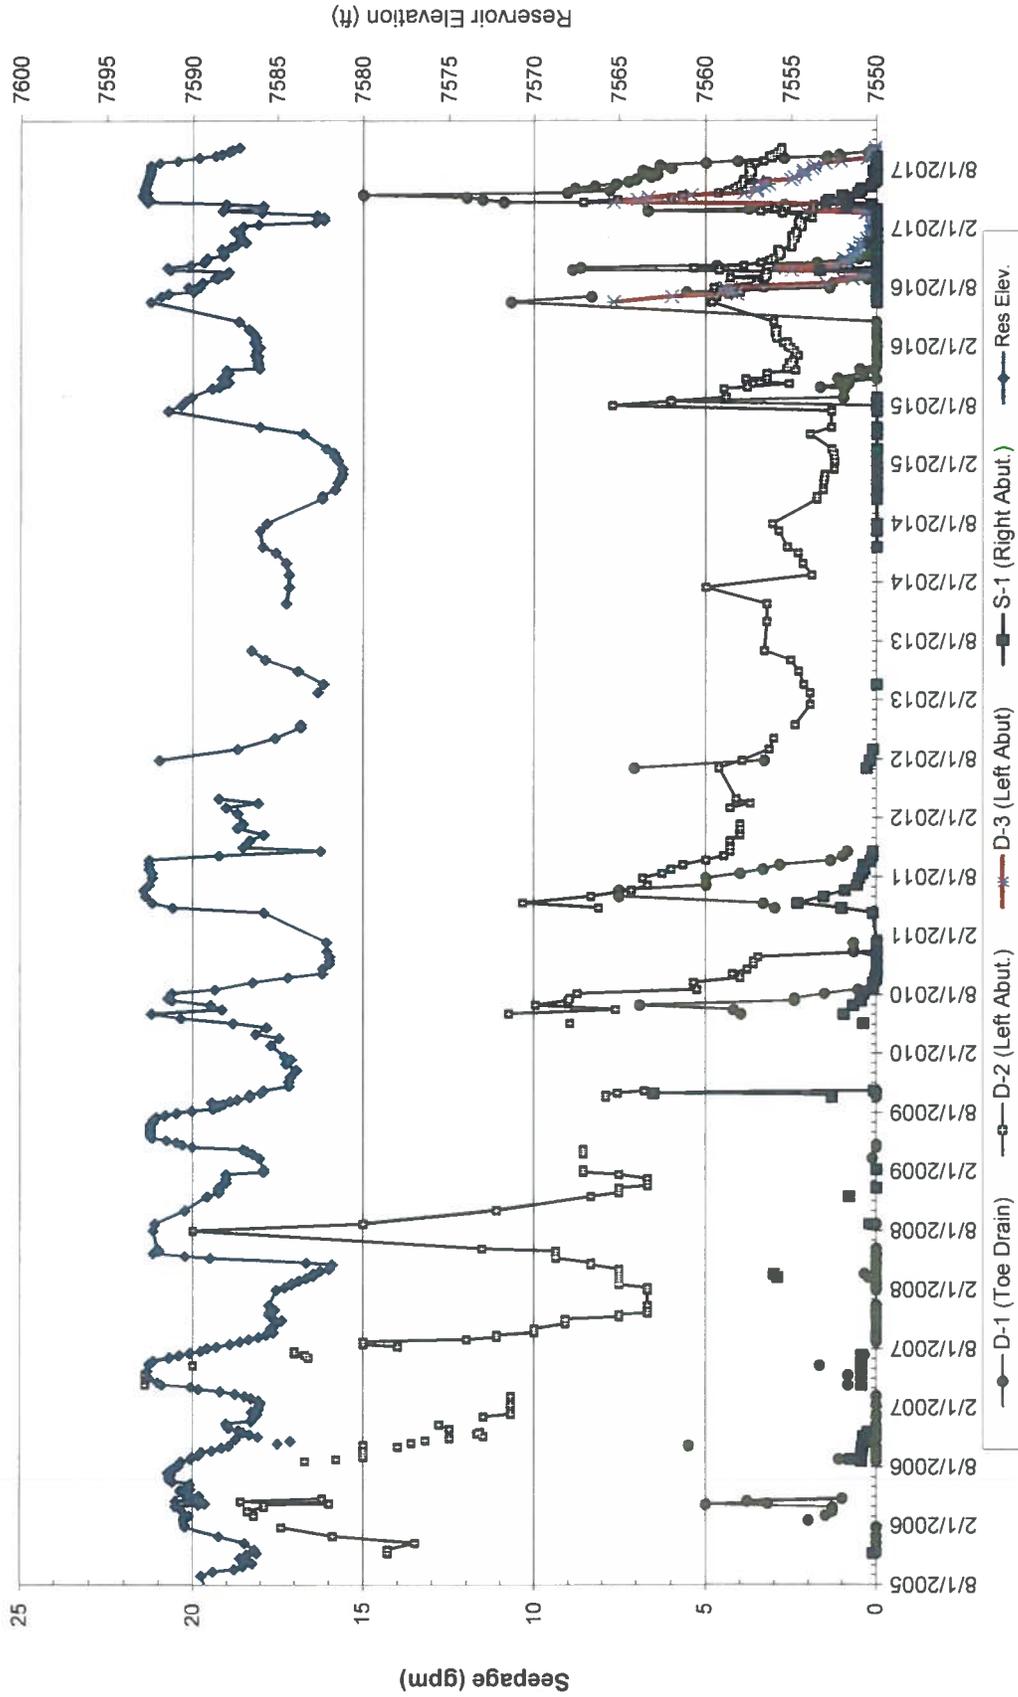
Figure C-2A
Reservoir Elevation and Seepage Readings
August 2005 to October 7, 2017
Some additional readings by RB&G Eng
Grassy Trail Dam and Reservoir

Seepage through the dam, foundation, and abutments has been collected at four locations, including the toe drain connected to the dam's internal drainage system (D-1), a seepage collection system located on the east (left) abutment with two collection points D-2 and D-3, and a collection pipe located downstream of the west (right) abutment (S-1). The flows from the drains are measured by recording the time to fill a container of known volume with water from each collection point. The clarity of the water has also been recorded during seepage readings. Clear seepage indicates that the flow is adequately filtered and is not moving material through the dam or foundation. Cloudy seepage can be a sign of internal erosion, which could lead to a piping-related failure of the structure. No cloudy water has been noted during our site visits. D-3, which was installed in 2015, will sometimes have some sand sized particles in the container which catches the flow in between site visits. This sediment is likely derived from surficial runoff during storms.
