Re: West Ridge Mine C/007/041
WR17-001 Seismic Monitoring

GRASSY TRAIL DAM MONITORING/INSPECTION PLAN

West Ridge Mine Project Area
 Grassy Trail Reservoir Mining Induced Seismicity
 Near East Carbon, Carbon County, Utah

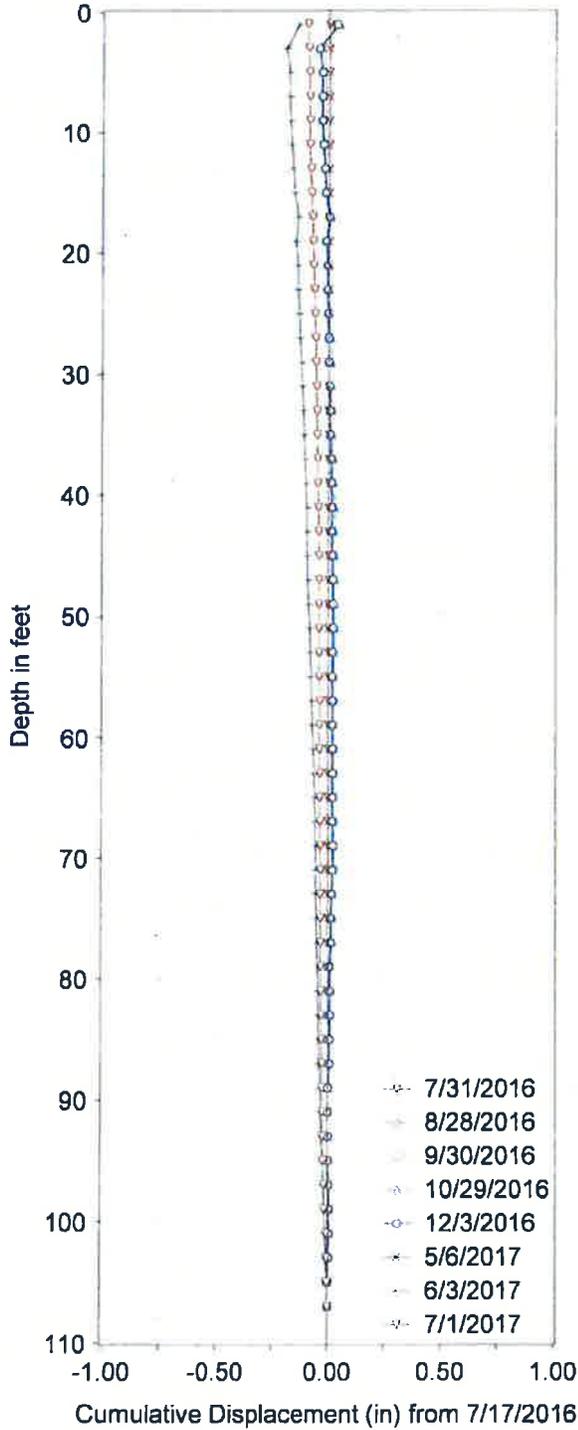
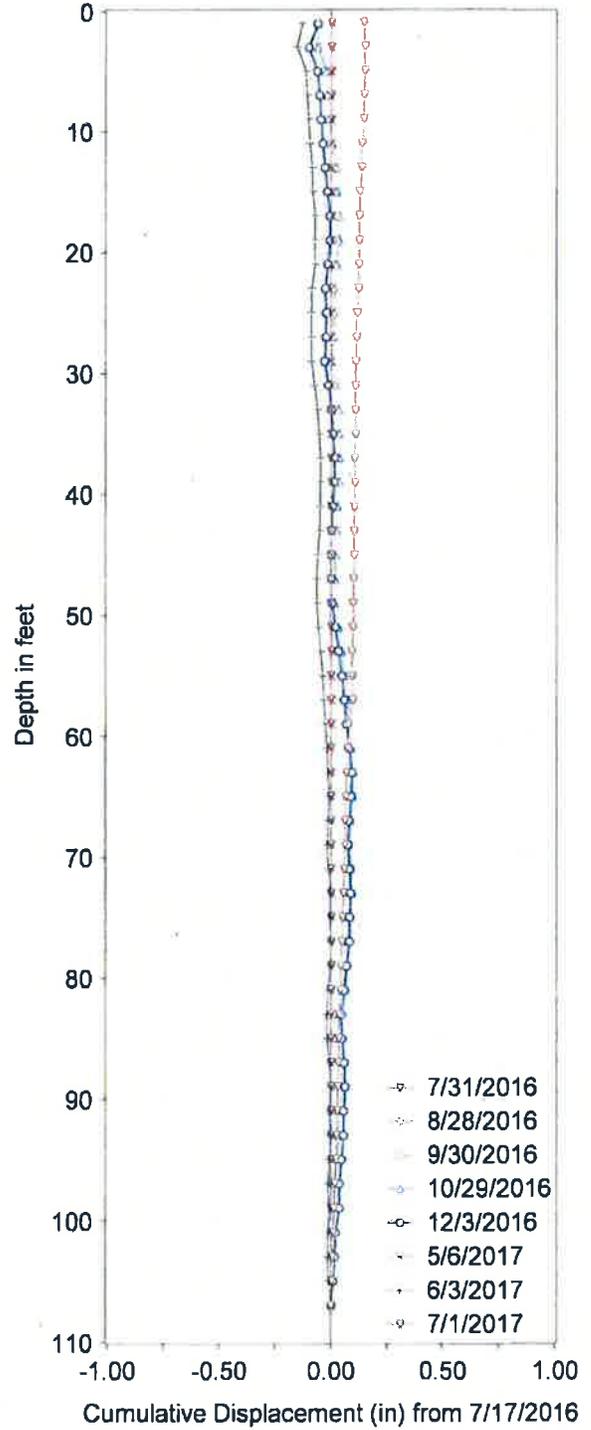
No significant movement observed

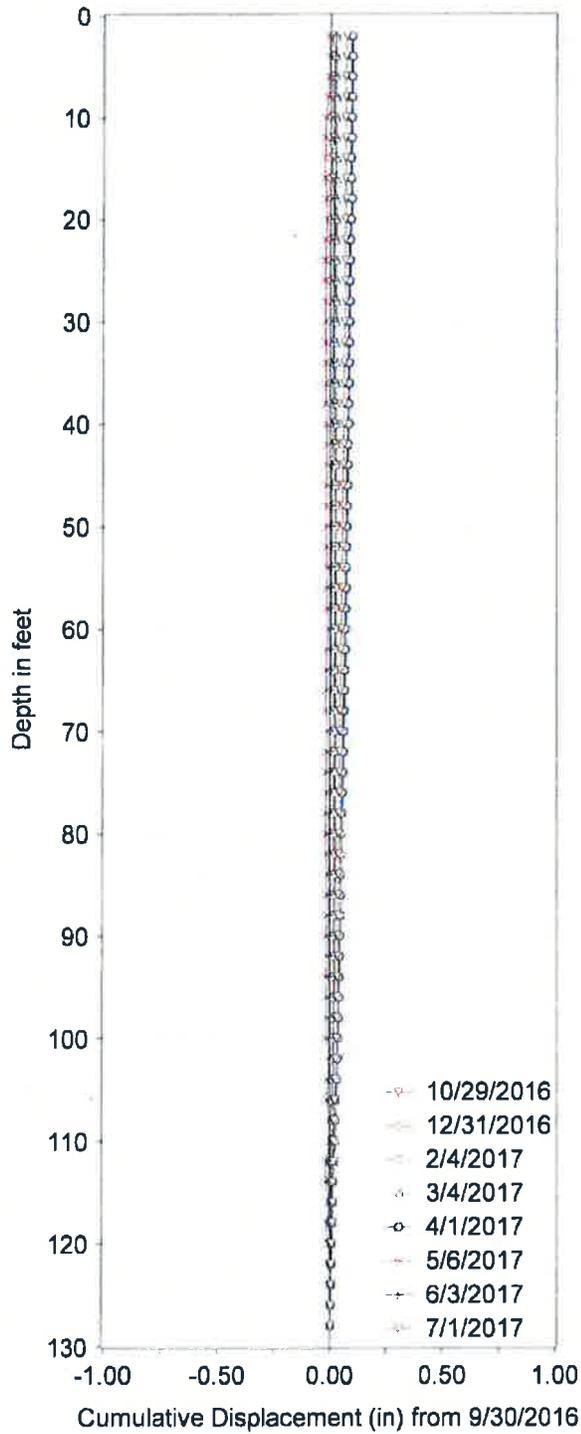
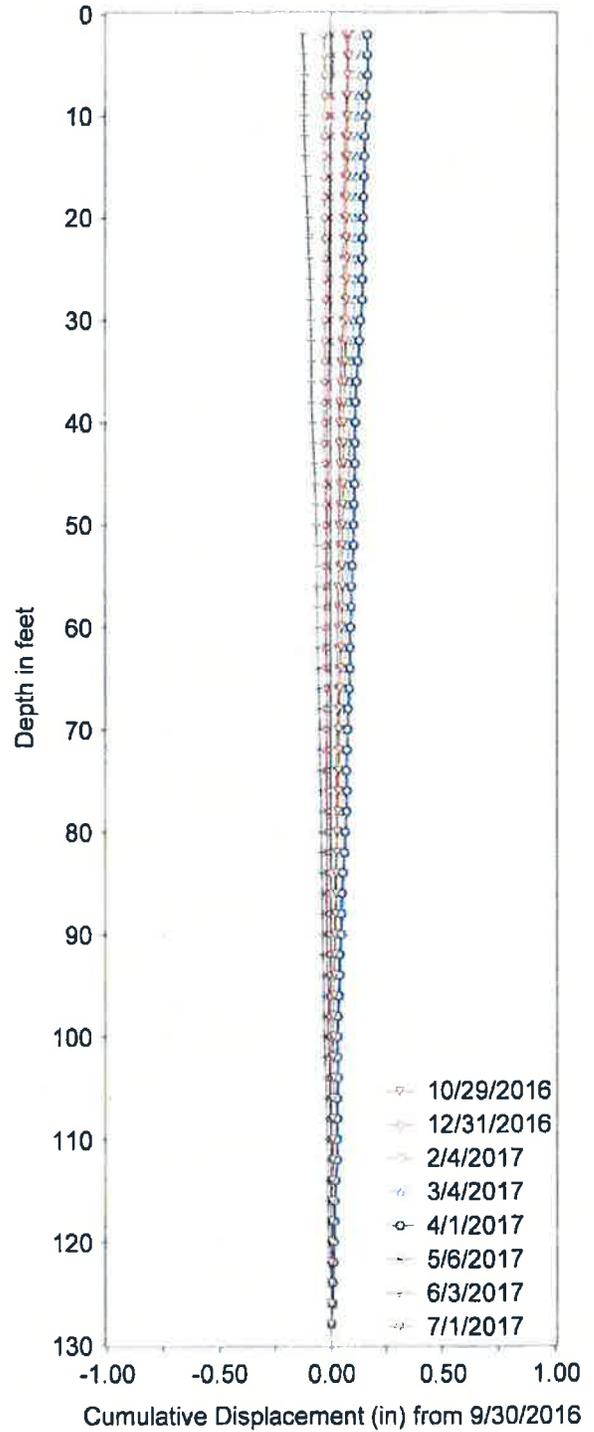
Figure B2
Inclinometer 2 - Deflection Profile
Grassy Trail Dam, Carbon County, Utah

The deflected shape of Inclinator 2 on January 26, 2008 relative to a baseline shape measured on July 20, 2004 is shown in plan view on Figure B-3. The figure shows that the measured deflections are oriented primarily along the dam axis from the west (right) abutment toward the maximum section to the east. The slight “bulging” noted on the “B” axis profile is in the upstream direction. Since no significant movement has occurred between 2010 and October 2016, this information is not included on this figure.

There appears to be a very strong correlation between the deflections measured by Inclinator 2 and the proximity of longwall mining. The larger magnitudes of events recorded during Panel 7 mining compared to Panel 6 mining may also contribute to the larger lateral deflections observed during Panel 7 mining.

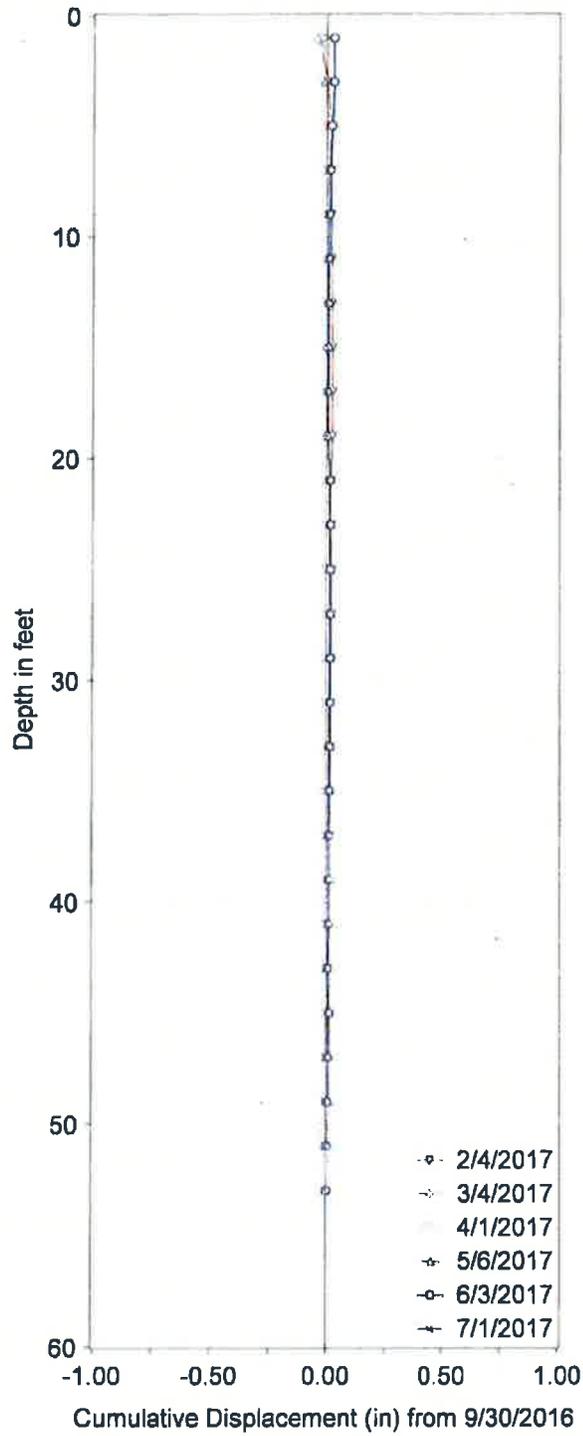
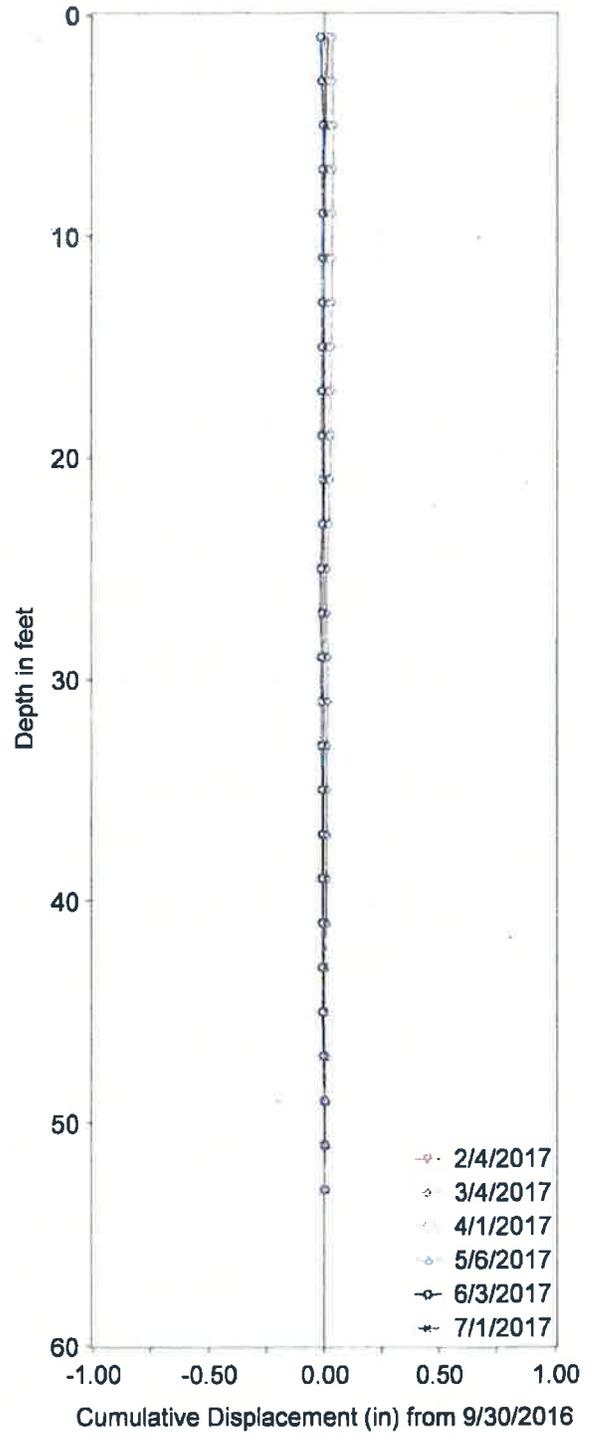
Figure B-3
Inclinometer 3 - Deflection Profile
Grassy Trail Dam, Carbon County, Utah

The deflections measured at Inclinometer 3 are substantially smaller than those measured at Inclinometer 2; however, it should be noted that the bottom eight feet of Inclinometer 2 appears to be fixed in place, suggesting that the pipe may be anchored in a stationary stratum. By contrast, Inclinometer 3 shows deflections beginning at the deepest

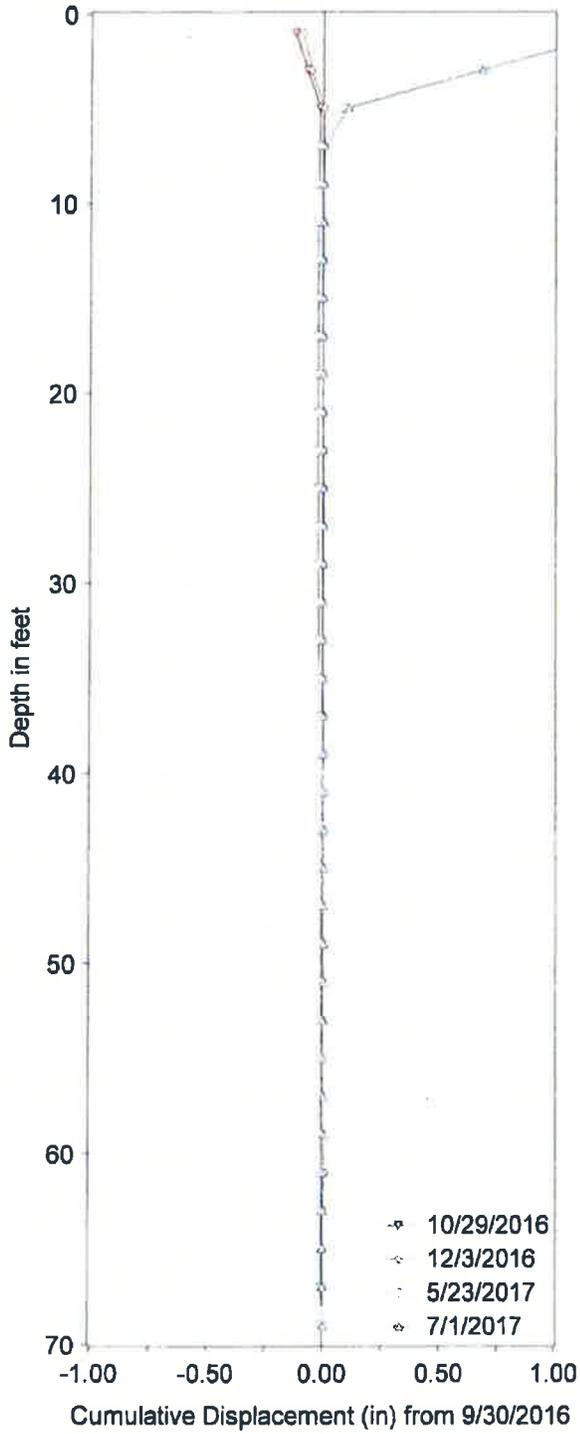
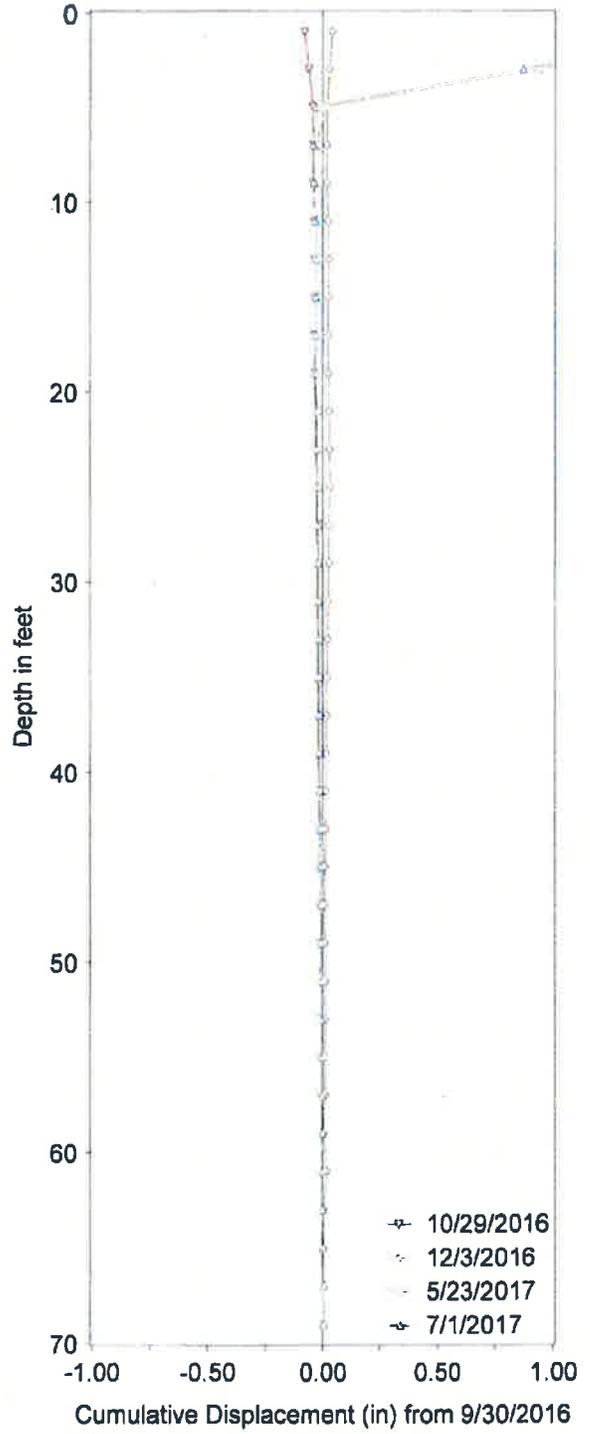
Repairs made 5/26/10 new survey
may not match true with old surveys

Top few feet of pipe were loose

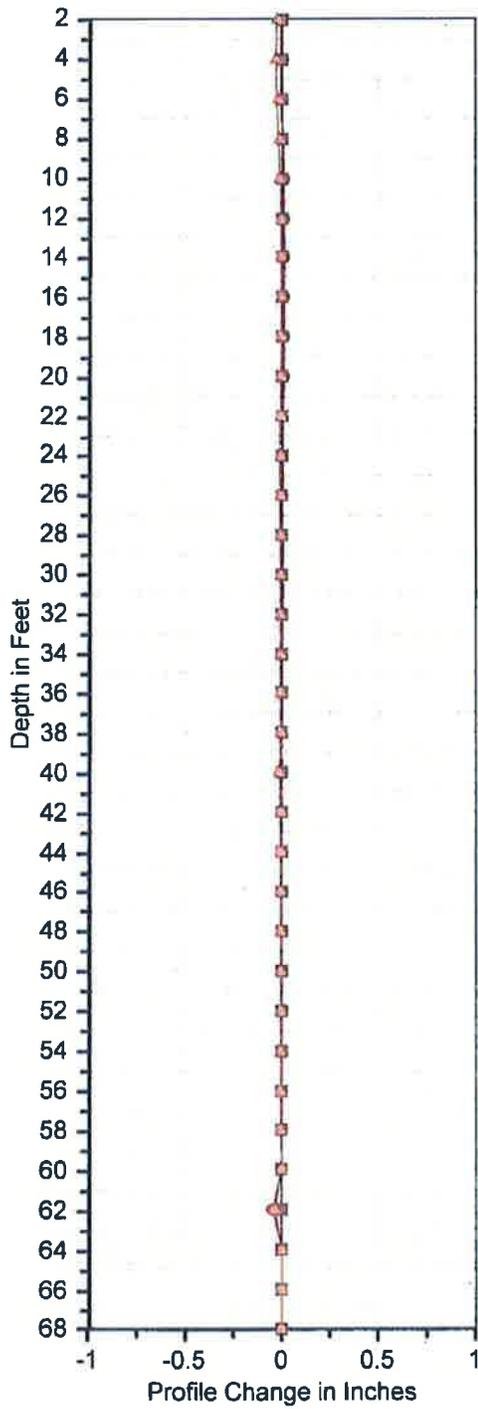
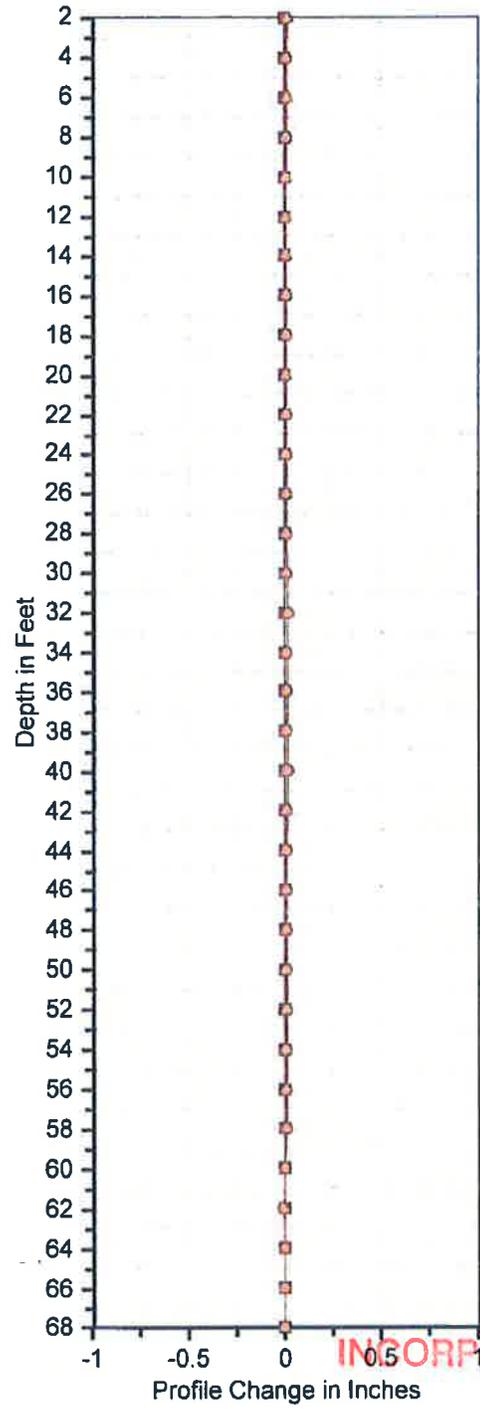
Figure B-8 GrassyTrail I-4 A

Deflection profiles for Inclinator 4 are shown on Figure B-8. This figure shows relative movement compared to a base line reading taken in June, 2010. The larger displacements shown in the upper 4 feet indicate that the top of the pipe is loose and is moving during the readings.

Taking into account the possible reading error due to the damage, the inclinometer does not show any significant movement since 2007. Some additional repairs are advisable to secure and protect the top of the instrument.

- Inclinator 4 was damaged and then buried by a surficial landslide. This slide was triggered by a road cut made to widen the roadway along the west side of the dam. We recommend stabilizing and protecting the top of this inclinometer. It is recommended that modifications to the existing slopes not be performed without considering hillside stability.

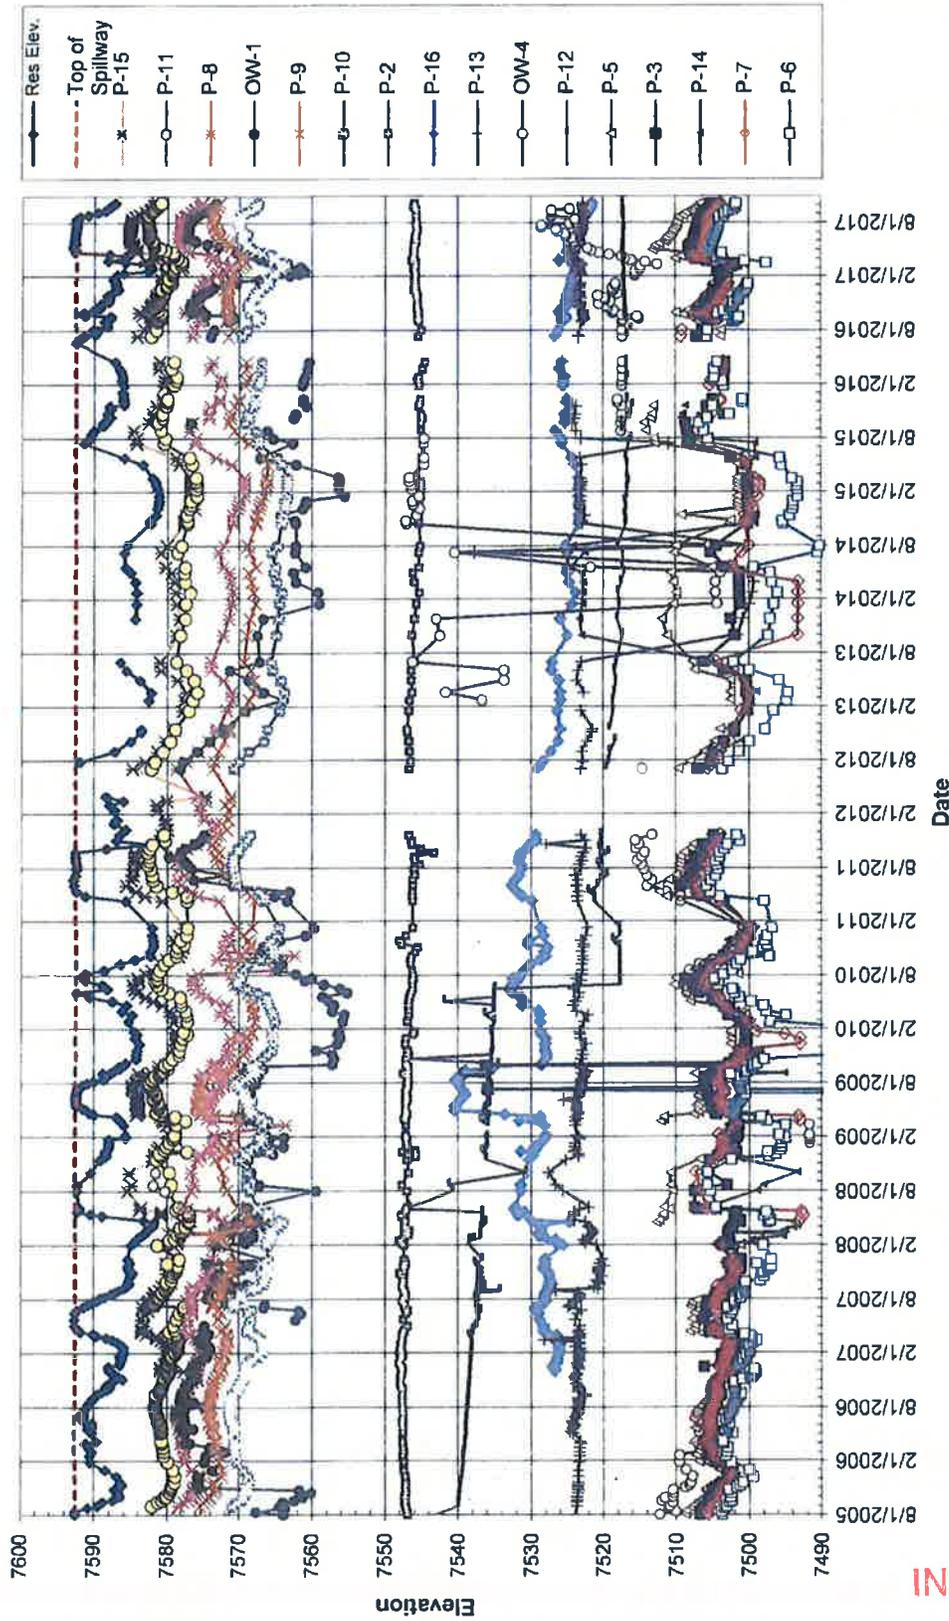
Figure C-1A
Reservoir Elevation and Piezometer Readings
August 2005 to Oct 7, 2017
Grassy Trail Dam and Reservoir

A review of the other piezometer readings shows an occasional spike on a single piezometer reading. These spikes appear to be errors in data entry since the next reading is back to normal. With exception of these spikes and the erratic P-4 readings discussed above, no substantial or unusual changes in water levels were observed.

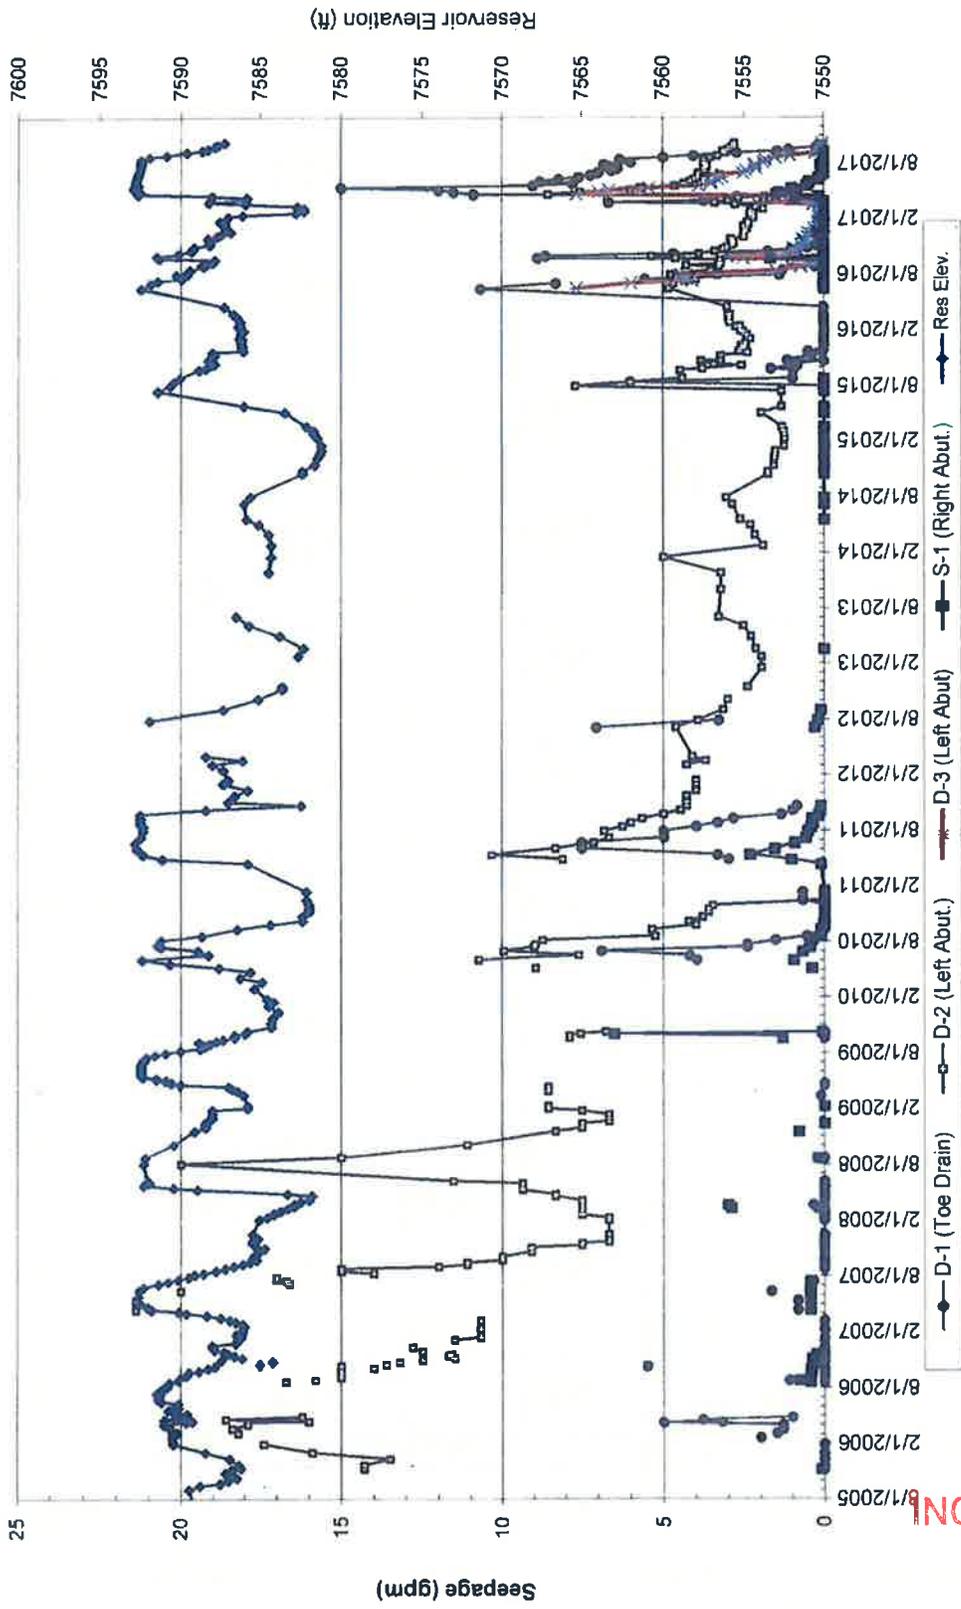
Figure C-2A

Seepage through the dam, foundation, and abutments has been collected at three locations, including the toe drain connected to the dam's internal drainage system (D-1), a seepage collection system located on the east (left) abutment (D-2), and a collection pipe located on the west (right) abutment (S-1). A second collection point (D-3) was added on the left abutment sometime in late 2015 or early 2016. The flows from the drains are measured by recording the time to fill a container of known volume with water from each collection point. The clarity of the water has also been recorded during seepage readings. Clear seepage indicates that the flow is adequately filtered and is not moving material through the dam or foundation. Cloudy seepage could be a sign of internal erosion, which could lead to a piping-related failure of the structure. No cloudy water was noted during our site visits prior to 2015.

After recent modifications to the left abutment seepage collection system, significant seepage appears to have been redirected to D-3 on the left abutment. We have also observed a trace of sediment in the bottom of the 5 gallon bucket during some site visits. It is not known if the sediment is coming from the surface or if it is due to the reworking of the drain lines.

- We recommend that regular monitoring of piezometers and seepage collection points continue as directed by the State. All seepage from the left and right abutments should be collected and measured. The amount of sediment, if any, should be quantified and recorded.
