Sunnyside Cogeneration Associates

RE: Annual 2003 Inspection Report
Star Point Refuse Pile C/007/042

| IMPOUNDMENT INSPECTION AND CERTIFIED REPORT | | Sediment Pond 006 | |

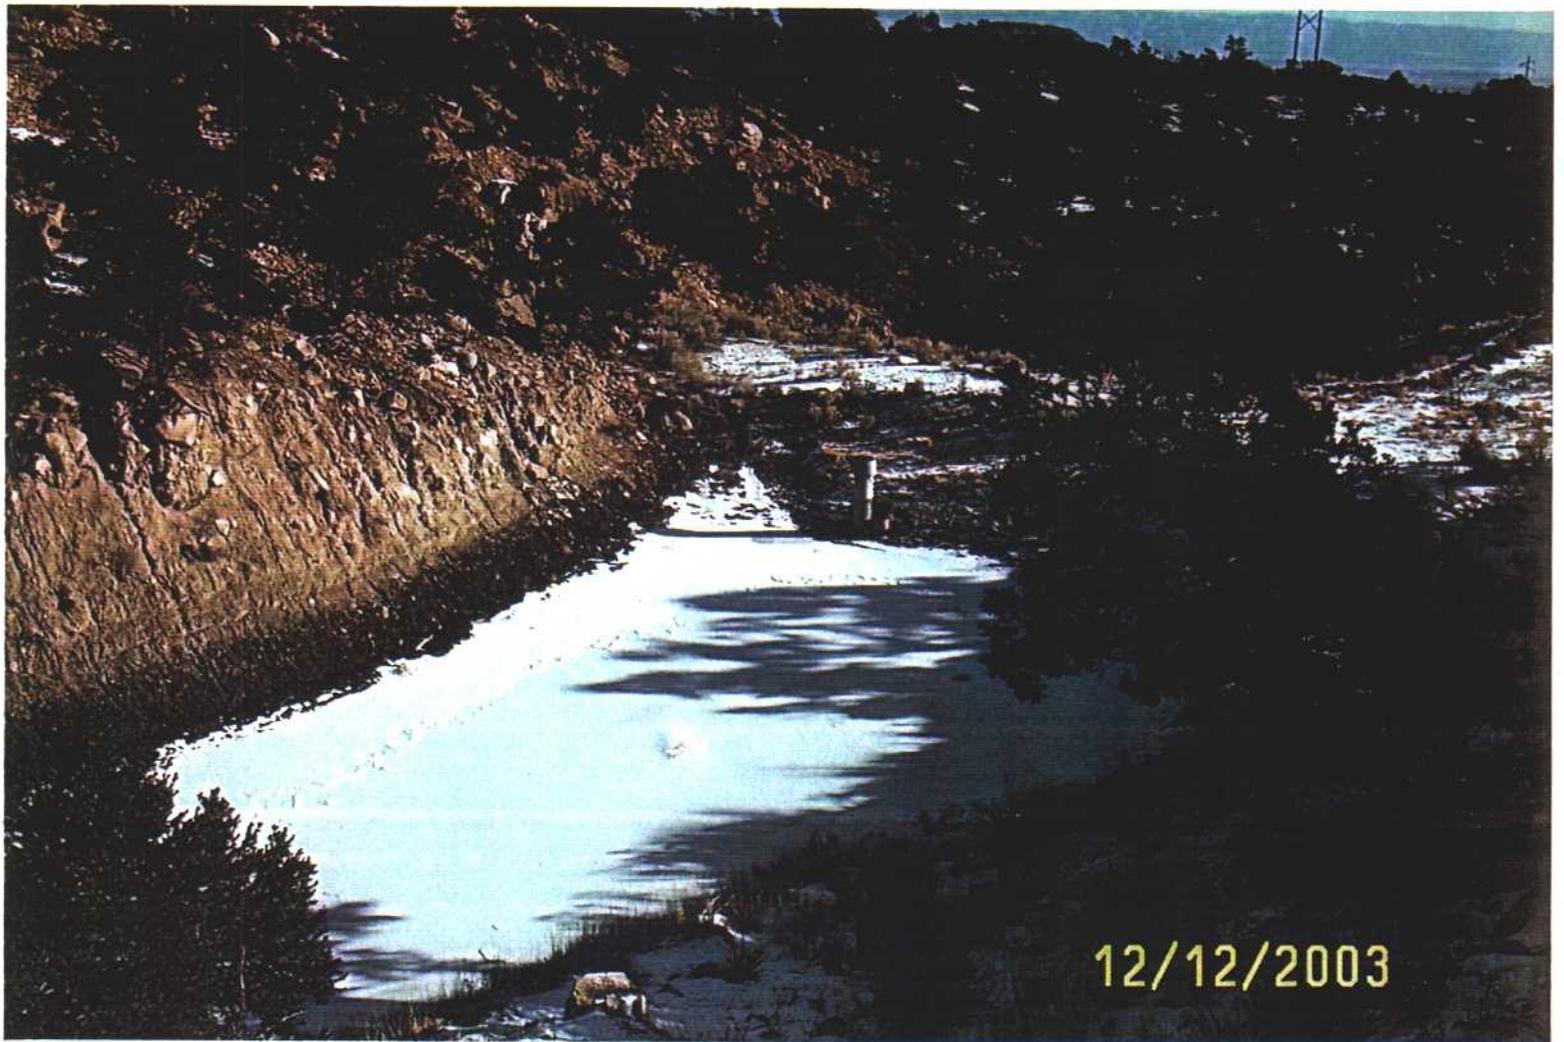
Sediment Pond # 006

No discharge, inlet/outlet conditions are good,
no structural or hazardous conditions exist.

No changes. Pond was essentially empty.
No structure or stability problems observed.

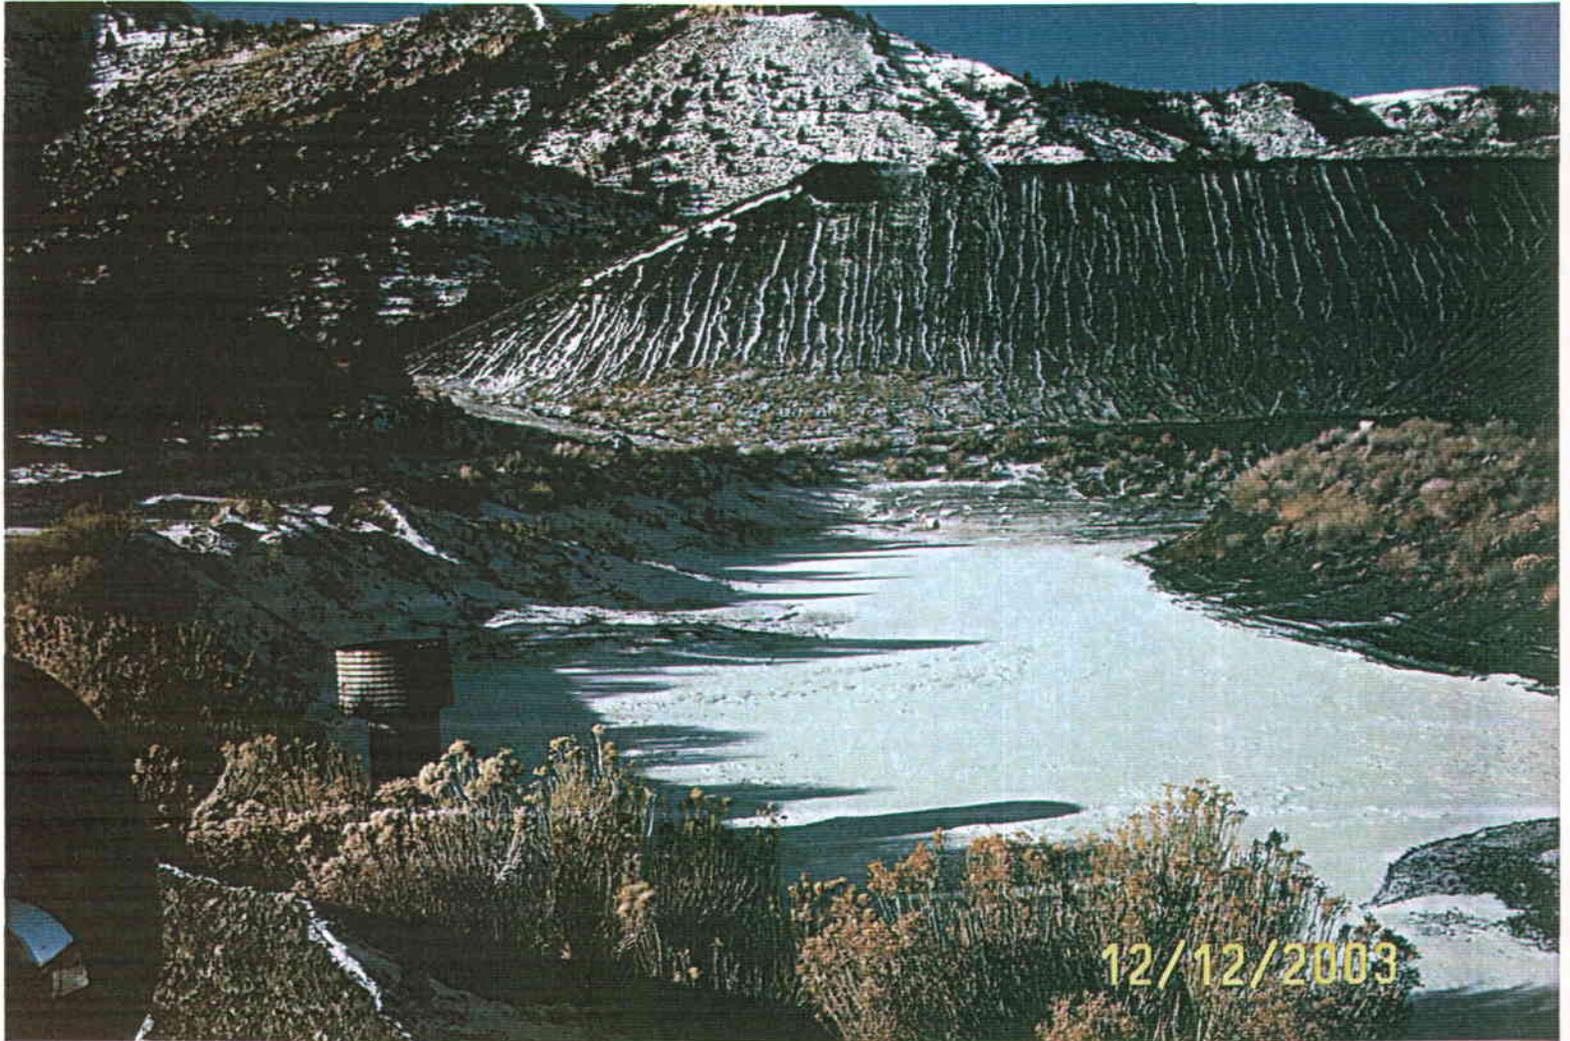
Sediment Pond # 005

No discharge, inlet/outlet conditions are good

No structural or hazardous conditions exist.

Pond was essentially empty.

No structure or stability problems observed.

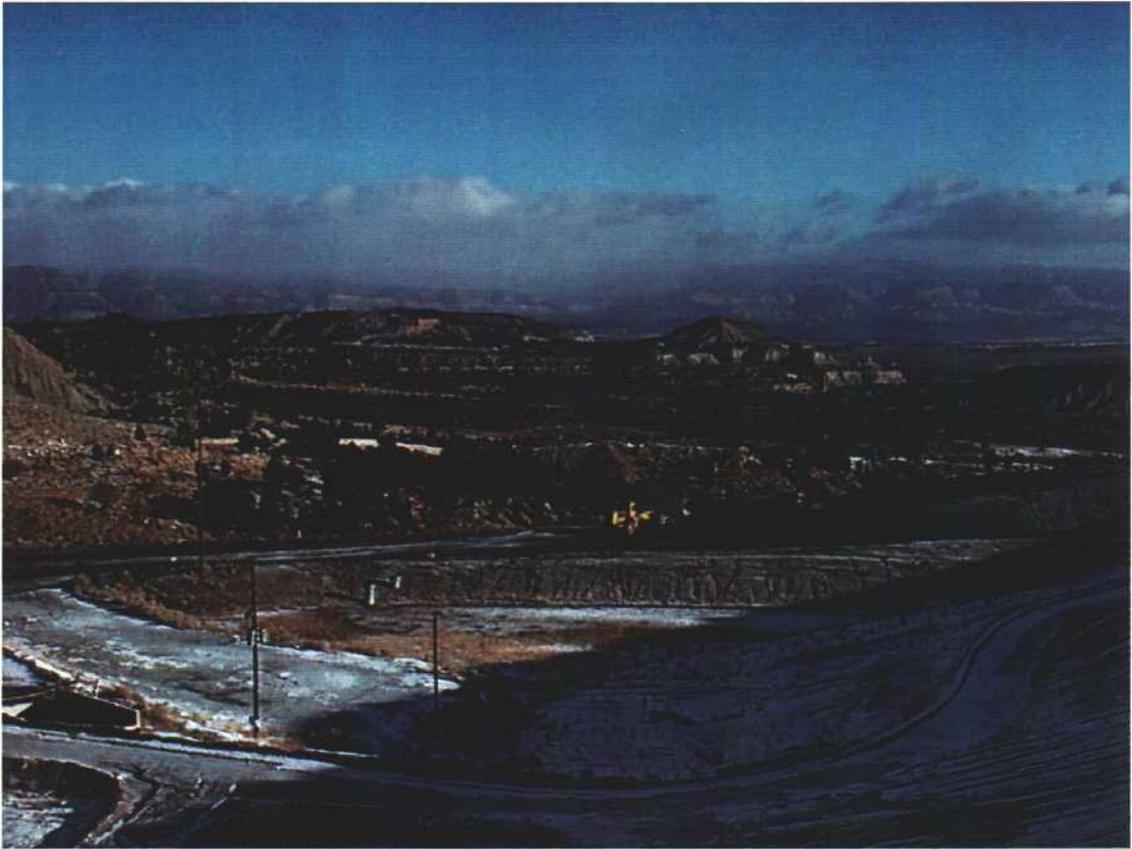
Sediment Pond 009 (12/12/03)

| <p>1. Describe any appearance of any instability, structural weakness, or any other hazardous condition.</p> <p>NONE</p> | | | |

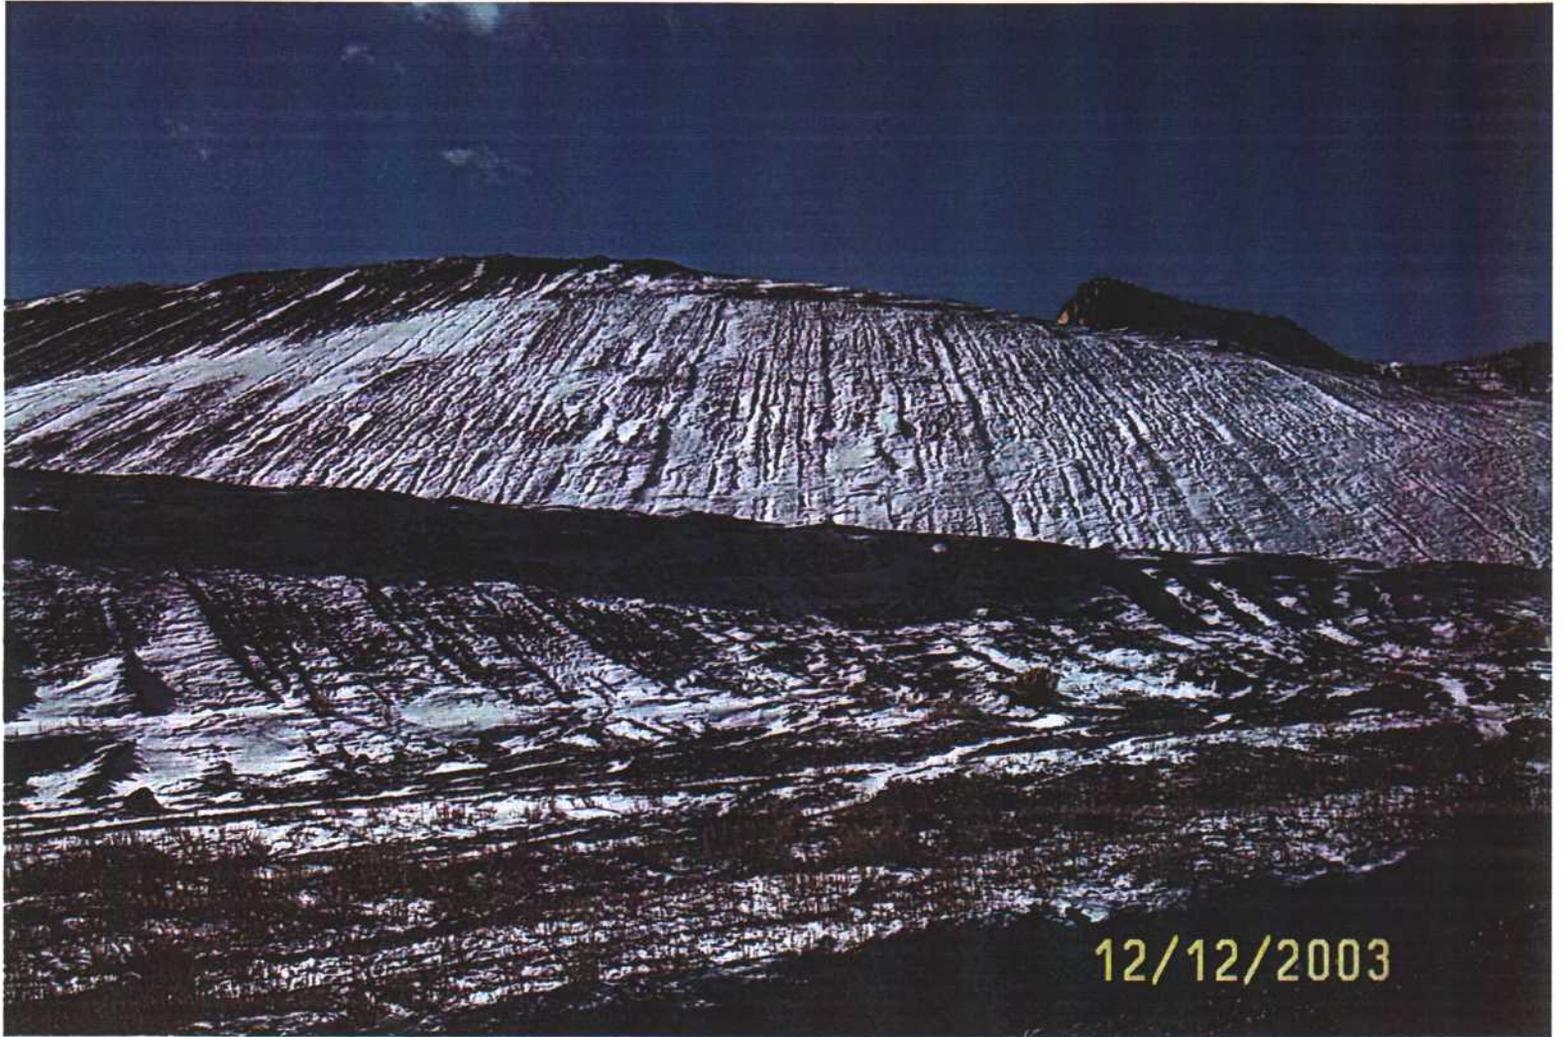
COARSE REFUSE PILE

No smokers visible

Many small rills exist on the out slopes of the refuse pile. These have reportedly been there for some time and are typical for exposed refuse materials. They do not appear to pose a structural hazard. Runoff from the top surface is not directed to the out slope, therefore it is expected that re-grading would simply start new rills. Sediment from this erosion reports to existing sediment ponds. In time, SCA's operations to remove the pile will eliminate the problem.

Waste Coal Removal

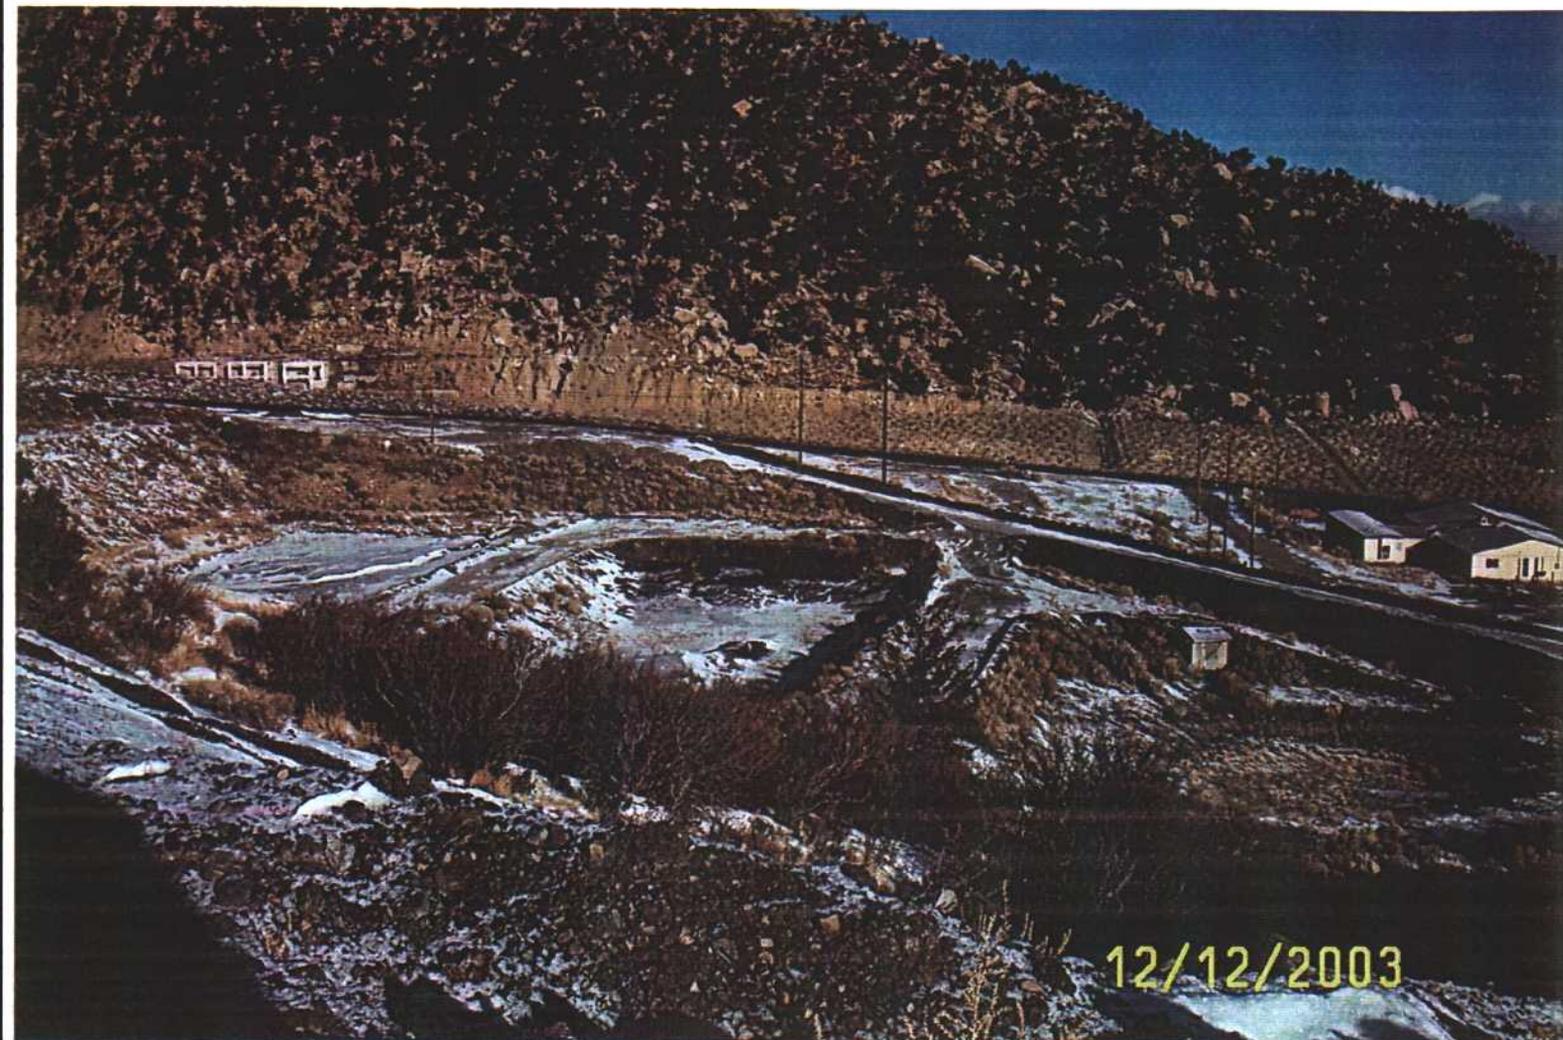
SITE of PROPOSED DISPOSAL AREA

| <p>1. Foundation preparation, including the removal of all organic material and topsoil.</p> <p>The site selected for the new disposal area is the old slurry ponds. Any topsoil recovered would have been addressed prior to the pond construction.</p> | | | |
| <p>4. Placement and compaction of fill materials.</p> <p>Did not receive disposal materials during this Quarter.</p> | | | |

None

No Construction occurred during this quarter.
