Sunnyside Cogeneration Associates

RE: First Quarter 2004 Inspection Report
Star Point Refuse Pile C/007/042

IMPOUNDMENT INSPECTION AND CERTIFIED REPORT		Sediment Pond 005	
Permit Number	C/007/042	Report Date 4/6/04	
Mine Name	STAR POINT WASTE FUEL		
Company Name	SUNNYSIDE COGENERATION ASSOCIATES		
Impoundment Identification	Impoundment Name	Sediment Pond 005	
	Impoundment Number	005	
	UPDES Permit Number	UTR000604	
	MSHA ID Number	N/A	
IMPOUNDMENT INSPECTION			
Inspection Date	March 12, 2004		
Inspected By	Scott Carlson		
Reason for Inspection (Annual, Quarterly or Other Periodic Inspection, Critical Installation, or Completion of Construction)		First Quarter Inspection 2004	
<p>1. Describe any appearance of any instability, structural weakness, or any other hazardous condition.</p> <p>NONE</p>			
<p>Required for an impoundment which functions as a SEDIMENTATION POND.</p>	<p>2. Sediment storage capacity, including elevation of 60% and 100% sediment storage volumes, and, estimated average elevation of existing sediment.</p> <p>Total Pond volume = 6.96 acre-feet</p> <p>Sediment Storage Capacity = 2.42 acre-feet Pond bottom elevation = 7387.3 60% sediment elevation = 7393 Maximum Se

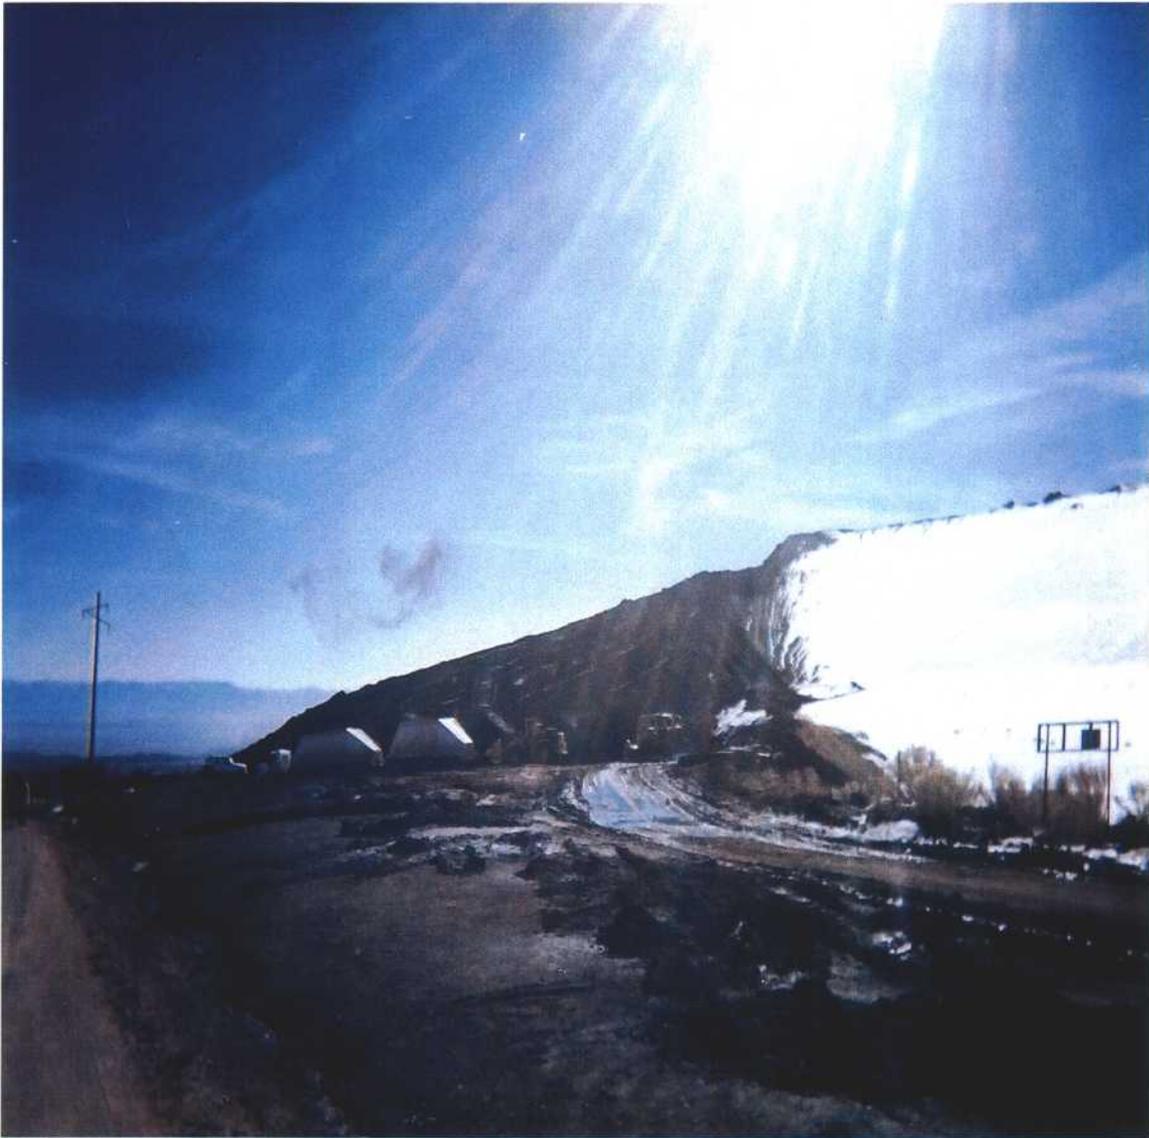
Star Point Refuse Pile A, Northeast face

Many small rills exist on the out slopes of the refuse pile. These have reportedly been there for some time and are typical for exposed refuse materials. They do not appear to pose a structural hazard. Runoff from the top surface is not directed to the out slope, therefore it is expected that re-grading would simply start new rills. Sediment from this erosion reports to existing sediment ponds. In time, SCA's operations to remove the pile will eliminate the problem.

In early 2004, the operator removed material from the lower face of the pile, resulting in a steeper slope. It was determined that this did not comply with the approved mining plan and the inspector issued a notice of violation (NOV # N04-49-3-1) on February 25, 2004. SCA immediately stopped its operation until the slope was restored. SCA then submitted a permit amendment on March 24, 2004 to allow for excavation of coal materials from the slopes with specific criteria regarding appropriately safe slopes. The amendment is currently under review by DOGM.
