## Sunnyside Cogeneration Associates

RE: Second Quarter 2004 Inspection Report  
Star Point Refuse Pile C/007/042

<b>IMPOUNDMENT INSPECTION AND CERTIFIED REPORT</b>		Sediment Pond 005	
<b>Permit Number</b>	C/007/042	<b>Report Date</b> 7/8/04	
<b>Mine Name</b>	STAR POINT WASTE FUEL		
<b>Company Name</b>	SUNNYSIDE COGENERATION ASSOCIATES		
<b>Impoundment Identification</b>	<b>Impoundment Name</b>	Sediment Pond 005	
	<b>Impoundment Number</b>	005	
	<b>UPDES Permit Number</b>	UTR000604	
	<b>MSHA ID Number</b>	N/A	
<b>IMPOUNDMENT INSPECTION</b>			
<b>Inspection Date</b>	June 23, 2004		
<b>Inspected By</b>	Scott Carlson		
<b>Reason for Inspection</b> (Annual, Quarterly or Other Periodic Inspection, Critical Installation, or Completion of Construction)		Second Quarter Inspection 2004	
<p>1. Describe any appearance of any instability, structural weakness, or any other hazardous condition.</p> <p>NONE</p>			
<p>Required for an impoundment which functions as a SEDIMENTATION POND.</p>	<p>2. Sediment storage capacity, including elevation of 60% and 100% sediment storage volumes, and, estimated average elevation of existing sediment.</p> <p>Total Pond volume = 6.96 acre-feet</p> <p>Sediment S

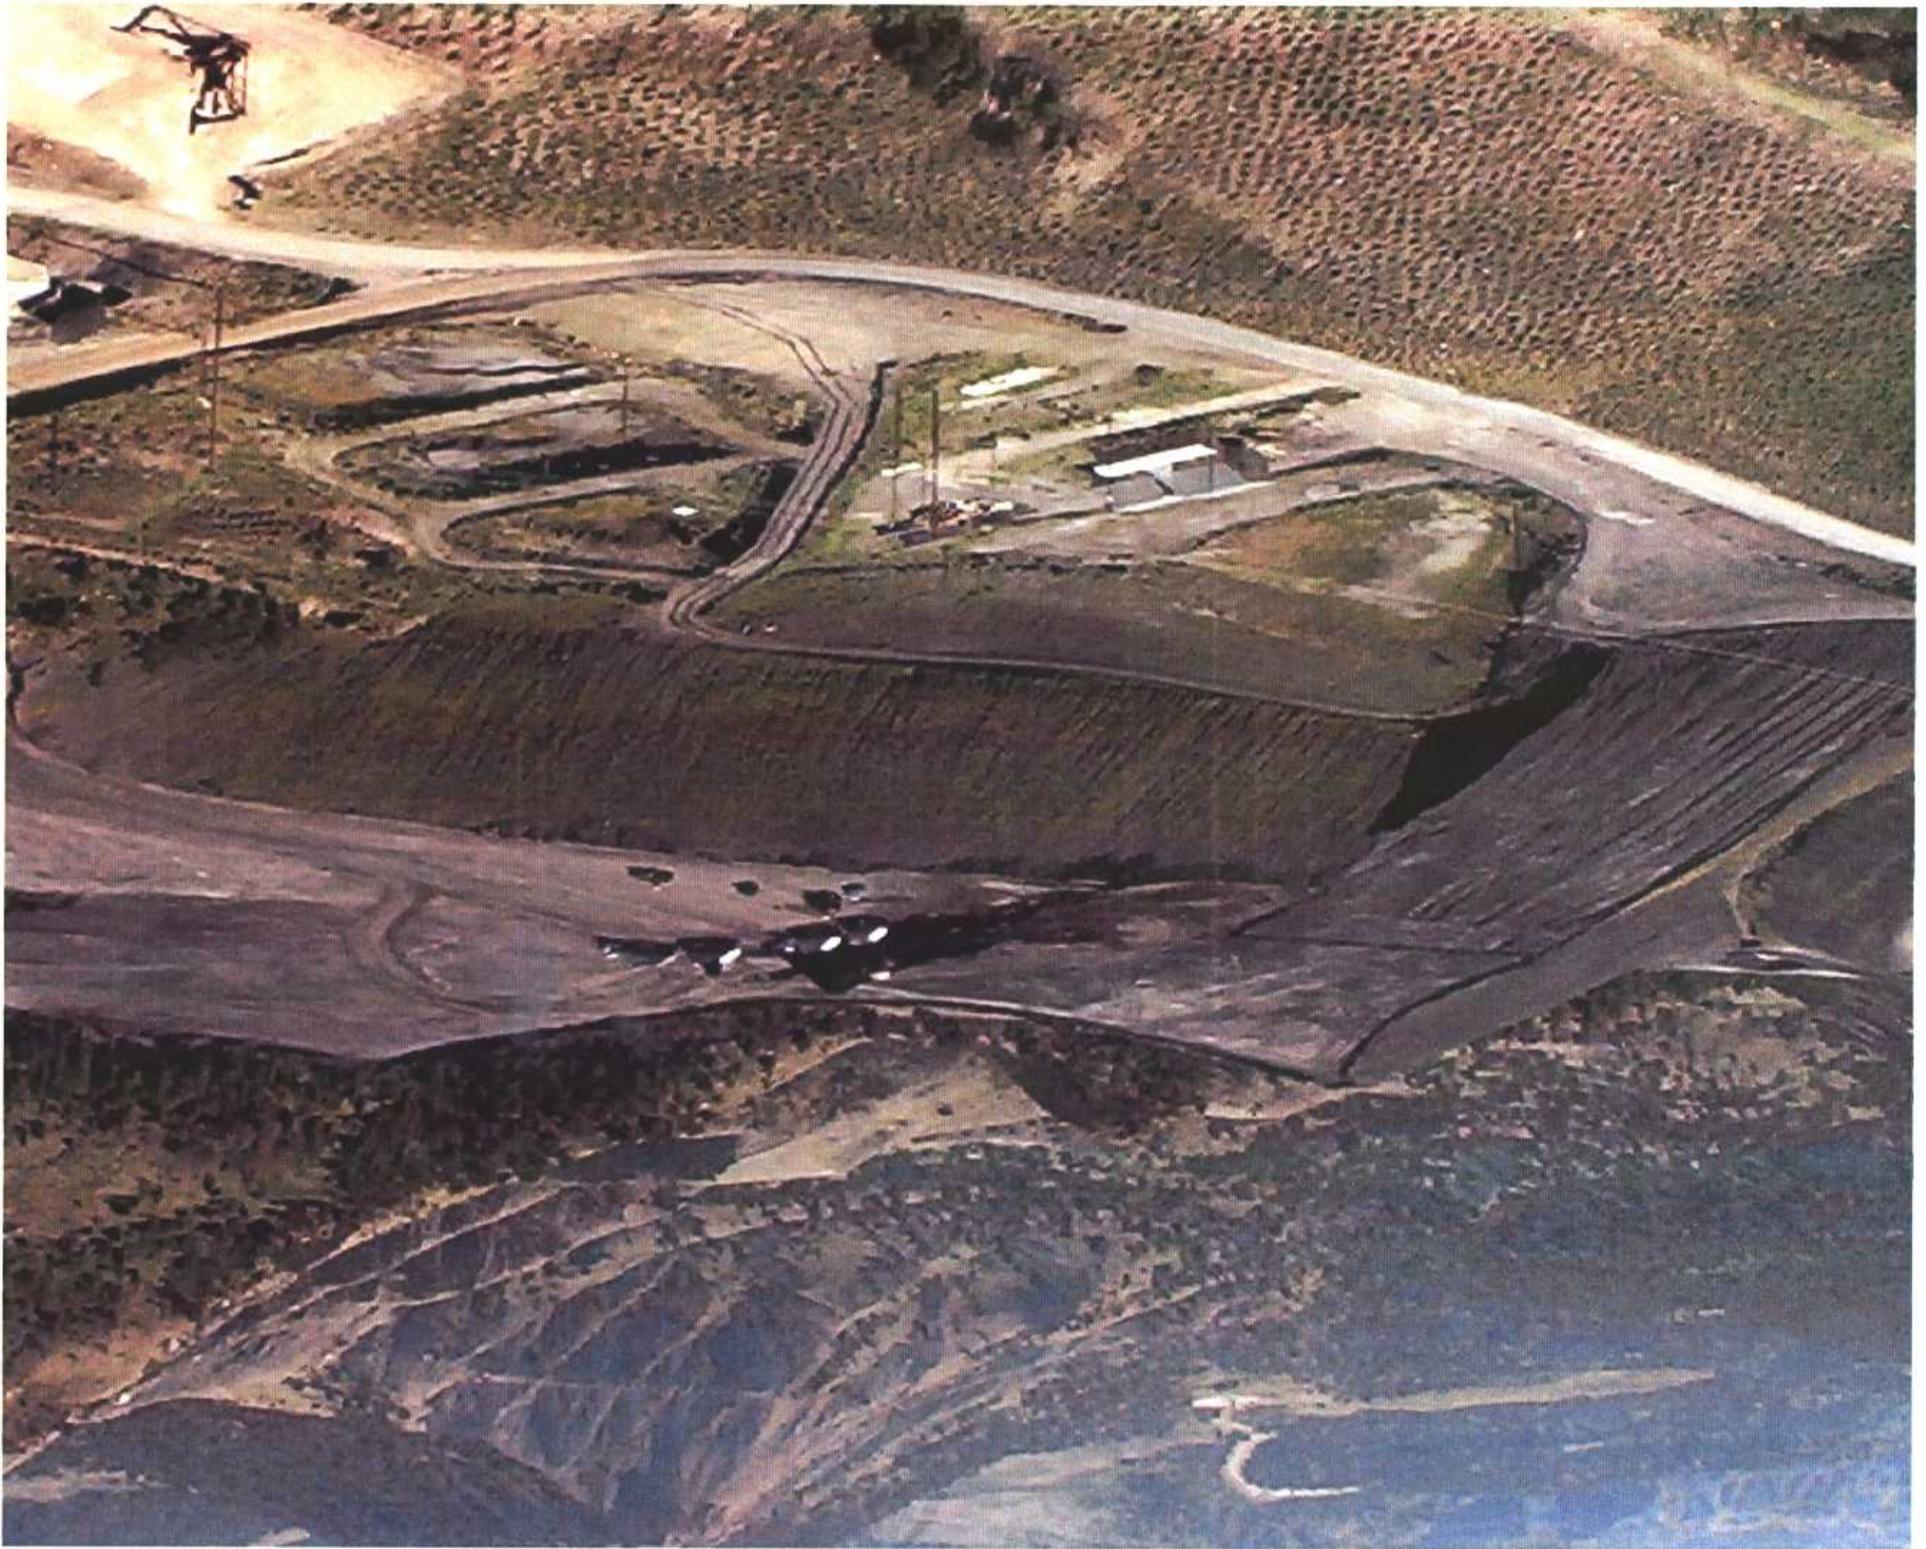
No smokers visible

Many small rills exist on the out slopes of the refuse pile. These have reportedly been there for some time and are typical for exposed refuse materials. They do not appear to pose a structural hazard. Runoff from the top surface is not directed to the out slope, therefore it is expected that re-grading would simply start new rills. Sediment from this erosion reports to existing sediment ponds. In time, SCA's operations to remove the pile will eliminate the problem.
