Sunnyside Cogeneration Associates

RE: First Quarter 2005 Inspection Report
Star Point Refuse Pile C/007/042

IMPOUNDMENT INSPECTION AND CERTIFIED REPORT		Sediment Pond 005	
Permit Number	C/007/042	Report Date 4/8/05	
Mine Name	STAR POINT WASTE FUEL		
Company Name	SUNNYSIDE COGENERATION ASSOCIATES		
Impoundment Identification	Impoundment Name	Sediment Pond 005	
	Impoundment Number	005	
	UPDES Permit Number	UTG040025	
	MSHA ID Number	N/A	
IMPOUNDMENT INSPECTION			
Inspection Date	March 25, 2005		
Inspected By	Scott Carlson		
Reason for Inspection (Annual, Quarterly or Other Periodic Inspection, Critical Installation, or Completion of Construction)		First Quarter Inspection 2005	
<p>1. Describe any appearance of any instability, structural weakness, or any other hazardous condition.</p> <p>NONE</p>			
<p>Required for an impoundment which functions as a SEDIMENTATION POND.</p>	<p>2. Sediment storage capacity, including elevation of 60% and 100% sediment storage volumes, and, estimated average elevation of existing sediment.</p> <p>Total Pond volume = 6.96 acre-feet</p> <p>Sediment Storage Capacity = 2.42 acre-feet Pond bottom elevation = 7387.3 60% sediment elevation = 7393 Maximum Se

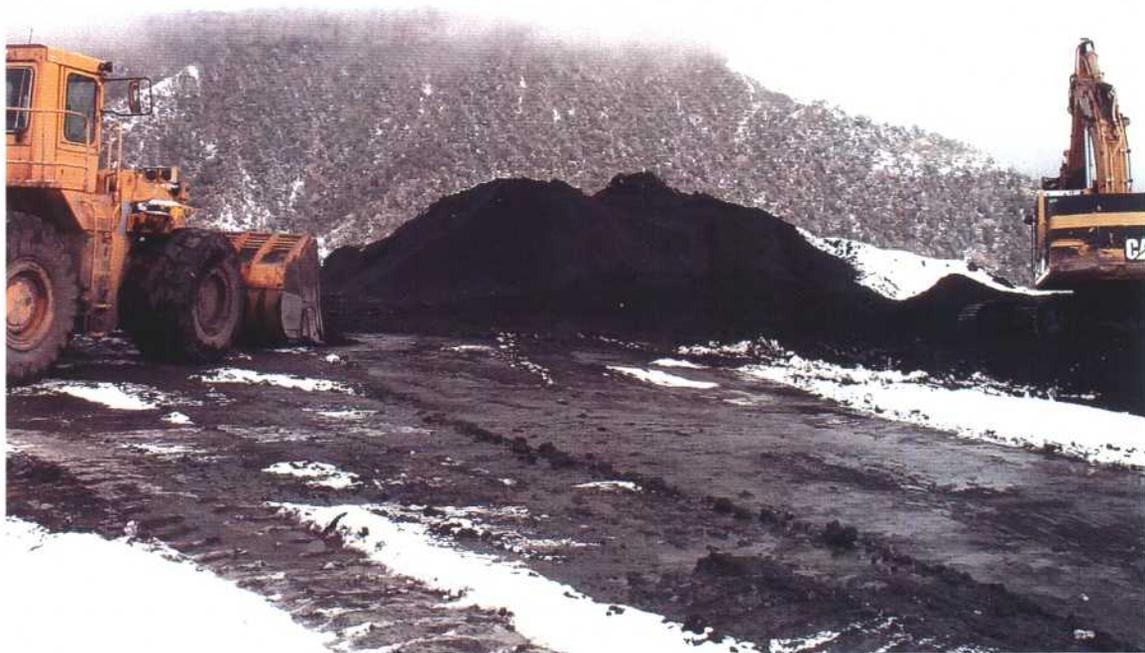
No smokers visible

Many small rills exist on the out slopes of the refuse pile. These have reportedly been there for some time and are typical for exposed refuse materials. They do not appear to pose a structural hazard. Runoff from the top surface is not directed to the out slope, therefore it is expected that re-grading would simply start new rills. Sediment from this erosion reports to existing sediment ponds. In time, SCA's operations to remove the pile will eliminate the problem.

Excavation and hauling operations are occurring from the top of the pile

Refuse Pile Operations, Looking Northerly

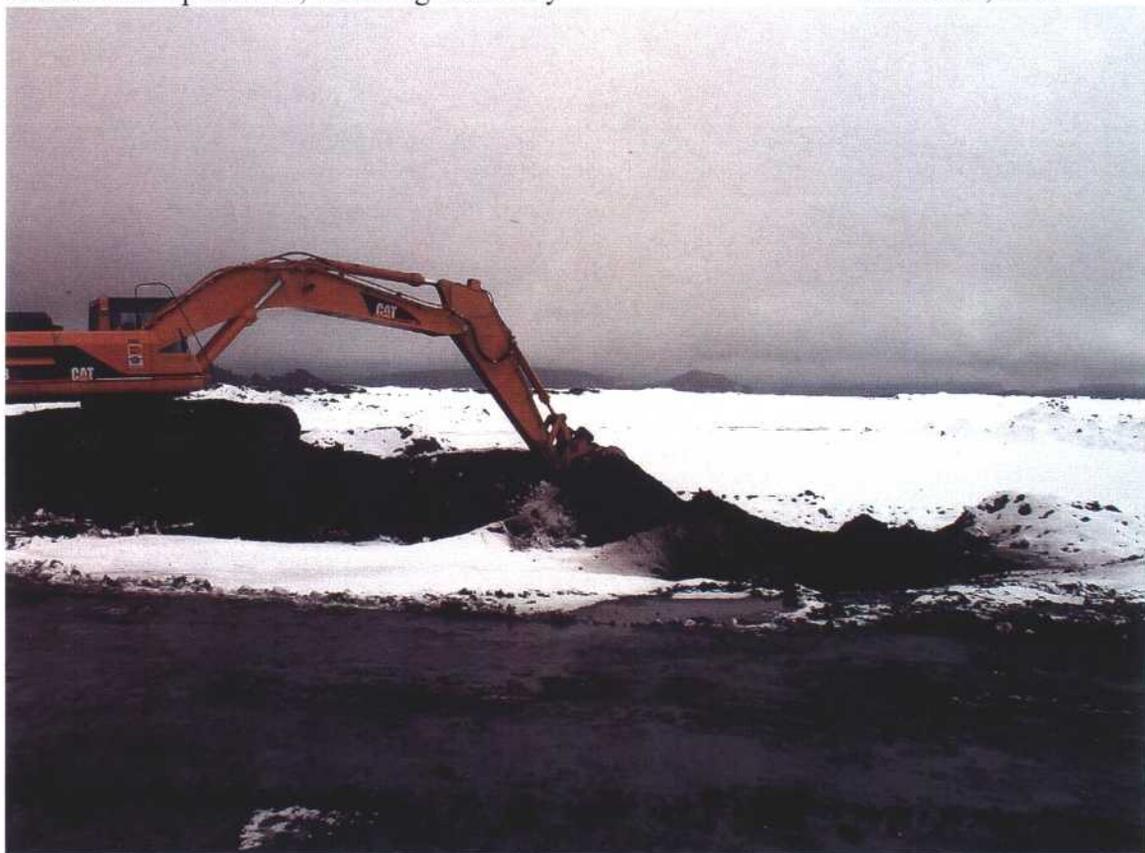
Refuse Pile Operations, Looking Northerly
