Sunnyside Cogeneration Associates

RE: Second Quarter 2005 Inspection Report
Star Point Refuse Pile C/007/042

| Mine Name | STAR POINT WASTE FUEL | | |

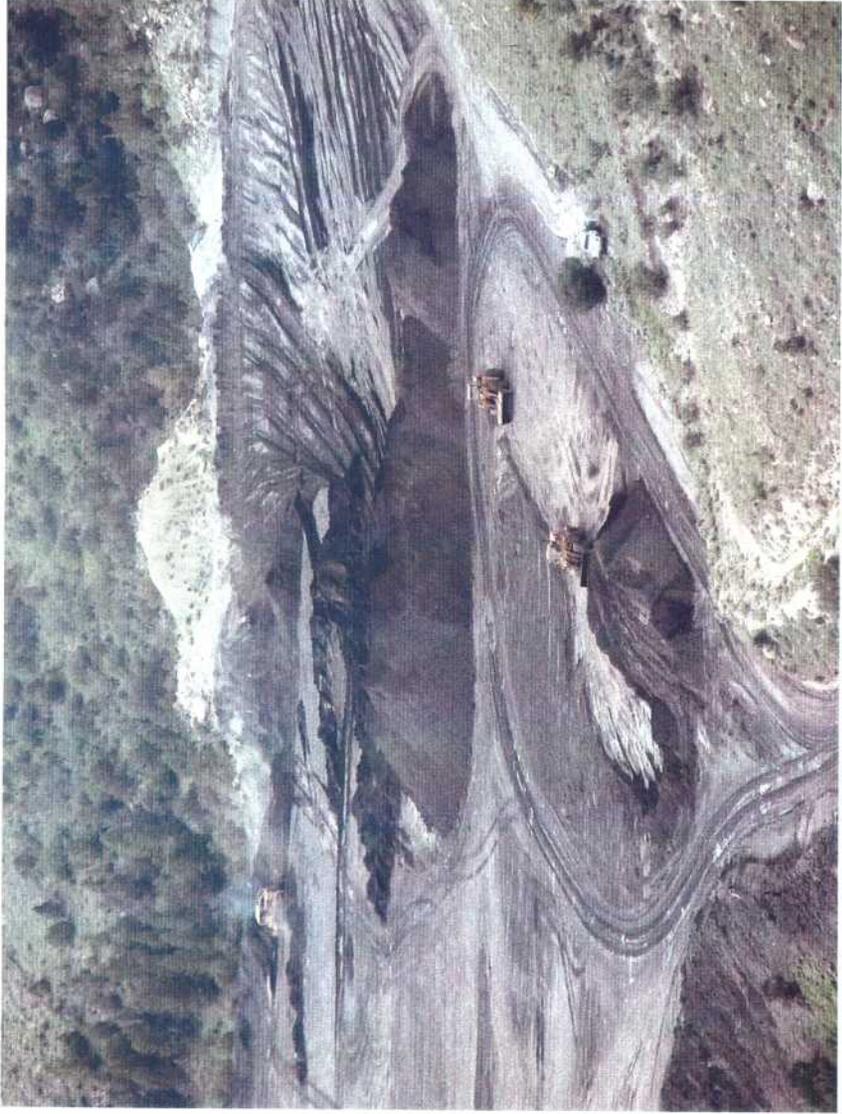
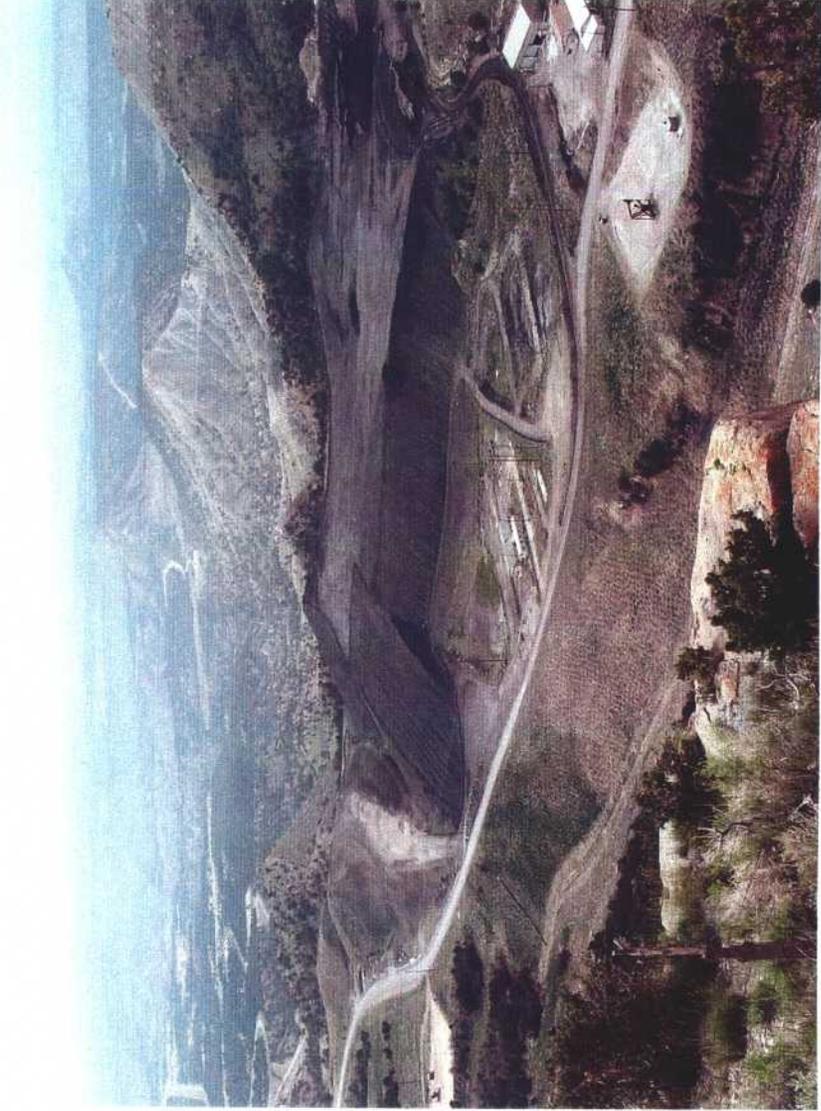
Coarse Refuse Pile

Many small rills exist on the out slopes of the refuse pile. These have reportedly been there for some time and are typical for exposed refuse materials. They do not appear to pose a structural hazard. Runoff from the top surface is not directed to the out slope, therefore it is expected that re-grading would simply start new rills. Sediment from this erosion reports to existing sediment ponds. In time, SCA's operations to remove the pile will eliminate the problem.
