Sunnyside Cogeneration Associates

RE: Third Quarter 2005 Inspection Report
Star Point Refuse Pile C/007/042

Please find enclosed a copy of the Third Quarter 2005 Inspection Report for the Star Point refuse pile, impoundments, and excess spoil area. The inspection was performed by a professional engineer from Twin Peaks Engineering.

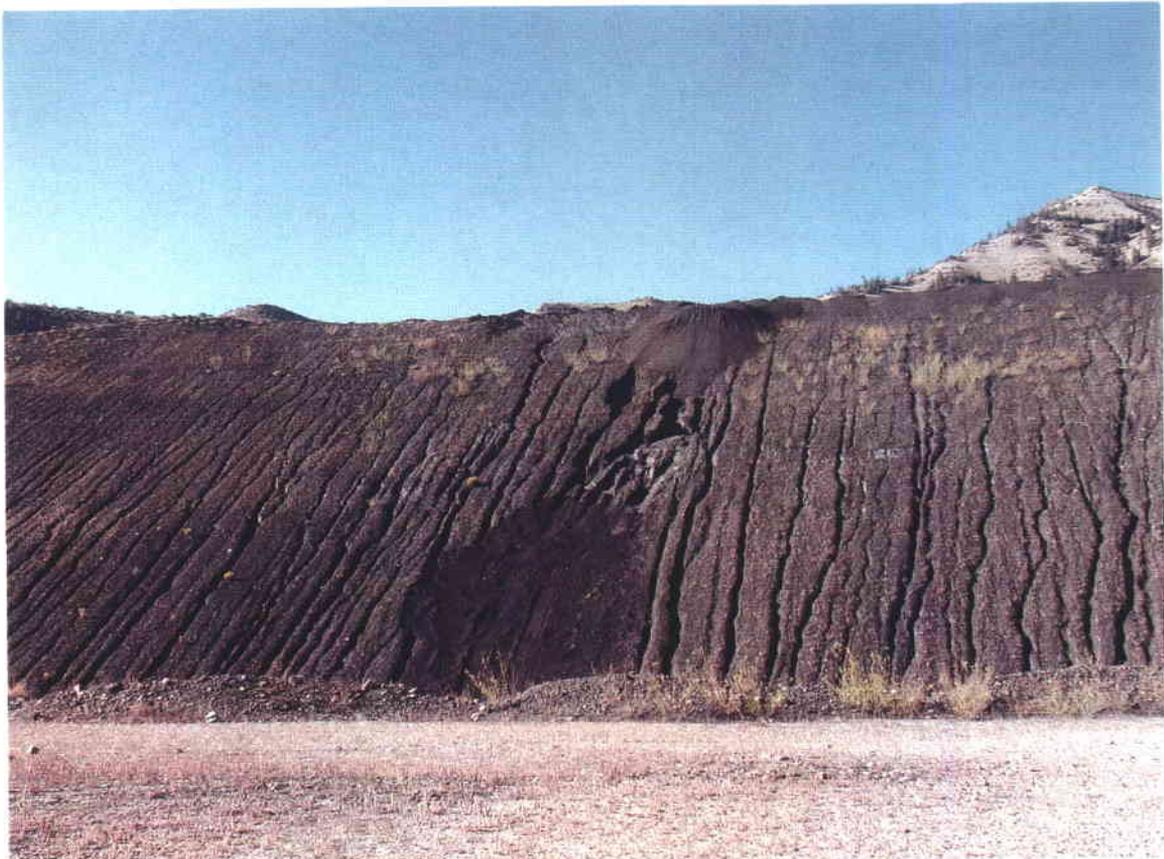
Recent storms had caused noticeable erosion on the site and interim catchment areas had collected a lot of sediment. SCA was in the process of cleaning these areas and restoring the eroded areas.

East Face Refuse Pile A – Eroded area with restoration efforts underway Sept 20, 2005

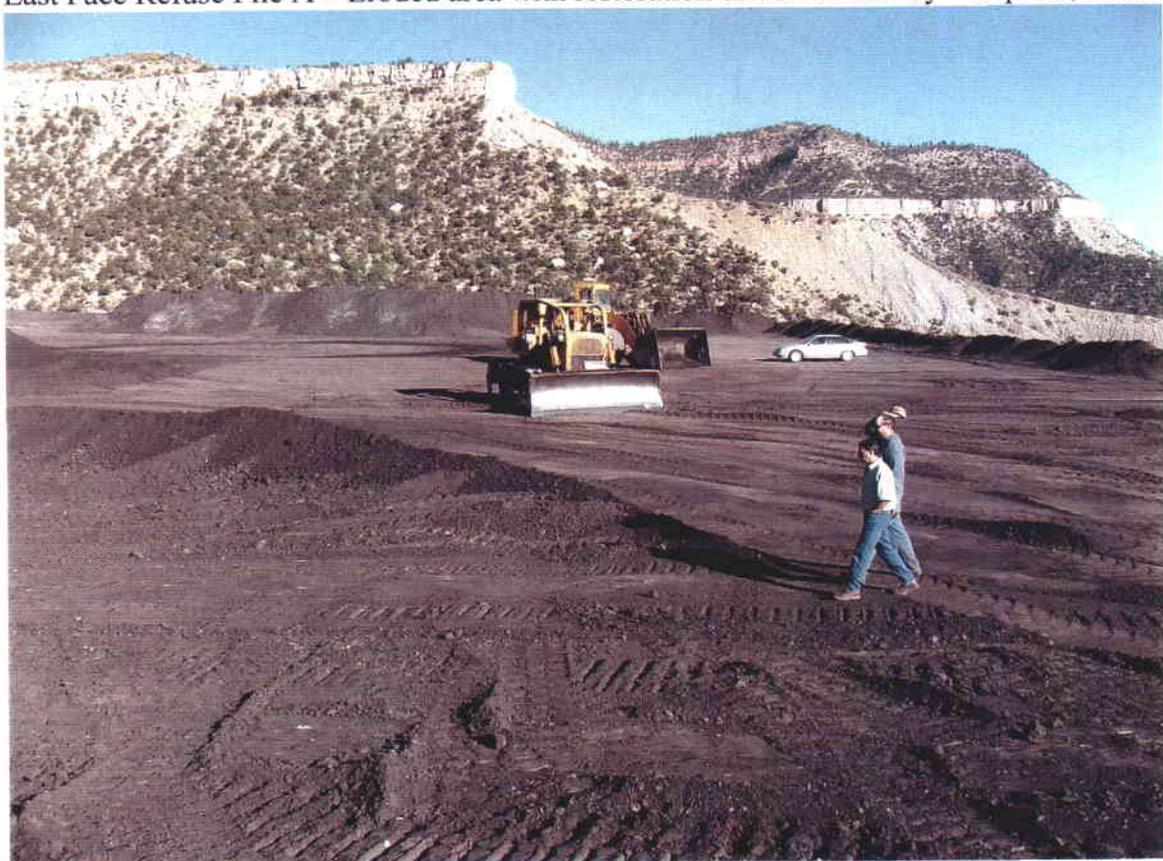
Excavation and hauling operations are occurring from the top of the pile

Top East End Refuse Pile Looking northerly
