RE: Fourth Quarter 2005 Inspection Report
Star Point Refuse Pile C/007/042

IMPOUNDMENT INSPECTION AND CERTIFIED REPORT		Sediment Pond 005	
Permit Number	C/007/042	Report Date	1/20/06
Mine Name	STAR POINT WASTE FUEL		
Company Name	SUNNYSIDE COGENERATION ASSOCIATES		
Impoundment Identification	Impoundment Name	Sediment Pond 005	
	Impoundment Number	005	
	UPDES Permit Number	UTG040025	
	MSHA ID Number	N/A	
IMPOUNDMENT INSPECTION			
Inspection Date	December 14, 2005		
Inspected By	Rusty Netz		
Reason for Inspection (Annual, Quarterly or Other Periodic Inspection, Critical Installation, or Completion of Construction)		Fourth Quarter Inspection 2005	
<p>1. Describe any appearance of any instability, structural weakness, or any other hazardous condition.</p> <p>NONE</p>			
<p>Required for an impoundment which functions as a SEDIMENTATION POND.</p>	<p>2. Sediment storage capacity, including elevation of 60% and 100% sediment storage volumes, and, estimated average elevation of existing sediment.</p> <p>Total Pond volume = 6.96 acre-feet</p> <p>Sediment Storage Capacity = 2.42 acre-feet Pond bottom elevation = 7387.3 60% sediment elevation = 7393 Maximum Sediment Depth Elevation = 7394.9 E

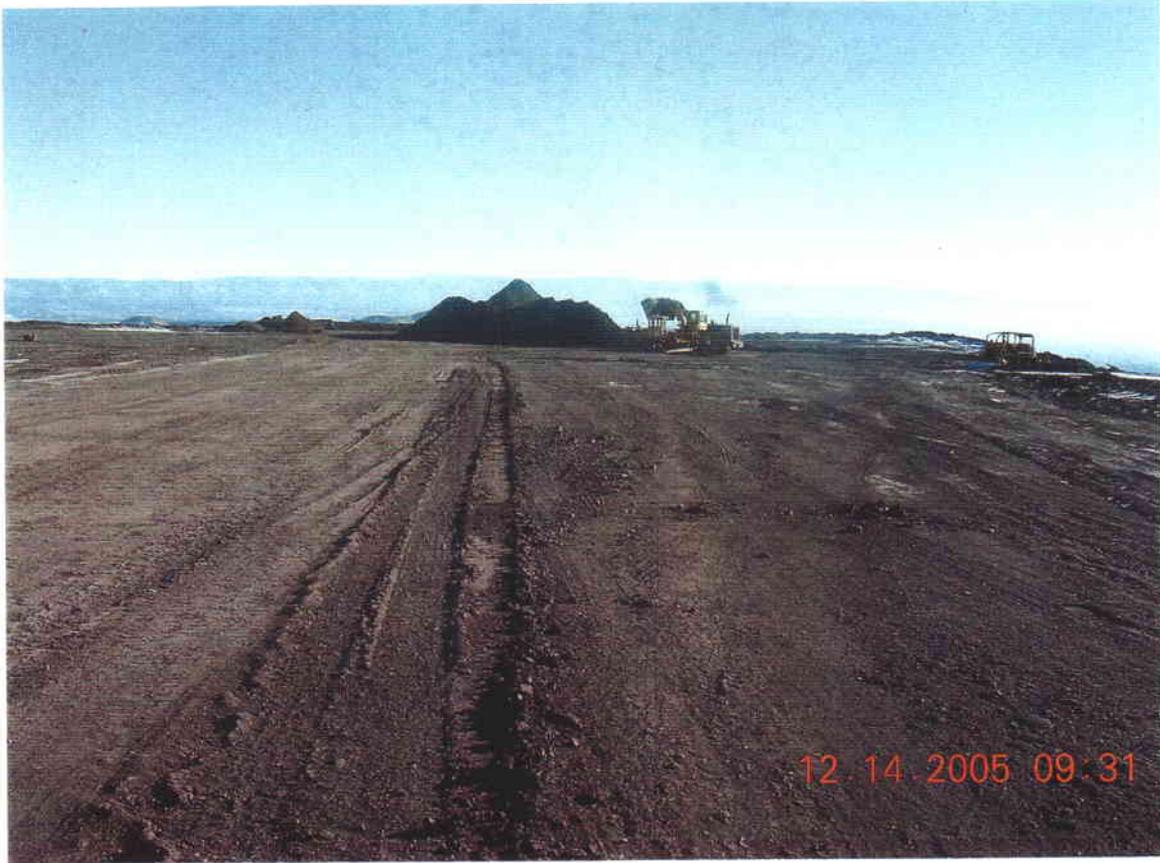
Coarse Refuse Pile

No smokers visible

Waste Coal Removal
Excavation and hauling operations are occurring from the top of the pile
