Sunnyside Cogeneration Associates

Star Point Waste Fuel

**SUNNYSIDE COGENERATION ASSOCIATES
STAR POINT WASTE FUEL
C/007/042
2005 ANNUAL REPORT**

SUNNYSIDE COGENERATION ASSOCIATES
STAR POINT WASTE FUEL
2005 ANNUAL REPORT

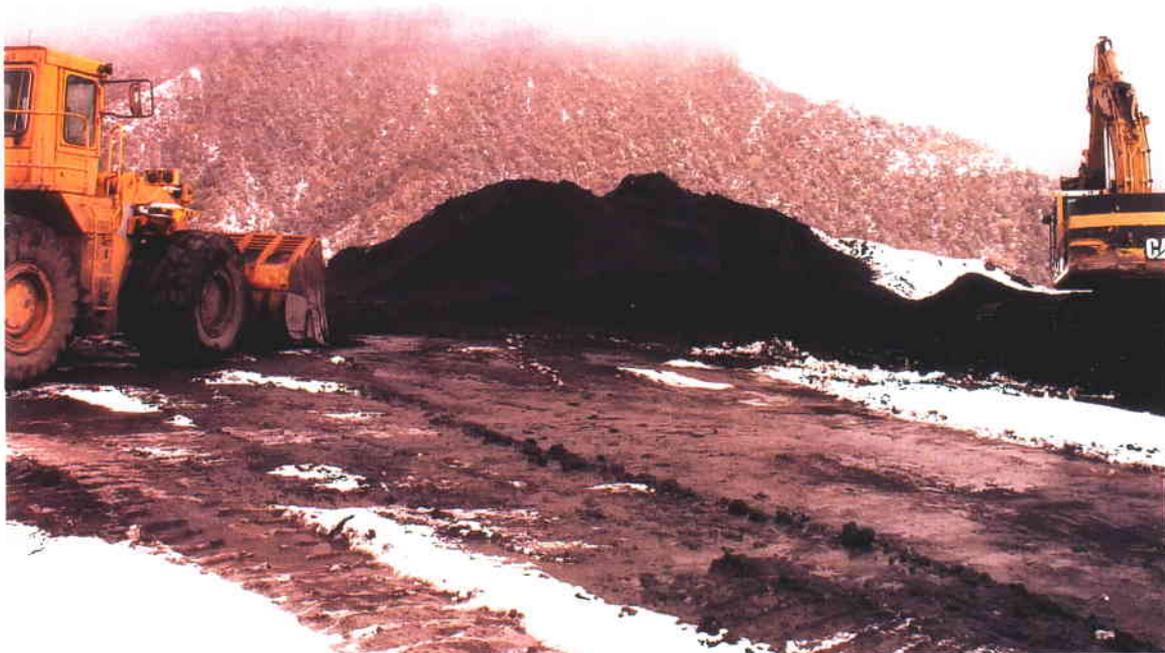
Refuse Pile Operations, Looking Northerly

March 25, 2005

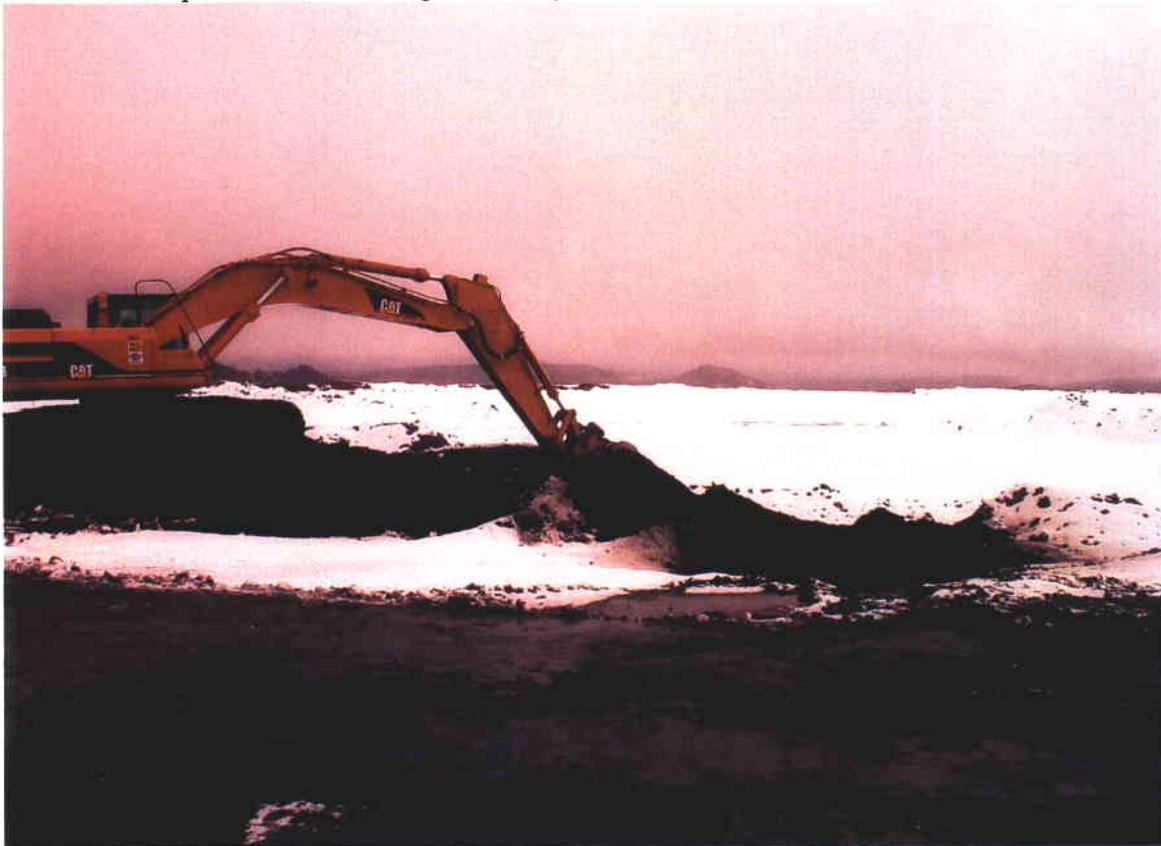
Refuse Pile Operations, Looking Northerly

March 25, 2005

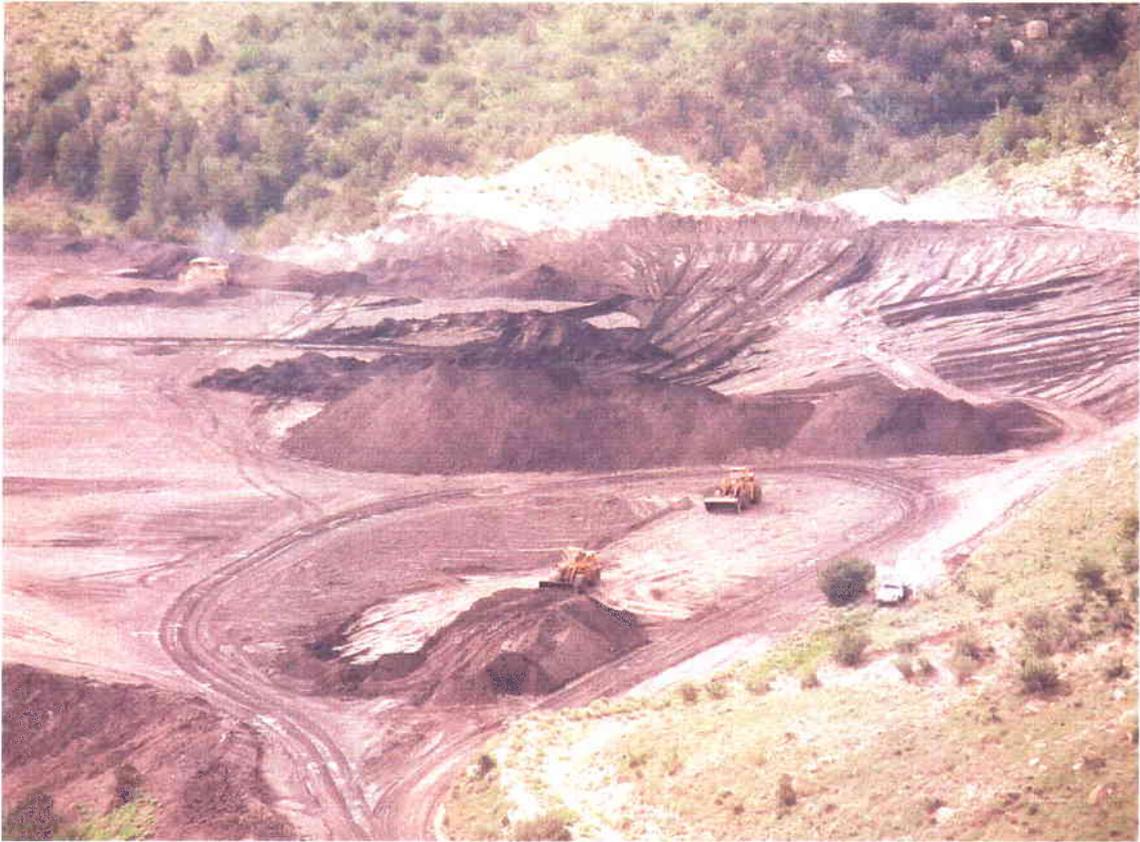
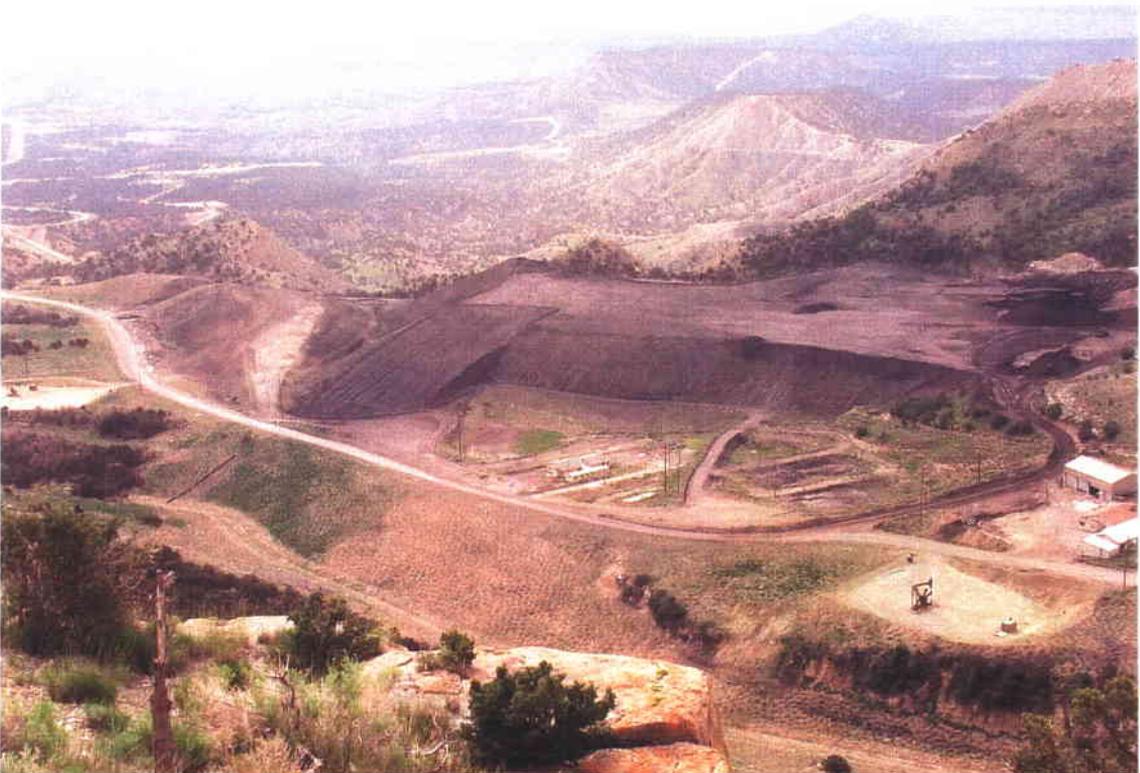
Coarse Refuse Pile

Many small rills exist on the out slopes of the refuse pile. These have reportedly been there for some time and are typical for exposed refuse materials. They do not appear to pose a structural hazard. Runoff from the top surface is not directed to the out slope, therefore it is expected that re-grading would simply start new rills. Sediment from this erosion reports to existing sediment ponds. In time, SCA's operations to remove the pile will eliminate the problem.

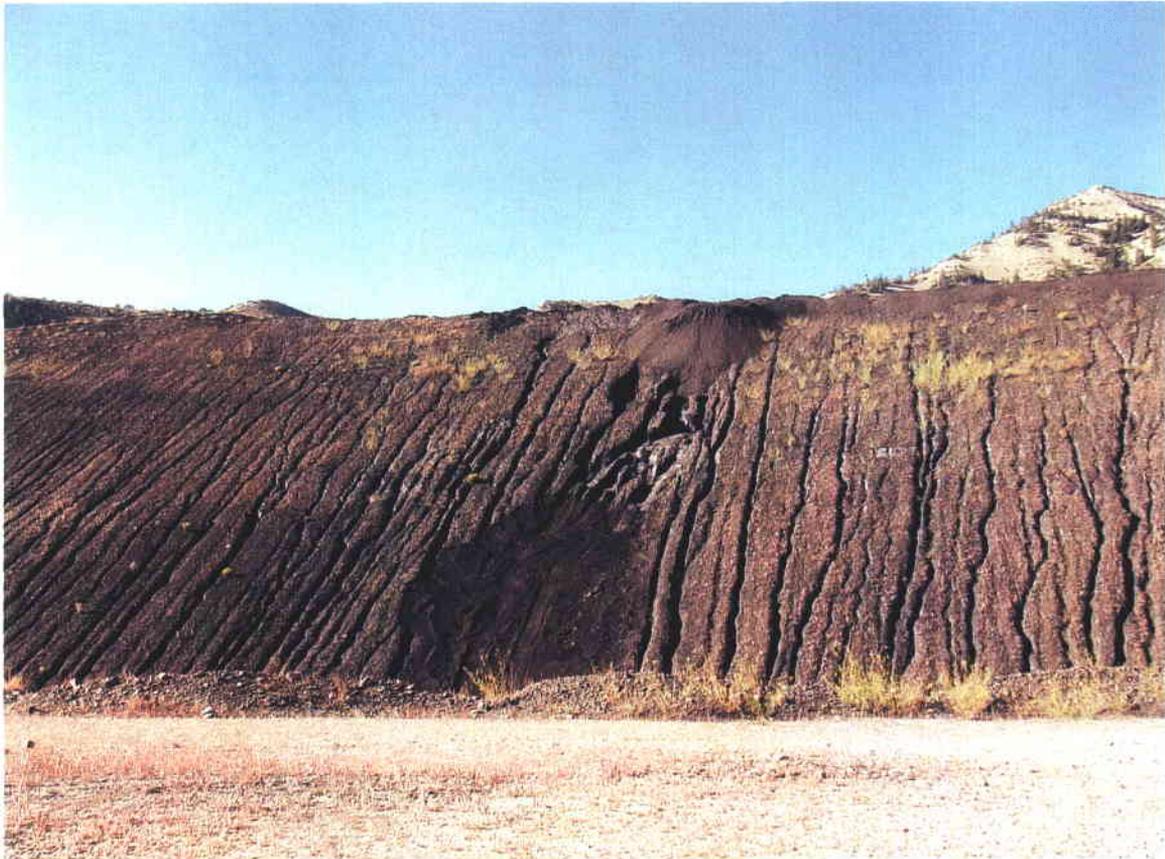
Recent storms had caused noticeable erosion on the site and interim catchment areas had collected a lot of sediment. SCA was in the process of cleaning these areas and restoring the eroded areas.

East Face Refuse Pile A – Eroded area with restoration efforts underway Sept 20, 2005

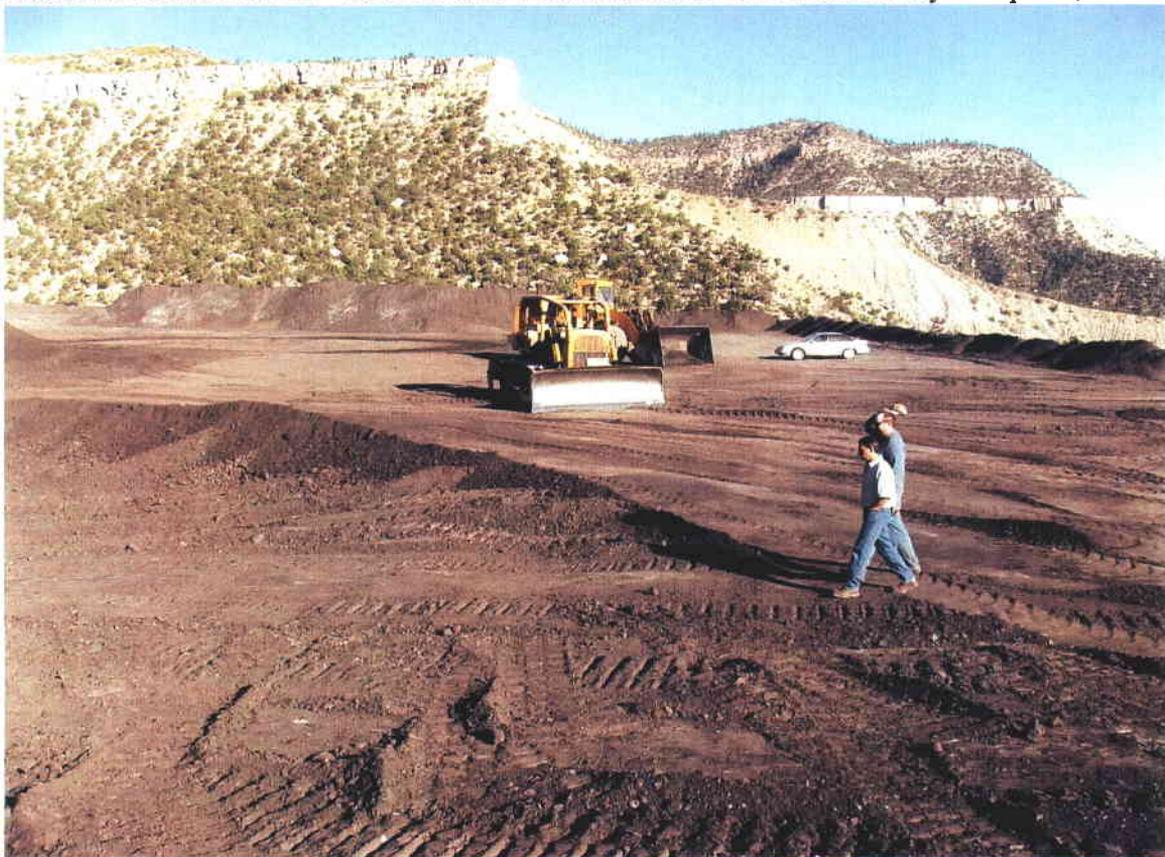
Top East End Refuse Pile Looking northerly

September 20, 2005

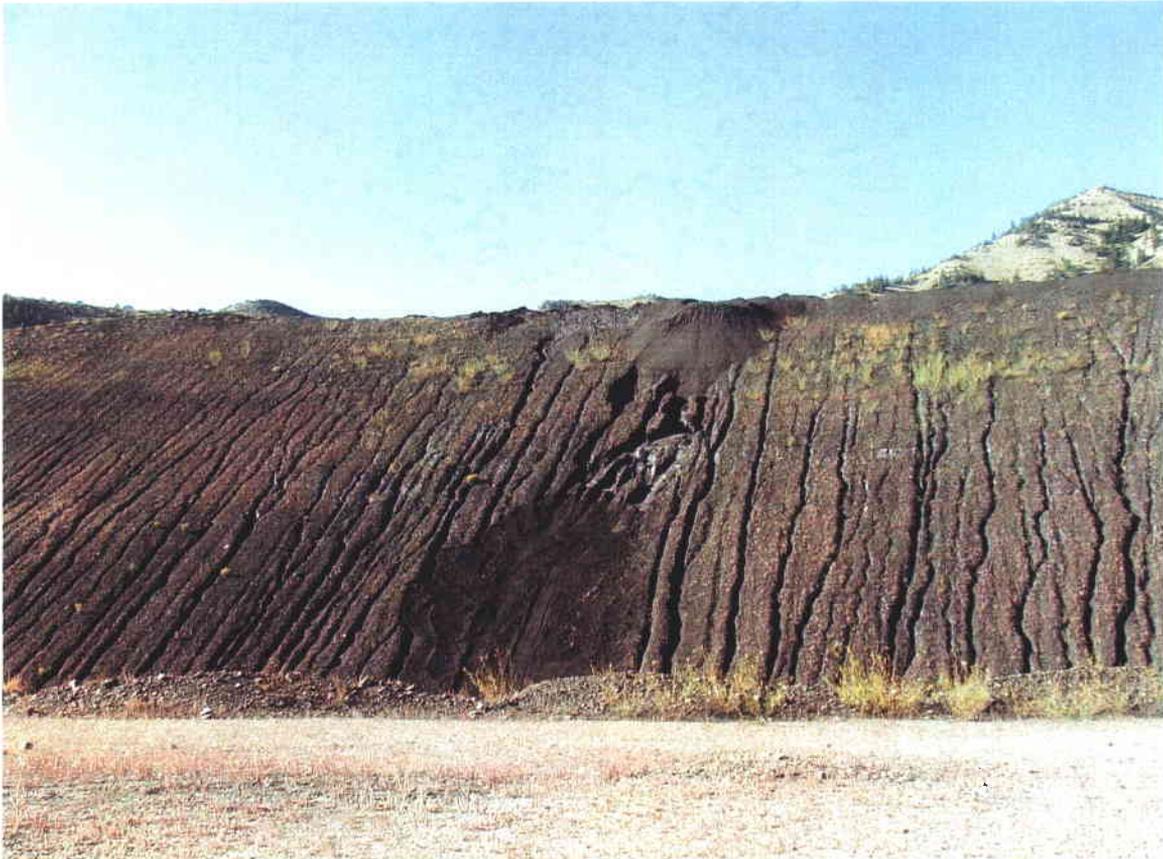
All of the impoundments met or exceeded the storage capacity requirements identified in the permit. Storms during the third quarter of 2005 caused noticeable erosion on the easterly face of the main refuse pile and contributed a significant quantity of sediments to the interim catchment areas and some to the sediment ponds. The eroded areas were restored and the catchment areas were cleaned out.

East Face Refuse Pile A – Eroded area with restoration efforts underway Sept 20, 2005

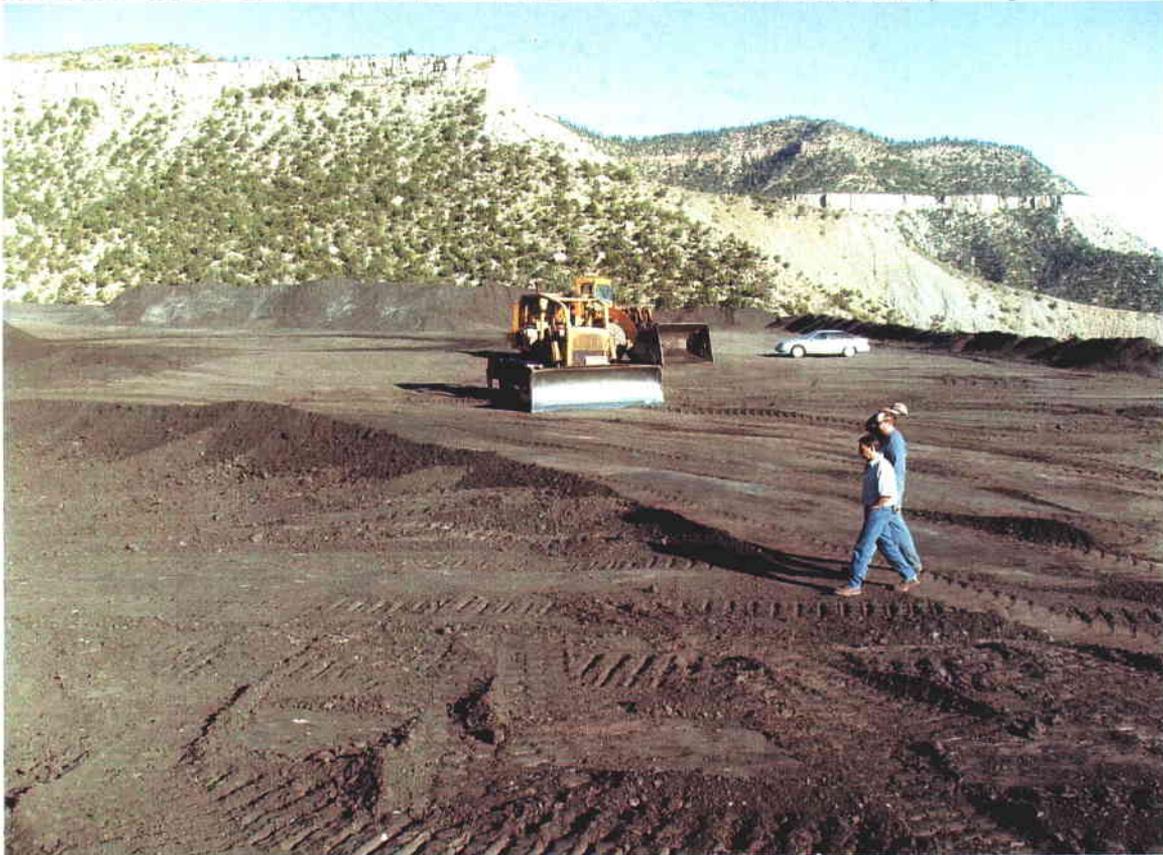
Top East End Refuse Pile Looking northerly

September 20, 2005
