RE: Annual 2006 Inspection Report
Star Point Refuse Pile C/007/042

IMPOUNDMENT INSPECTION AND CERTIFIED REPORT		Sediment Pond 005	
Permit Number	C/007/042	Report Date	1/18/07
Mine Name	STAR POINT WASTE FUEL		
Company Name	SUNNYSIDE COGENERATION ASSOCIATES		
Impoundment Identification	Impoundment Name	Sediment Pond 005	
	Impoundment Number	005	
	UPDES Permit Number	UTG040025	
	MSHA ID Number	N/A

INSPECTION AND CERTIFIED REPORT ON EXCESS SPOIL PILE OR REFUSE PILE		Coarse Refuse Pile
Permit Number	C/007/042	Report Date 1/18/07
Mine Name	STAR POINT WASTE FUEL	
Company Name	SUNNYSIDE COGENERATION ASSOCIATES	
Excess Spoil Pile or Refuse Pile Identification	File Name:	Coarse Refuse Pile
	File Number	N/A
	MSHA ID Number	Abandoned by MSHA Jan 2004
Inspection Date	December 19, 2006	
Inspected By	Rusty Netz	
Reason for Inspection (Annual, Quarterly or Other Periodic Inspection, Critical Installation, or Completion of Construction)		Annual Inspection 2006
		Attachments to Report? <input type="checkbox"/> No <input checked="" type="checkbox"/> Yes
Field Evaluation

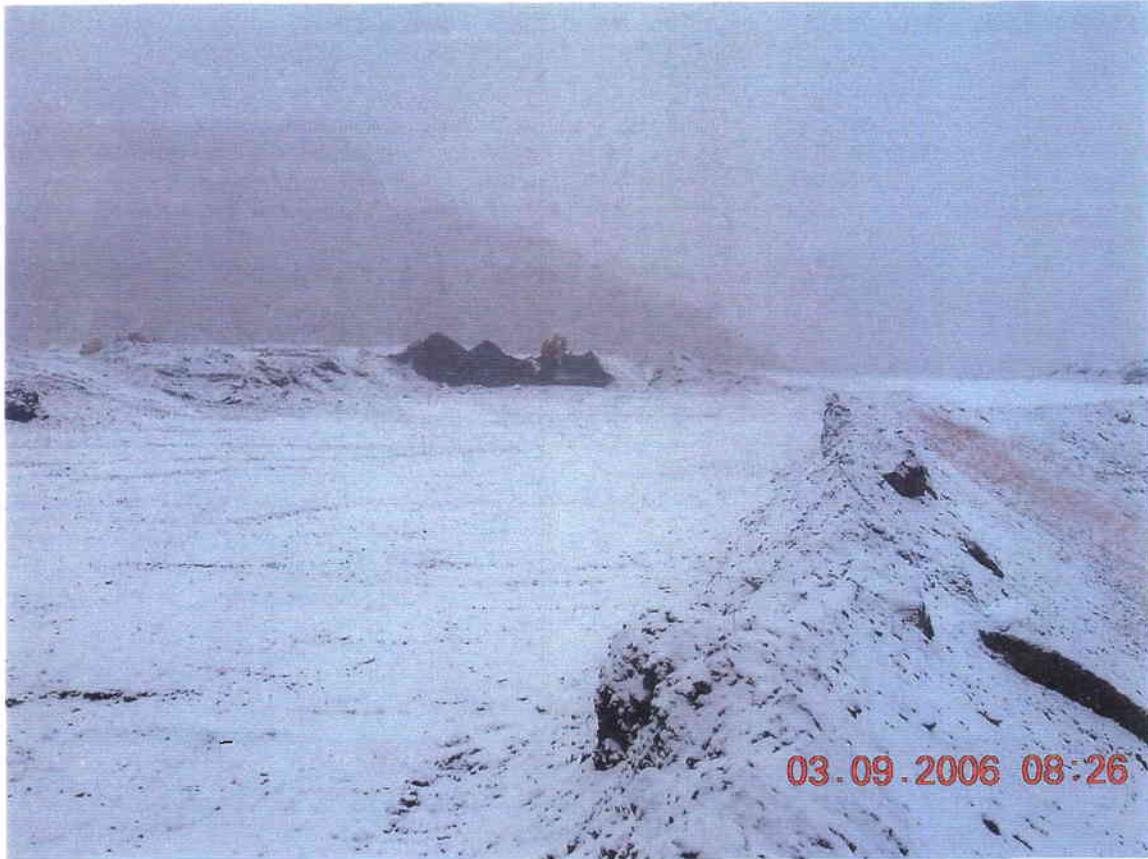
Coarse Refuse Pile – looking easterly

March 9, 2006

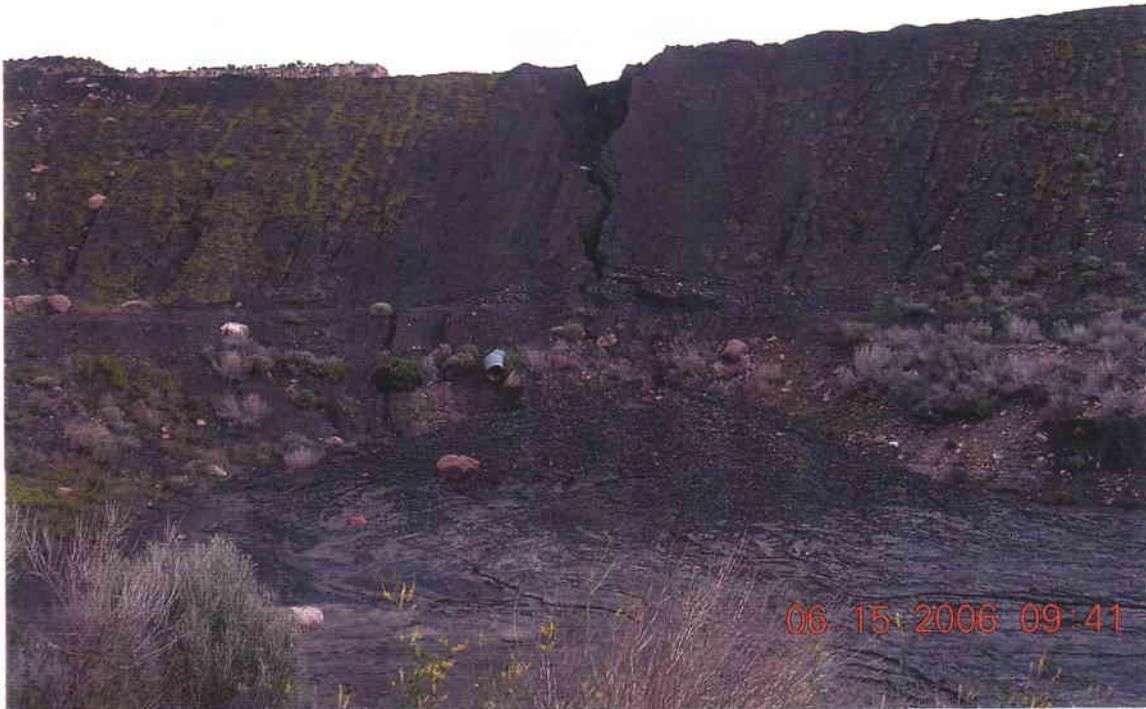
There was a culvert on the side of the pile that washed out and contributed a significant amount of sediment into the pond below. The culvert was repaired and the area restored. See attached pictures of the conditions before and during the repairs.

South Side of Coarse Refuse Pile (Pond 005 in foreground)

June 15, 2006

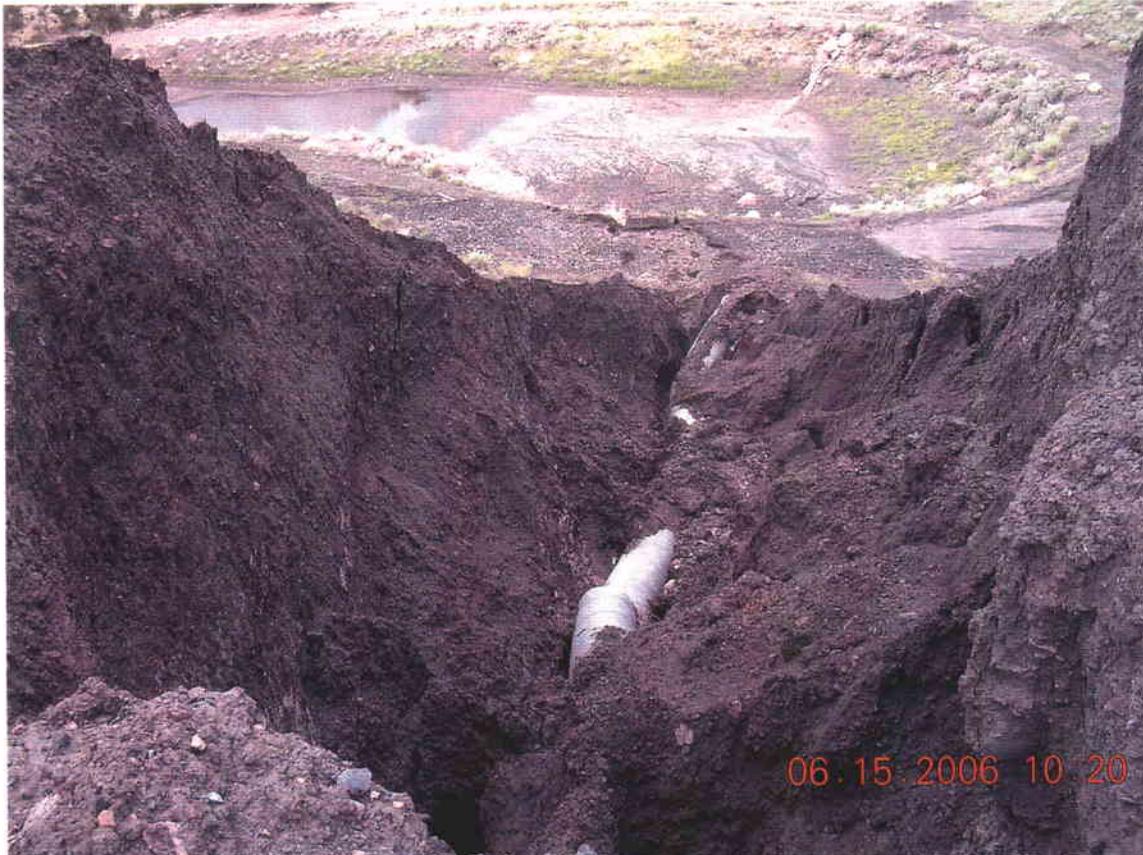
From top of refuse pile looking down culvert alignment towards Pond 005 June 15, 2006

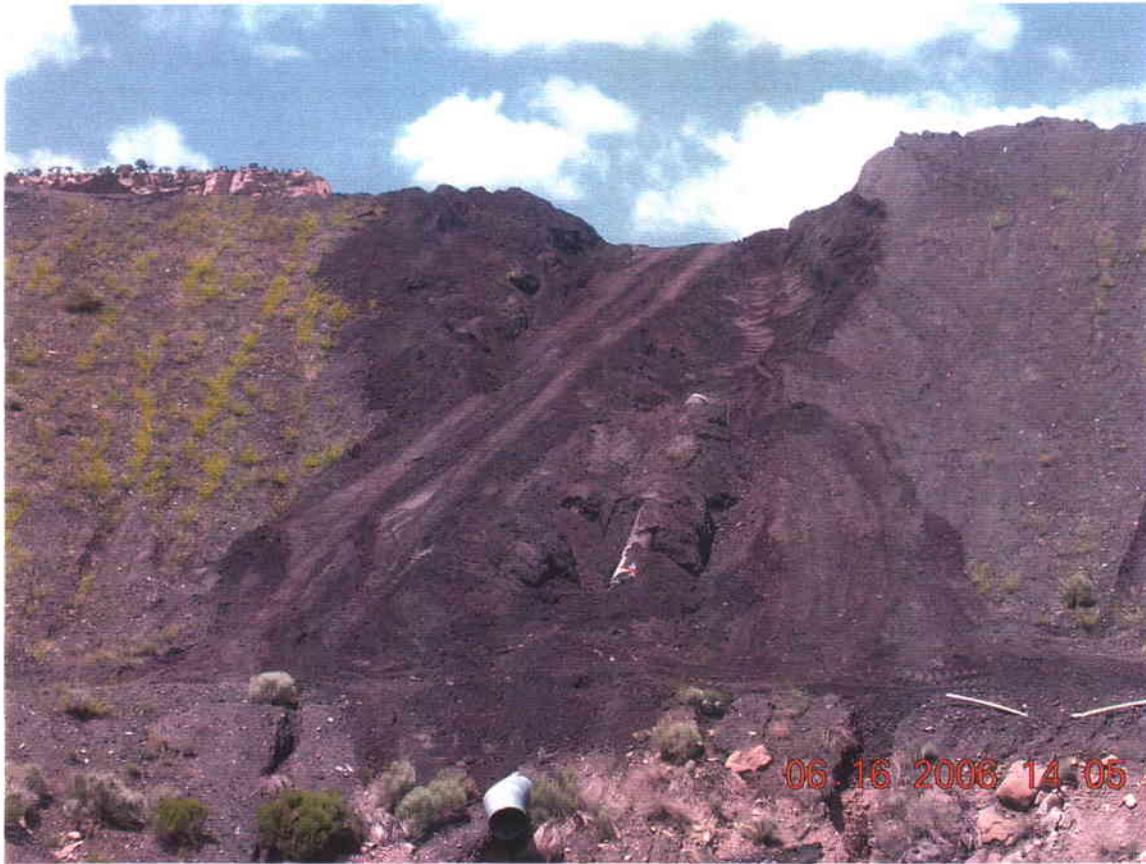
Looking at culvert and slope repairs in progress

June 16, 2006
