Sunnyside Cogeneration Associates

RE: First Quarter 2007 Inspection Report
Star Point Refuse Pile C/007/042

IMPOUNDMENT INSPECTION AND CERTIFIED REPORT

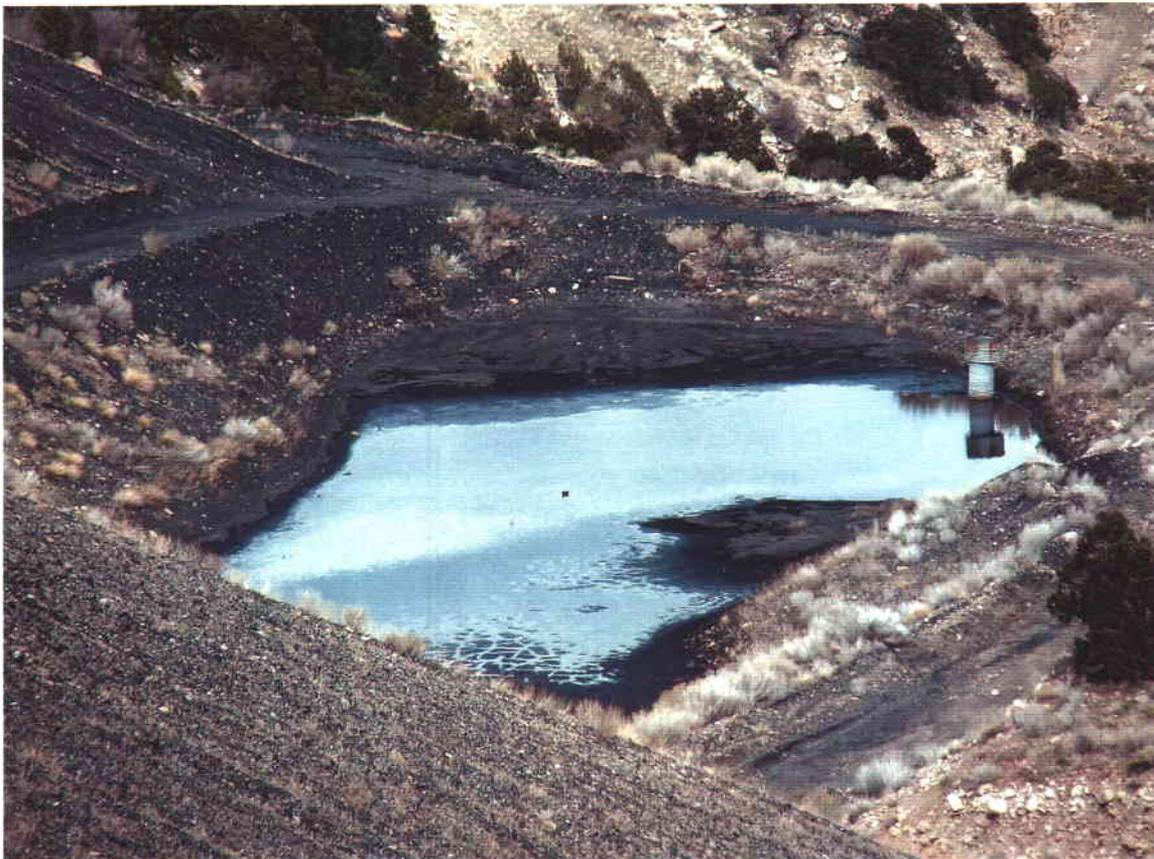
Sediment Pond #005 (looking easterly)

Pond had some water in it but was not discharging. No samples were taken
Sediment level was in need of cleaning. Pond did not require decanting.
Embankment conditions were good. Vegetation on out slopes was adequate.
Inlet / Outlet conditions were good. No structural or hazardous conditions were observed.

No recent changes in the geometry of the structure have been observed
Depth of impounded water was minimal
Sediment level was above clean out limit.
No other aspects were observed to affect stability or functionality.

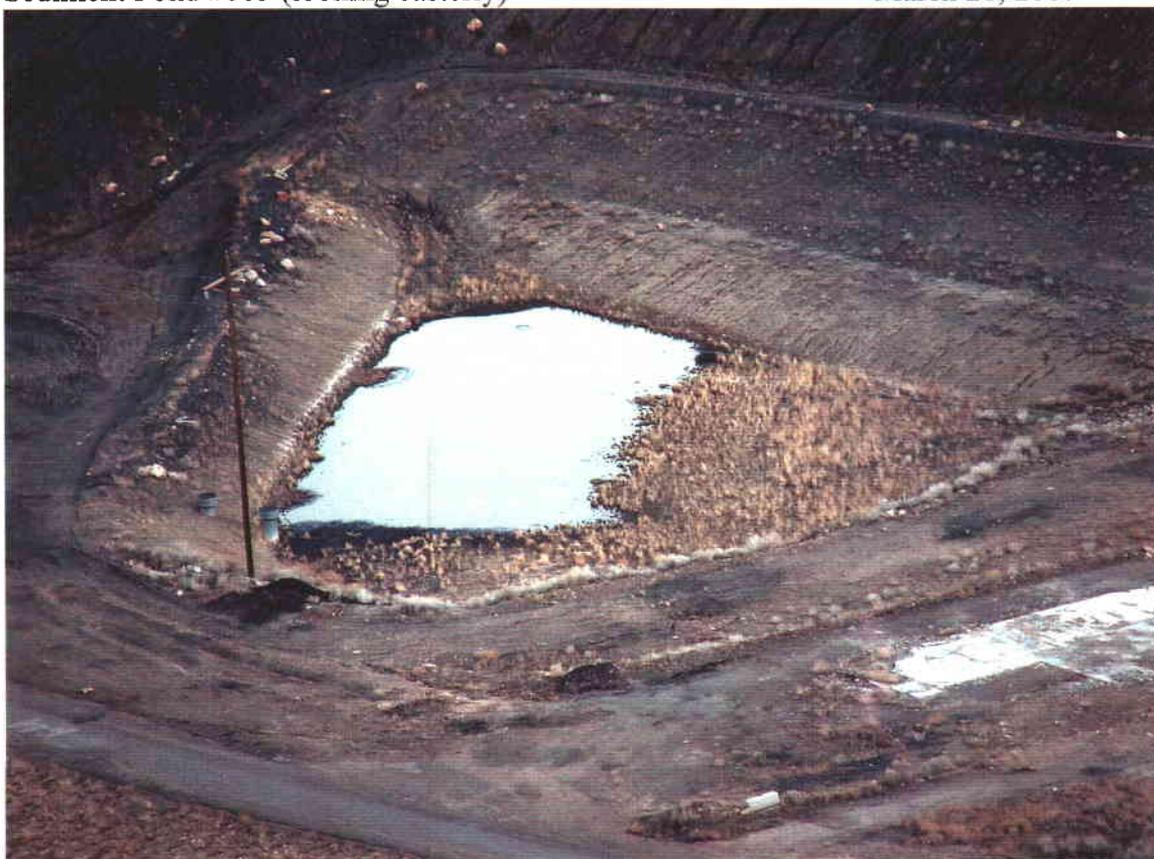
Sediment Pond #009 (looking easterly)

Pond had some water in it but was not discharging. No samples were taken
Sediment level was in need of cleaning. Pond did not require decanting.
Embankment conditions were good. Vegetation on out slopes was adequate.
Inlet / Outlet conditions were good. No structural or hazardous conditions were observed.

No recent changes in the geometry of the structure have been observed
Depth of impounded water was minimal
Sediment level was above clean out limit.

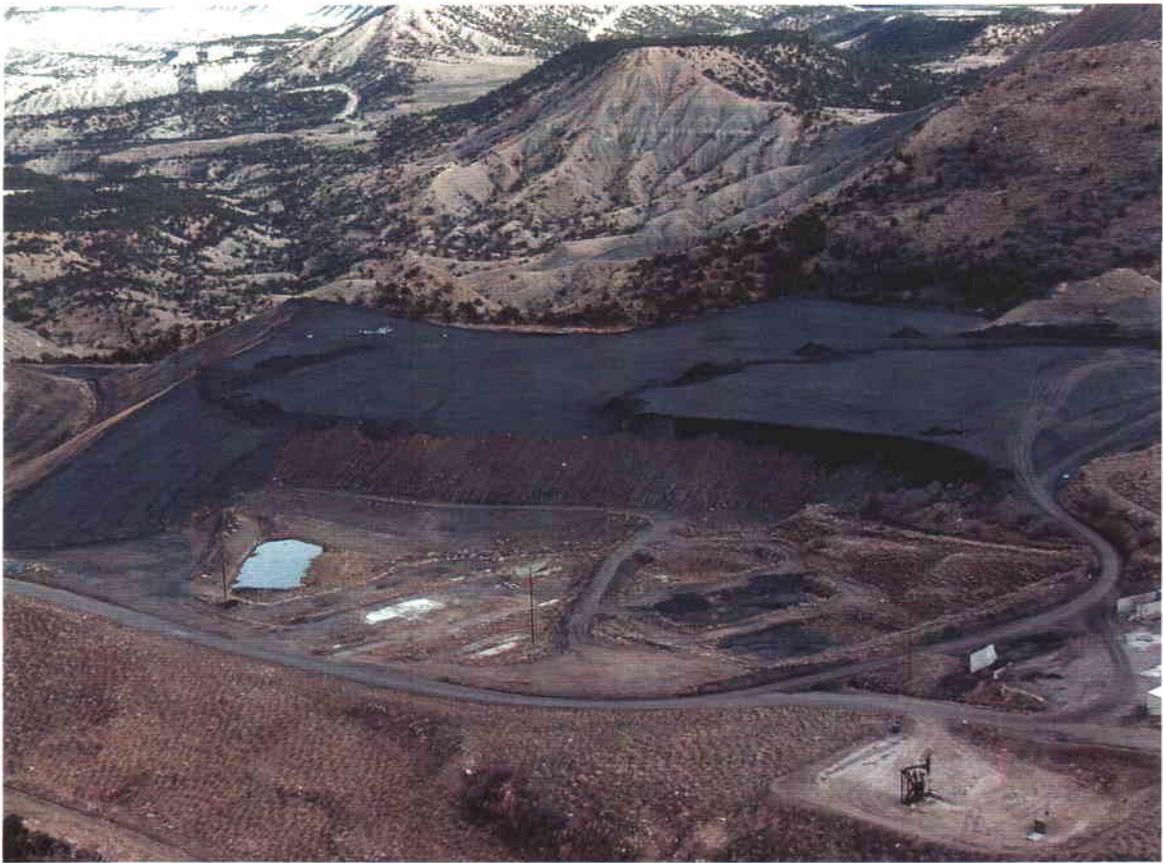
Coarse Refuse Pile (looking southeasterly)

Refuse material is actively being excavated and removed from the top of the pile

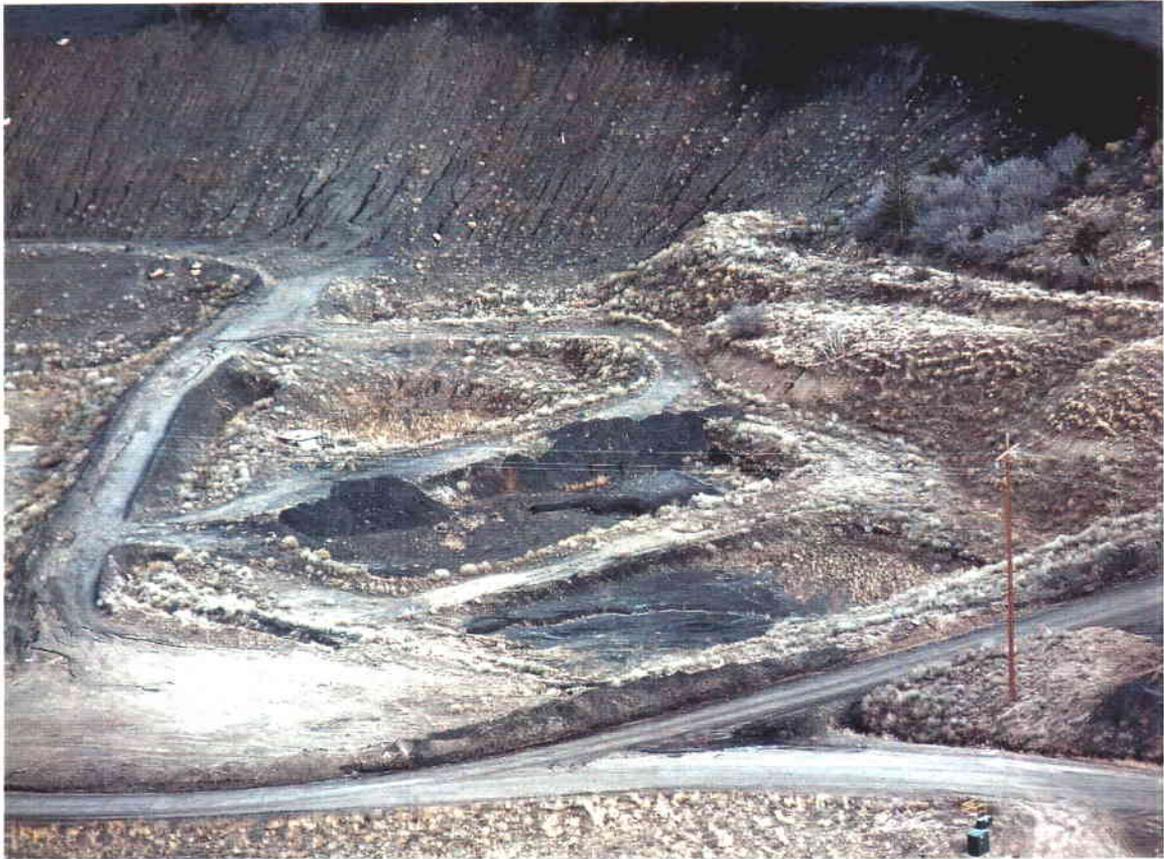
Disposal Area (looking southeasterly)

The disposal area did not receive any materials during the quarter.

No aspects of the Fill structure were observed that could affect its stability or functionality
