# 2006 Annual Report

## Sunnyside Cogeneration Associates

### Star Point Waste Fuel

C/007/042

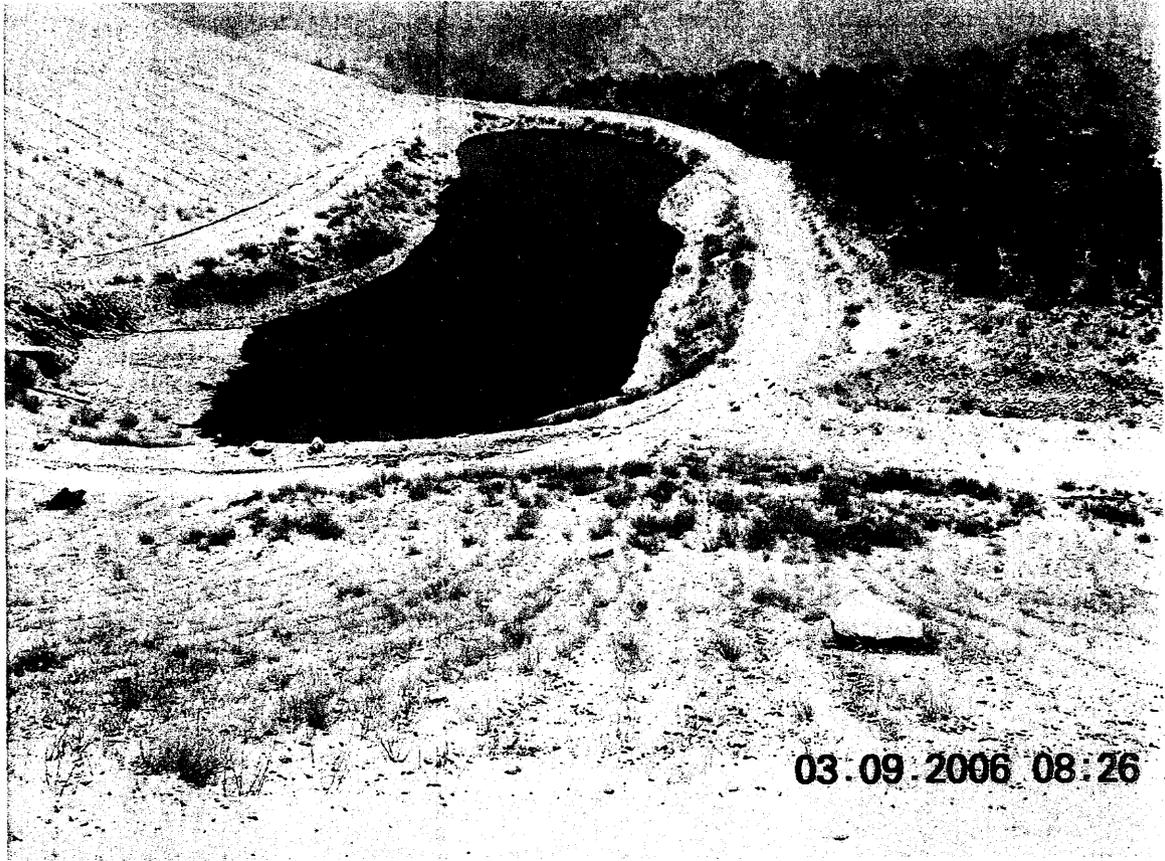
Sediment Pond 005

No discharge, inlet/outlet conditions are good, no structural or hazardous conditions exist.

No changes.  
No structure or stability problems observed.

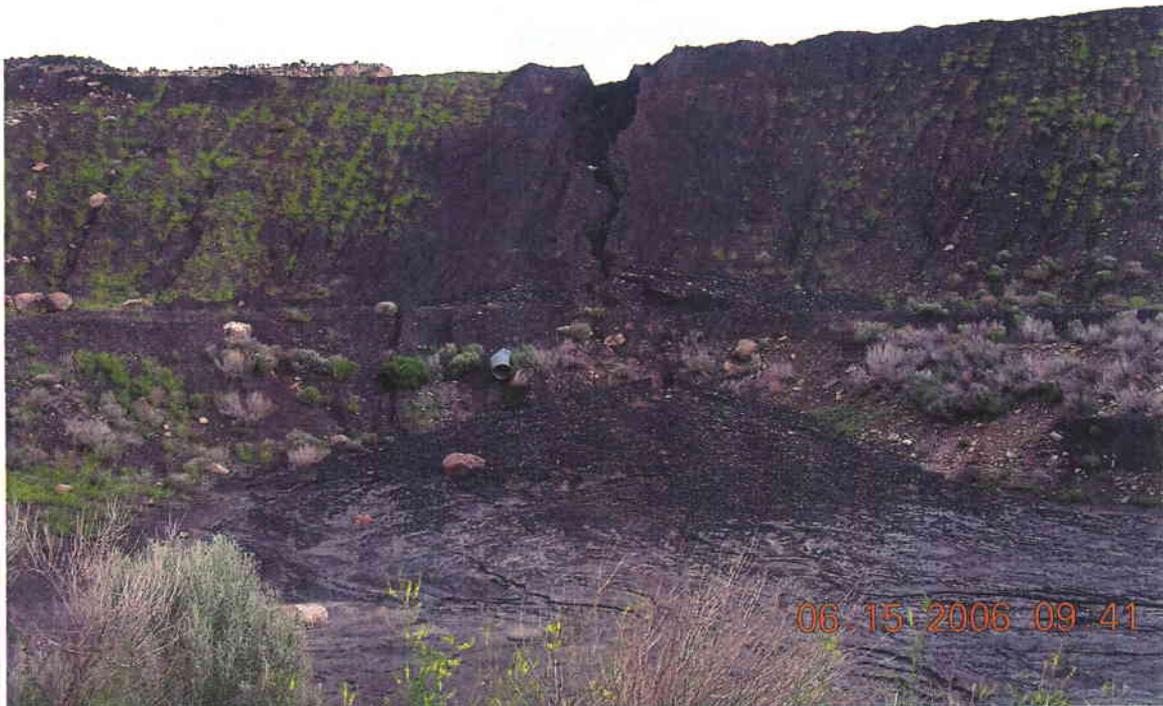
All of the impoundments met or exceeded the storage capacity requirements identified in the permit. During the 2<sup>nd</sup> Quarter 2006 there was a culvert between the refuse pile and pond 005 which washed out and contributed a significant amount of sediment into the pond. The culvert was repaired, pond cleaned and the area restored.

South Side of Coarse Refuse Pile (Pond 005 in foreground)

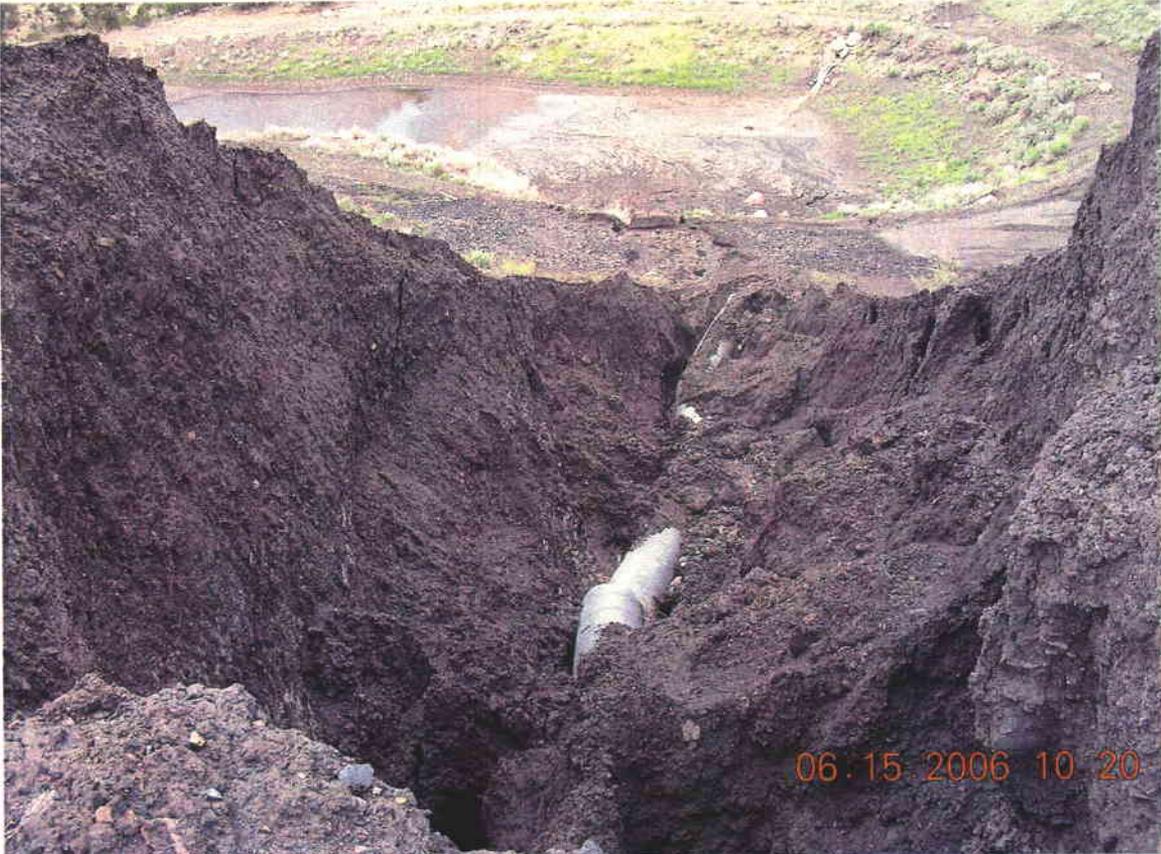
From top of refuse pile looking down culvert alignment towards Pond 005 June 15, 2006

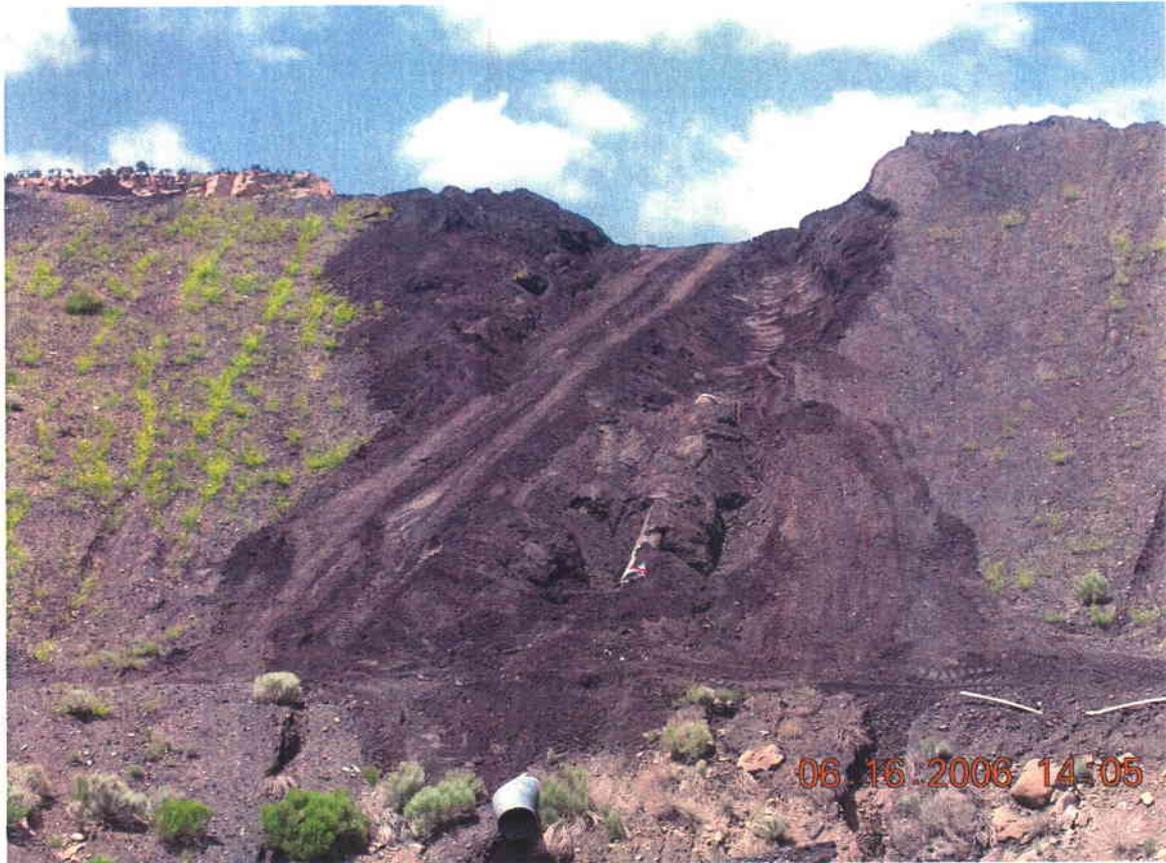
Looking at culvert and slope repairs in progress

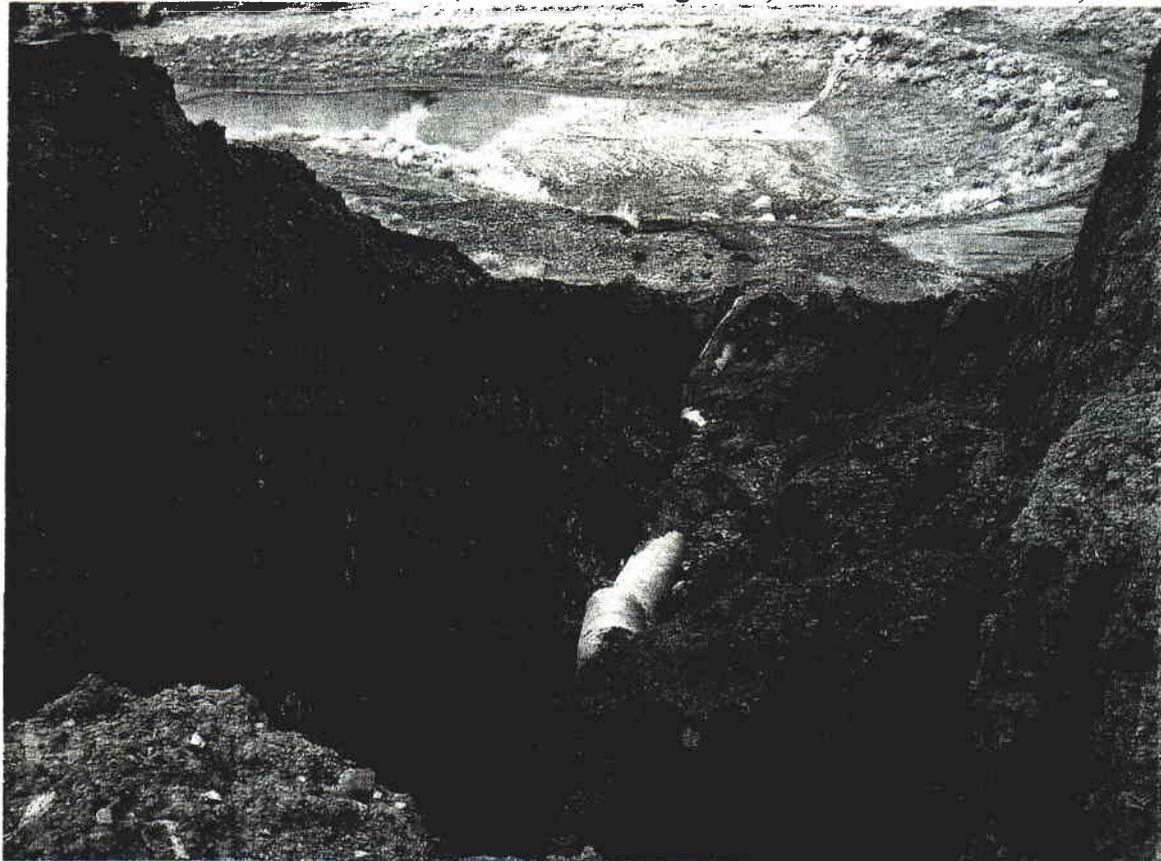
From top of refuse pile looking down culvert alignment towards Pond 005 June 15, 2006

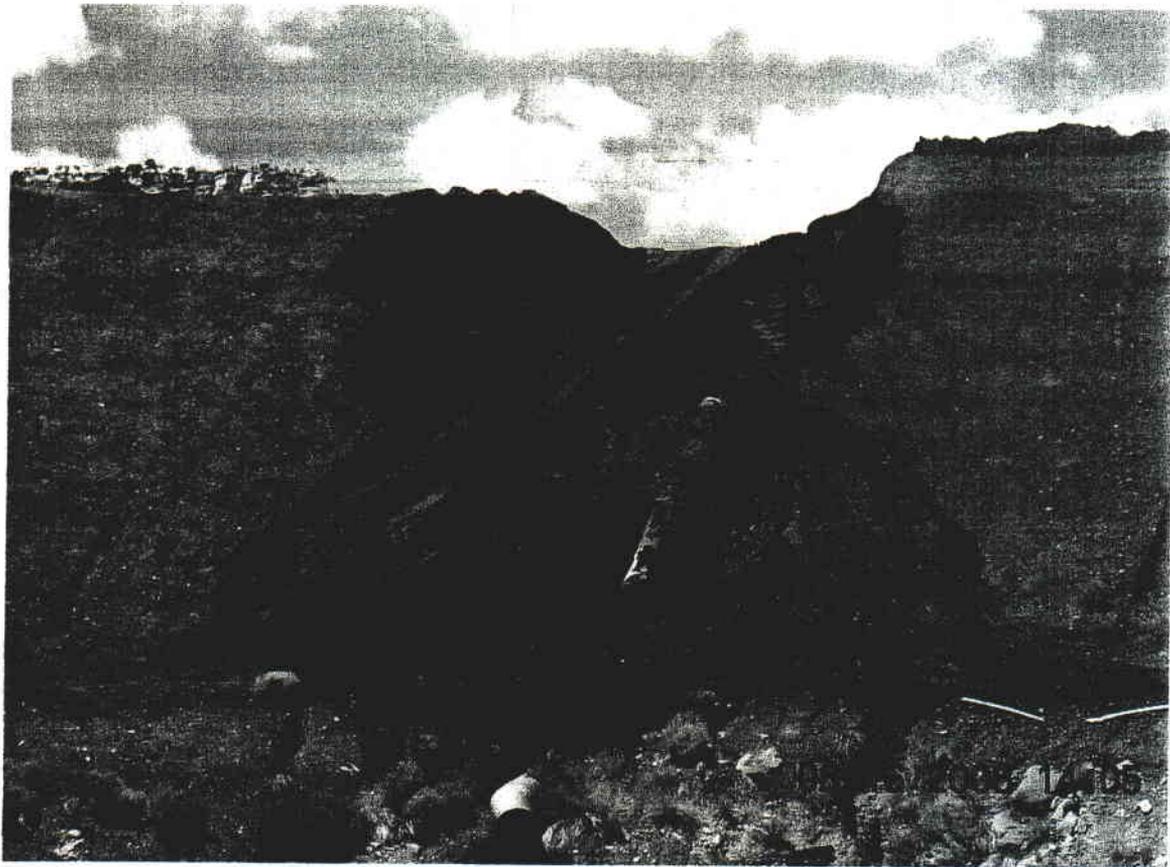
Looking at culvert and slope repairs in progress
