Sunnyside Cogeneration Associates

RE: Annual 2007 Inspection Report
Star Point Refuse Pile C/007/042

IMPOUNDMENT INSPECTION AND CERTIFIED REPORT

Report Date January 18, 2008
Permit Number C/007/042
Mine Name Star Point Waste Fuel
Company Name Sunnyside Cogeneration Associates

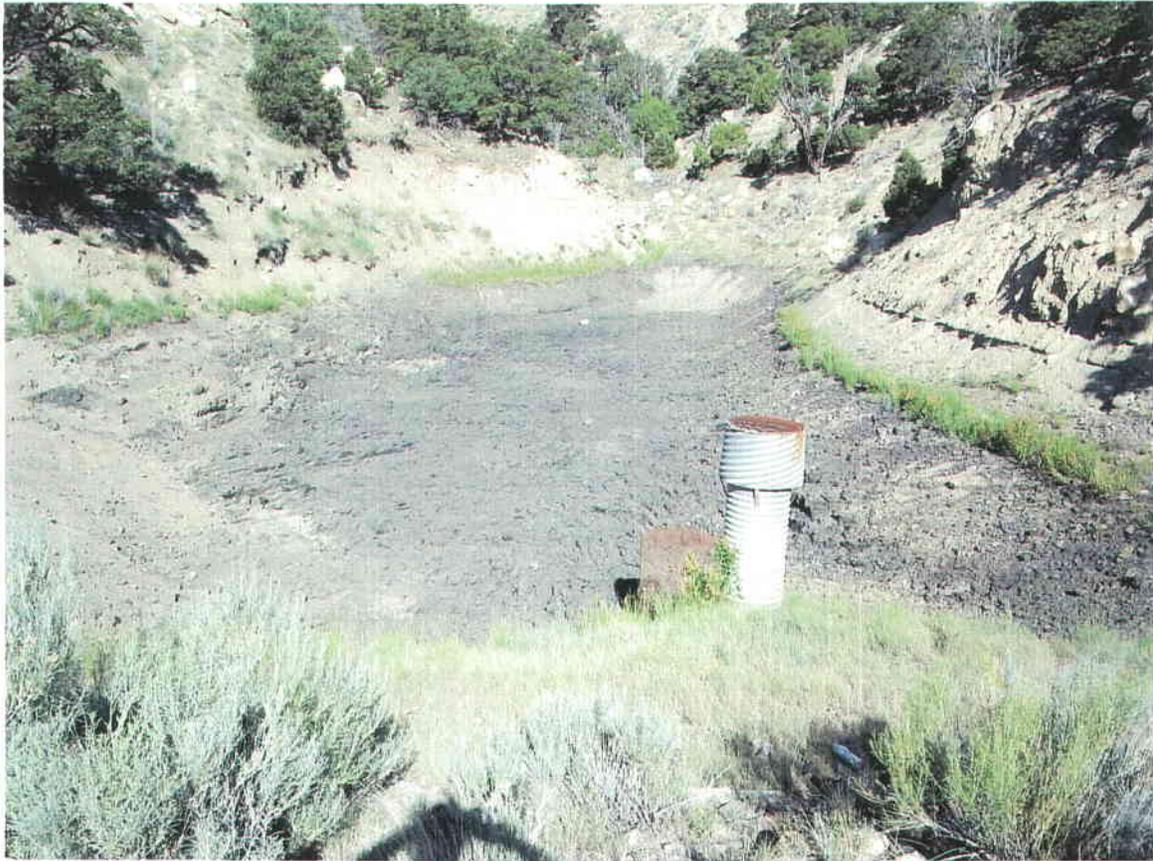
Sediment Pond 006 (looking westerly)

Pond had no water in it. No samples were taken
Sediment was cleaned out during 2007. Pond did not require decanting.
Embankment conditions were good. Vegetation on out slopes was adequate.
Inlet / Outlet conditions were good. No structural or hazardous conditions were observed.

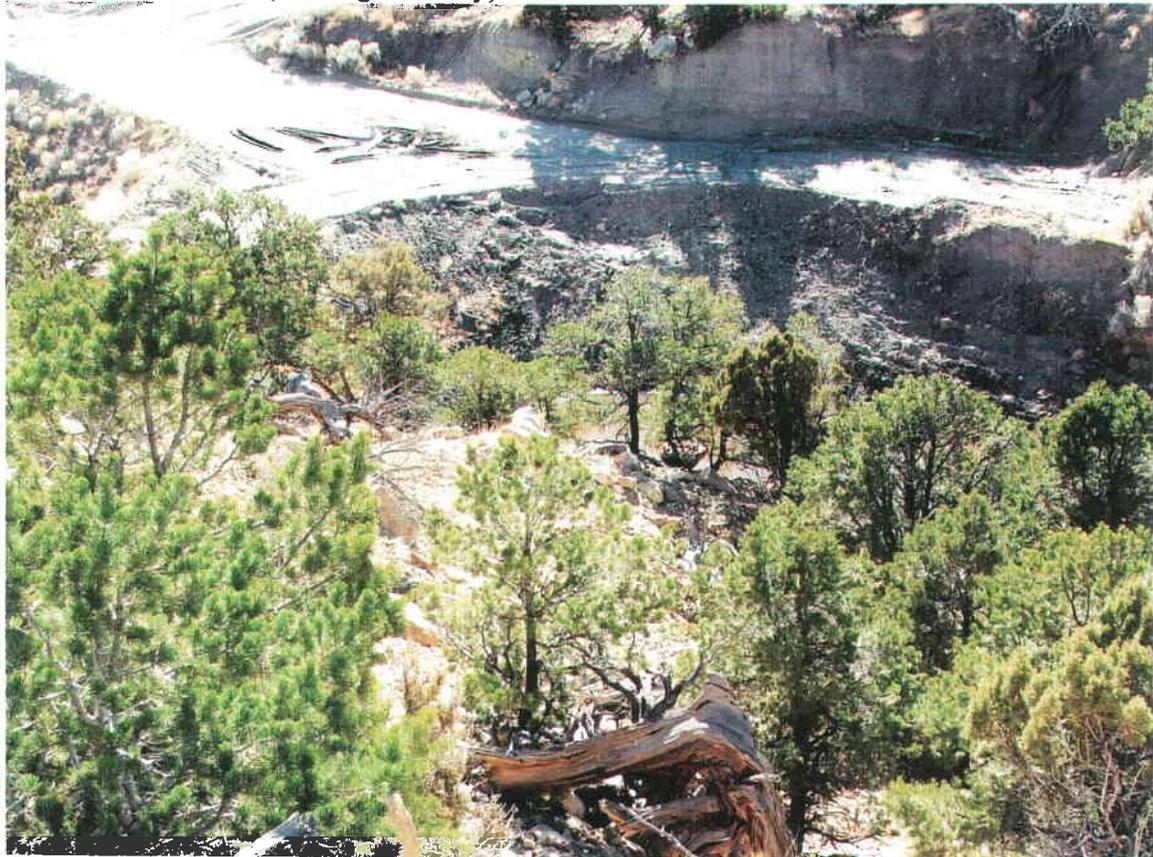
Sediment Pond 006 (looking southerly)

No recent changes in the geometry of the structure have been observed beyond sediment cleaning

Depth of impounded water was minimal

Sediment level was good.

No other aspects of the impounding structure were observed that could affect its stability or functionality.

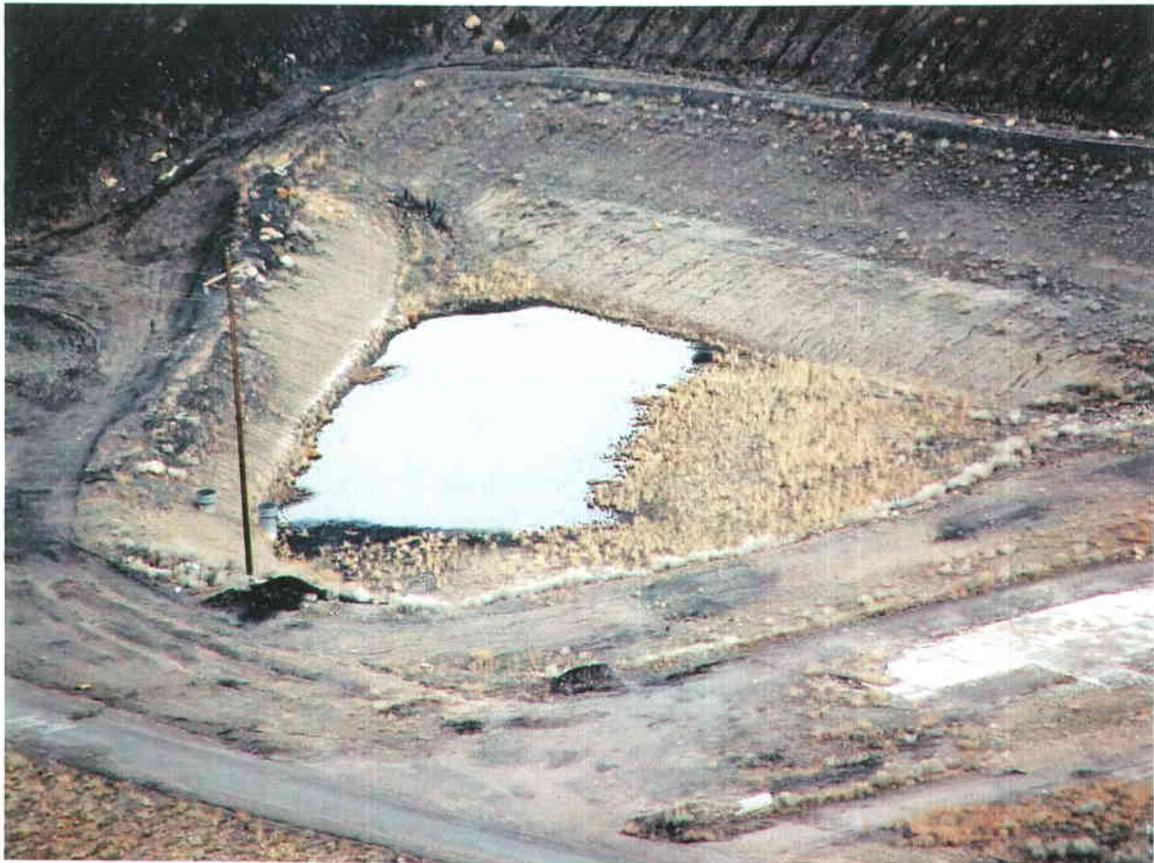
Sediment Pond 009 (looking easterly)

Pond had no water in it. No samples were taken. Pond did not require decanting.
Sediment was cleaned out across much of the pond during 2007.
Embankment conditions were good. Vegetation on out slopes was adequate.
Inlet / Outlet conditions were good. No structural or hazardous conditions were observed.

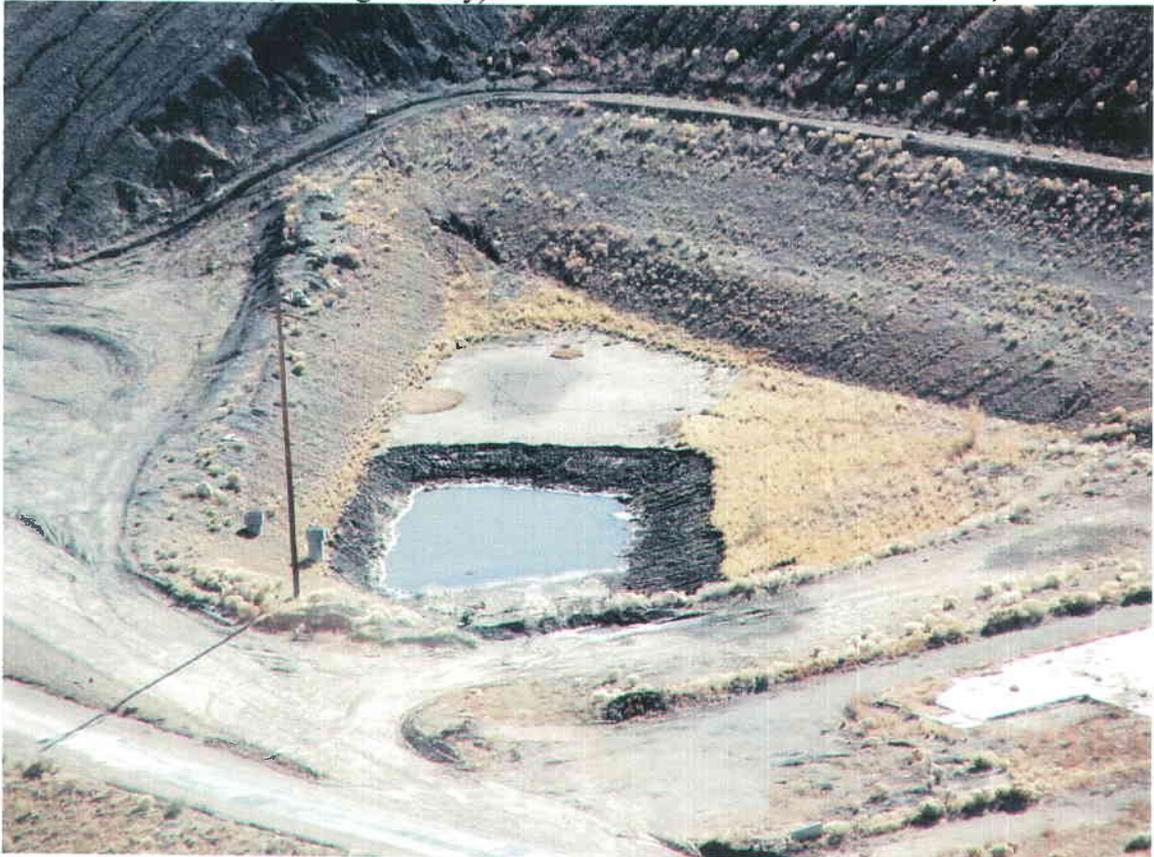
Sediment Pond 009 (looking easterly)

No recent changes in the geometry of the structure have been observed beyond sediment cleaning

Depth of impounded water was minimal

Sediment level was good.

No other aspects of the impounding structure were observed that could affect its stability or functionality.

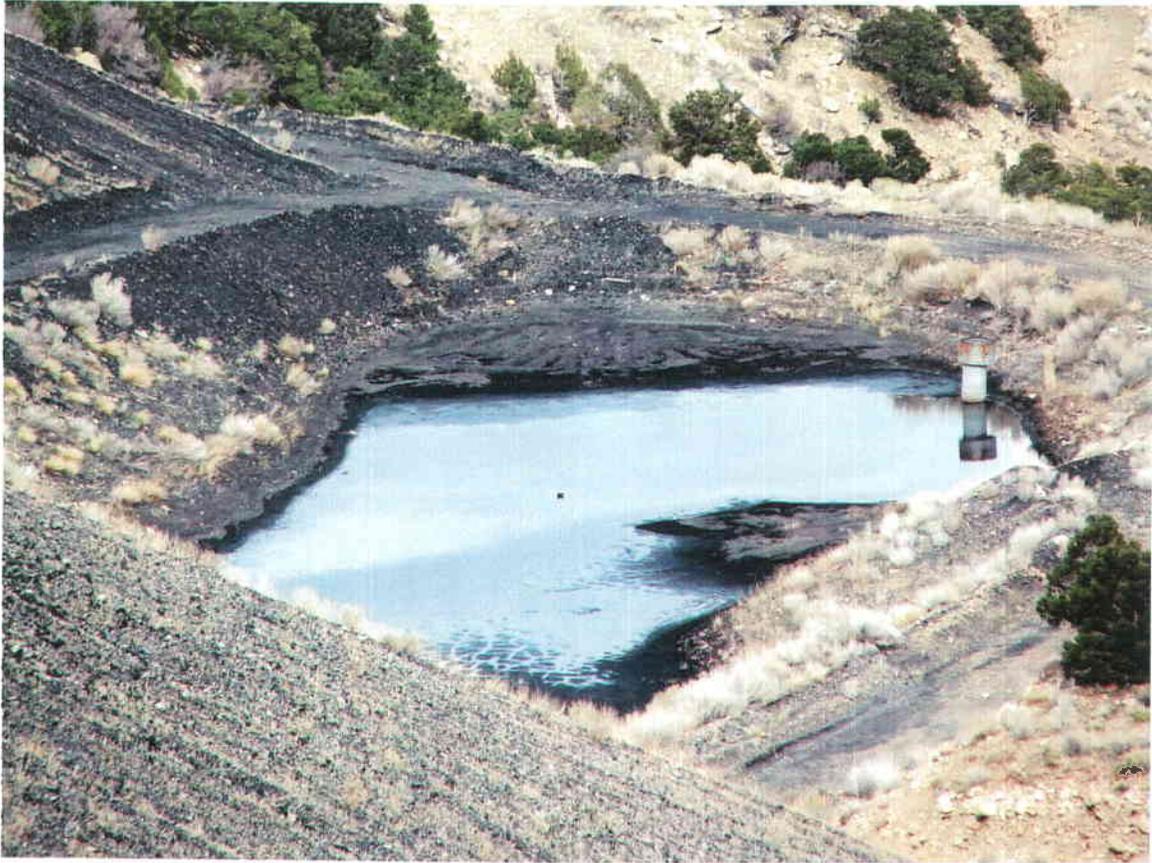
Sediment Pond 005 (looking easterly)

Pond had some water in it but was not discharging. No samples were taken
Sediment was cleaned out during 2007. Pond did not require decanting.
Embankment conditions were good. Vegetation on out slopes was adequate.
Inlet / Outlet conditions were good. No structural or hazardous conditions were observed.

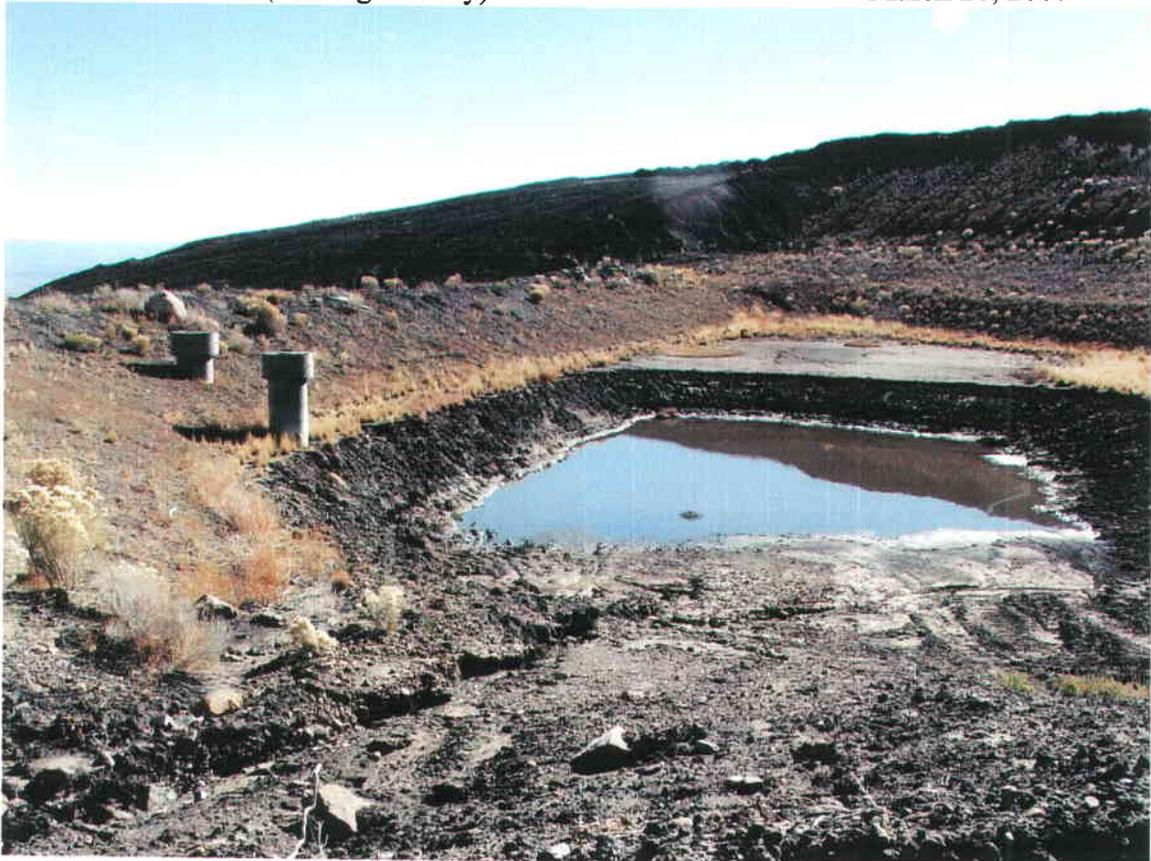
Sediment Pond 005 (looking westerly)

No recent changes in the geometry of the structure have been observed beyond sediment cleaning

Depth of impounded water was minimal

Sediment level was good.

No other aspects were observed to affect stability or functionality.

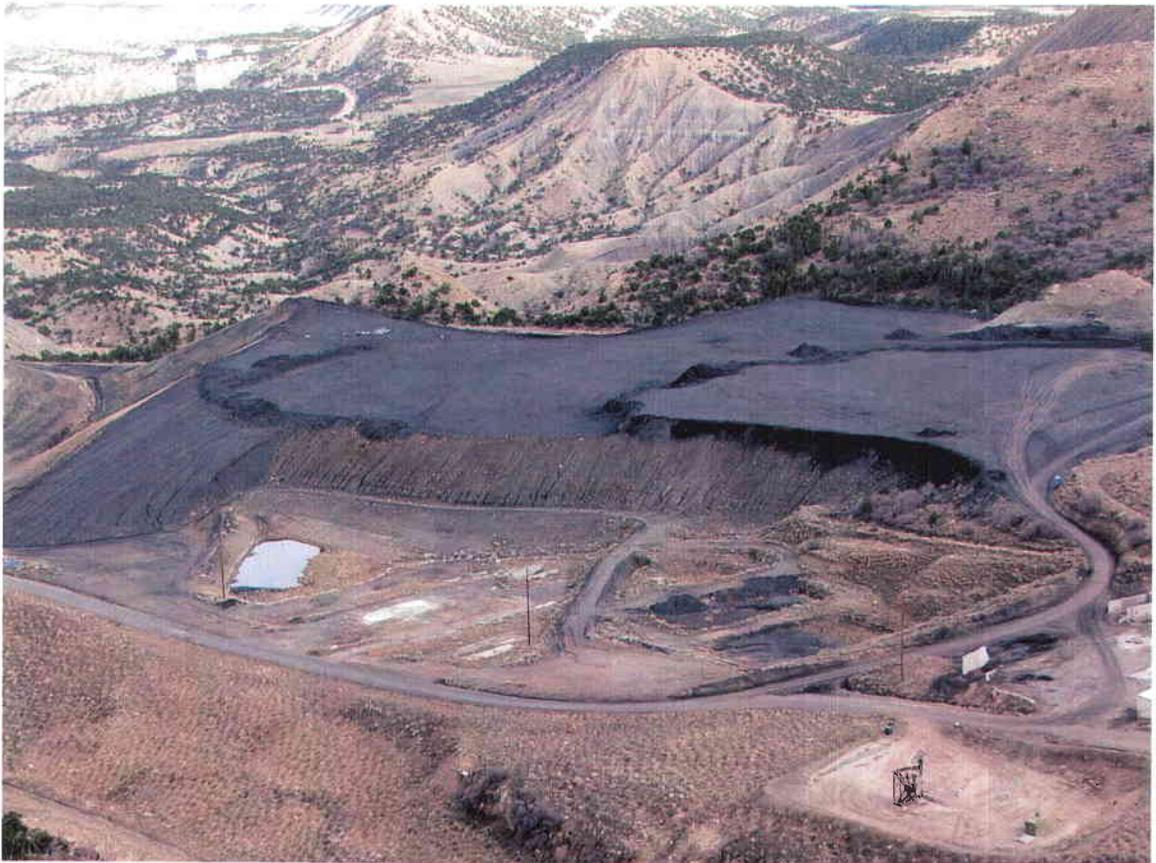
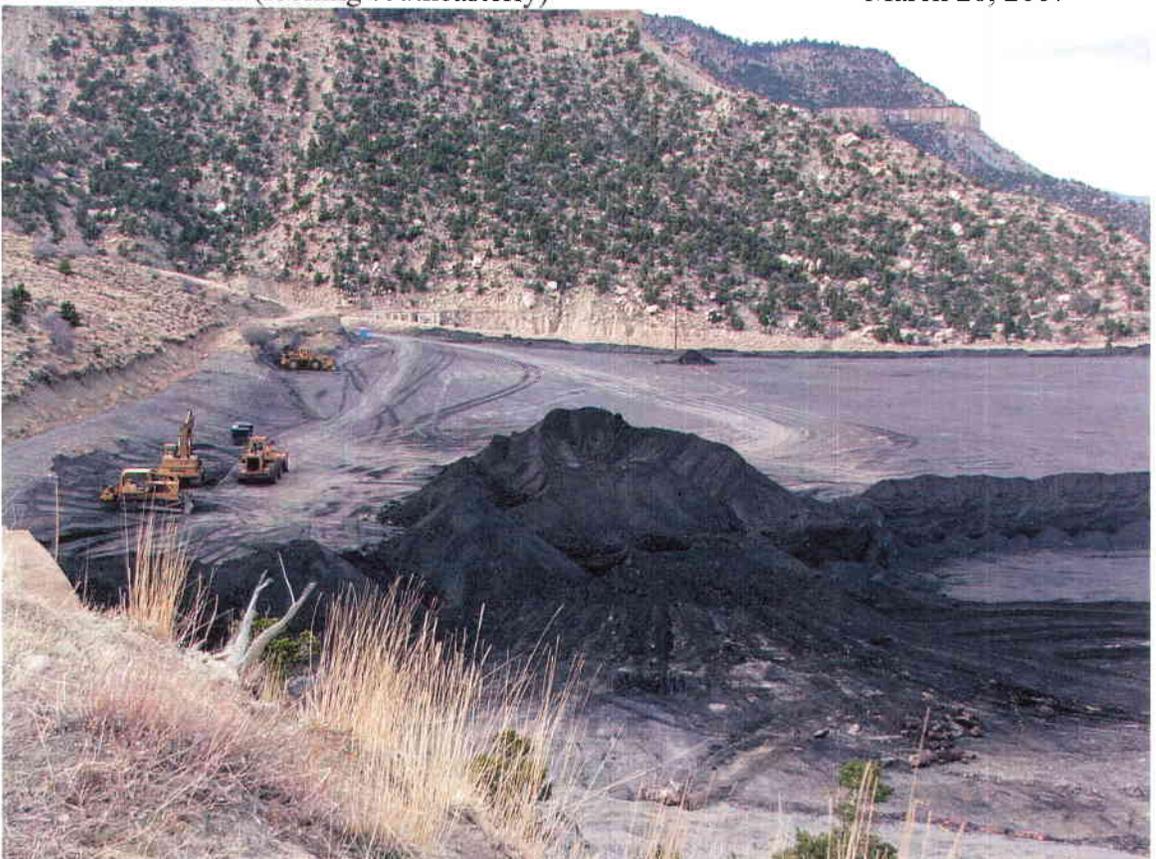
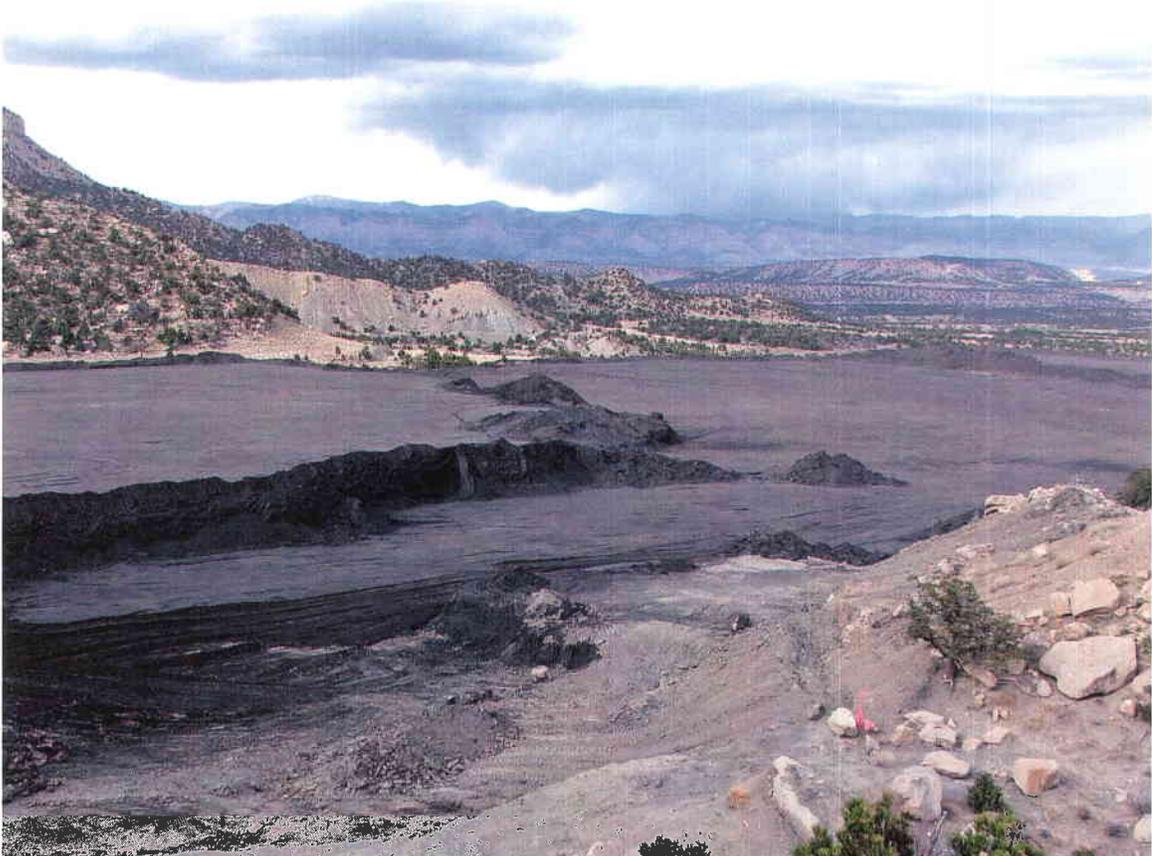
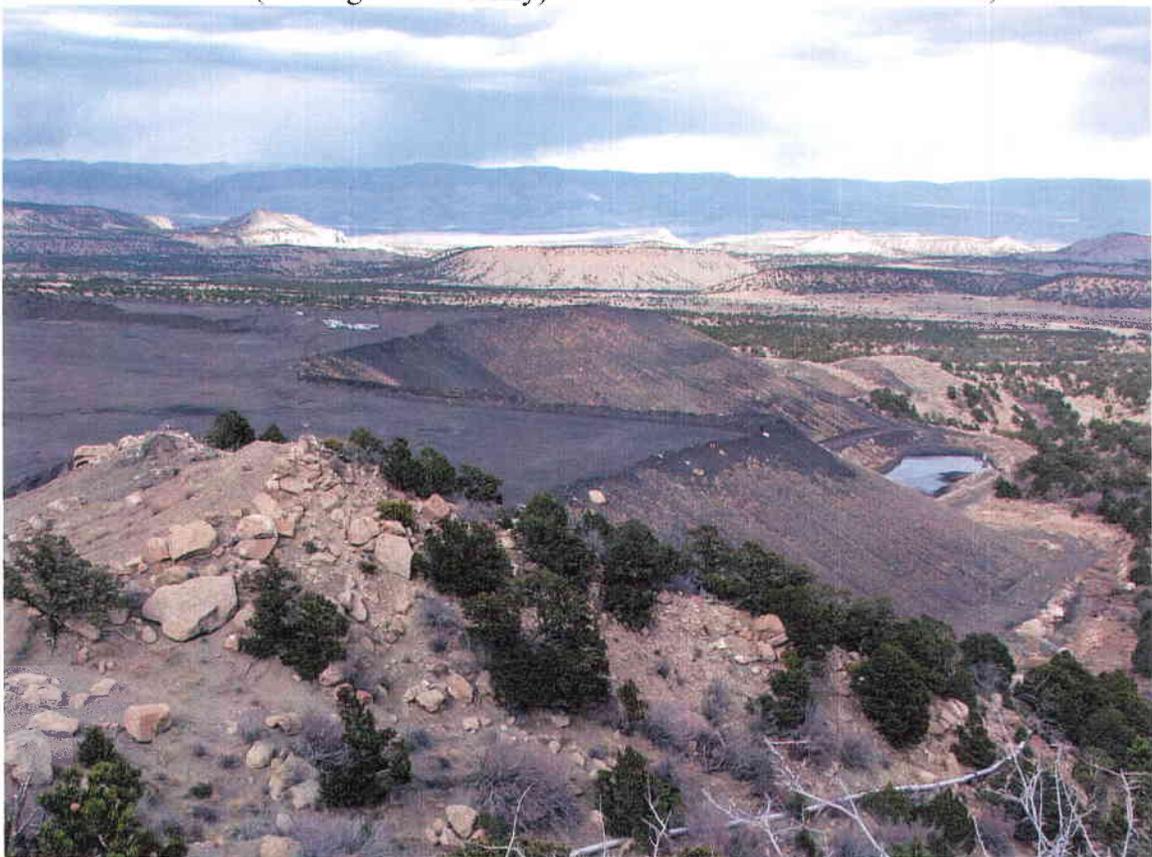
No aspects of the Fill structure were observed that could affect its stability or functionality

Refuse material is actively being excavated and removed from the top of the pile

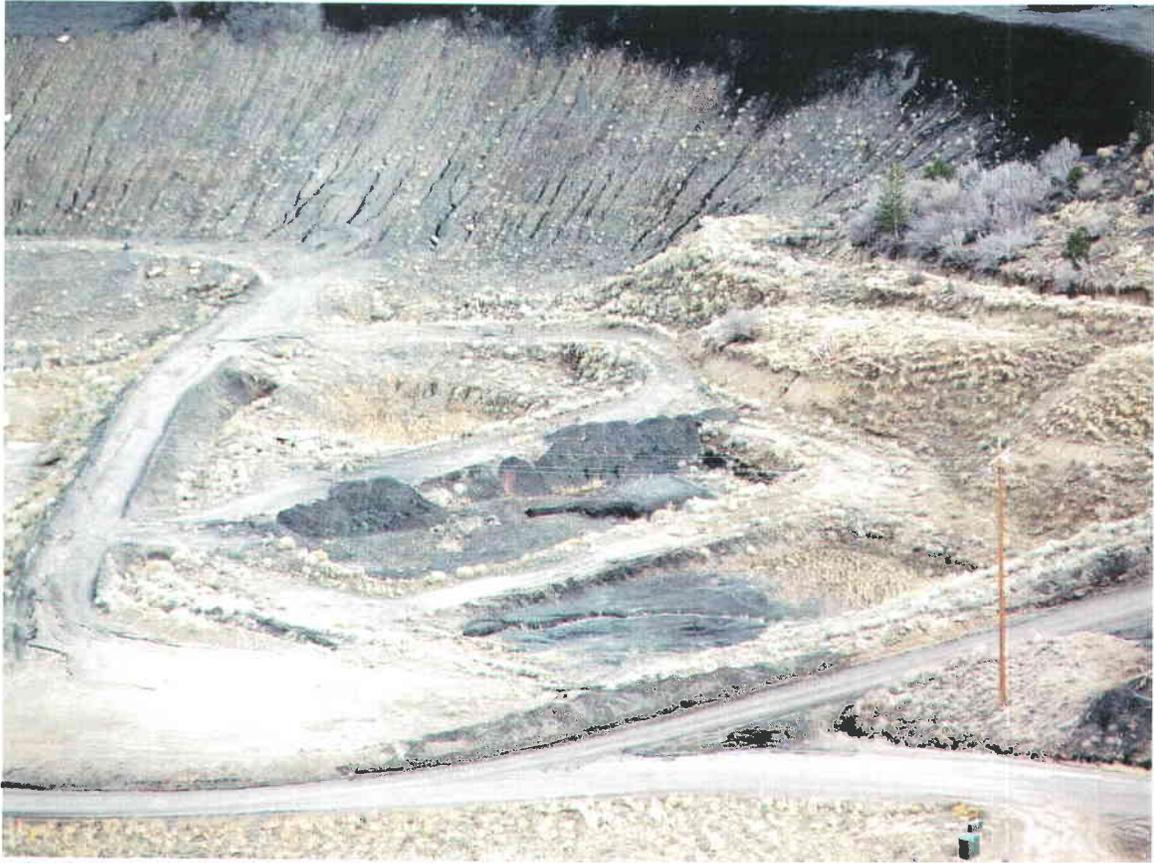
Disposal Area (looking southeasterly)

No aspects of the Fill structure were observed that could affect its stability or functionality

The disposal area only received materials during the mid part of the year from pond cleaning.

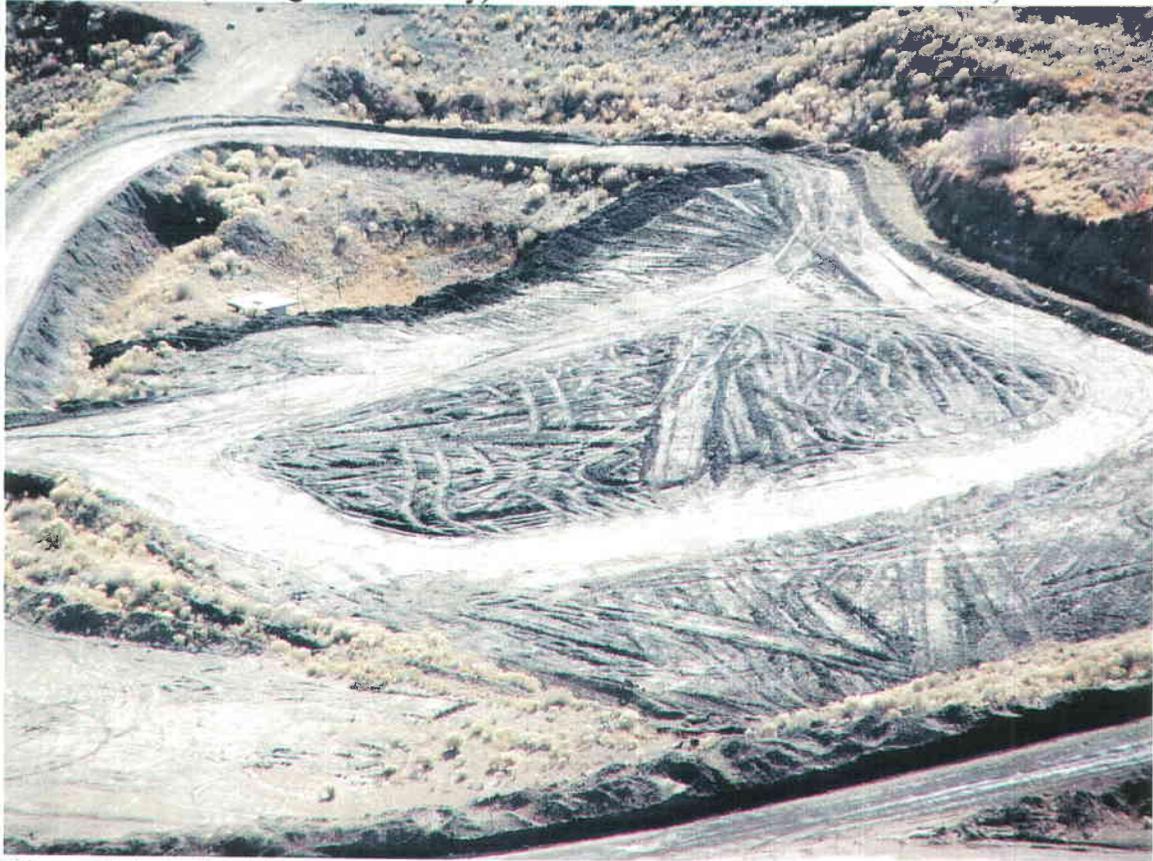
Disposal Area (looking southeasterly)

The disposal area received approximately 8,059 cubic yards of material from sediment pond cleaning.
