2007 Annual Report

Sunnyside Cogeneration Associates

Star Point Waste Fuel

**SUNNYSIDE COGENERATION ASSOCIATES
STAR POINT WASTE FUEL
C/007/042
2007 ANNUAL REPORT**

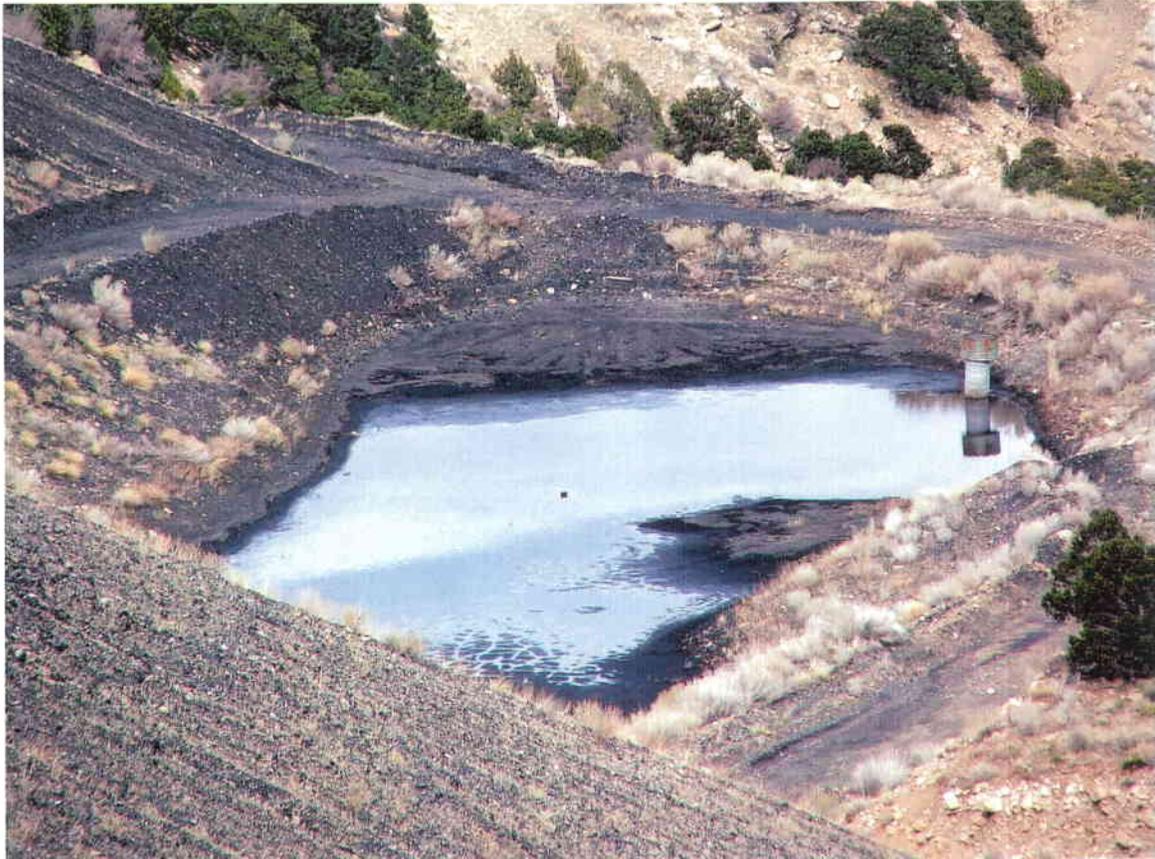
Sediment Pond #005 (looking easterly)

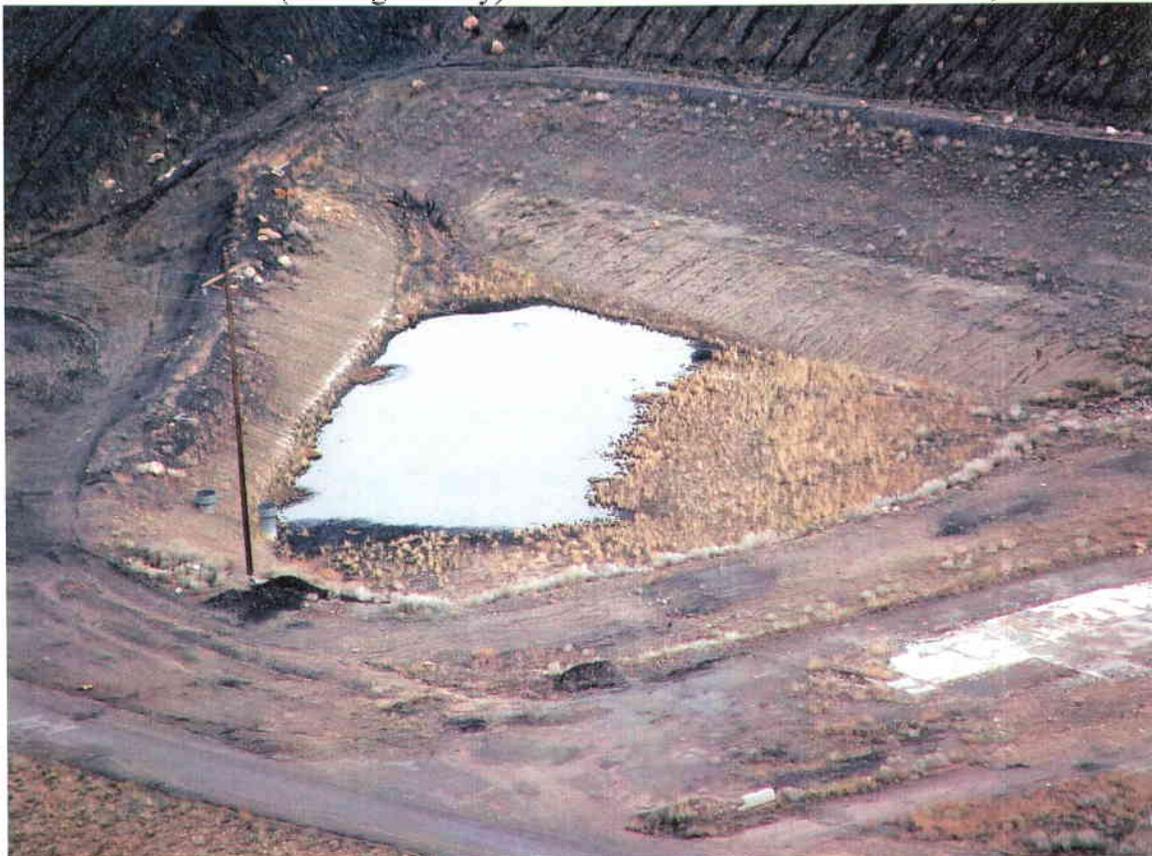
Sediment Pond #009 (looking easterly)

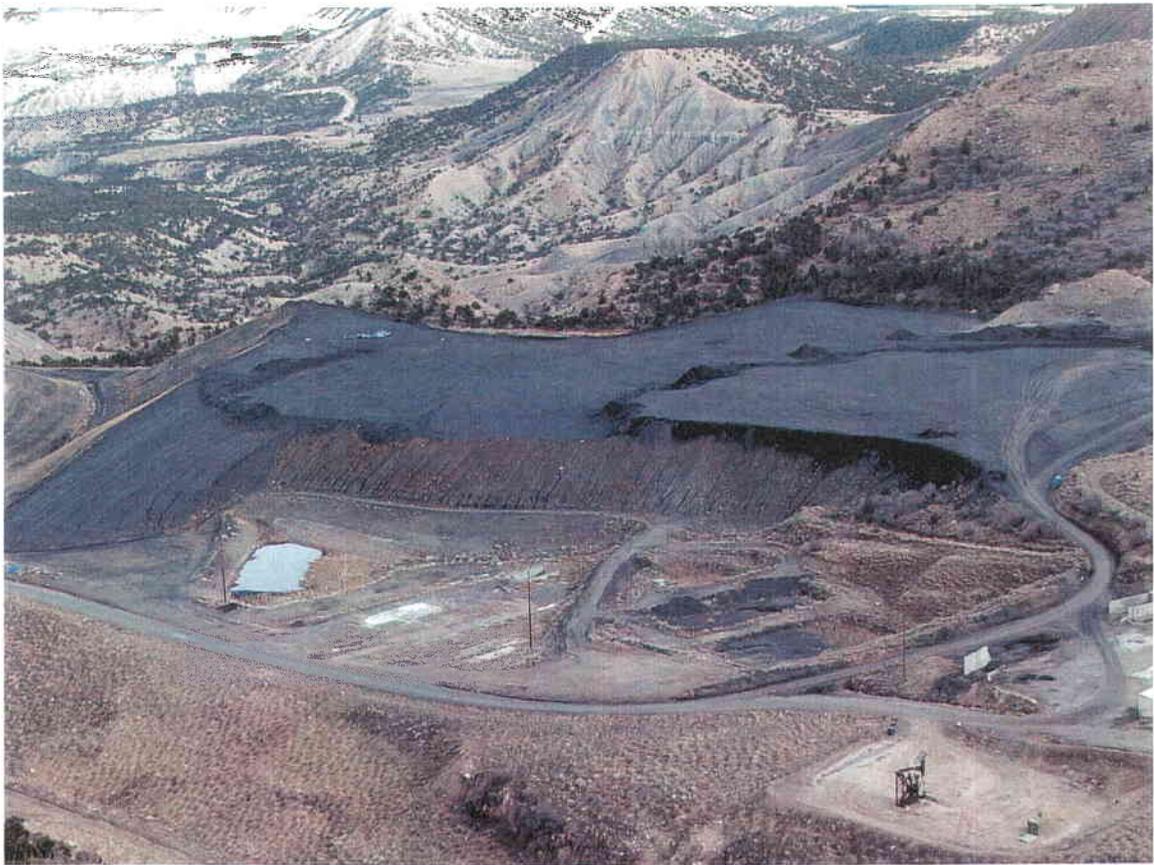
Coarse Refuse Pile (looking southeasterly)

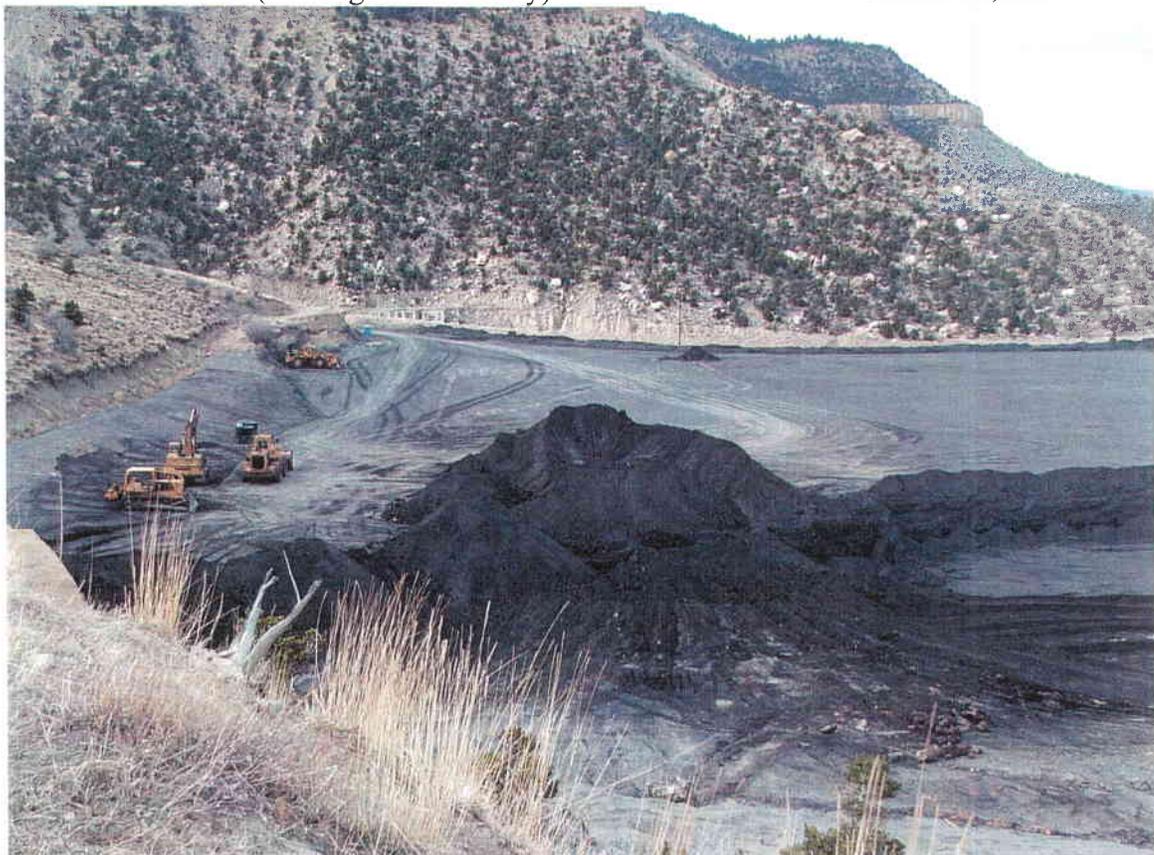
Coarse Refuse Pile (looking northerly)

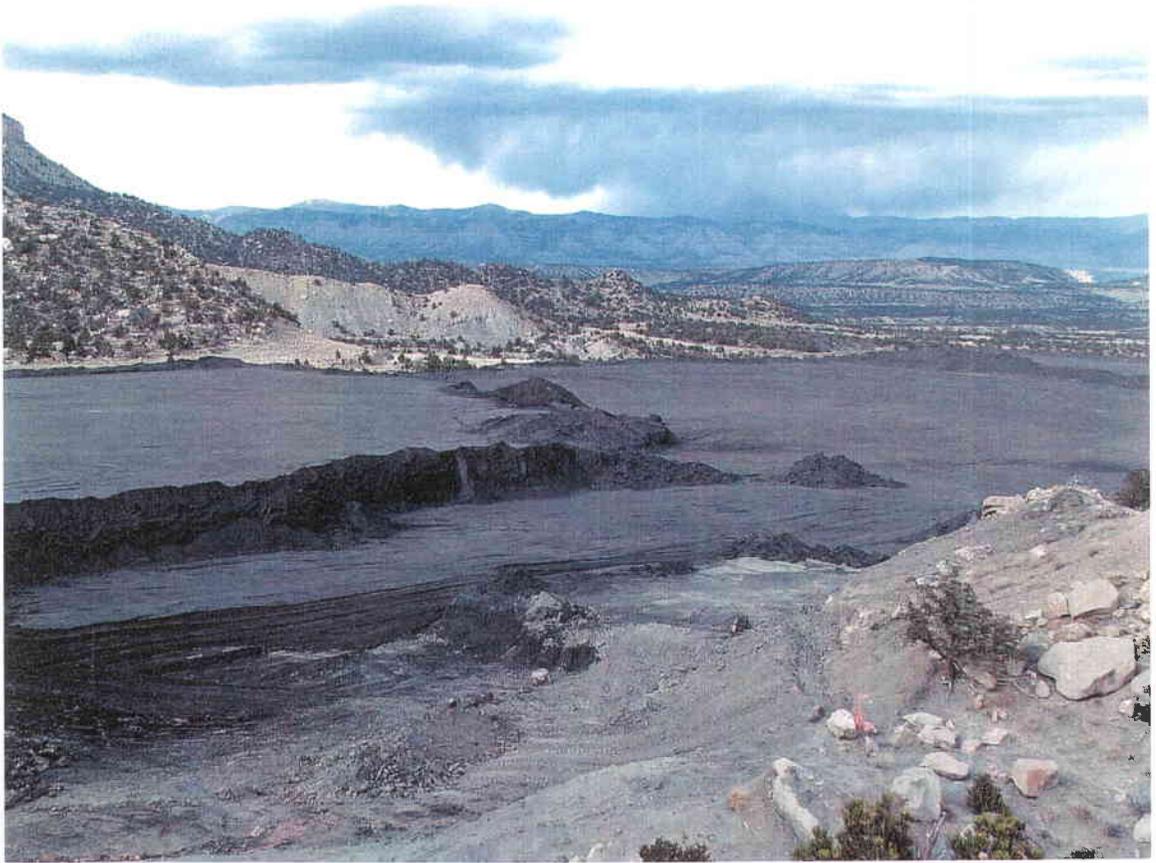
Coarse Refuse Pile (looking northeasterly)

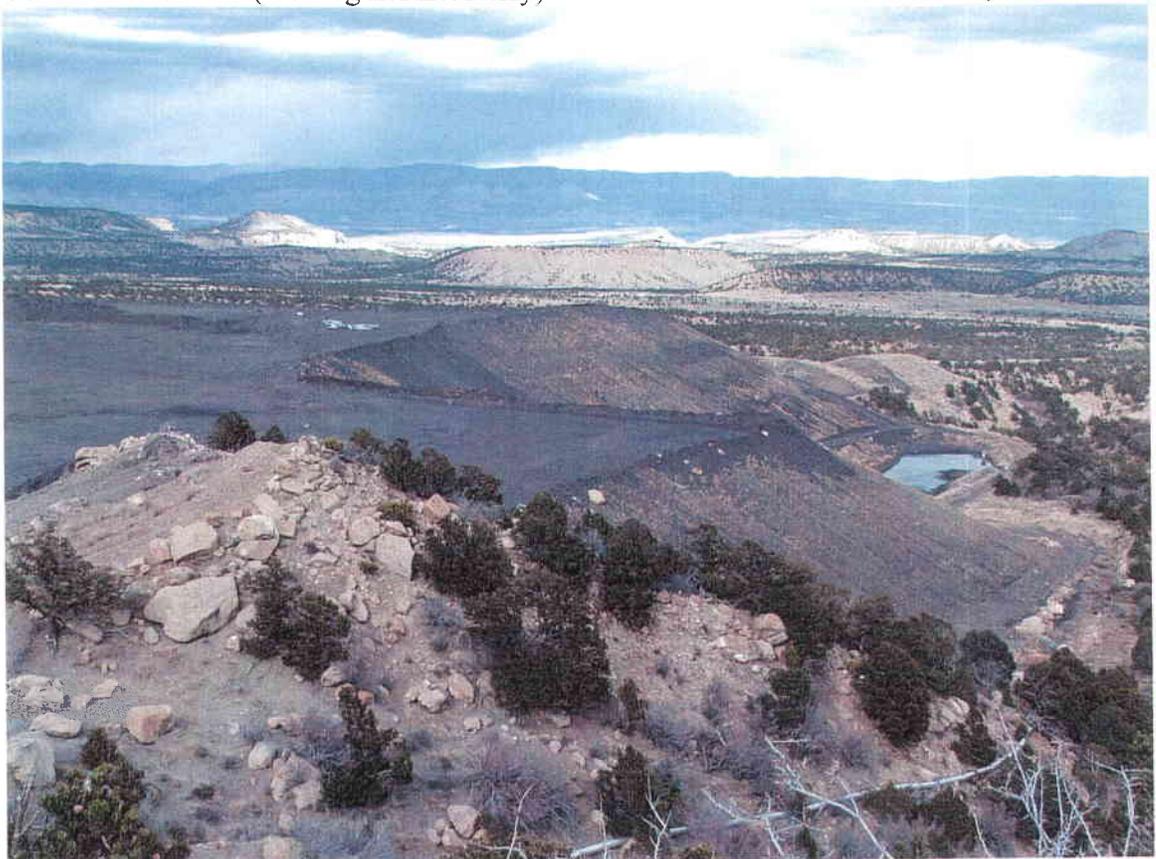
Coarse Refuse Pile (looking easterly)

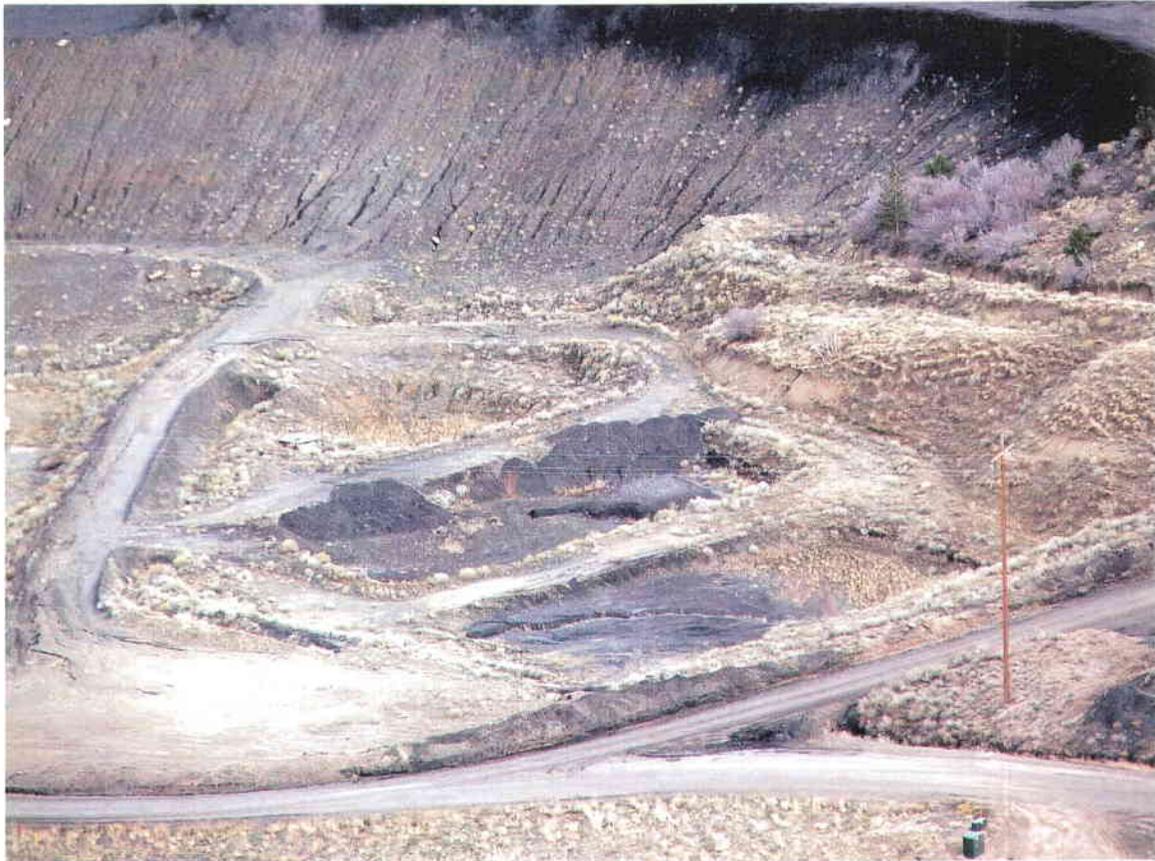
Disposal Area (looking southeasterly)

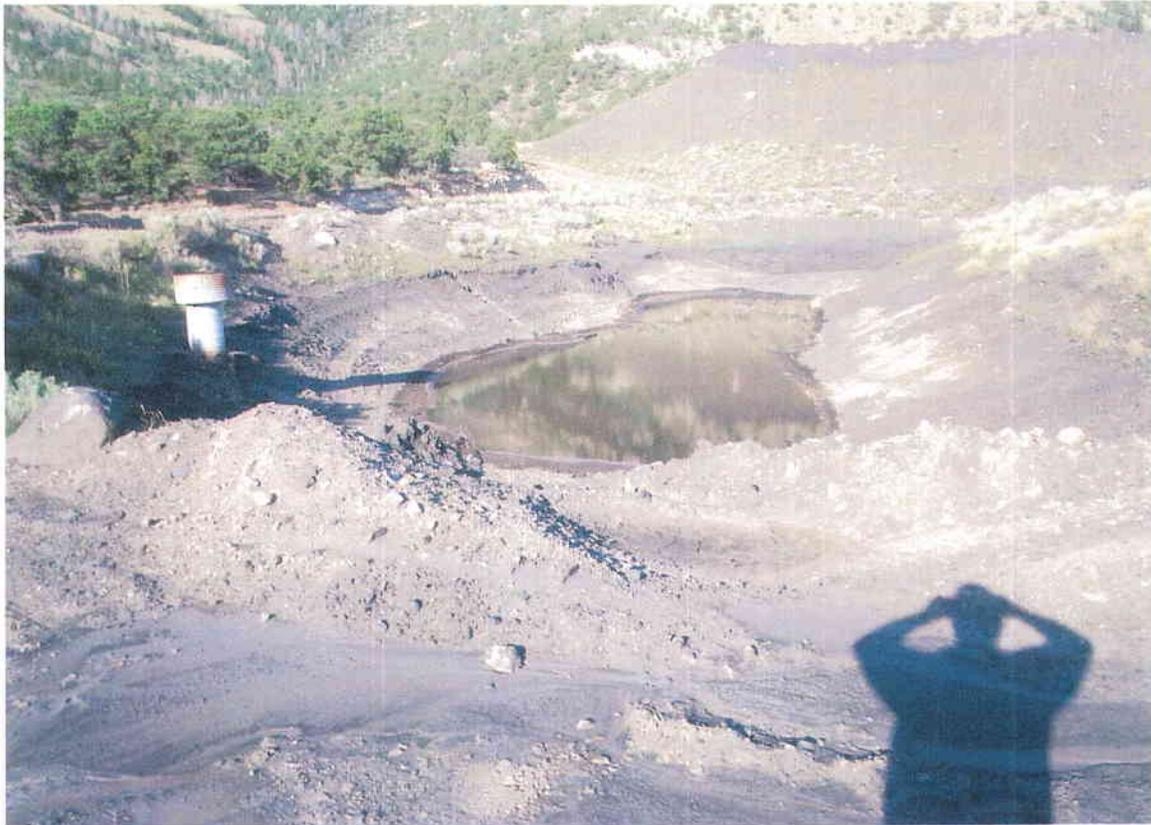
Sediment Pond #005 (looking westerly)

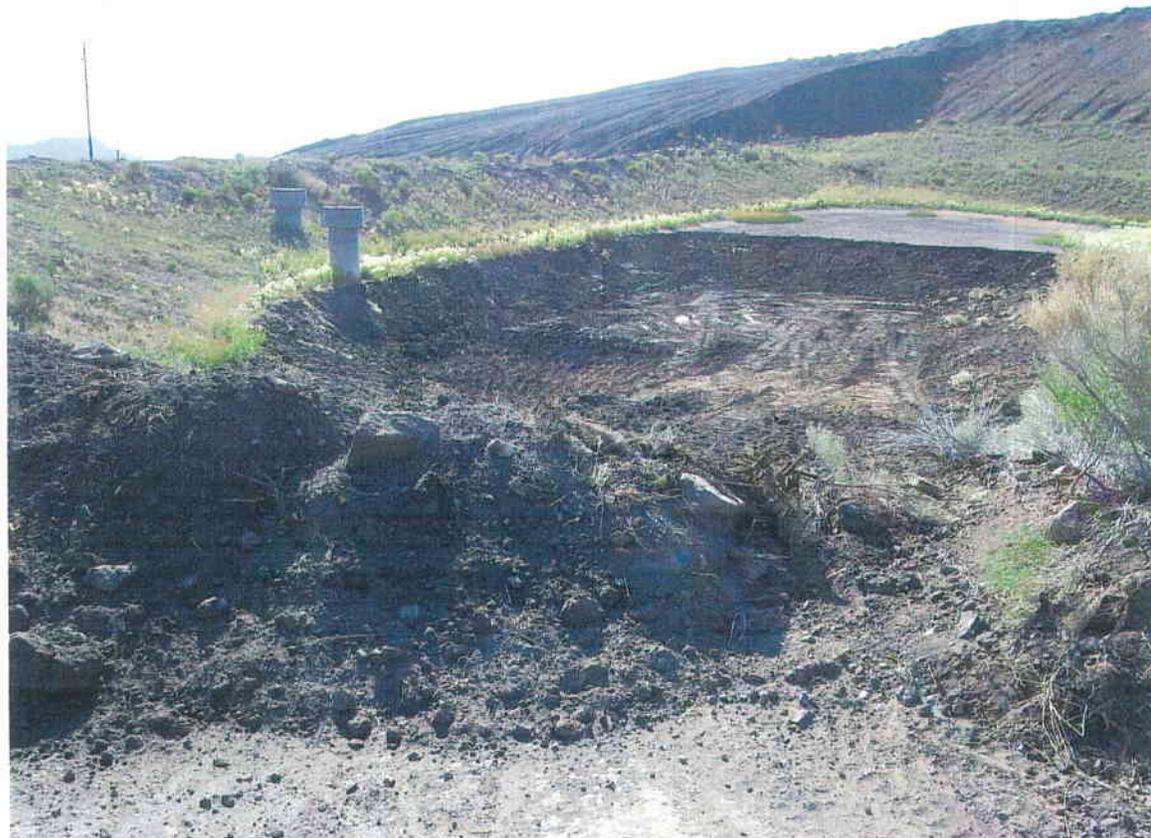
Sediment Pond #009 (looking easterly)

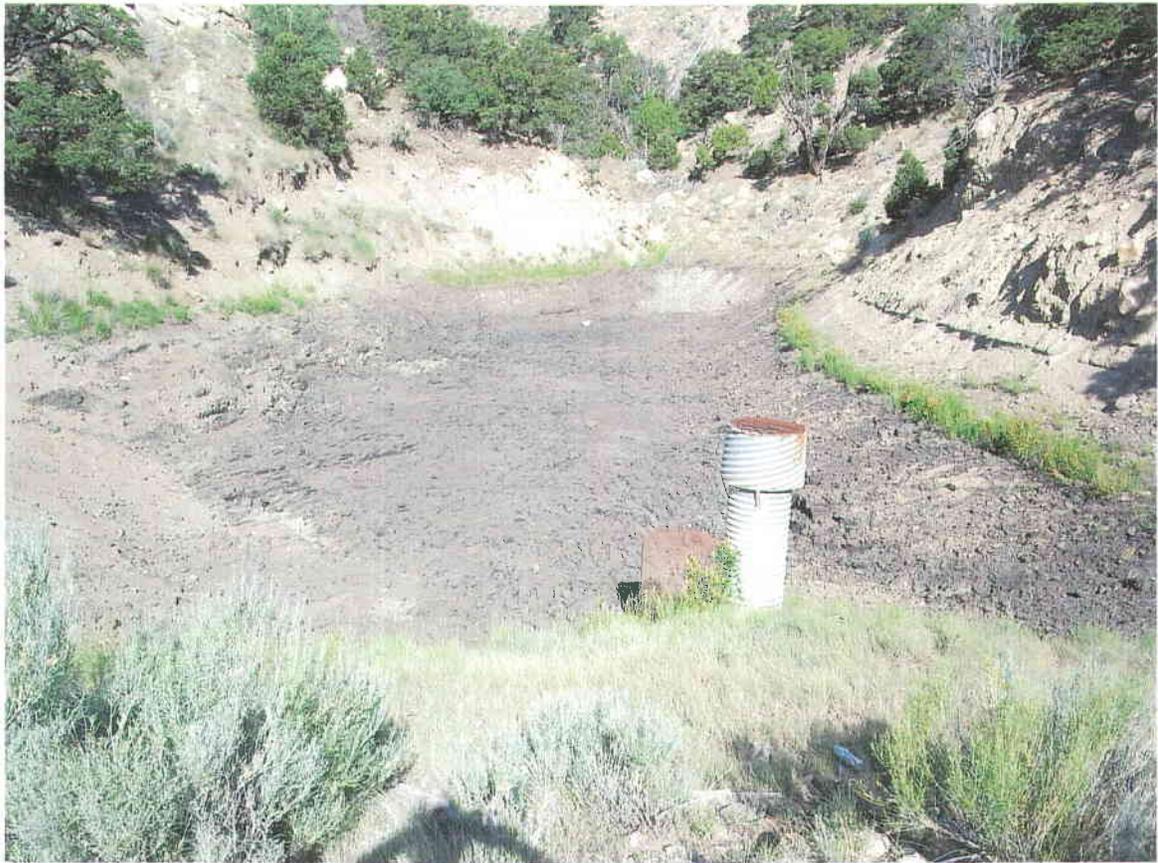
Sediment Pond #006 (looking westerly)

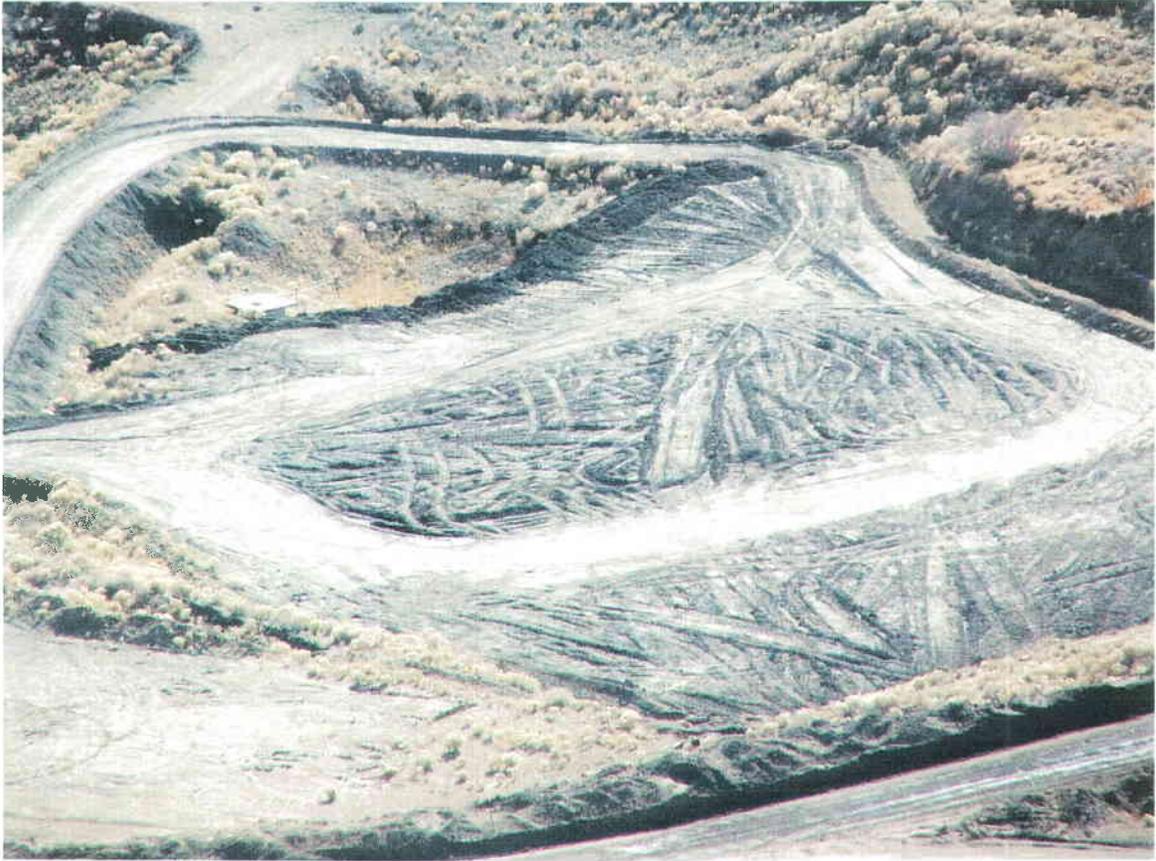
Disposal Area (looking southeasterly)

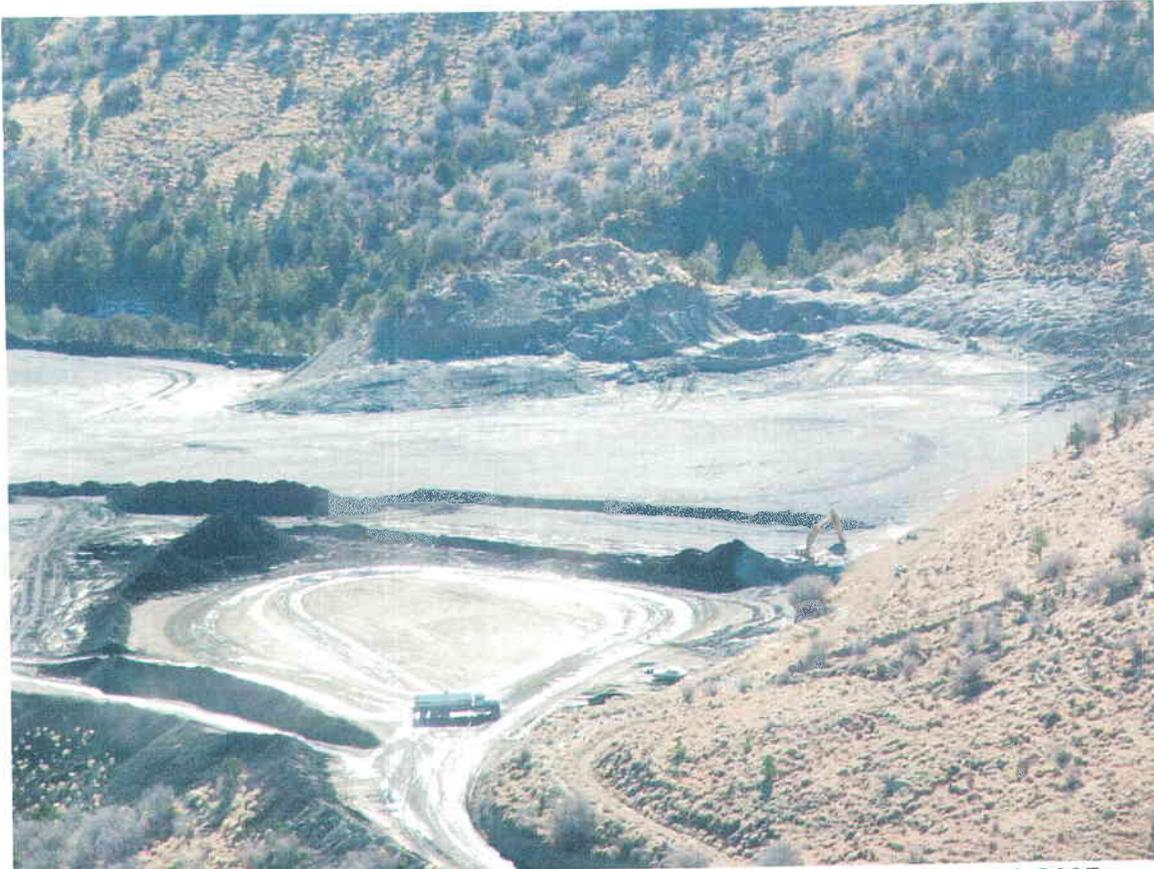
Coarse Refuse Pile -- Active Area
