## Sunnyside Cogeneration Associates

RE: 2<sup>nd</sup> Quarter 2011 Inspection Report  
Star Point Refuse Pile C/007/042

**IMPOUNDMENT INSPECTION AND CERTIFIED REPORT**

Report Date July 13, 2011  
Permit Number C/007/042  
Mine Name Star Point Waste Fuel  
Company Name Sunnyside Cogeneration Associates

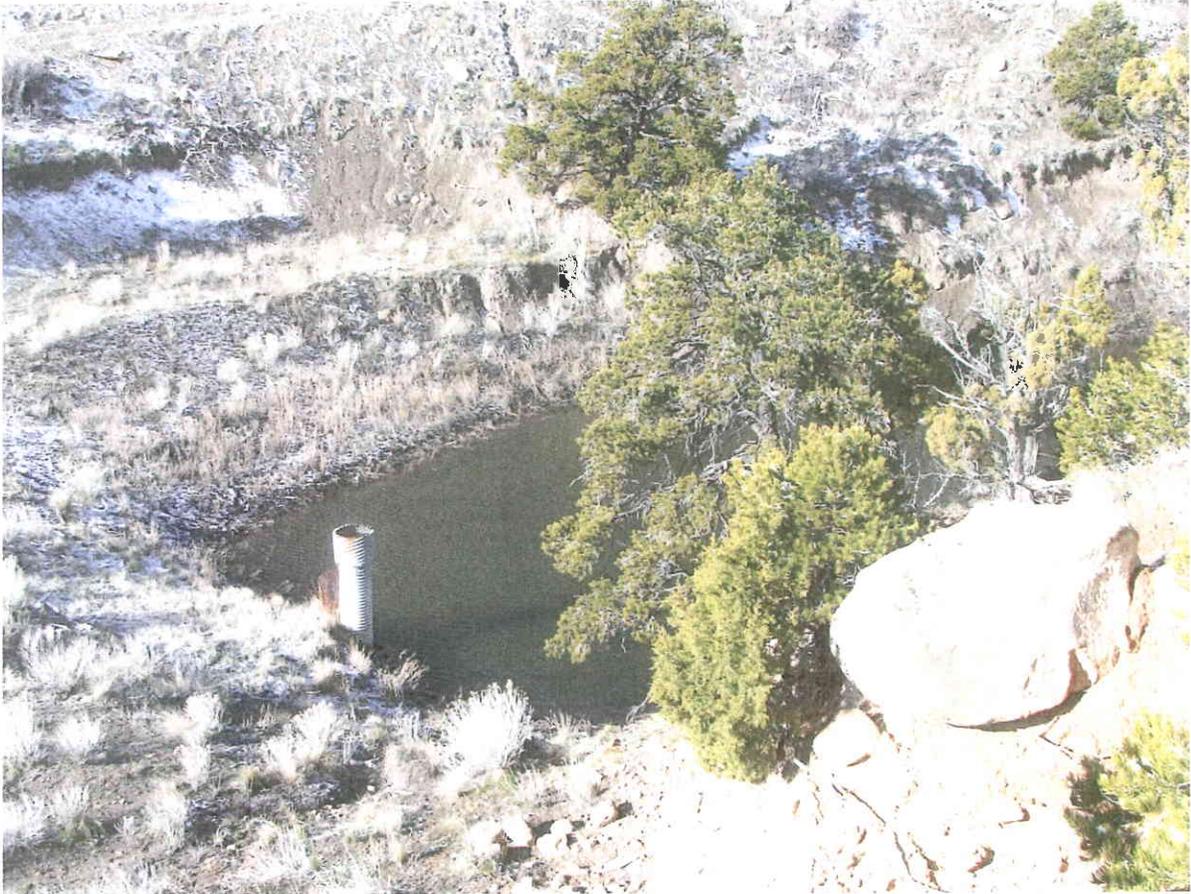
Sediment Pond 006

Pond had some water in it. No samples were taken  
Sediment levels were reasonably low. Pond did not require decanting.  
Embankment conditions were good. Vegetation on outslopes was adequate.  
Inlet / Outlet conditions were good. No structural or hazardous conditions were observed.

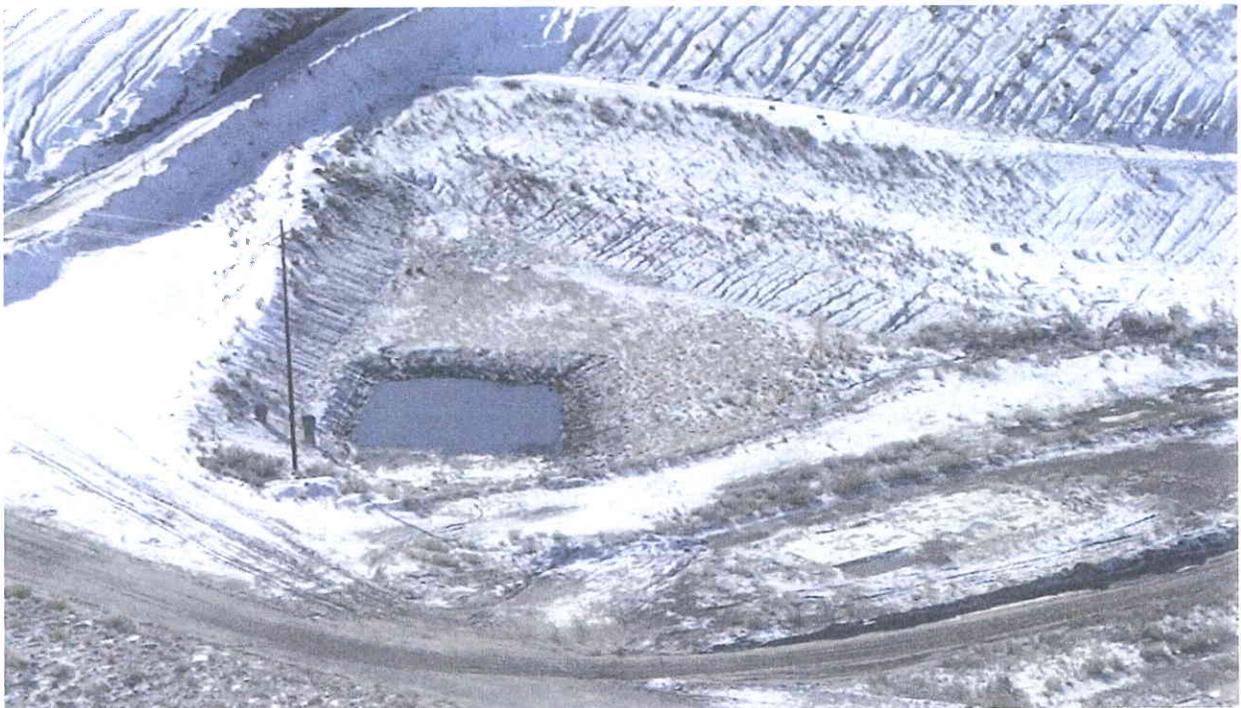
Sediment Pond 009

Pond had some water in it. No samples were taken. Pond did not require decanting.  
Sediment levels were reasonable.  
Embankment conditions were good. Vegetation on outslopes was adequate.  
Inlet / Outlet conditions were good. No structural or hazardous conditions were observed.

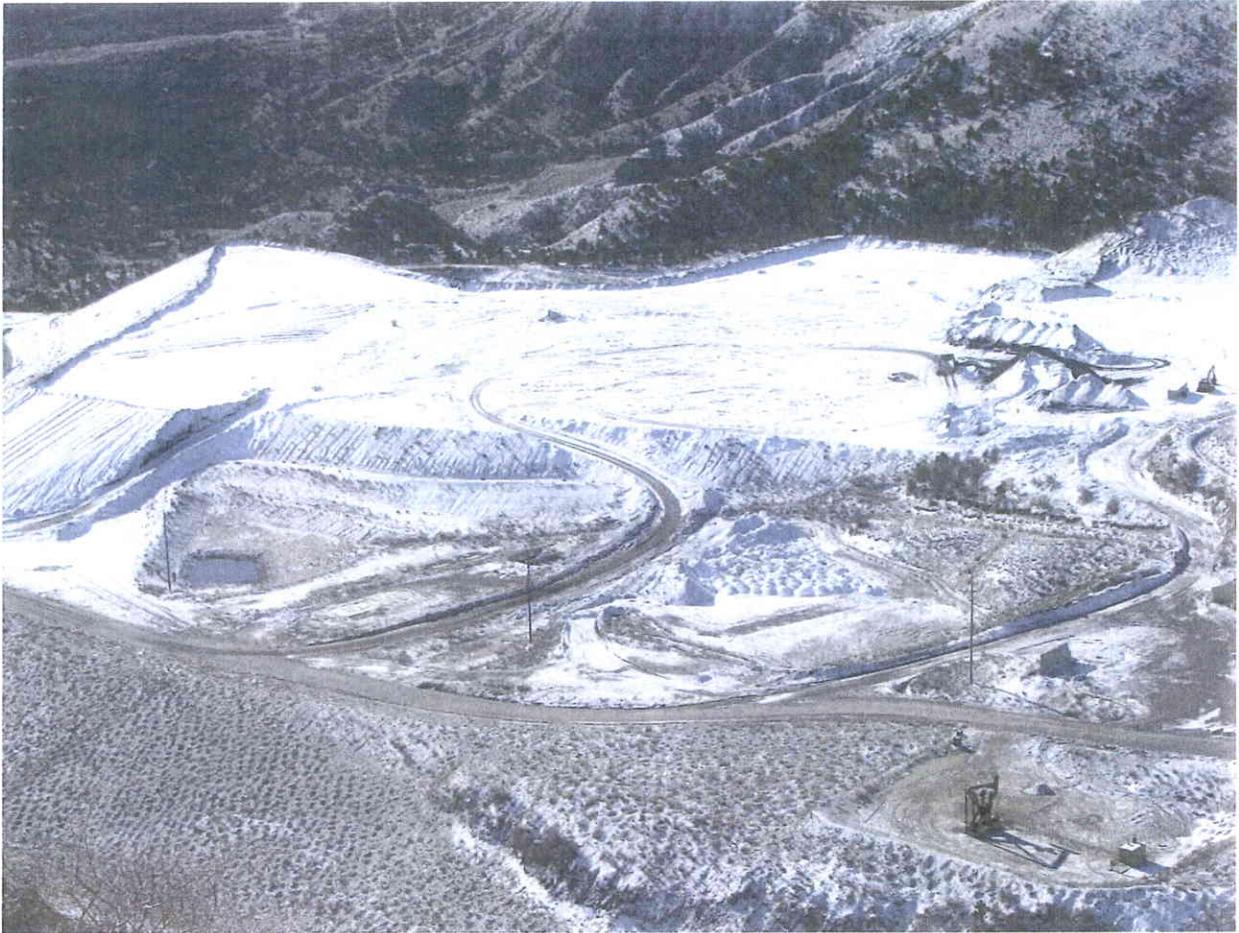
Coarse Refuse Pile

Refuse material is actively being excavated and removed from the top of the pile
