Sunnyside Cogeneration Associates

RE: Annual 2011 Inspection Report
Star Point Refuse Pile C/007/042

IMPOUNDMENT INSPECTION AND CERTIFIED REPORT

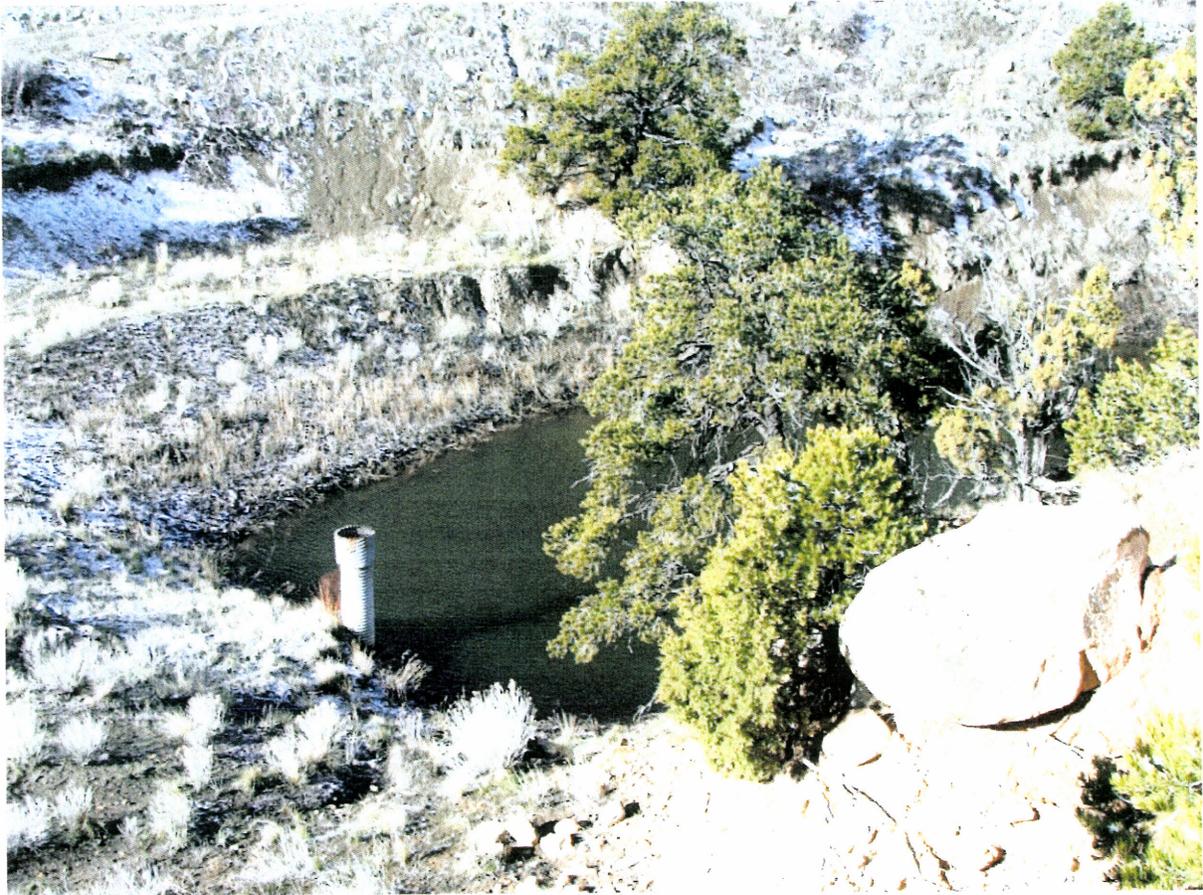
Sediment Pond 006

Pond had some water in it. No samples were taken
Sediment levels were reasonably low. Pond did not require decanting.
Embankment conditions were good. Vegetation on out slopes was adequate.
Inlet / Outlet conditions were good. No structural or hazardous conditions were observed.

No recent changes in the geometry of the structure have been observed
Depth of impounded water was minimal
Sediment level was good.

No other aspects of the impounding structure were observed that could affect its stability or functionality.

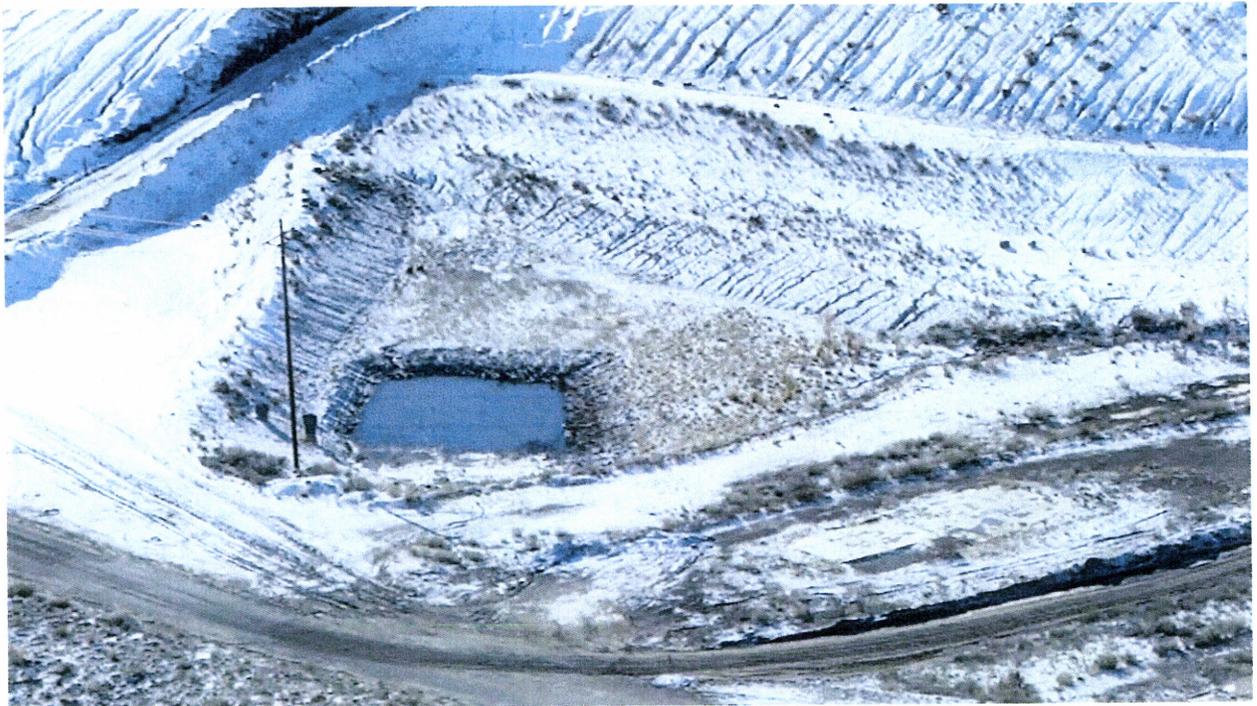
Sediment Pond 009

Pond had some water in it. No samples were taken. Pond did not require decanting.
Sediment levels were reasonable.
Embankment conditions were good. Vegetation on out slopes was adequate.
Inlet / Outlet conditions were good. No structural or hazardous conditions were observed.

No recent changes in the geometry of the structure have been observed
Depth of impounded water was minimal
Sediment level was good.

No other aspects of the impounding structure were observed that could affect its stability or functionality.

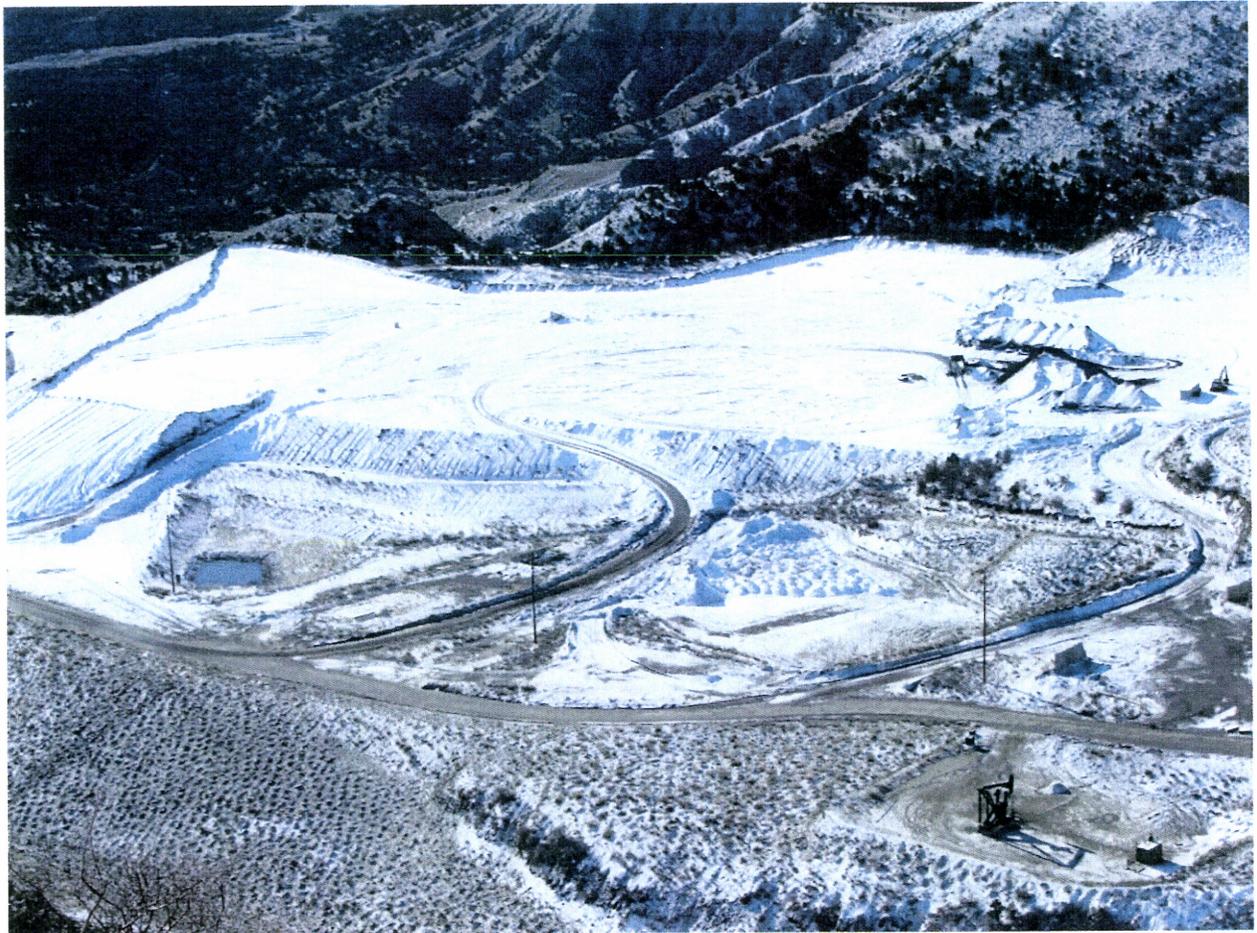
Coarse Refuse Pile

No aspects of the Fill structure were observed that could affect its stability or functionality

Refuse material is actively being excavated and removed from the top of the pile

New access roads were constructed at the north side of the pile during the winter of 2010/2011
