RE: Annual 2012 Inspection Report
Star Point Refuse Pile C/007/042

IMPOUNDMENT INSPECTION AND CERTIFIED REPORT

Report Date January 14, 2013
Permit Number C/007/042
Mine Name Star Point Waste Fuel
Company Name Sunnyside Cogeneration Associates

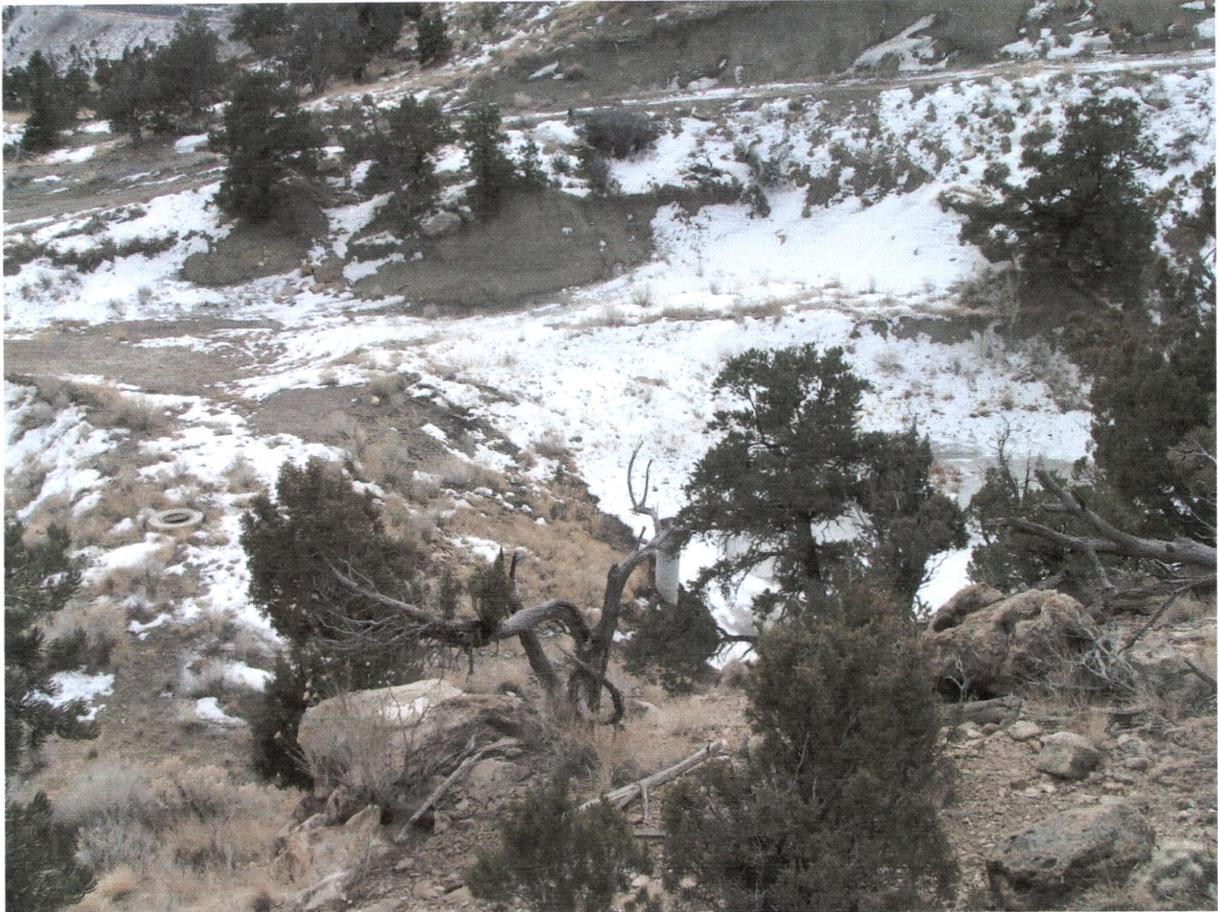
Sediment Pond 006

Pond had some snow cover. No samples were taken
Sediment levels were reasonably low. Pond did not require decanting.
Embankment conditions were good. Vegetation on out slopes was adequate.
Inlet / Outlet conditions were good. No structural or hazardous conditions were observed.

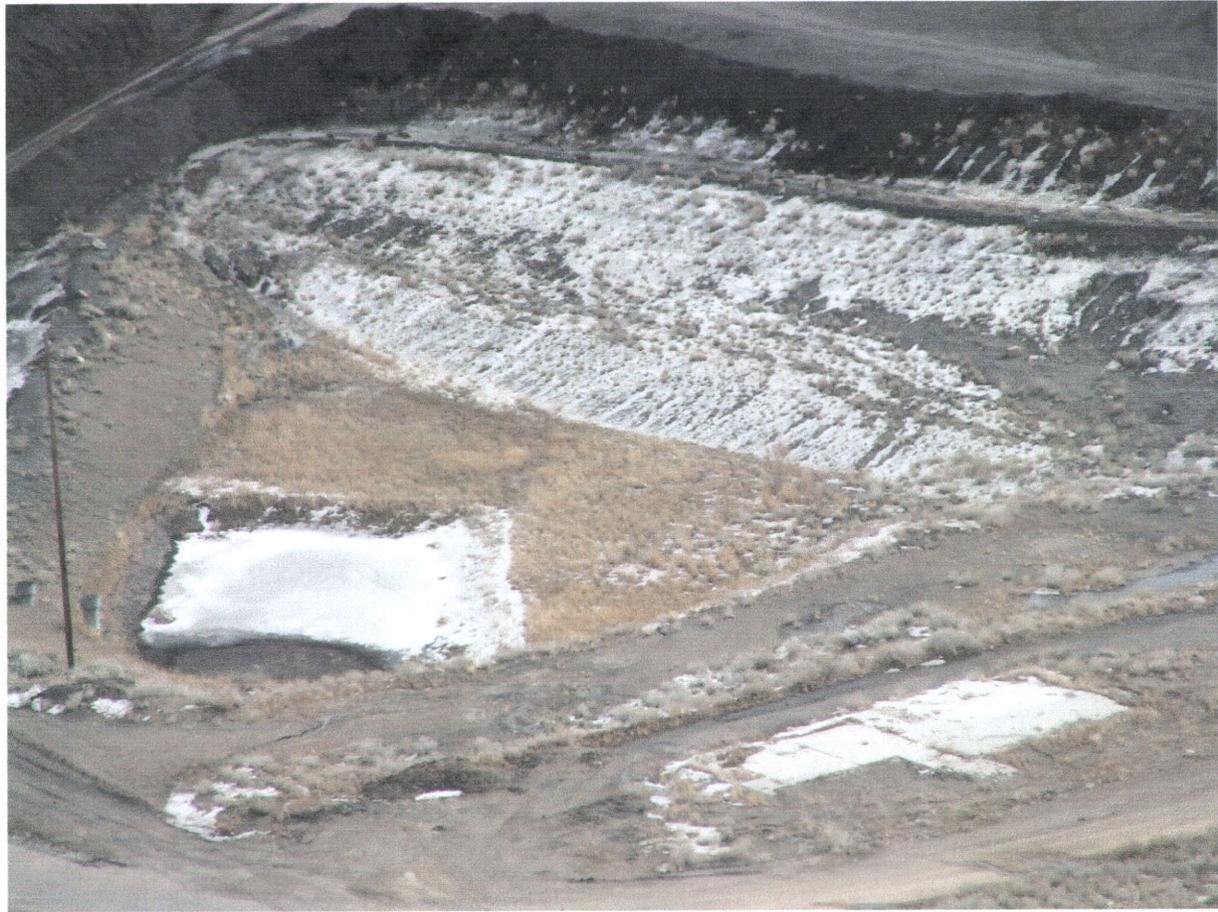
Sediment Pond 009

Pond had some snow cover. No samples were taken. Pond did not require decanting.
Sediment levels were reasonable.
Embankment conditions were good. Vegetation on outslopes was adequate.
Inlet / Outlet conditions were good. No structural or hazardous conditions were observed.

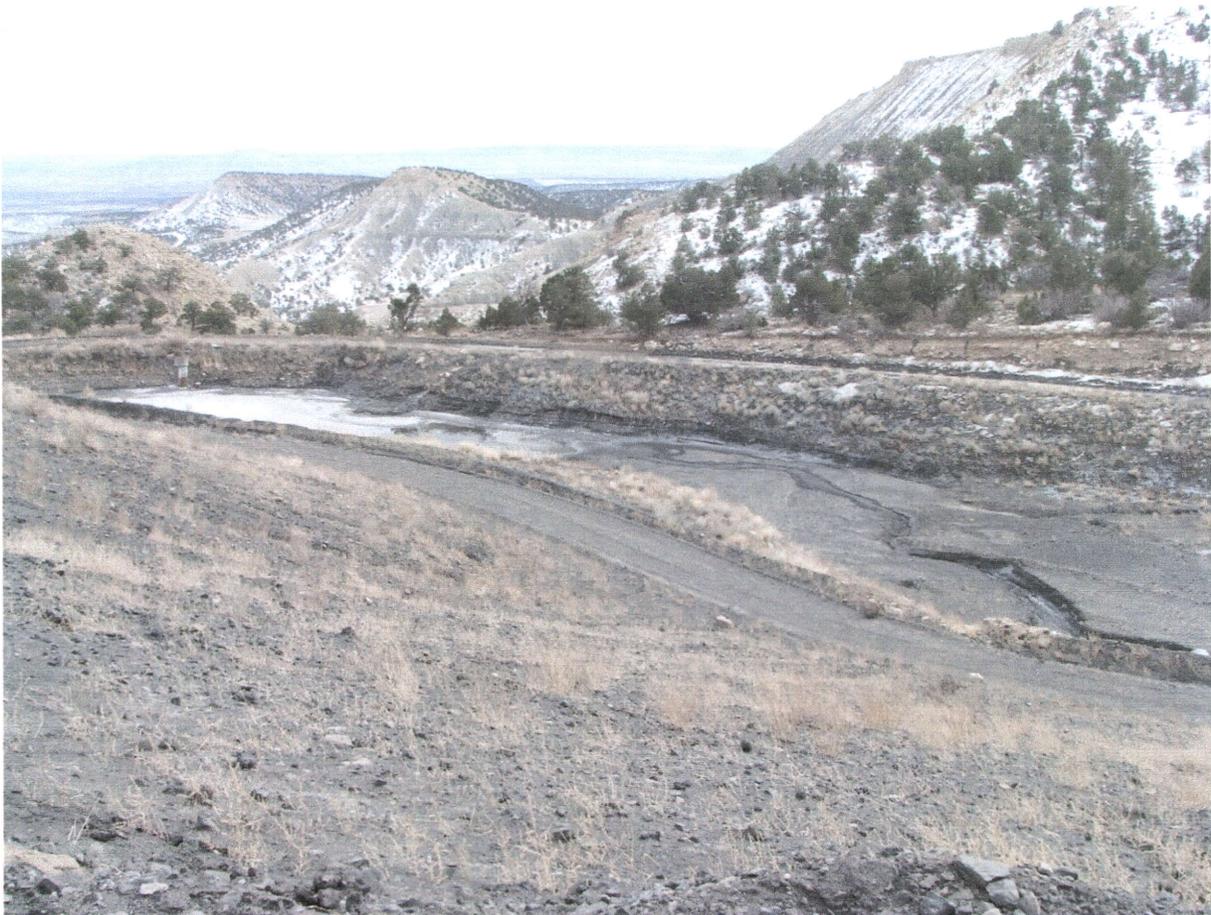
Sediment Pond 005

Pond had some snow cover. No samples were taken
Sediment levels were reasonably low. Pond did not require decanting.
Embankment conditions were good. Vegetation on out slopes was adequate.
Inlet / Outlet conditions were good. No structural or hazardous conditions were observed.

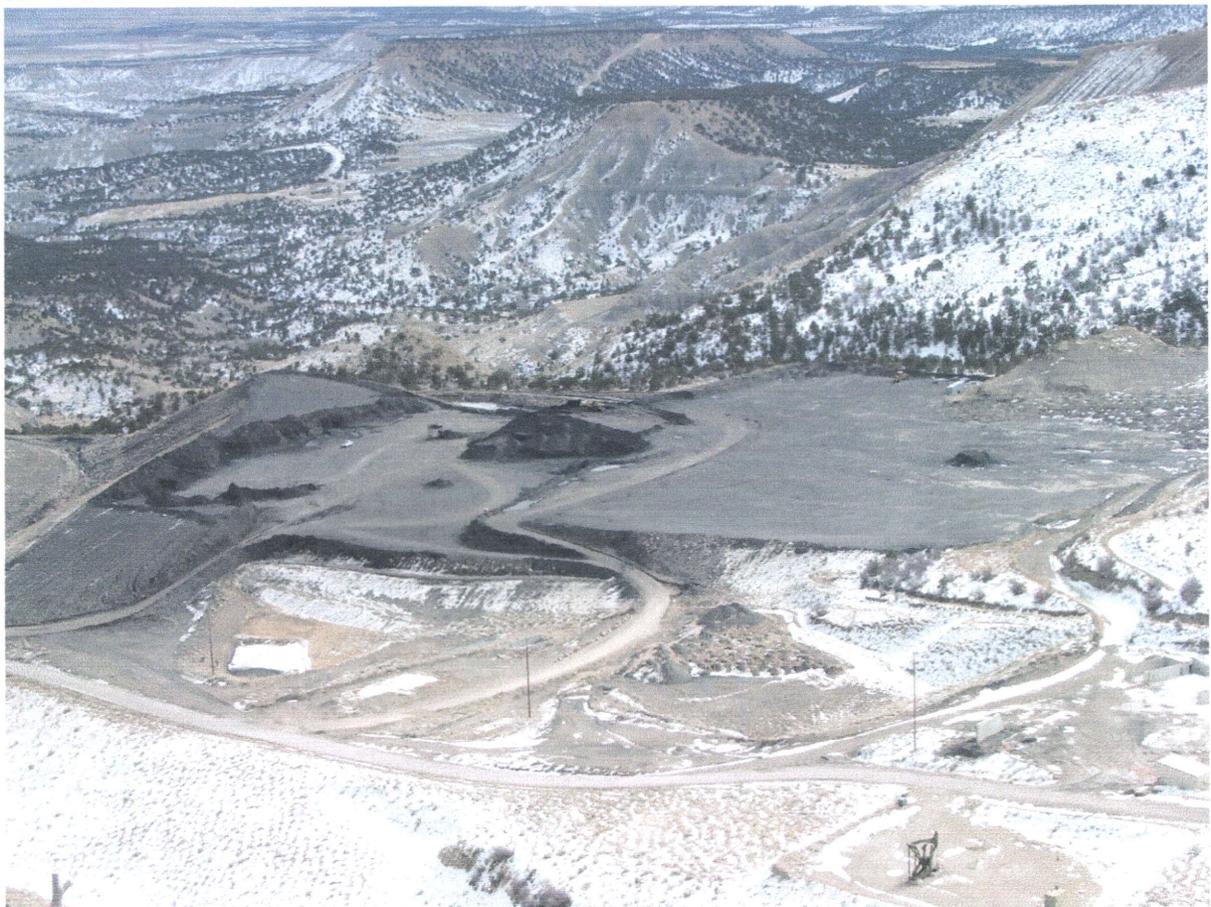
Coarse Refuse Pile

Refuse material is actively being excavated and removed from the top of the pile
