RE: 3rd Quarter 2014 Inspection Report
Star Point Refuse Pile C/007/042

QUARTERLY INSPECTION FORM – IMPOUNDMENT

Permit Number: C/007/042 Inspection Date: Sept 25, 2014
Mine Name: Star Point Waste Fuel Third Quarter 2014
Mine Operator (Permittee): Sunnyside Cogeneration Associates Inspector: Rusty Netz
MSHA ID Number: N/A Signature:

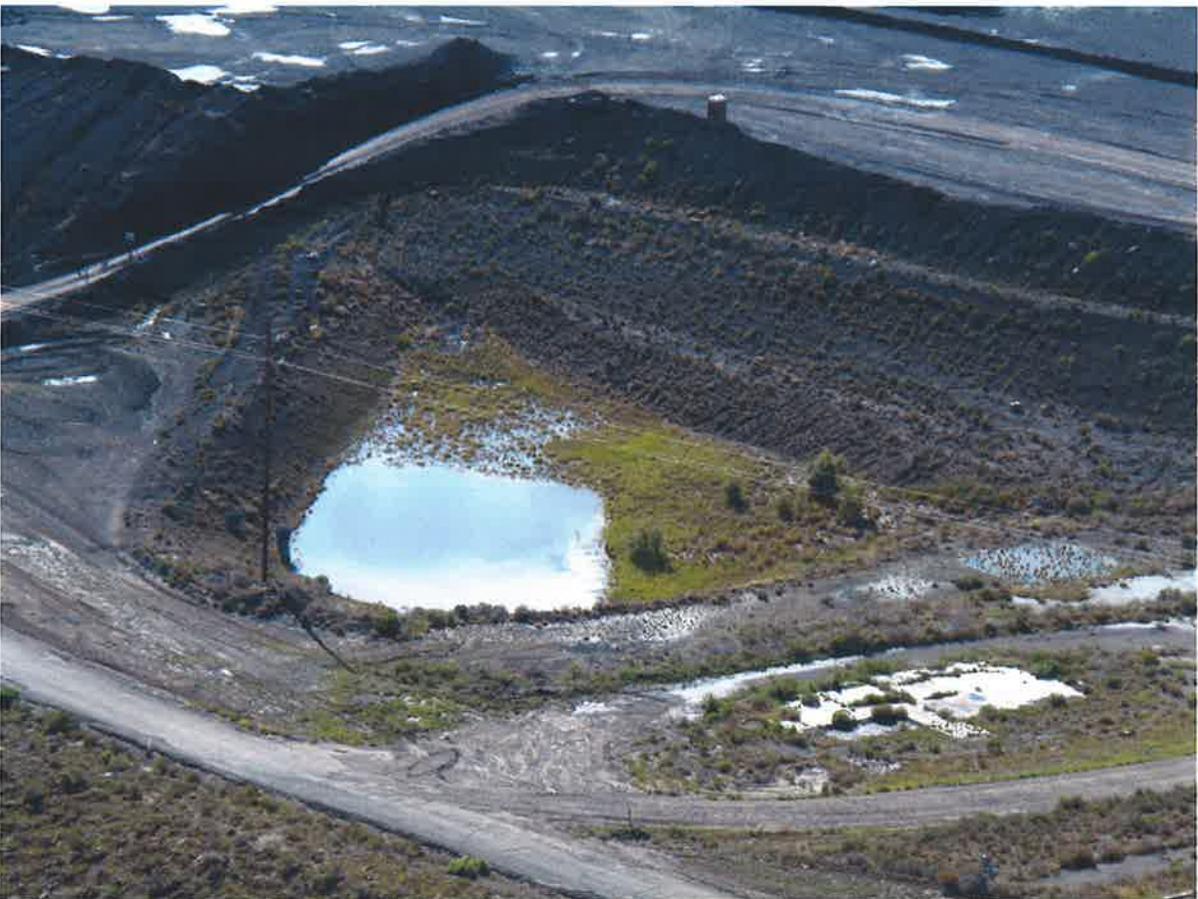
Sediment Pond 009

Recent storms caused some culverts within the Pond 009 drainage area to accumulate sediment. During an inspection, UDOGM issued NOV 12148. SCA completed an internal evaluation of culvert needs, submitted a permit amendment, cleaned ditches and removed unneeded culverts in the area. All diversions and culverts in this drainage 009 area functioned well during the late September storms experienced.

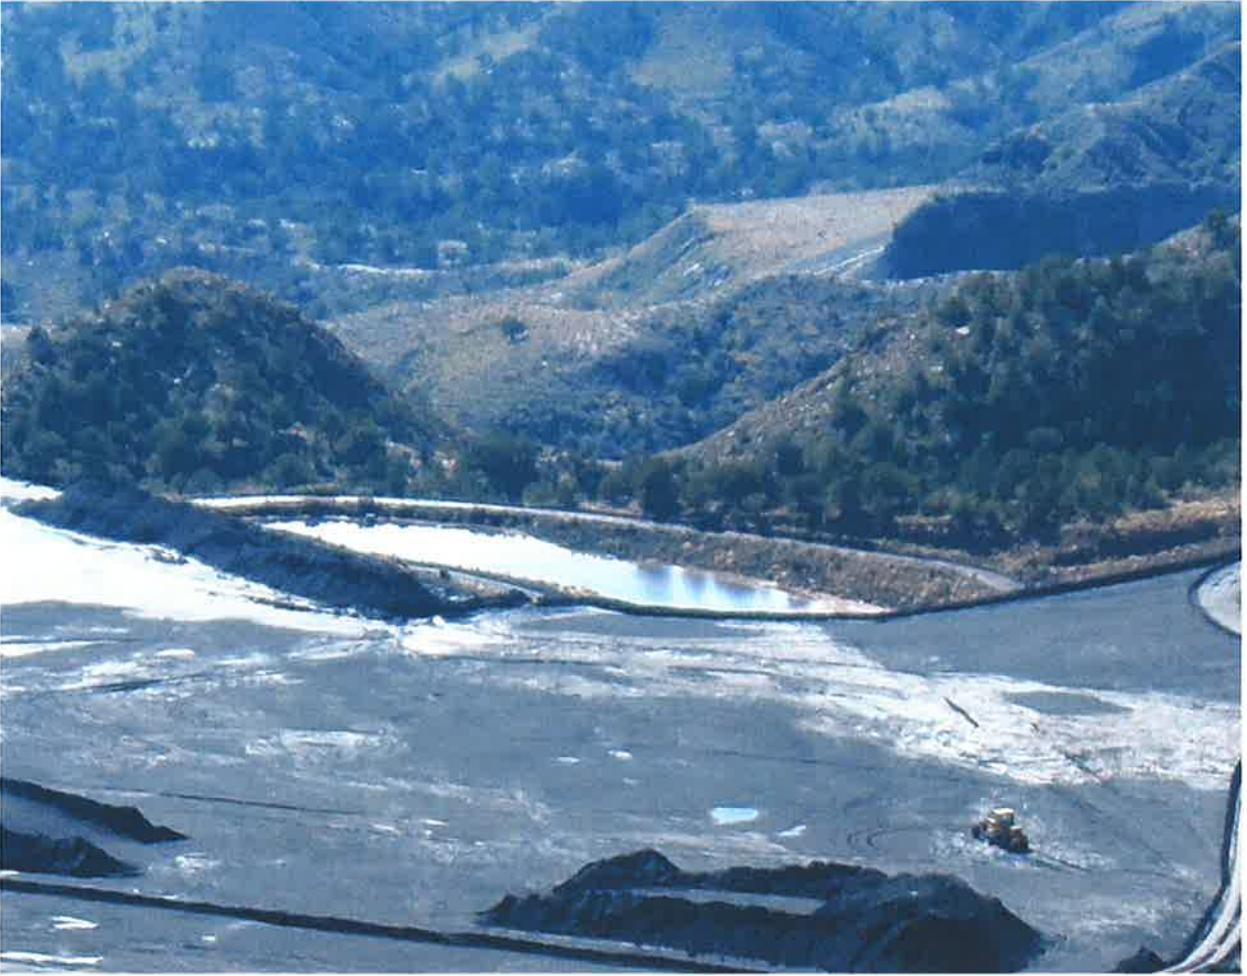
Sediment Pond 005

Although a discharge did occur from Pond 5 as a result of multiple storms in late September, it is expected that adequate detention time occurred and the state discharge limitations were not exceeded. Test results will be included with the next quarters report.
