Subject: Response to NOV #12148, Sunnyside Cogeneration Associates, Star Point Refuse, C/007/0042, Task ID #4685

## Technical Analysis and Findings

**PID:** C0070042  
**TaskID:** 4685  
**Mine Name:** STAR POINT REFUSE  
**Title:** NOV #12148 RESPONSE

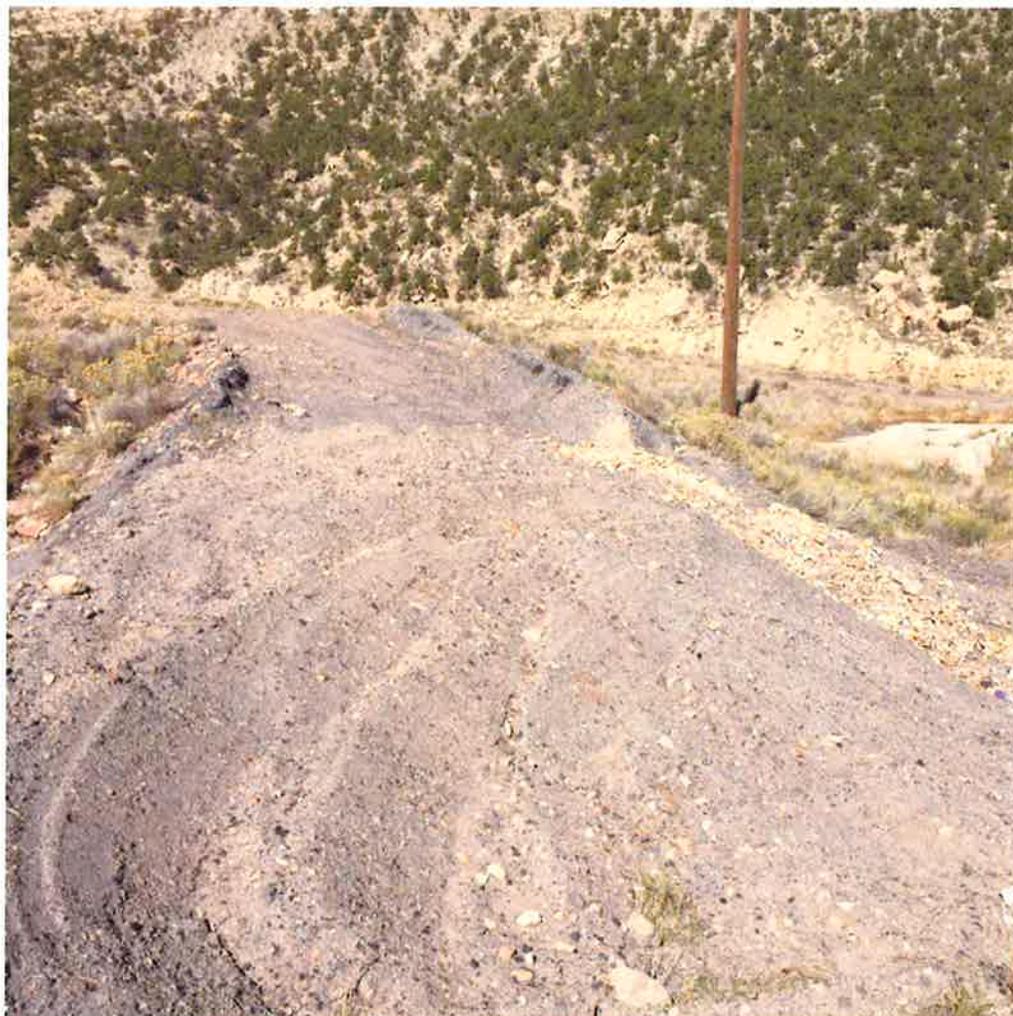
Figure 1

R645-301-731.720 The MRP and maps should be updated to include the new riprapped ditch locate just north of the 72B ditch section. The MRP should include ditch sizing design specifications for the ditch. A picture of this new ditch is attached as Figure 1.
