Division of Oil, Gas and Mining

Inspection Report

Permit Number:	C0070042
Inspection Type:	PARTIAL
Inspection Date:	Tuesday, April 05, 2016
Start Date/Time:	4/5/2016 10:00:00 AM
End Date/Time:	4/5/2016 12:30:00 PM
Last Inspection:	Monday, April 04, 2016

Site: **STAR POINT REFUSE**

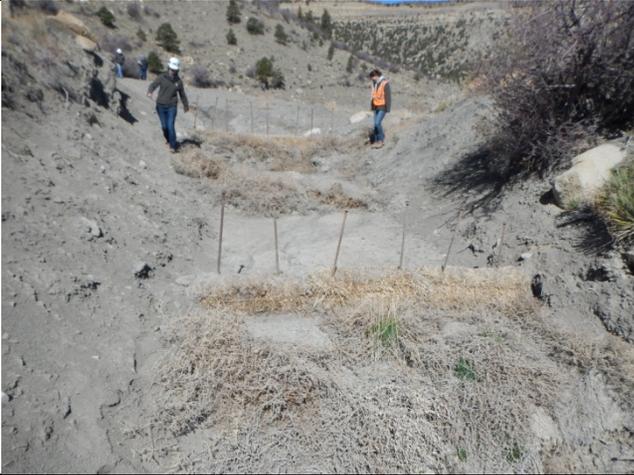
PHOTO 1

The Permittee was notified to maintain the straw bale check dams at the end of ditch 76 just before flow is routed into culvert 7F (Photo 1). The check dams appeared to be filled to capacity and piping was present underneath one of the structures.

Ditch 76 straw bale check dams need maintenance.
April 05, 2016

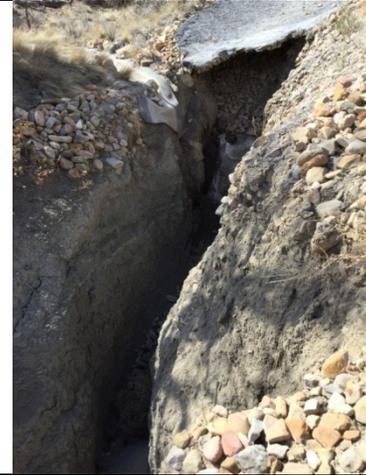
PHOTO 2

The Riprap energy dissipation basin at the end of ditch 14 needs immediate repair (Photos 2 and 3). An eight foot gully is being scoured at the end of the ditch. The gully is head-cutting underneath the shotcrete creating an unsafe situation (Photo 4). The Permittee is given two weeks to address this issue.

Gully at end of ditch 14 needs immediate repair.
April 05, 2016

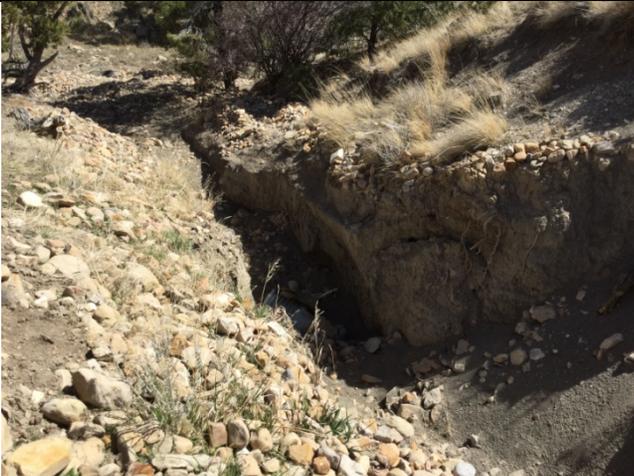
PHOTO 3

Gully at end of ditch 14 needs immediate repair.
April 05, 2016

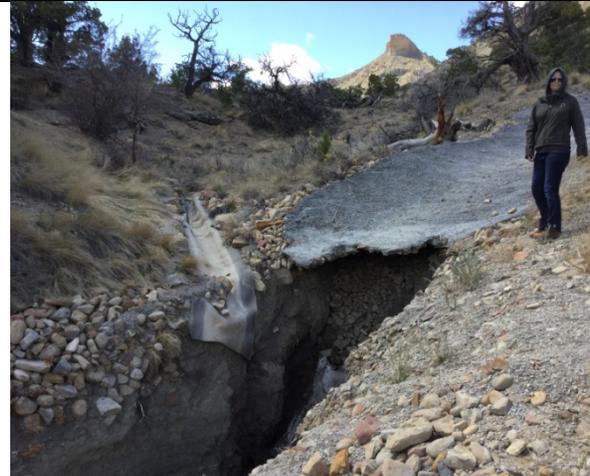
PHOTO 4

Gully at end of ditch 14 needs immediate repair.
April 05, 2016

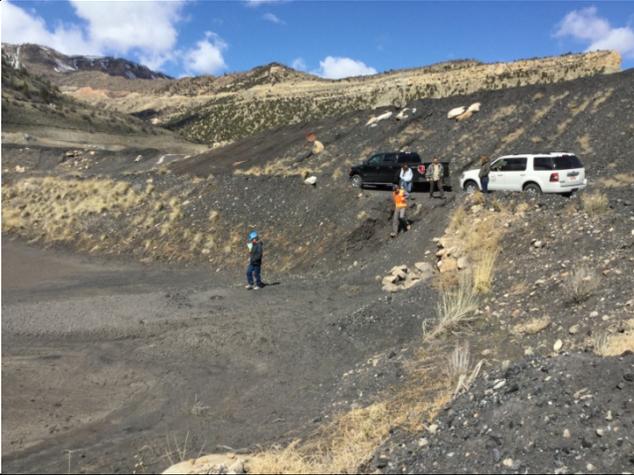
PHOTO 5

Sediment Pond 5 needs maintenance. There is an un-designed inlet draining water from the road into the pond on its northeastern embankment (Photos 5 through 8). This gully inlet is contributing a significant amount of sediment to this pond and may cause short circuiting if the pond discharges. The road must be graded appropriately to divert runoff to the SC basin and the gully must be repaired.

Pond 5: Un-designed inlet draining to pond
April 05, 2016

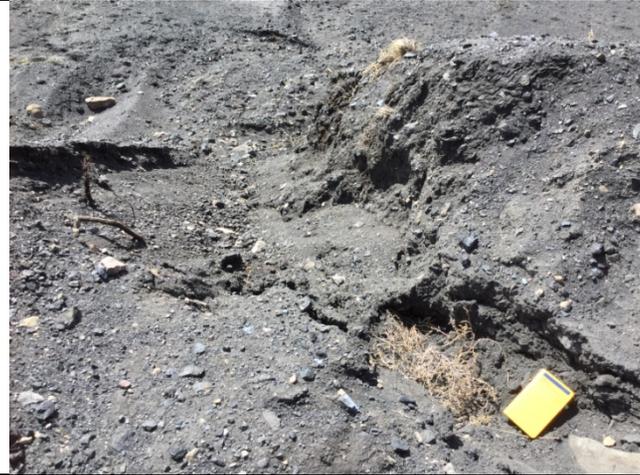
PHOTO 6

Pond 5: Un-designed inlet draining to pond
April 05, 2016

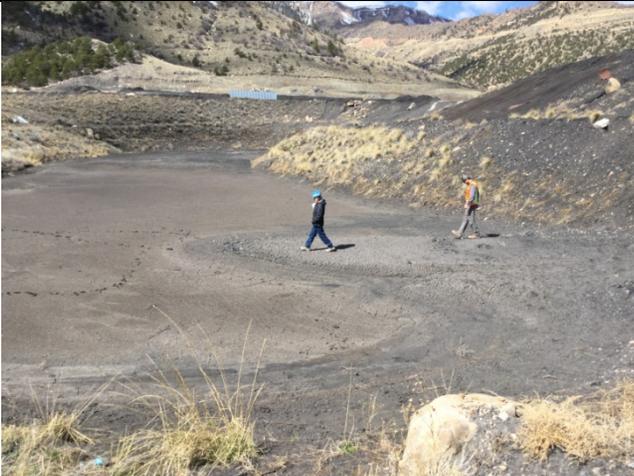
PHOTO 7

Pond 5: Walking on sediment deposited from undersigned inlet.
April 05, 2016

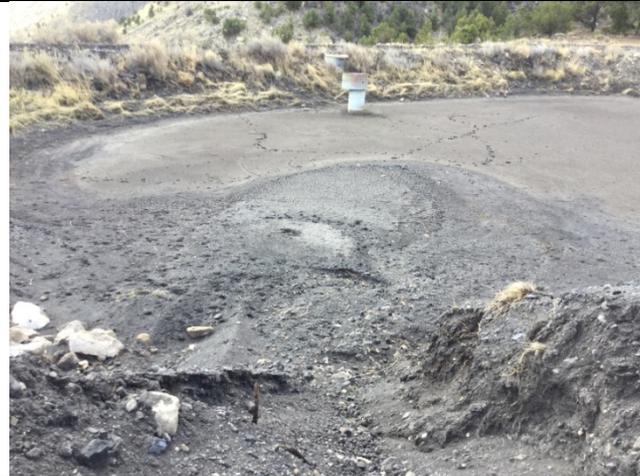
PHOTO 8

Pond 5: Sediment deposition close to outlet.
April 05, 2016

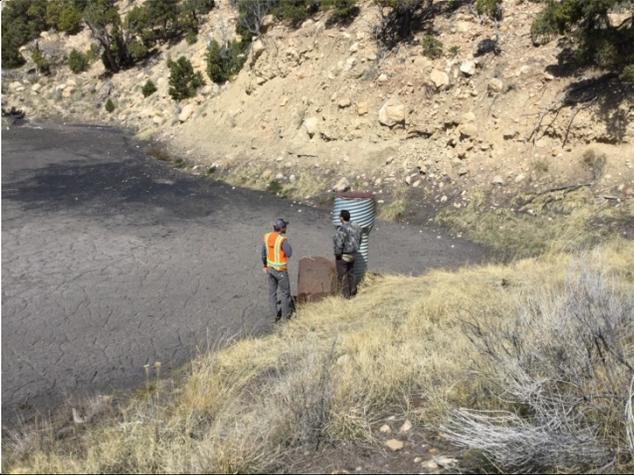
Sediment Pond 5 and 6 are slated for sediment removal. Pond 6 appears to be very full of sediment. The decant pipe is almost covered with sediment (Photo 9).

PHOTO 9
Standing at decant inlet Pond 6.
April 05, 2016

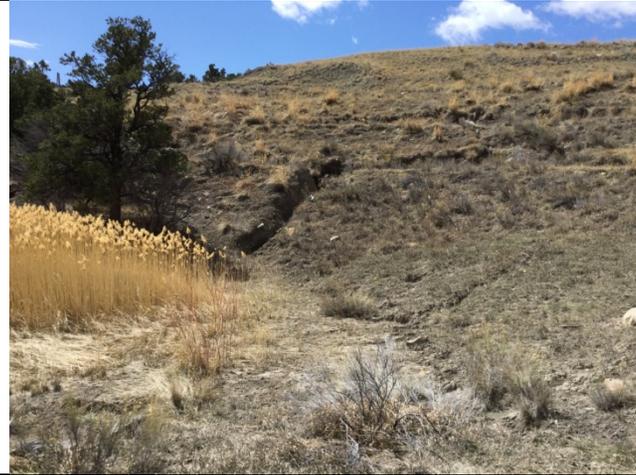
The Subsoil Pile north of the main road needs maintenance. There are a few major gullies on the pile that need to be stabilized (Photo 10). Runoff from the northernmost gully flowing into the diversion ditch needs to be re-routed to flow into the SC basin (Photo 11). It was discussed with the Permittee that the re-routing should cause as little disturbance as possible to the vegetation currently growing at the base of the gully. The fear is that if the vegetation is disturbed too much a larger gully may be formed that will cause even more trouble.

PHOTO 10
Gullies on Subsoil Pile need maintenance.
April 05, 2016

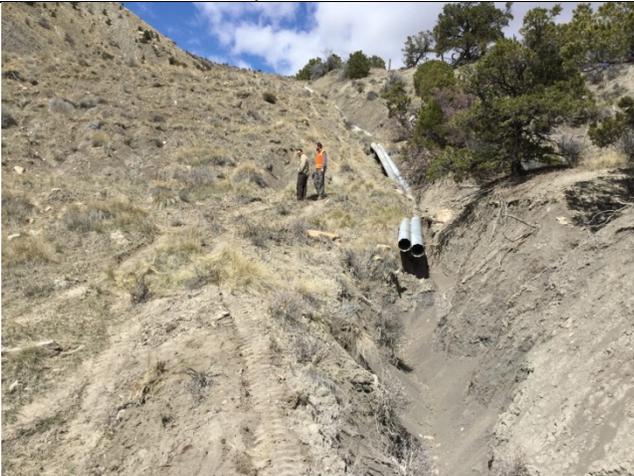
PHOTO 11
Standing at gully that needs to be re-routed into the SC basin.
April 05, 2016

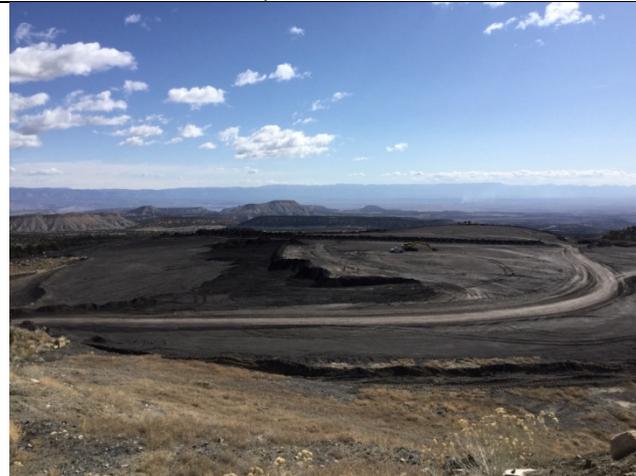
The Permittee said it takes roughly a year to mine one eight to nine foot lift. During winter operations bulldozers push up refuse into large piles for easier loading and to help control moisture. There were still large winter piles present on Refuse Pile A (Photo 12).

The Permittee continues operations removing the refuse piles as seen in Photo 12. The annual report was submitted by the end of March detailing the current operation elevations on the waste piles in 2013 in relation to contours flown in 2010. Mr. Netz estimated the current lift is at 7,420 ft. elevation (which is 50 ft. below the 2013 surface contour in the middle of Area A and about 30 feet above native ground.

PHOTO 12
Winter dozer piles.
April 05, 2016

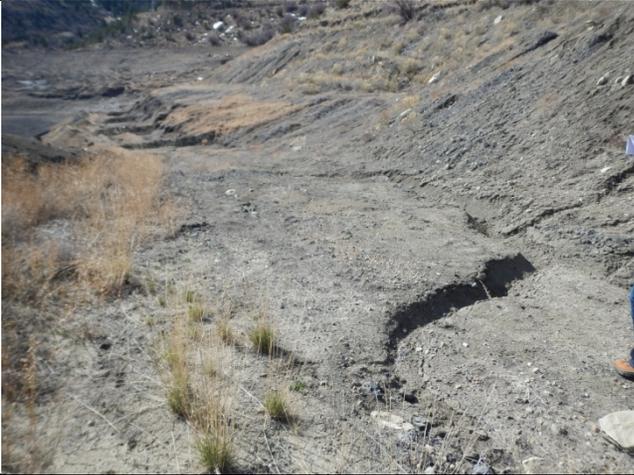
A large gully is forming on the old ancillary road on the southwest corner of Refuse Pile A (Photo 13). This was going to be an access road for a well pad operation, but there are no longer plans to install the well pad. Berms have been constructed perpendicular to the grade of the road to slow drainage, however in many cases the berms have filled with sediment and have failed at the lowest 'spillway' point along the berm (Photo 14). Gullying along this road must be addressed.

PHOTO 13
Gulying on ancillary road.
April 05, 2016

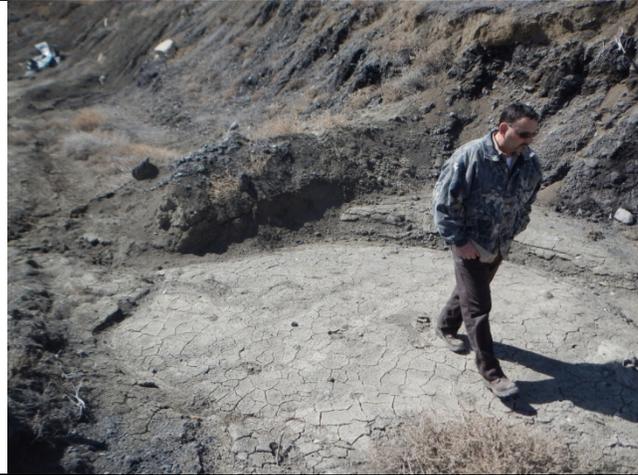
PHOTO 14
Berm failure and gulying on ancillary road.
April 05, 2016
