## Inspection Report

Permit Number:	C0070042
Inspection Type:	PARTIAL
Inspection Date:	Tuesday, May 03, 2016
Start Date/Time:	5/3/2016 10:00:00 AM
End Date/Time:	5/3/2016 12:30:00 PM
Last Inspection:	Tuesday, April 05, 2016

Permitee: **SUNNYSIDE COGENERATION ASSOCIATES**  
 Operator: **SUNNYSIDE COGENERATION ASSOCIATES**  
 Site: **STAR POINT REFUSE**  
 Address: **PO BOX 159, SUNNYSIDE UT 84539**  
 County: **CARBON**  
 Permit Type: **PERMANENT COAL PROGRAM**  
 Permit Status: **ACTIVE**

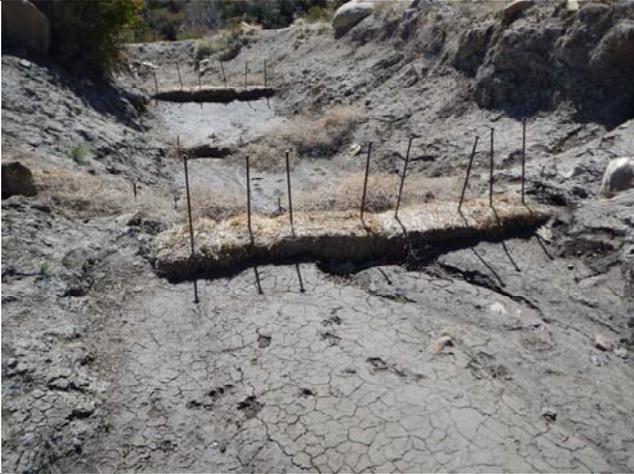
**PHOTO 1**

The two lower straw bale check dams appeared to be in working order. They had adequate storage volume to trap sediment and showed no areas where they were failing. The next highest or third straw bale check dam has failed by water piping underneath it (Photo 1). Mr. Netz discussed addressing this by digging the straw bales up and re-installing them by keying in a silt fence to reinforce the structure.

Runoff is piping underneath the upper straw bale .  
May 3, 2016

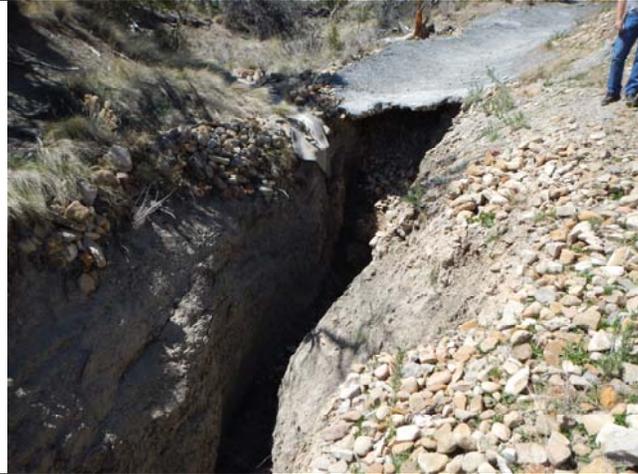
**PHOTO 2**

Gully at end of Ditch 14 needing repair.  
May 3, 2016

The operator plans to begin work this week to repair the gully at the outlet of Ditch 14 (Photos 2 & 3). The plan includes filling the deep gully and hardening this section of channel with riprap and/or roughened shotcrete.

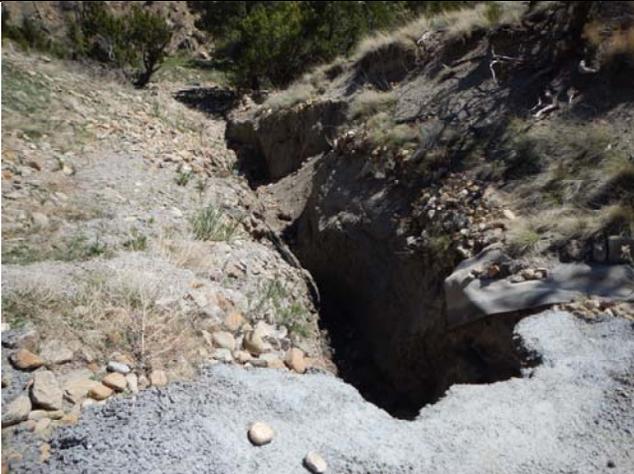
**PHOTO 3**

Looking down channel at the gully that has formed at the end of Ditch  
14.  
May 3, 2016

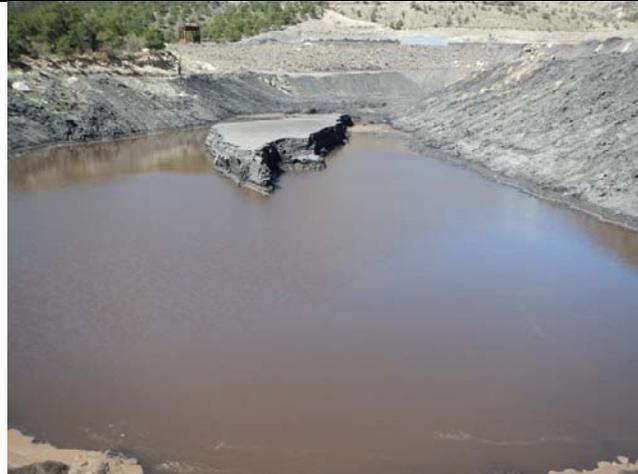
**PHOTO 4**

Sediment Pond 5 (Photo 4) and Pond 6 (Photo 5) have been cleaned out. The site received precipitation before the last bit of sediment could be cleaned out from Pond 5.

Pond 5 has been cleaned out. sediment in the center  
May 3, 2016

Mr. Netz will riprap the eroded inlet at the northeast corner of Sediment Pond 5 and submit as-built drawings to show the new location of this inlet.

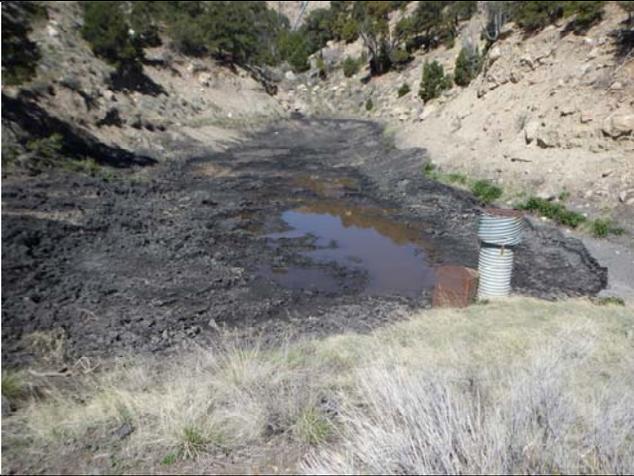
**PHOTO 5**  
Pond 6 has been cleaned out.  
May 3, 2016

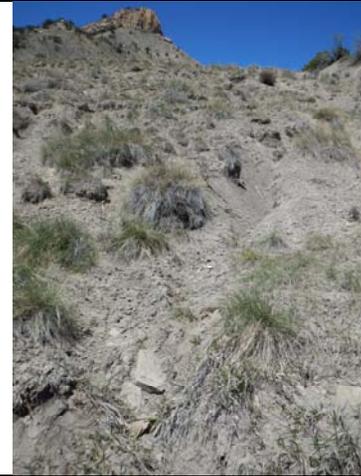
**PHOTO 6**  
Gully on Subsoil Stockpile.  
May 3, 2016

A few ideas were discussed of how the rills and gullies will be stabilized on the Subsoil pile (Photos 6 & 7). A berm may be installed on the lower northern edge of the pile to re-direct flow towards the sediment recapture basin at the base of the Subsoil pile. Erosion control stakes will be installed across the pile to help stabilize the largest gullies.

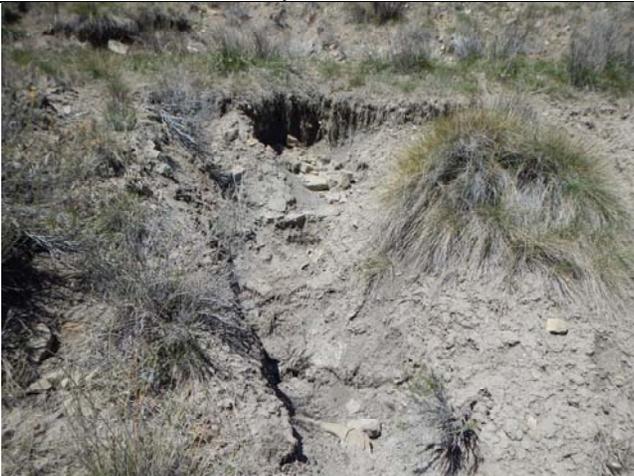
**PHOTO 7**  
Gully on Subsoil Stock pile.  
May 3, 2016

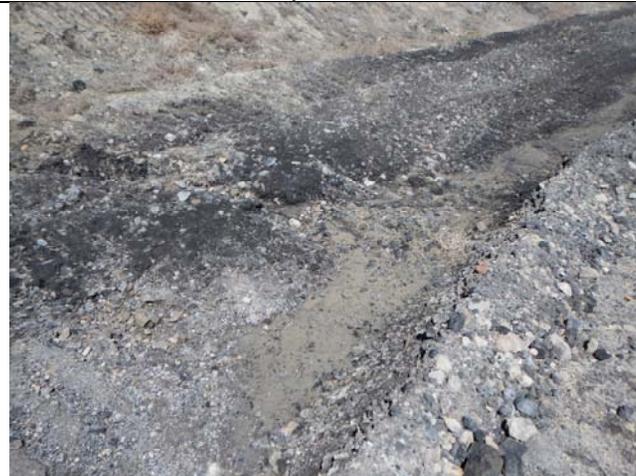
Very little sediment has eroded from the old ancillary road gully because very little sediment has re-deposited in the gully's outlet (Photo 8). It is assumed the gully feature has eroded to a stable depth. At this time it is recommended the feature be monitored, but no action is necessary.

**PHOTO 8**  
Outlet of gully on ancillary road. Very little sediment deposited.  
May 3, 2016
