RE: Sunnyside Cogeneration Associates, Annual Reports
Sunnyside Refuse/Slurry, C007/035
Star Point Waste Fuel, C/007/042

**SUNNYSIDE COGENERATION ASSOCIATES
STAR POINT REFUSE (WASTE FUEL)
C/007/0042
2018 ANNUAL REPORT**

SUNNYSIDE COGENERATION ASSOCIATES
STAR POINT WASTE FUEL
2018 ANNUAL REPORT

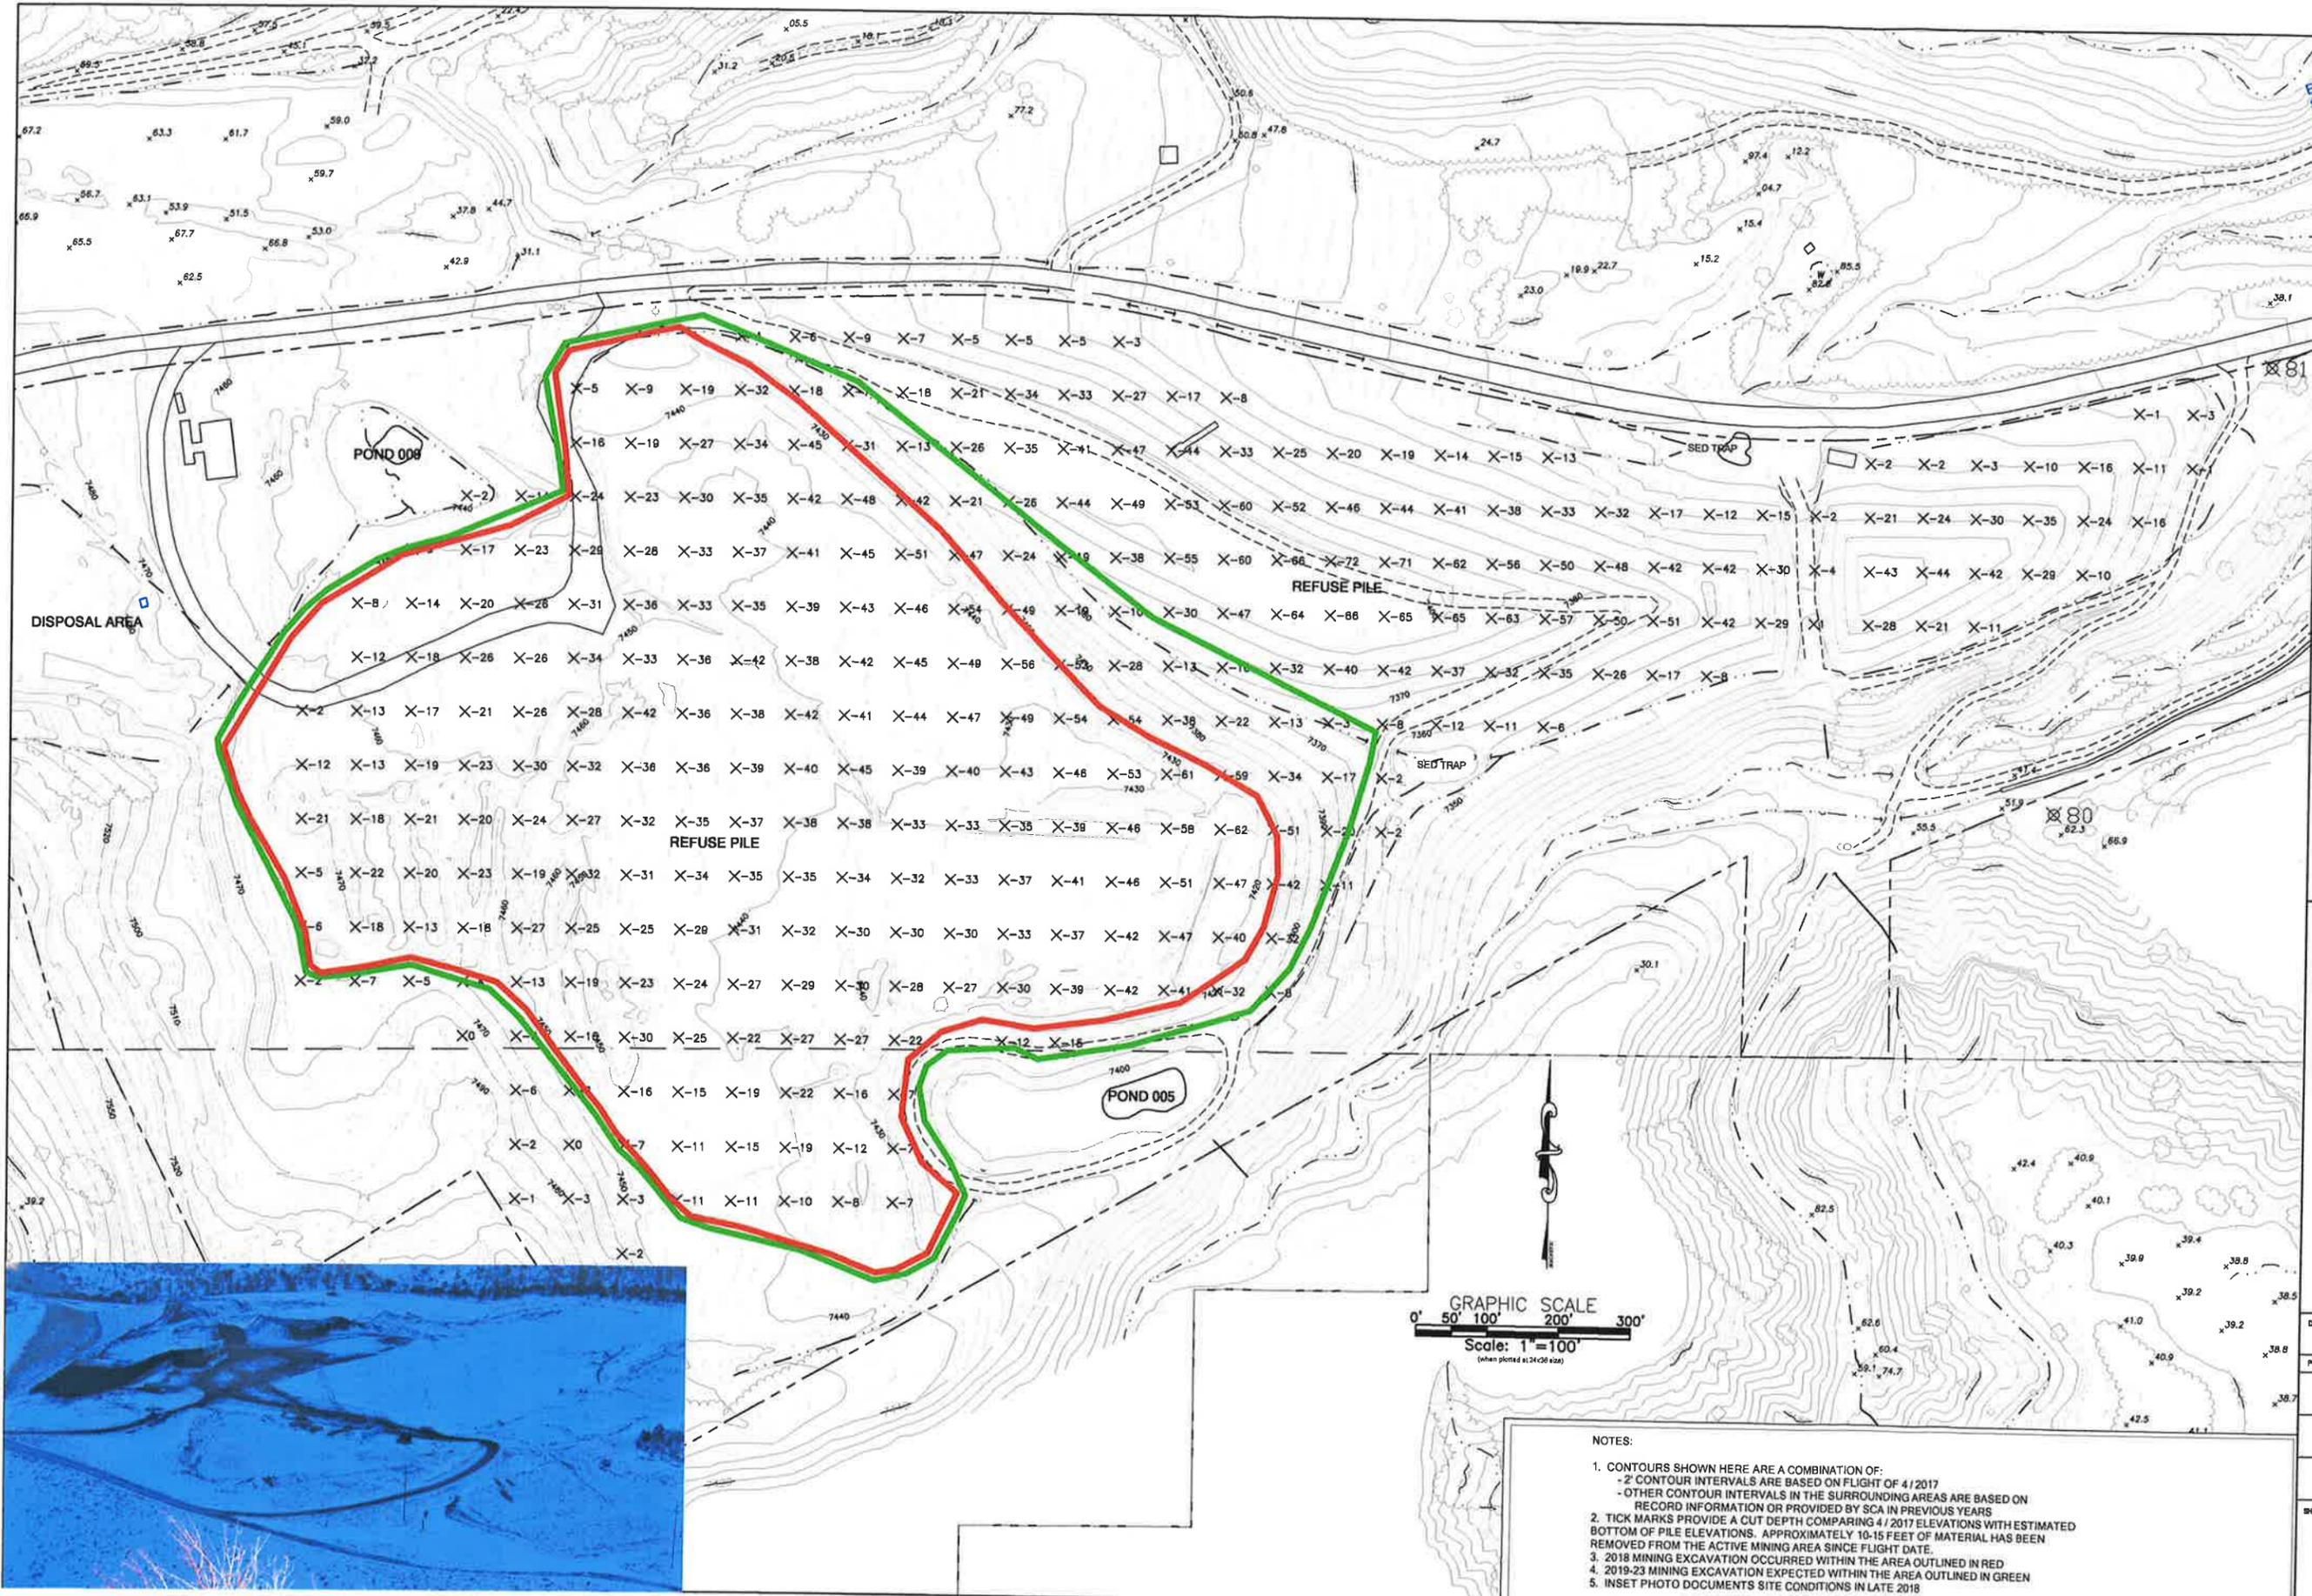
**SCA-STARPOINT WASTE FUEL
REFUSE PILE MINE MAP**
Carbon County, Utah

The mine map included in **Appendix C** of this report identifies the areas mined during 2018. This refuse is utilized as fuel for the Sunnyside Cogeneration Facility. The aerial survey used to generate contours of the site was performed in April 2017. A photo inset on the drawing documents the conditions in late 2018.
