**SUNNYSIDE COGENERATION ASSOCIATES  
STAR POINT REFUSE (WASTE FUEL)  
C/007/0042  
2019 ANNUAL REPORT**

**SUNNYSIDE COGENERATION ASSOCIATES**  
**STAR POINT WASTE FUEL**  
**2019 ANNUAL REPORT**

**Permit Number:** C/007/042

**Mine Name:** Star Point Waste Fuel

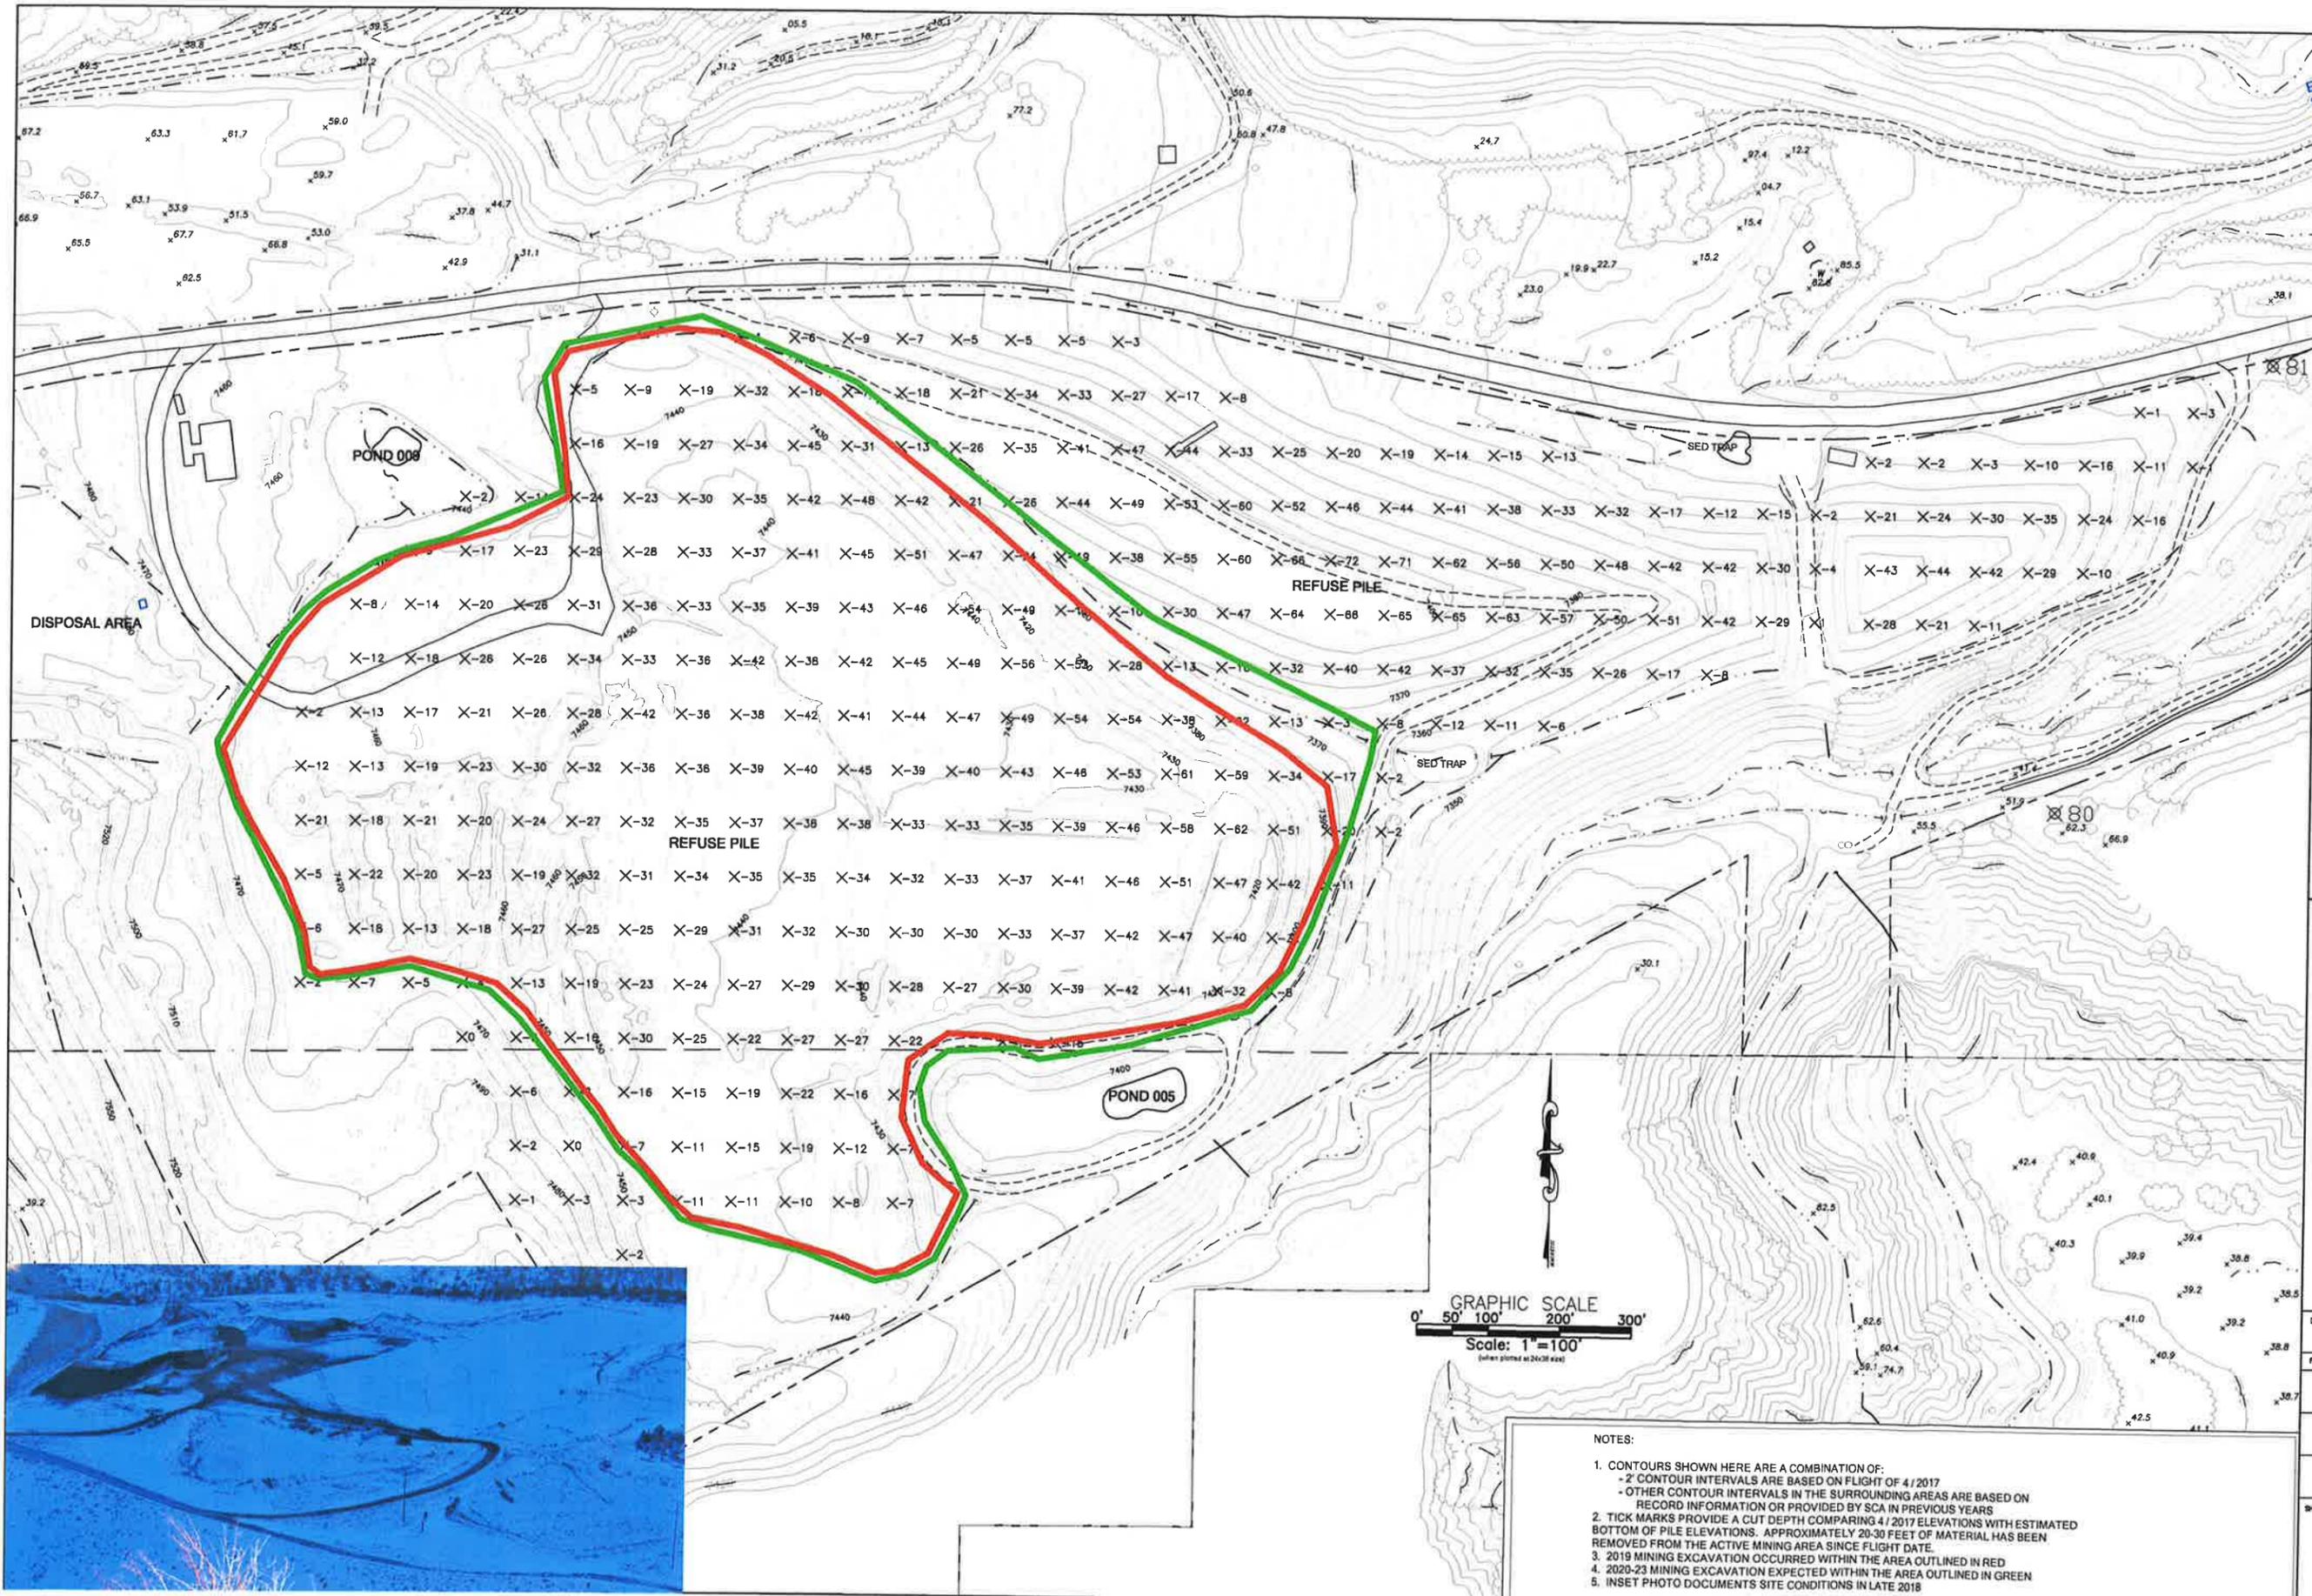
**SCA-STARPOINT WASTE FUEL  
REFUSE PILE MINE MAP**  
Carbon County, Utah

The mine map included in **Appendix C** of this report identifies the areas mined during 2019. This refuse is utilized as fuel for the Sunnyside Cogeneration Facility. The aerial survey used to generate contours of the site was performed in April 2017. A photo inset on the drawing documents the conditions in late 2018.
