NO. N 98-45-4-1

notice of violation

## INSPECTION REPORT

Mine Name: J.B. King County: Emery Permit Number: ACT/015/002

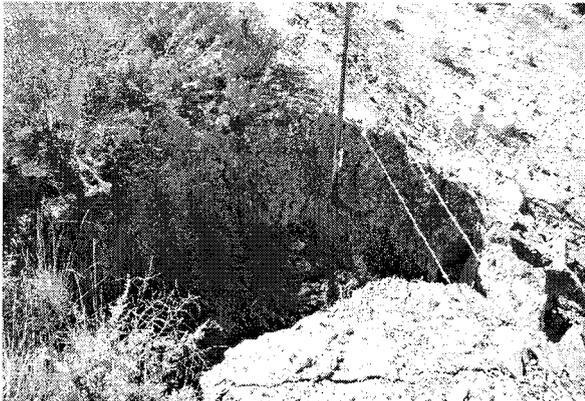
- \* Failure to maintain north diversion ditch according to plan.
- \* Failure to control or prevent additional contribution of suspended solids to runoff outside the permit area.

The north diversion ditch has breached in three locations. Two of the breaches are minor and the third breach is major with gully formation down and into the natural east-west trending drainage located just north of the breached diversion (Figures 1 and 2).

**Figure 1.** North diversion ditch failure. Looking towards the northwest from inside the disturbance area.

- \* Either repair the main breach and the two additional blow outs, on located below and the other located above the main blow out. OR,
- \* Repair and maintain the ditch to prevent additional blow outs, and ~~amend~~ amend the plan to remove ditch from the reclaimed area with alternate sediment control.

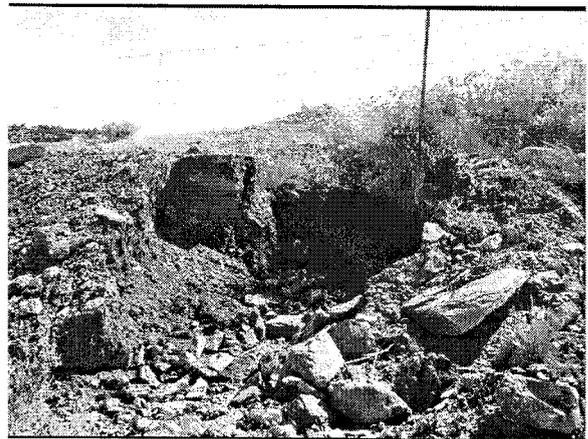
**Figure 2.** North diversion ditch failure. Standing in the natural drainage below and outside the disturbance area. Looking south.

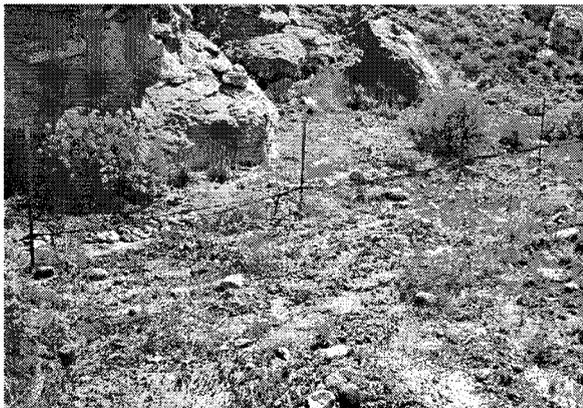
The Primary silt fence located between the undisturbed eastern diversion ditch and the top of the refuse pile has completely deteriorated and disintegrated on the northern edge of the site for approximately 50 feet (Figure 3).

**Figure 3.** Upper primary silt fence separating the top of the reclaimed refuse pile from the undisturbed drainage area to the east. Northeast portion of the refuse pile looking southeast.

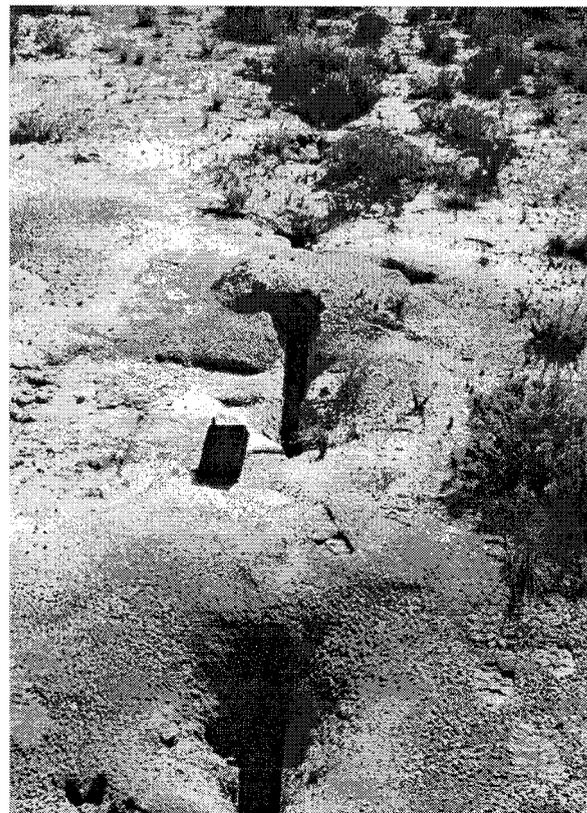
The subsidence cracks have worsened considerably since the last inspection, especially the north-south trending cracks along the eastern edge of the subsidence area. Sand and soil continues to erode down into the cracks furthering the exposure. Some cracks are now several tens of feet long (Figure 4). Personal injury to an unwary person or animal is certainly a possibility. The cracks need to be repaired and filled in accordingly. The possibility of injecting foam down into the crack was discussed with Buzz Gerick on August 8, 1998.

**Figure 4.** Subsidence cracks, mid-eastern edge of the upper subsidence area. Cracks have elongated substantially since last inspection.
