INSPECTION REPORT

Partial: X Complete: \_\_\_ Exploration: \_\_\_
Inspection Date & Time: 8/20/98, 11:00 am to 12:30 pm
Date of Last Inspection: 7/21/98

Mine Name: J.B. King County: Emery Permit Number: ACT/015/002
Permittee and/or Operator's Name: Western States Minerals Corp.
Business Address: Suite 130, 250 South Rock Blvd., Reno, Nevada 89502
Type of Mining Activity: Underground X Surface \_\_\_ Prep. Plant \_\_\_ Other \_\_\_
State Officials(s): Robert Davidson
Company Official(s):
Federal Official(s):
Weather Conditions: Sunny, clear, warm and breezy
Existing Acreage: Permitted-480 Disturbed-30 Regraded-\_\_\_ Seeded-30 Bonded-30
Increased/Decreased: Permitted-\_\_\_ Disturbed-\_\_\_ Regraded-\_\_\_ Seeded-\_\_\_ Bonded-\_\_\_
Status: \_\_\_Exploration/\_\_\_Active/\_\_\_Inactive/\_\_\_Temporary Cessation/\_\_\_Bond Forfeiture
Reclamation (\_\_\_Phase I/\_\_\_Phase II/\_\_\_Final Bond Release/\_\_\_Liability\_\_\_Year)

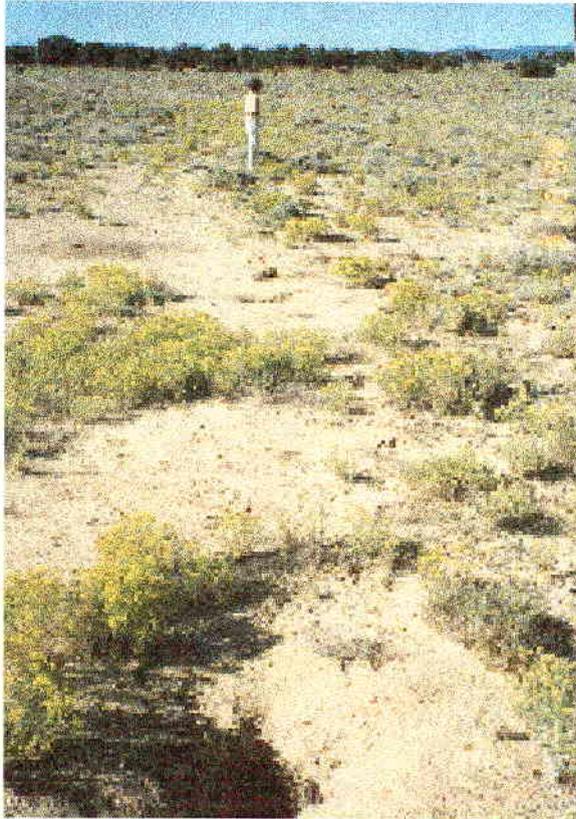
Walked through the subsidence area on top and observed several subsidence cracks. Most of the cracks are located along the northern and eastern edges of the subsidence area. With recent rains, some cracks have been exposed and are more prominent from past observations. The rains have washed sand down these cracks and have exposed the edges of sandstone slabs which have separated during subsidence. These sandstone cracks range in width from 3 to 4 inches, are up to a several feet long, and in some cases are many feet deep. Please refer to attached photos 1 through 6.

**Figure 1.** Looking South along eastern edge of subsidence area. Sharon Falvey is standing at southern most extent of cracks.

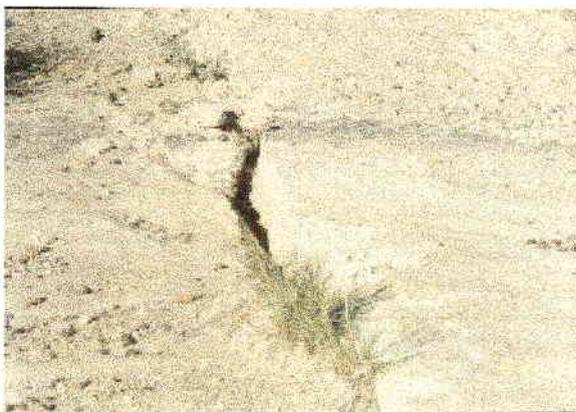
**Figure 2.** Surface crack where sandstone slabs have separated. Located immediately north of Fig 1 along the eastern edge of the subsidence area

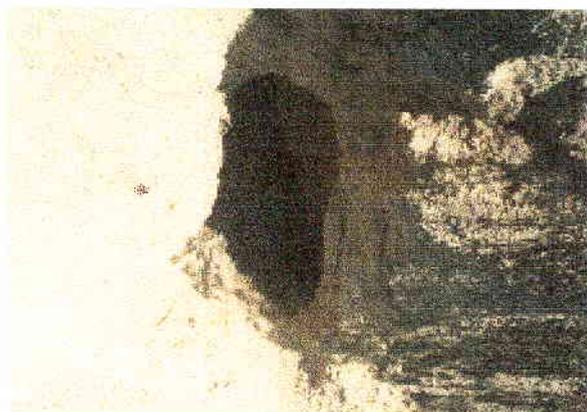
**Figure 3.** Subsidence crack (Fig. 1 crack as shown in foreground).

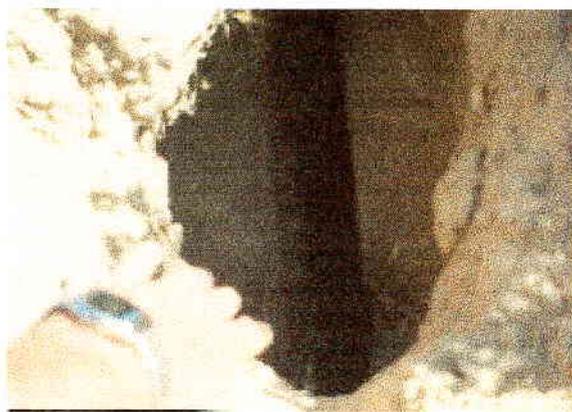
**Figure 4.** Same crack as Fig 3, but with size shown relative to hand and watch.

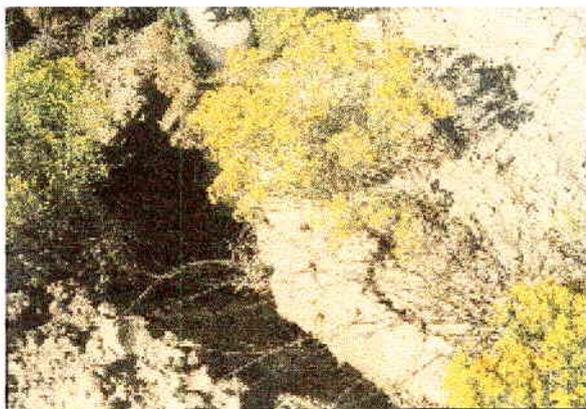
**Figure 5.** Crack opening at surface. located along the northern edge of the subsidence area.

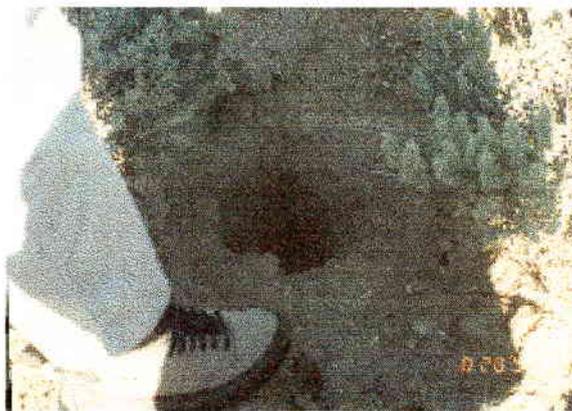
**Figure 6.** Crack opening at surface. located along the northern edge of the subsidence area.
