DIVISION OF OIL GAS & MINING FIELD VISIT FORM TECHNICAL

Date: December 1, 1999

Purpose: Phase II and Phase III Bond Release Inspection, Western States Minerals, Corp., J.B. King Mine, ACT/015/002, File #2, Carbon County, Utah

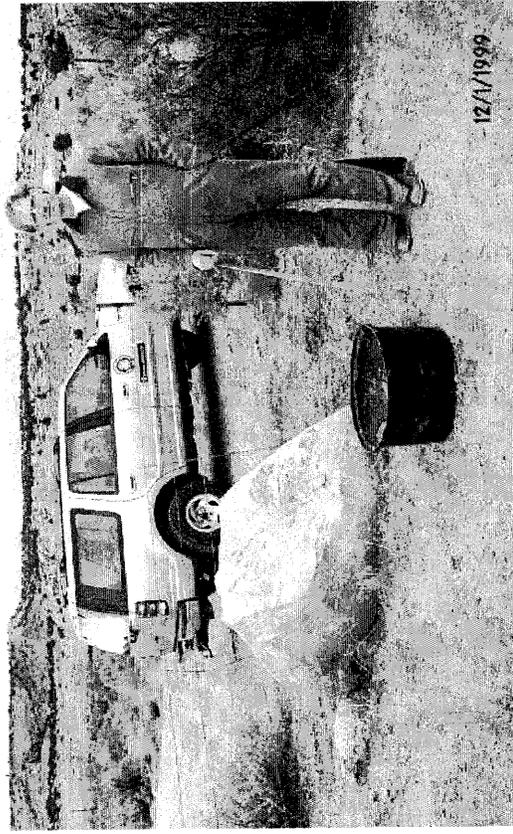
Cattle trespassed within the disturbed area. A salt lick was placed adjacent to the pond. Cattle trails were evident but vegetation appeared in a condition comparable to a November inspection.

Figure 7. Salt lick placed inside the permit area fence.

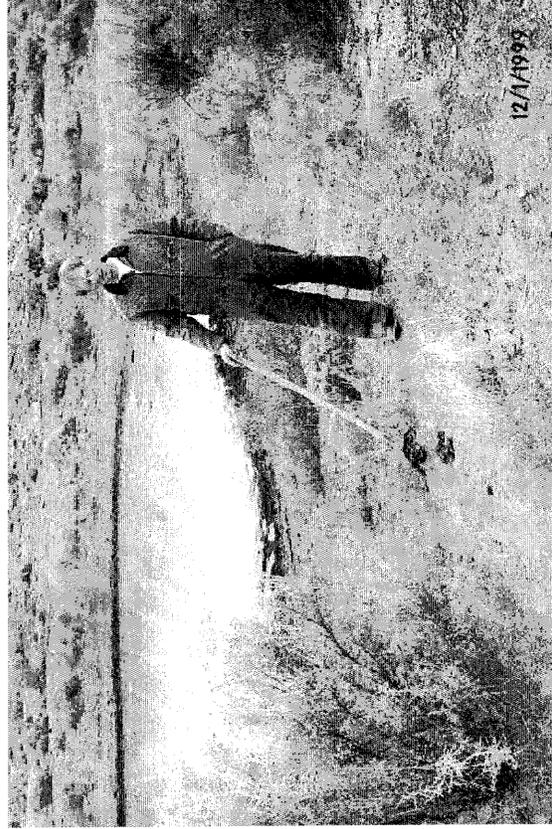
Figure 8. Fresh cow droppings. Cow trail around sed pond.

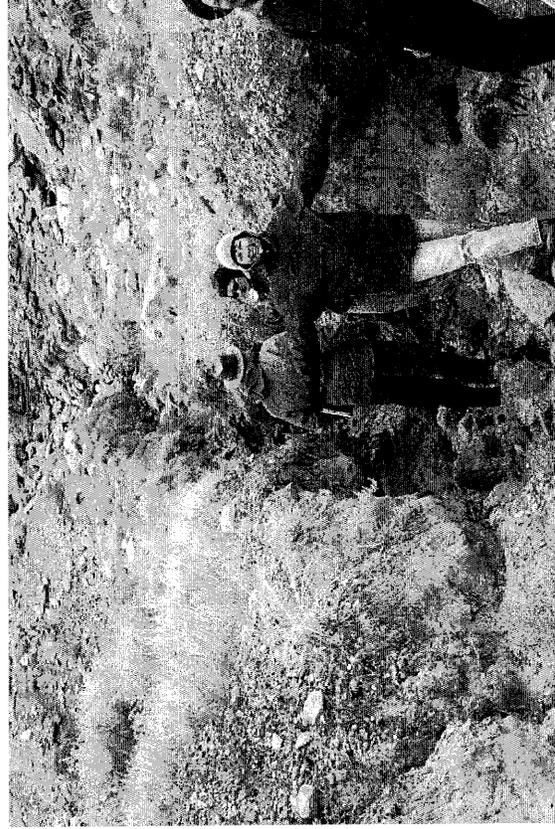
Figure 12. Right fork reclaimed channel.

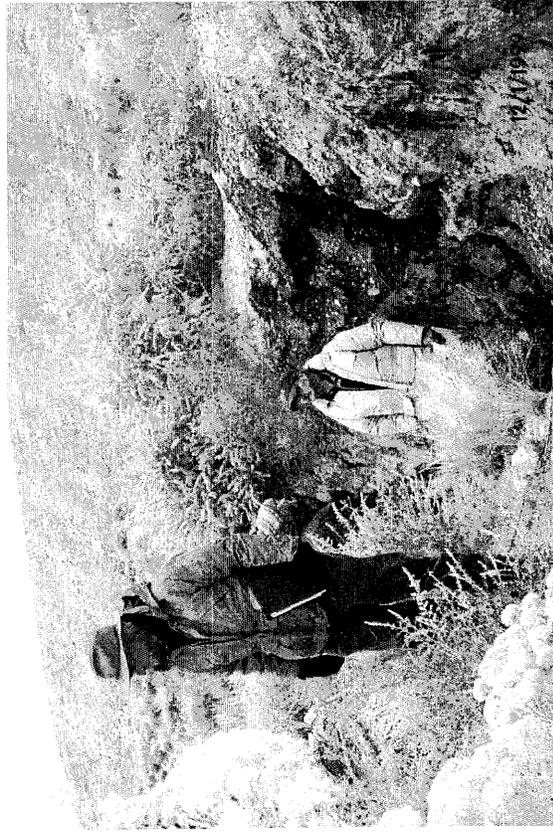
Small pockets of coal mine waste were exposed where drainage channels and rill and gullies formed. Old sites usually contain several pockets of coal mine waste. The Division believes that the coal mine waste poses little hazard to humans or wildlife. The main environmental concern is a coal fire.

Figure 11. Refuse in channel embankment - lower, right fork reclaimed drainage channel.

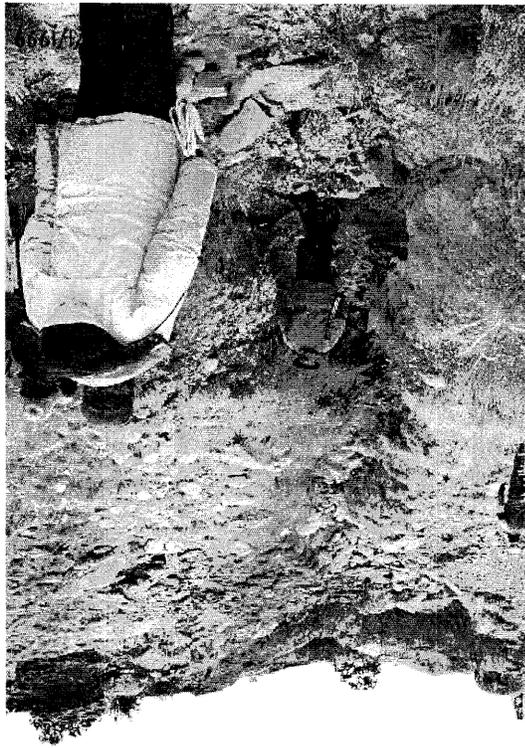
Figure 13. Right fork of reclaimed channel.

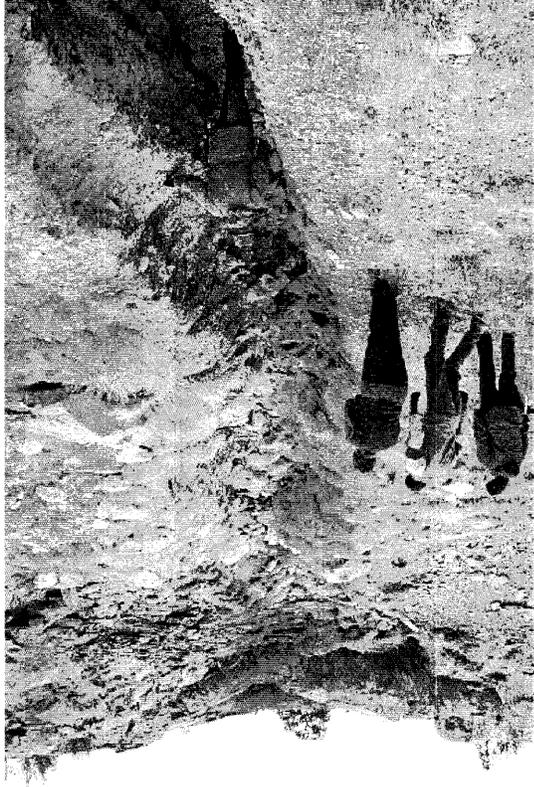
Figure 14. Right fork of reclaimed channel.

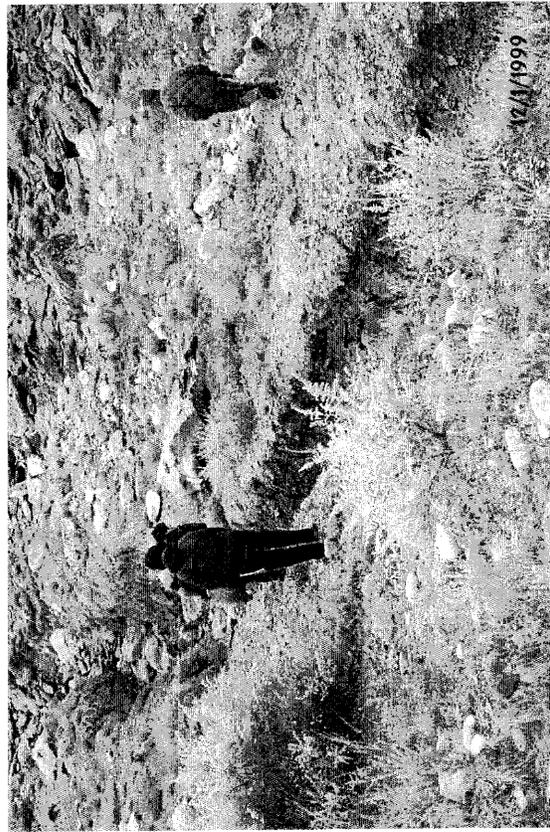
Figure 15. Right fork of reclaimed channel.

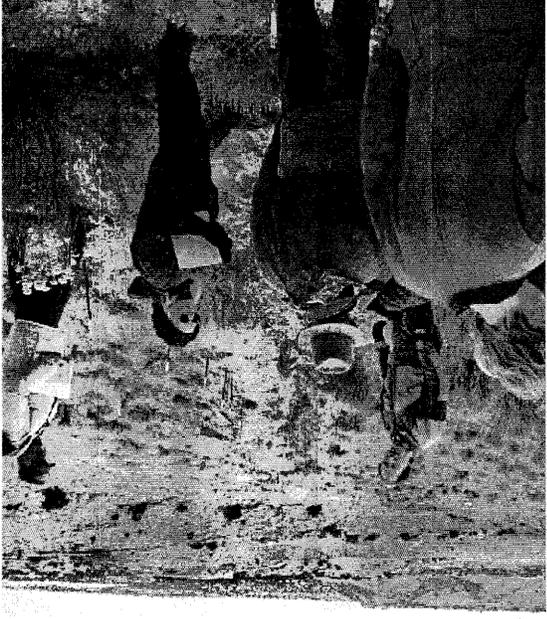
Figure 26. Upper end of North perimeter ditch.

The north perimeter disturbed area ditch and the silt fence need to be removed prior to bond release. Mr. Gerrick indicated the rain gage and climate station would be removed following the site inspection.

All non coal waste, the north perimeter ditch, and the silt fence need to be removed prior to Phase II bond release and the disturbed area perimeter fence, (requested to be removed by the land owner, State Trust Lands Administrator,(SITLA) needs to be removed prior to Phase III.

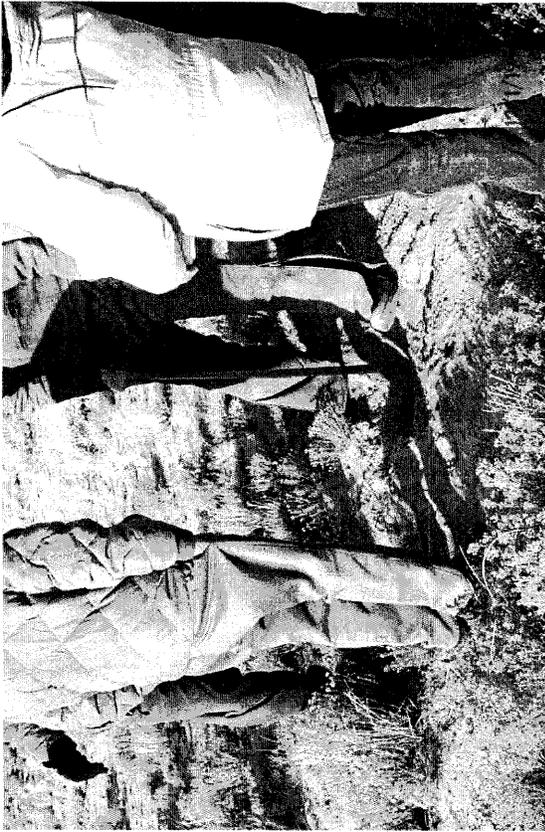
The Division saw some surface cracks above the areas where pillars had been pulled. The cracks are 4 to 6 inches wide 1 foot to 3 feet deep and up to 6 feet long. In the past, the Permittee has sealed old cracks with timber, soil and foam. The new cracks were most likely formed by small animals burrowing into the cracks followed by soil piping (soil flows into voids). The Division does not know of a practical way to prevent future cracks from forming. While the cracks may pose a safety hazard, the hazard is not significant and is similar to naturally occurring hazards in the area.

Figure 29. Subsidence surface void (note stick length ~ 3 feet).

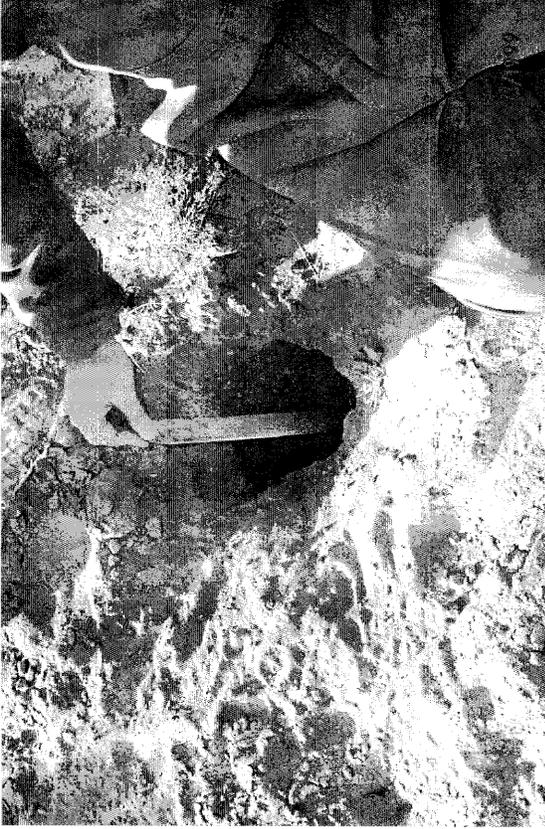
Figure 30. Subsidence surface void.

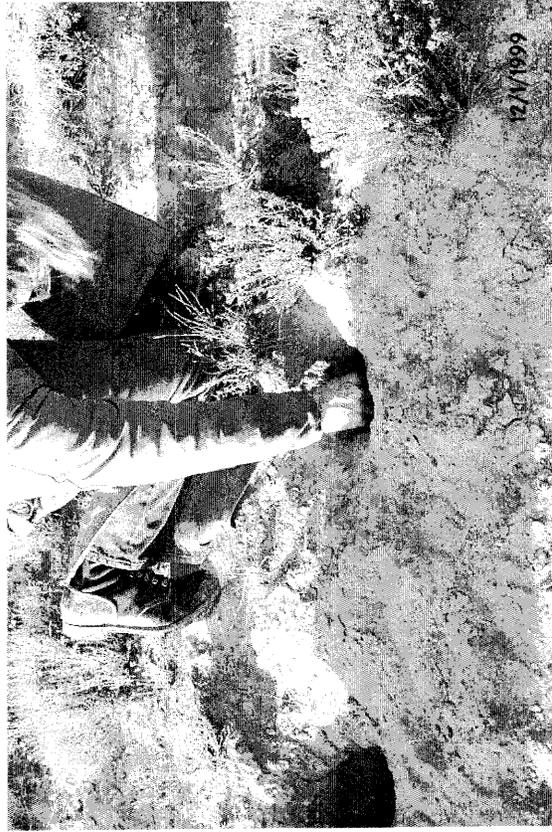
Figure 31. Subsidence surface voids - > 3 feet deep.

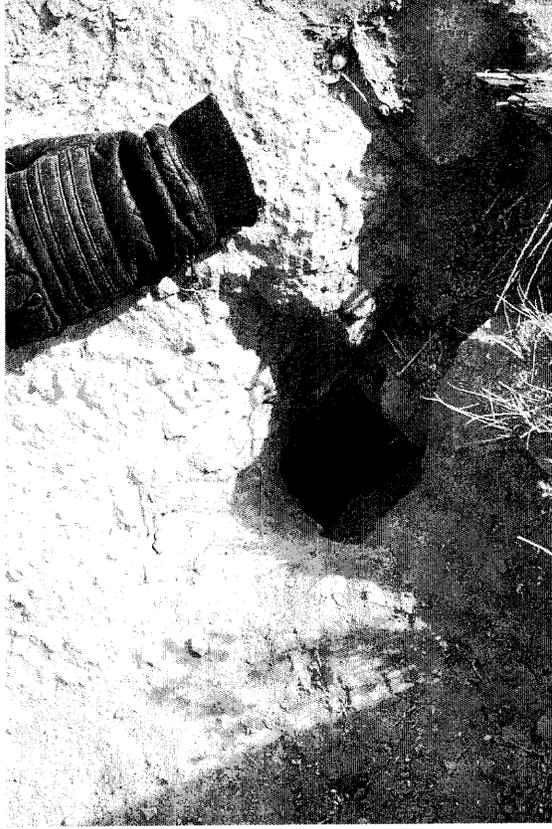
Figure 32. Subsidence surface void (old foam fill on right).
