# Inspection Report

Permit Number:	<b>C0150007</b>
Inspection Type:	PARTIAL
Inspection Date:	Monday, February 28, 2005
Start Date/Time:	2/28/2005 2:30:00 PM
End Date/Time:	2/28/2005 5:30:00 PM
Last Inspection:	Thursday, January 27, 2005

Permitee: **CONSOLIDATION COAL CO**  
 Operator: **CONSOLIDATION COAL CO MID-CONTINENT REGION**  
 Site: **HIDDEN VALLEY MINE**  
 Address: **PO BOX 566, SESSER IL 62884**  
 County: **EMERY**  
 Permit Type: **PERMANENT COAL PROGRAM**  
 Permit Status: **RECLAIMED**

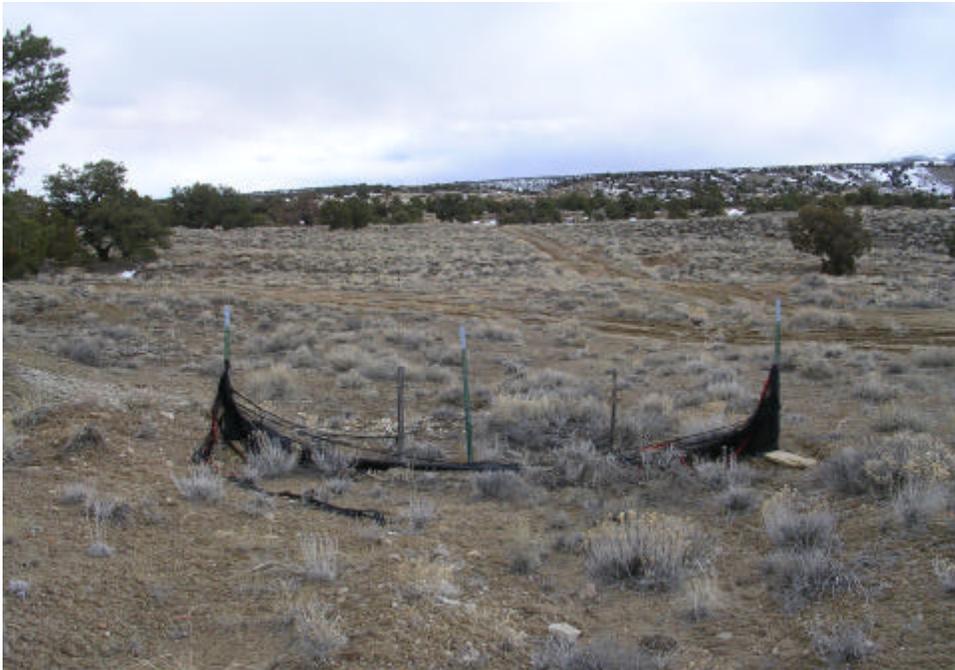
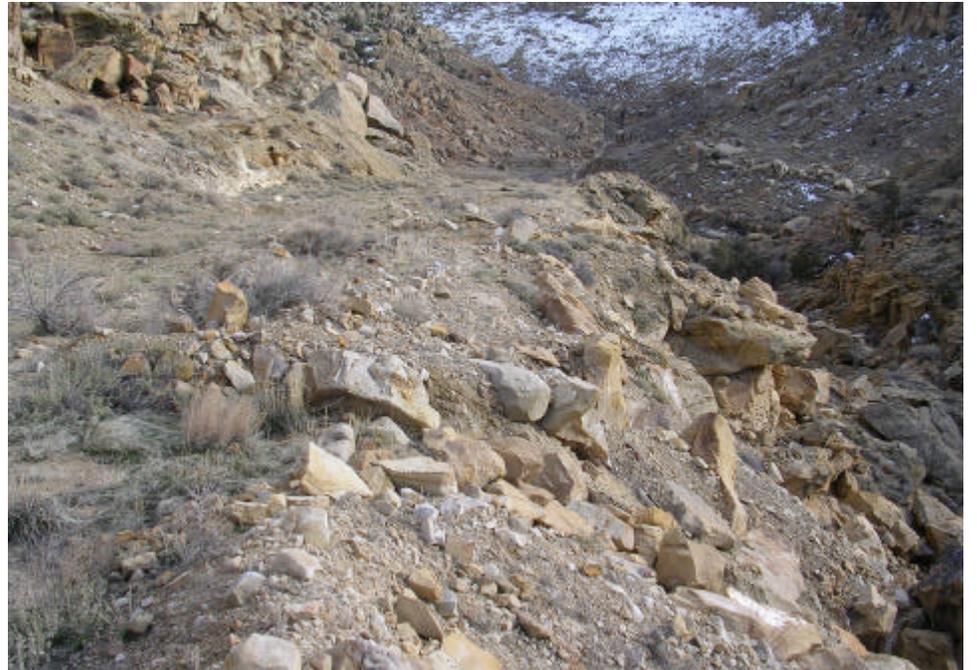
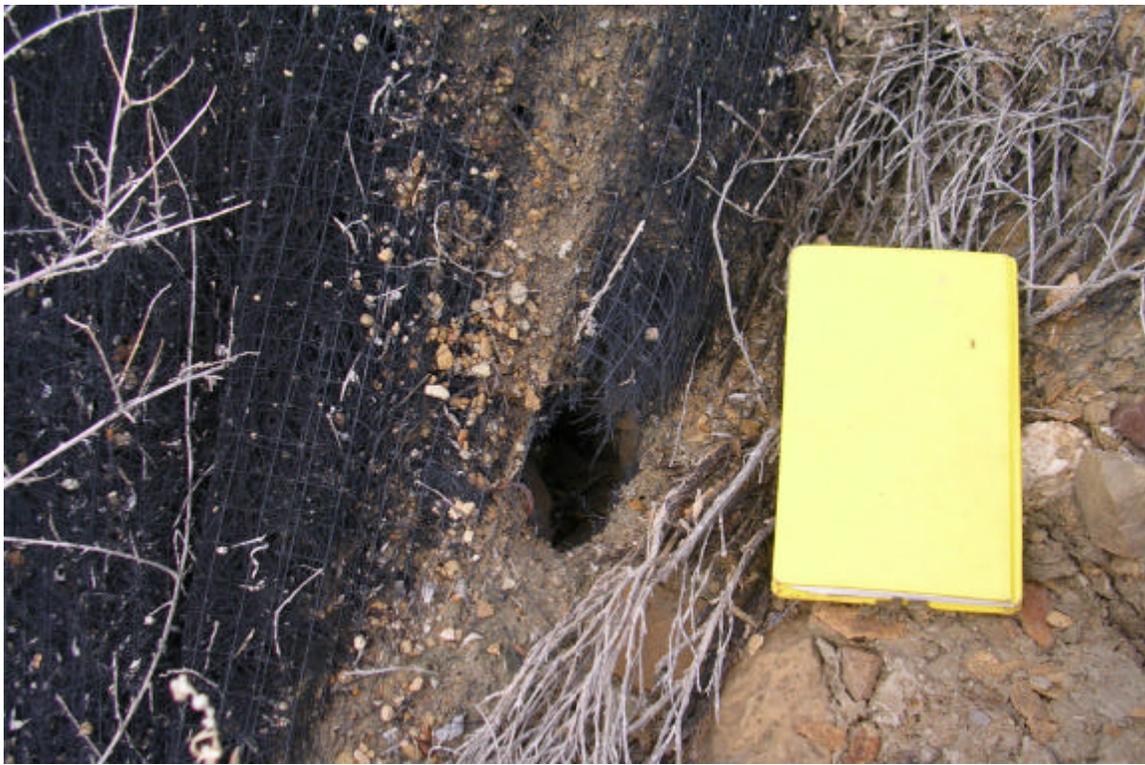
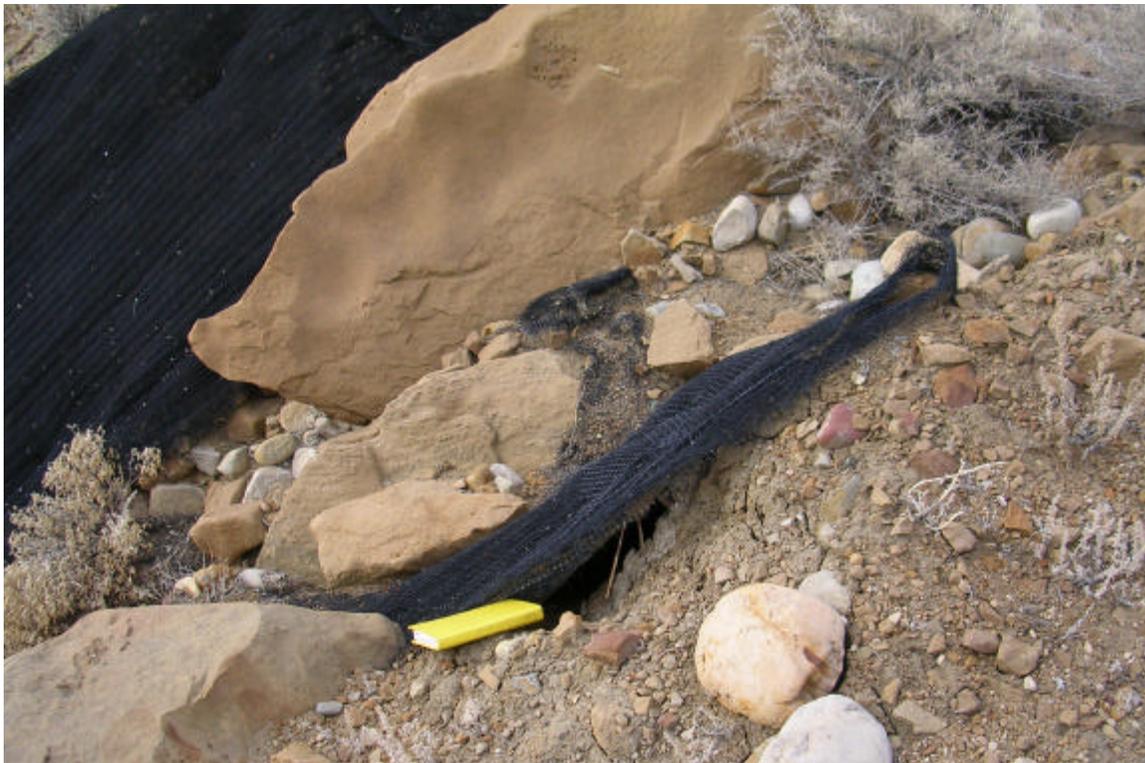
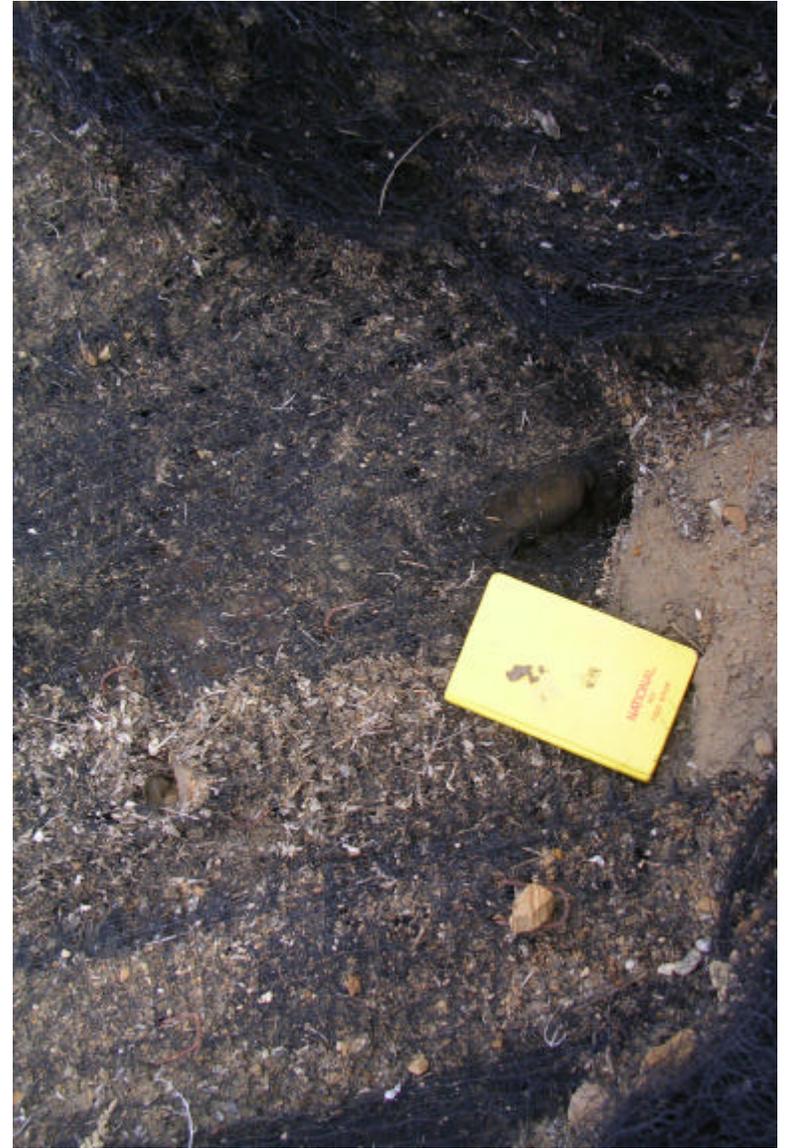
Plate III, Final Reclamation shows an area seeded at the end of the paved road. The vegetation in this area looked comparable to the surroundings. Silt fence installed at the lower end of the fairly level site has long since lost its effectiveness and is now beginning to channel water and create a cut (see photos 476 and 477). Along the access road upslope, drainage channels that are protected with boulders look much more natural and are providing sediment control. Those that are covered with Landlok fabric are not functioning as designed, piping holes and undercutting is evident (compare photos 478 and 479 as well as photos 432, 433, 444 taken on 1/27/05). At the base of the A seam, the silt fence has accumulated more than 1 ft of sediment that is now holding moisture and creating a drainage problem (see photos 481, 485, 486). In fact, the silt fence is channelling water along its downstream side and that has cut a new channel (photo 484). Along the restored ephemeral channel A seam side, the silt fence has deteriorated (photo 489).
