UTAH POWER & LIGHT COMPANY
SUBSIDENCE MONITORING PROGRAM
ANNUAL REPORT FOR 1986

April 1987

Submitted to: United States Department of the Interior
Office of Surface Mining
Minerals Management Service
Utah Division of Oil, Gas and Mining

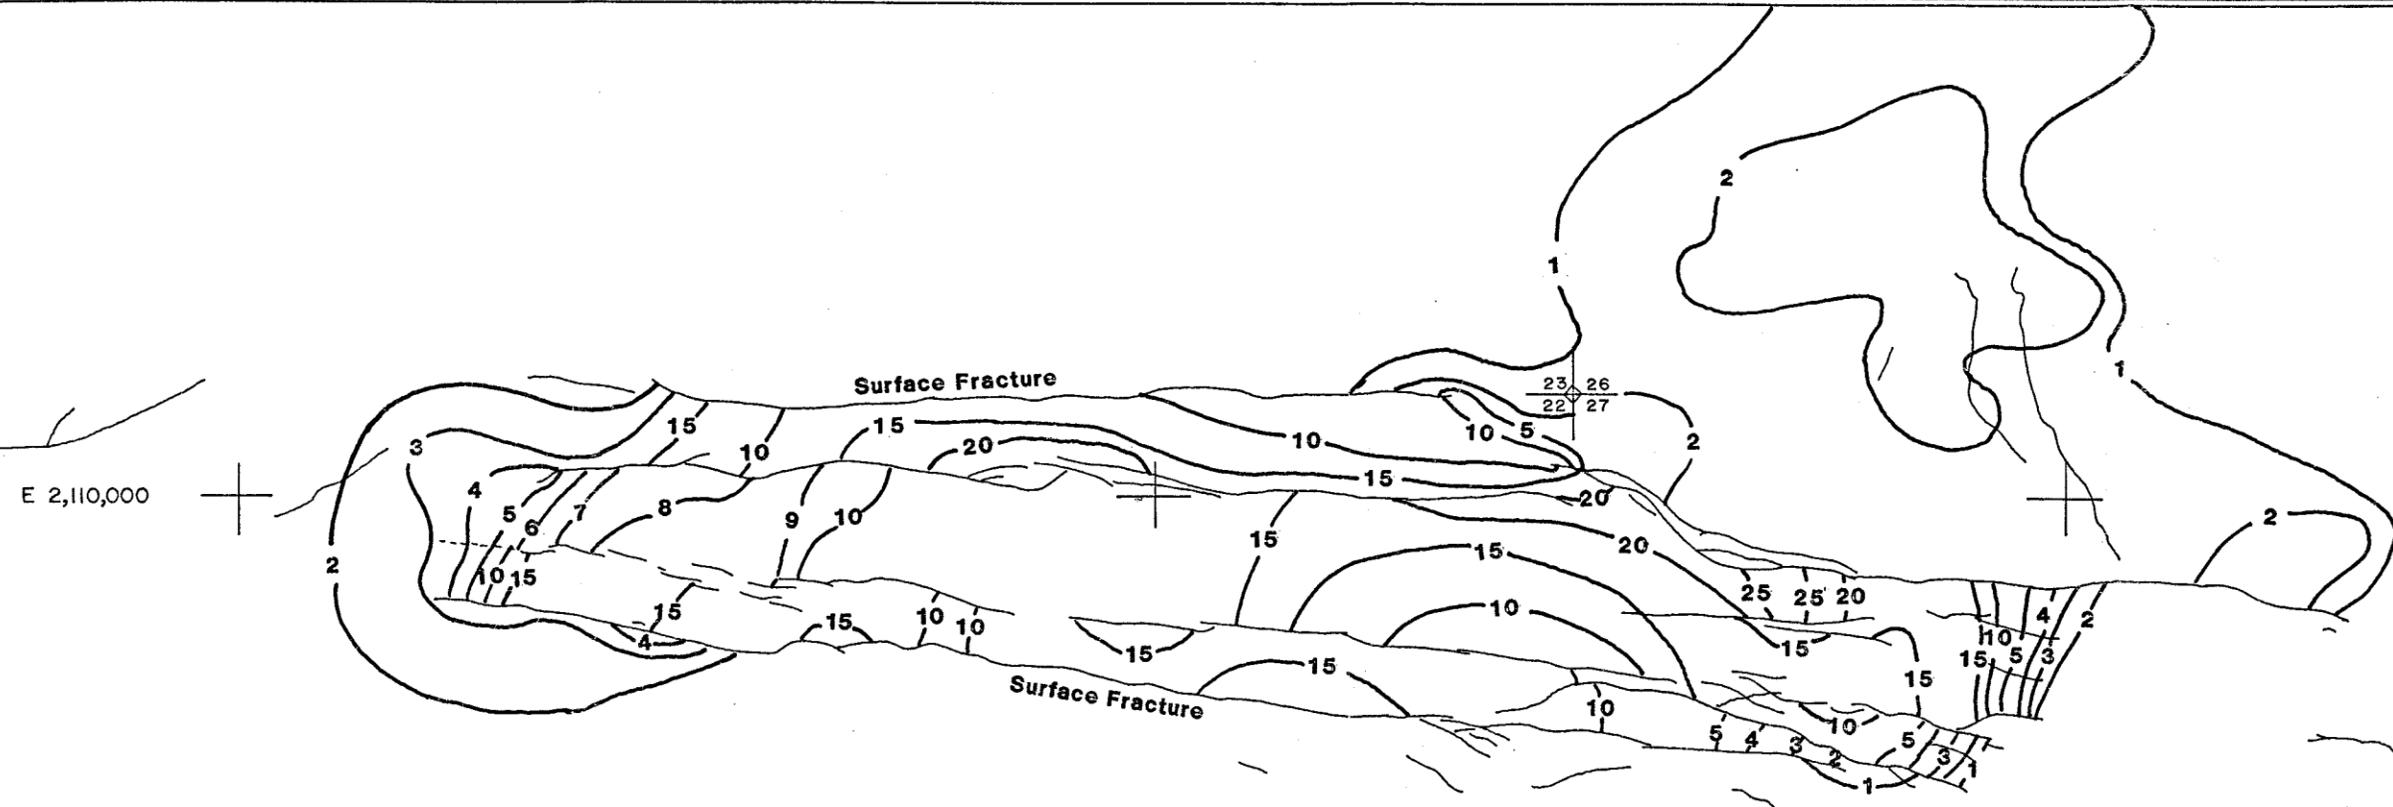
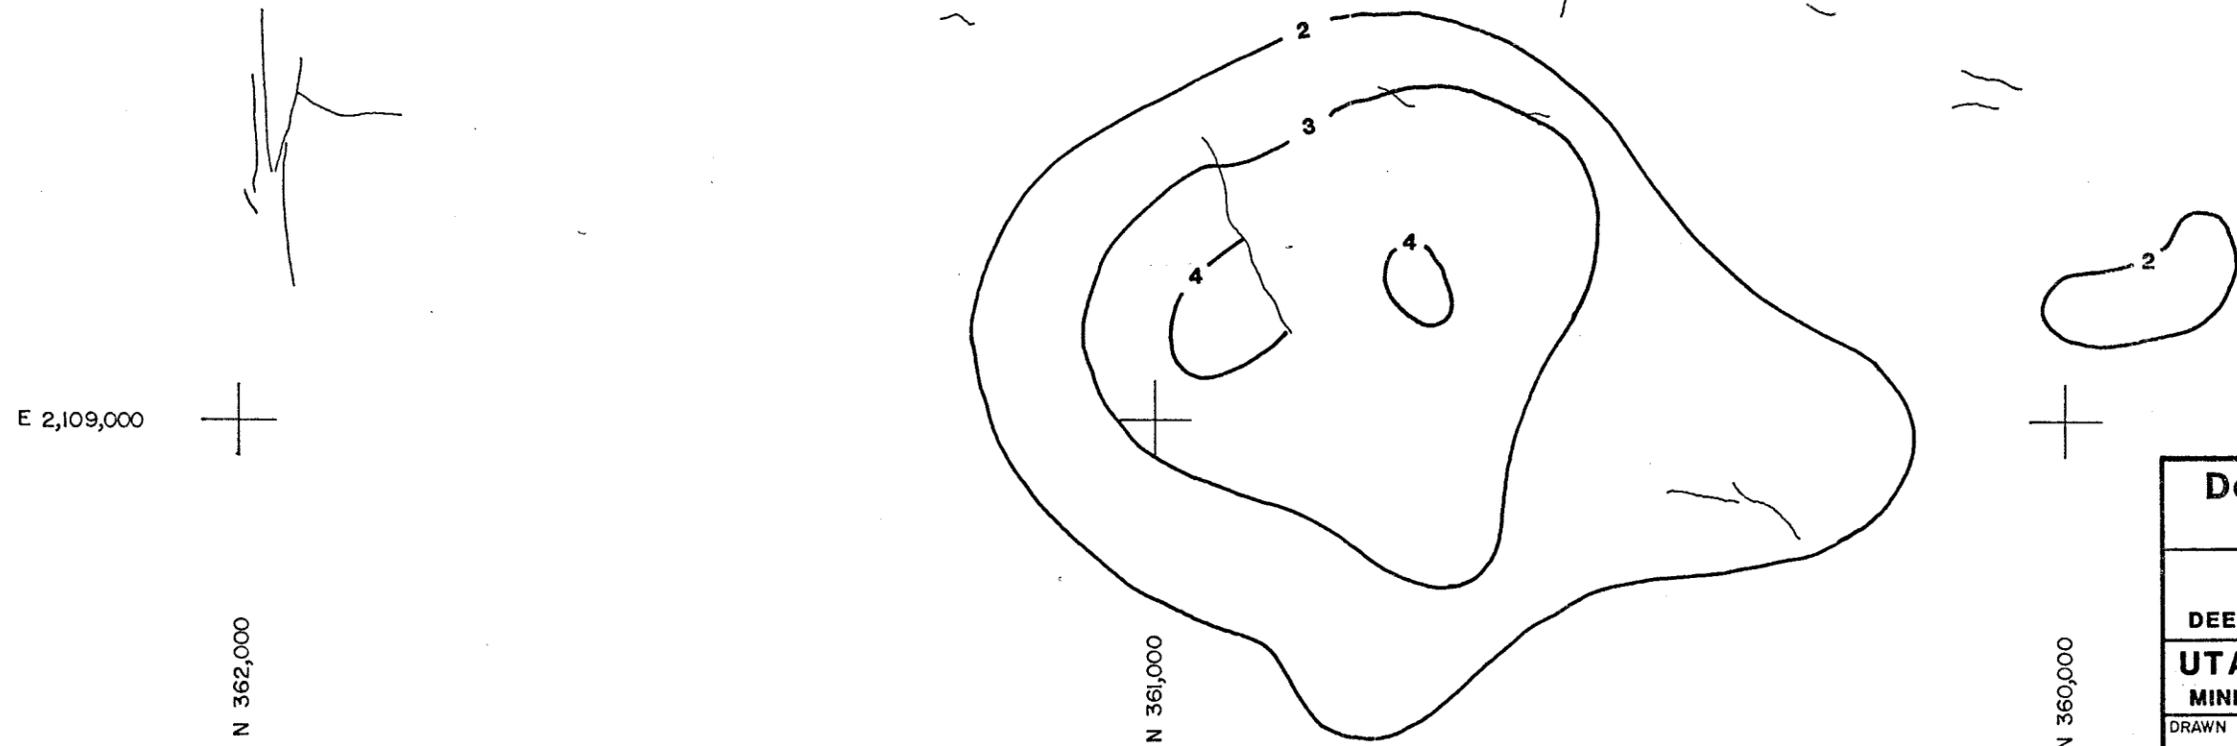
Deer Creek & Wilberg Mines		
EMERY COUNTY, UTAH		
1986 SUBSIDENCE		
DEER CREEK 9th EAST - WILBERG 1st RIGHT		
UTAH POWER & LIGHT COMPANY		
MINING DIVISION-SALT LAKE CITY, UTAH 84110		
DRAWN BY: LJ Hansen	CHECKED BY:	DATE: Mar. 10, 1987
Scale	Sheet No.	Drawing Number
1" = 200'		FIGURE 5

Subsidence monitoring during 1986 showed little or no change in subsidence from 1985. The maximum subsidence observed to date is 25 feet and occurs on a steep slope about 200 feet south of the southernmost mined-out area in 1st Right Wilberg over an area in which both the Hiawatha and Blind Canyon Seams are burned. This supports the theory that the clinker beds have been crushed, allowing subsidence to occur well outside the area of mine workings. An on-the-ground inspection of this area revealed that some of the fractures have begun to heal spontaneously with the soils filling in and smoothing out the fractures.

The angle-of-draw of subsidence in this area appears to be influenced by the Deer Creek Fault plane. On the east side of the mine workings the subsidence abruptly stops about 200 feet east of the mine workings, which coincides with the Deer Creek Fault surface trace. In this area the mine workings are covered with 1200 feet of overburden, indicating a 9.5° angle of draw on subsidence.

In a few areas, such as areas 1, 3, 7, and 10, fractures have been detected. In order to protect livestock UP&L has erected a fence around area 1, where fractures are of sufficient magnitude to pose a threat to wandering cattle. The U. S. Forest Service has recommended that no reclamation be undertaken in this area at this time. UP&L will reclaim the area when and if the Forest Service determines it is necessary.

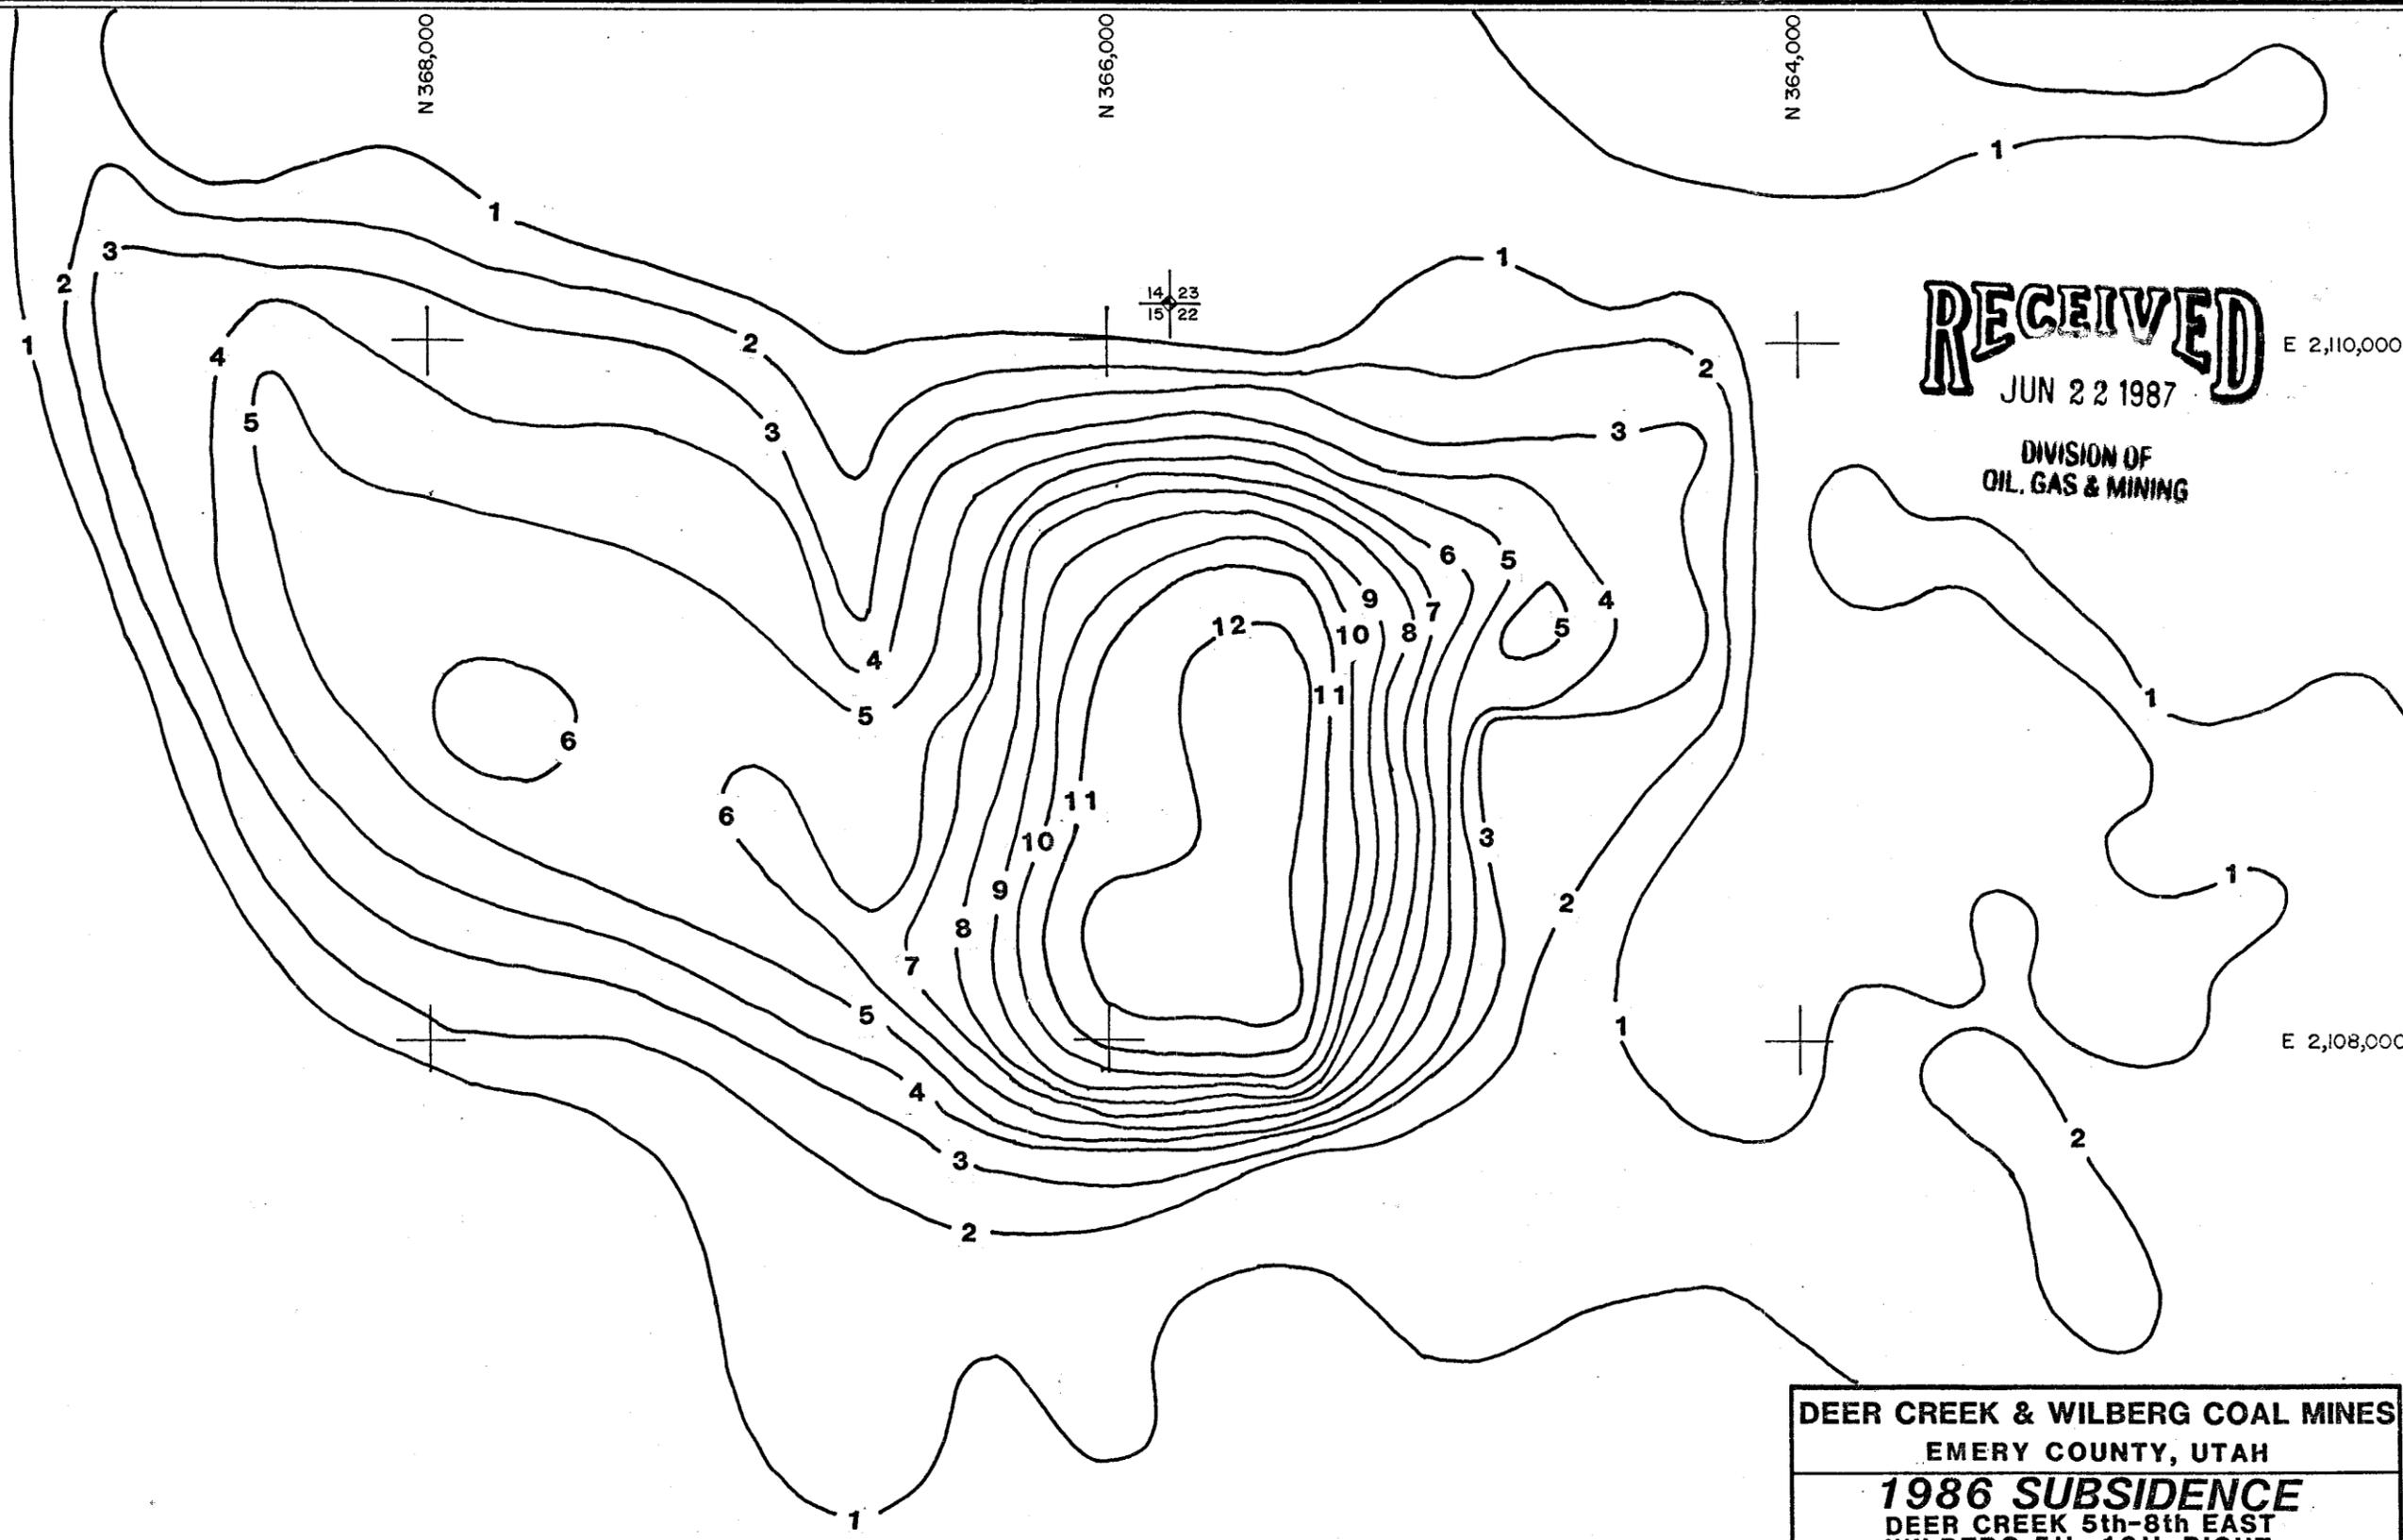
DEER CREEK & WILBERG COAL MINES		
EMERY COUNTY, UTAH		
1986 SUBSIDENCE		
DEER CREEK 5th-8th EAST WILBERG 5th-13th RIGHT		
UTAH POWER & LIGHT COMPANY		
MINING DIVISION-SALT LAKE CITY, UTAH 84110		
DRAWN BY: LJ Hansen	CHECKED BY:	DATE: Mar. 2, 1987
Scale 1" = 500'	Sheet No.	Drawing Number
		FIGURE 8a

In 1986 this area was surveyed by both photogrammetric methods and conventional on-the-ground methods (Figures 8a and 8b). Once again, the two surveys were in fairly close agreement. The photogrammetric survey showed a maximum of 12 feet of subsidence while on-the-ground methods indicated that nearly 12 feet had occurred. In both surveys maximum subsidence of the Deer Creek 6th East and Wilberg 6th and 7th Right longwall panels occurred. Although the magnitude of the subsidence did not increase, the area continued to elongate to the north and south in 1986. The photogrammetric survey appears to show greater detail since data points are more evenly spaced than with the conventional survey. It is interesting to note that the shape of the subsidence trough seems to be influenced more by the Wilberg Mine workings than the workings in the Deer Creek Mine. Neither UP&L nor contracted survey personnel have detected any surface fissures or any other visible disturbance.

Angle-of-draw has been calculated where possible for the area. On the eastern side the angle is influenced by the Deer Creek Fault and adjacent Little Dove Mine workings across the fault; it ranges from vertical to 18° . On the north and south the maximum angles-of-draw are 10° and 23° , respectively. On the western side the angle ranges from near vertical to 20° .

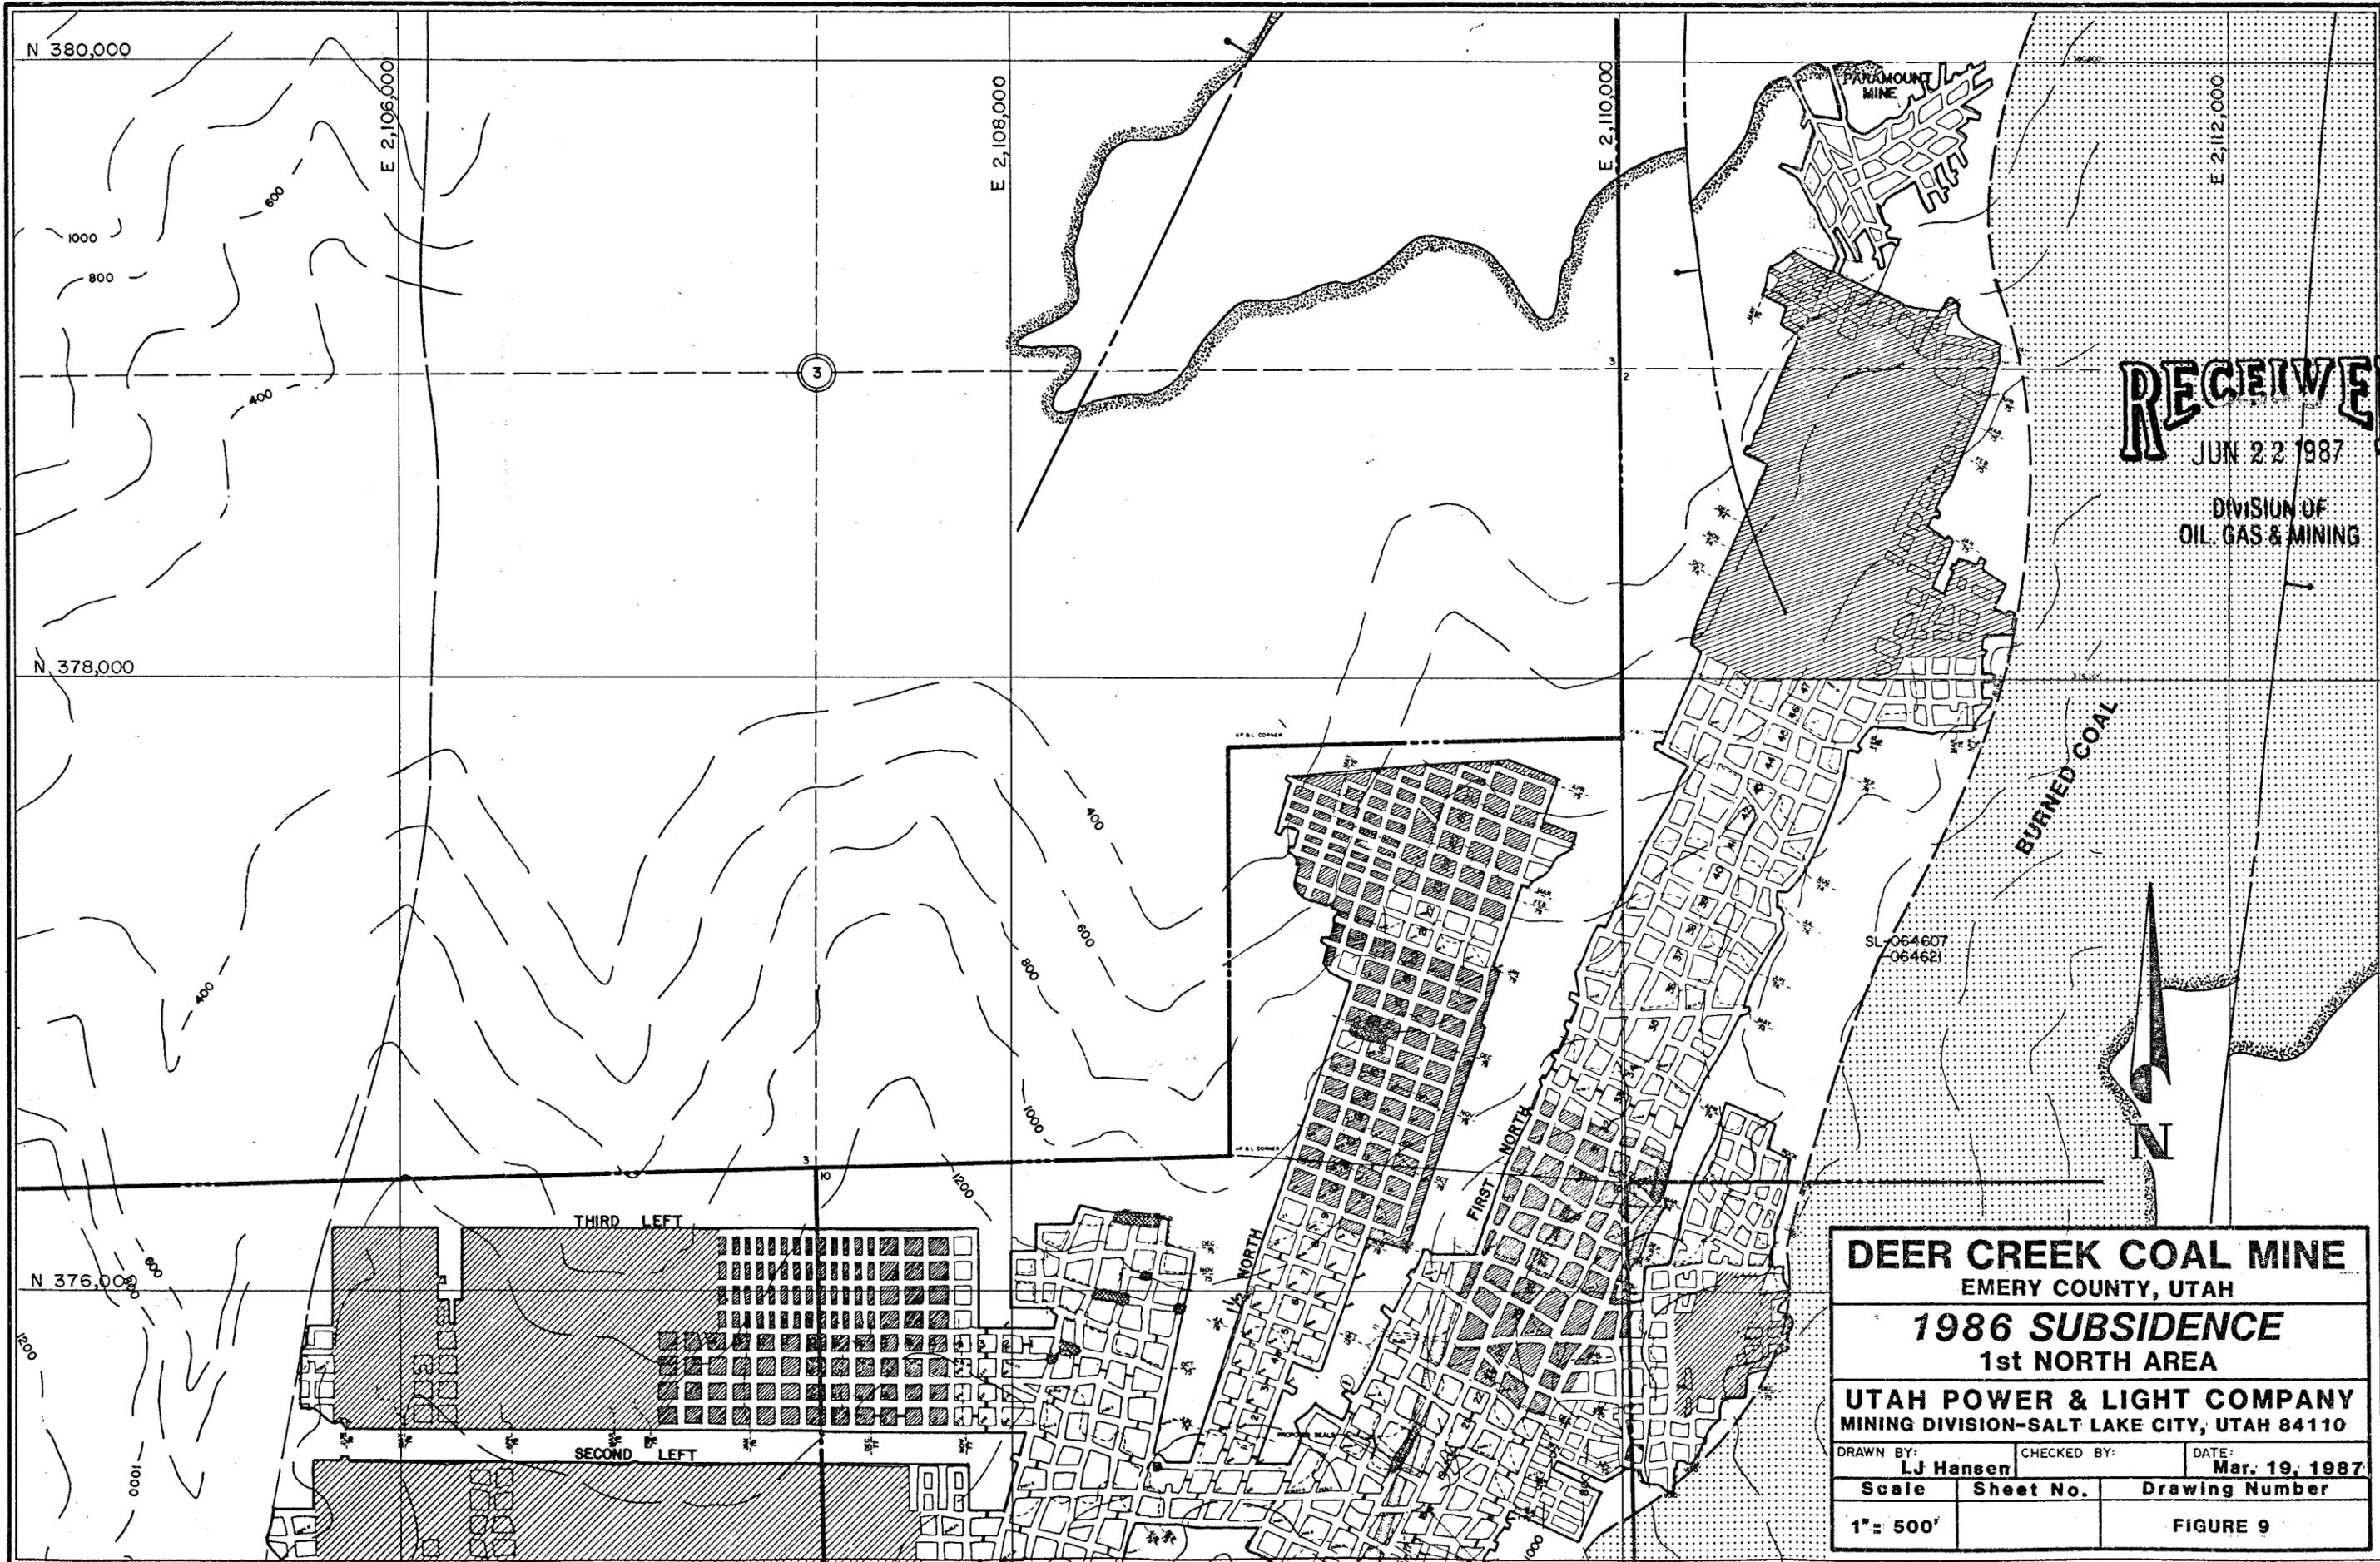
DEER CREEK COAL MINE		
EMERY COUNTY, UTAH		
1986 SUBSIDENCE		
1st NORTH AREA		
UTAH POWER & LIGHT COMPANY		
MINING DIVISION-SALT LAKE CITY, UTAH 84110		
DRAWN BY: LJ Hansen	CHECKED BY:	DATE: Mar. 19, 1987
Scale 1" = 500'	Sheet No.	Drawing Number
		FIGURE 9

Most of the 1st North section of the Deer Creek Mine was abandoned and sealed in 1978 after being mined out. The southern portion is still open and will be used for access to a block of coal which lies to the west. Pillar extraction in the 3rd Left and 1-1/2 North sections was completed early in 1980. The greatest subsidence observed over this area is 3 feet. It occurred over an area of burned coal 600 feet northeast of the 1st North workings (Figures 9 and 10). Other points showing greater elevation changes (up to 15 feet) were noted but these have been attributed to mass wasting, such as movement of a large boulder or escarpment failure. One rock slide occurred since the last monitoring period but it is so far (nearly 2000 feet) from the nearest workings that it is probably not related to mining.

In the past two years no measurable increase in subsidence has occurred and, since the workings in the area are no longer active, subsidence will now be monitored on an every-other-year basis.

The calculated angle-of-draw for the area ranges from vertical to 40°, but the measurements are influenced by burned coal, steep slopes, and fracturing, which have complicated the subsidence process.

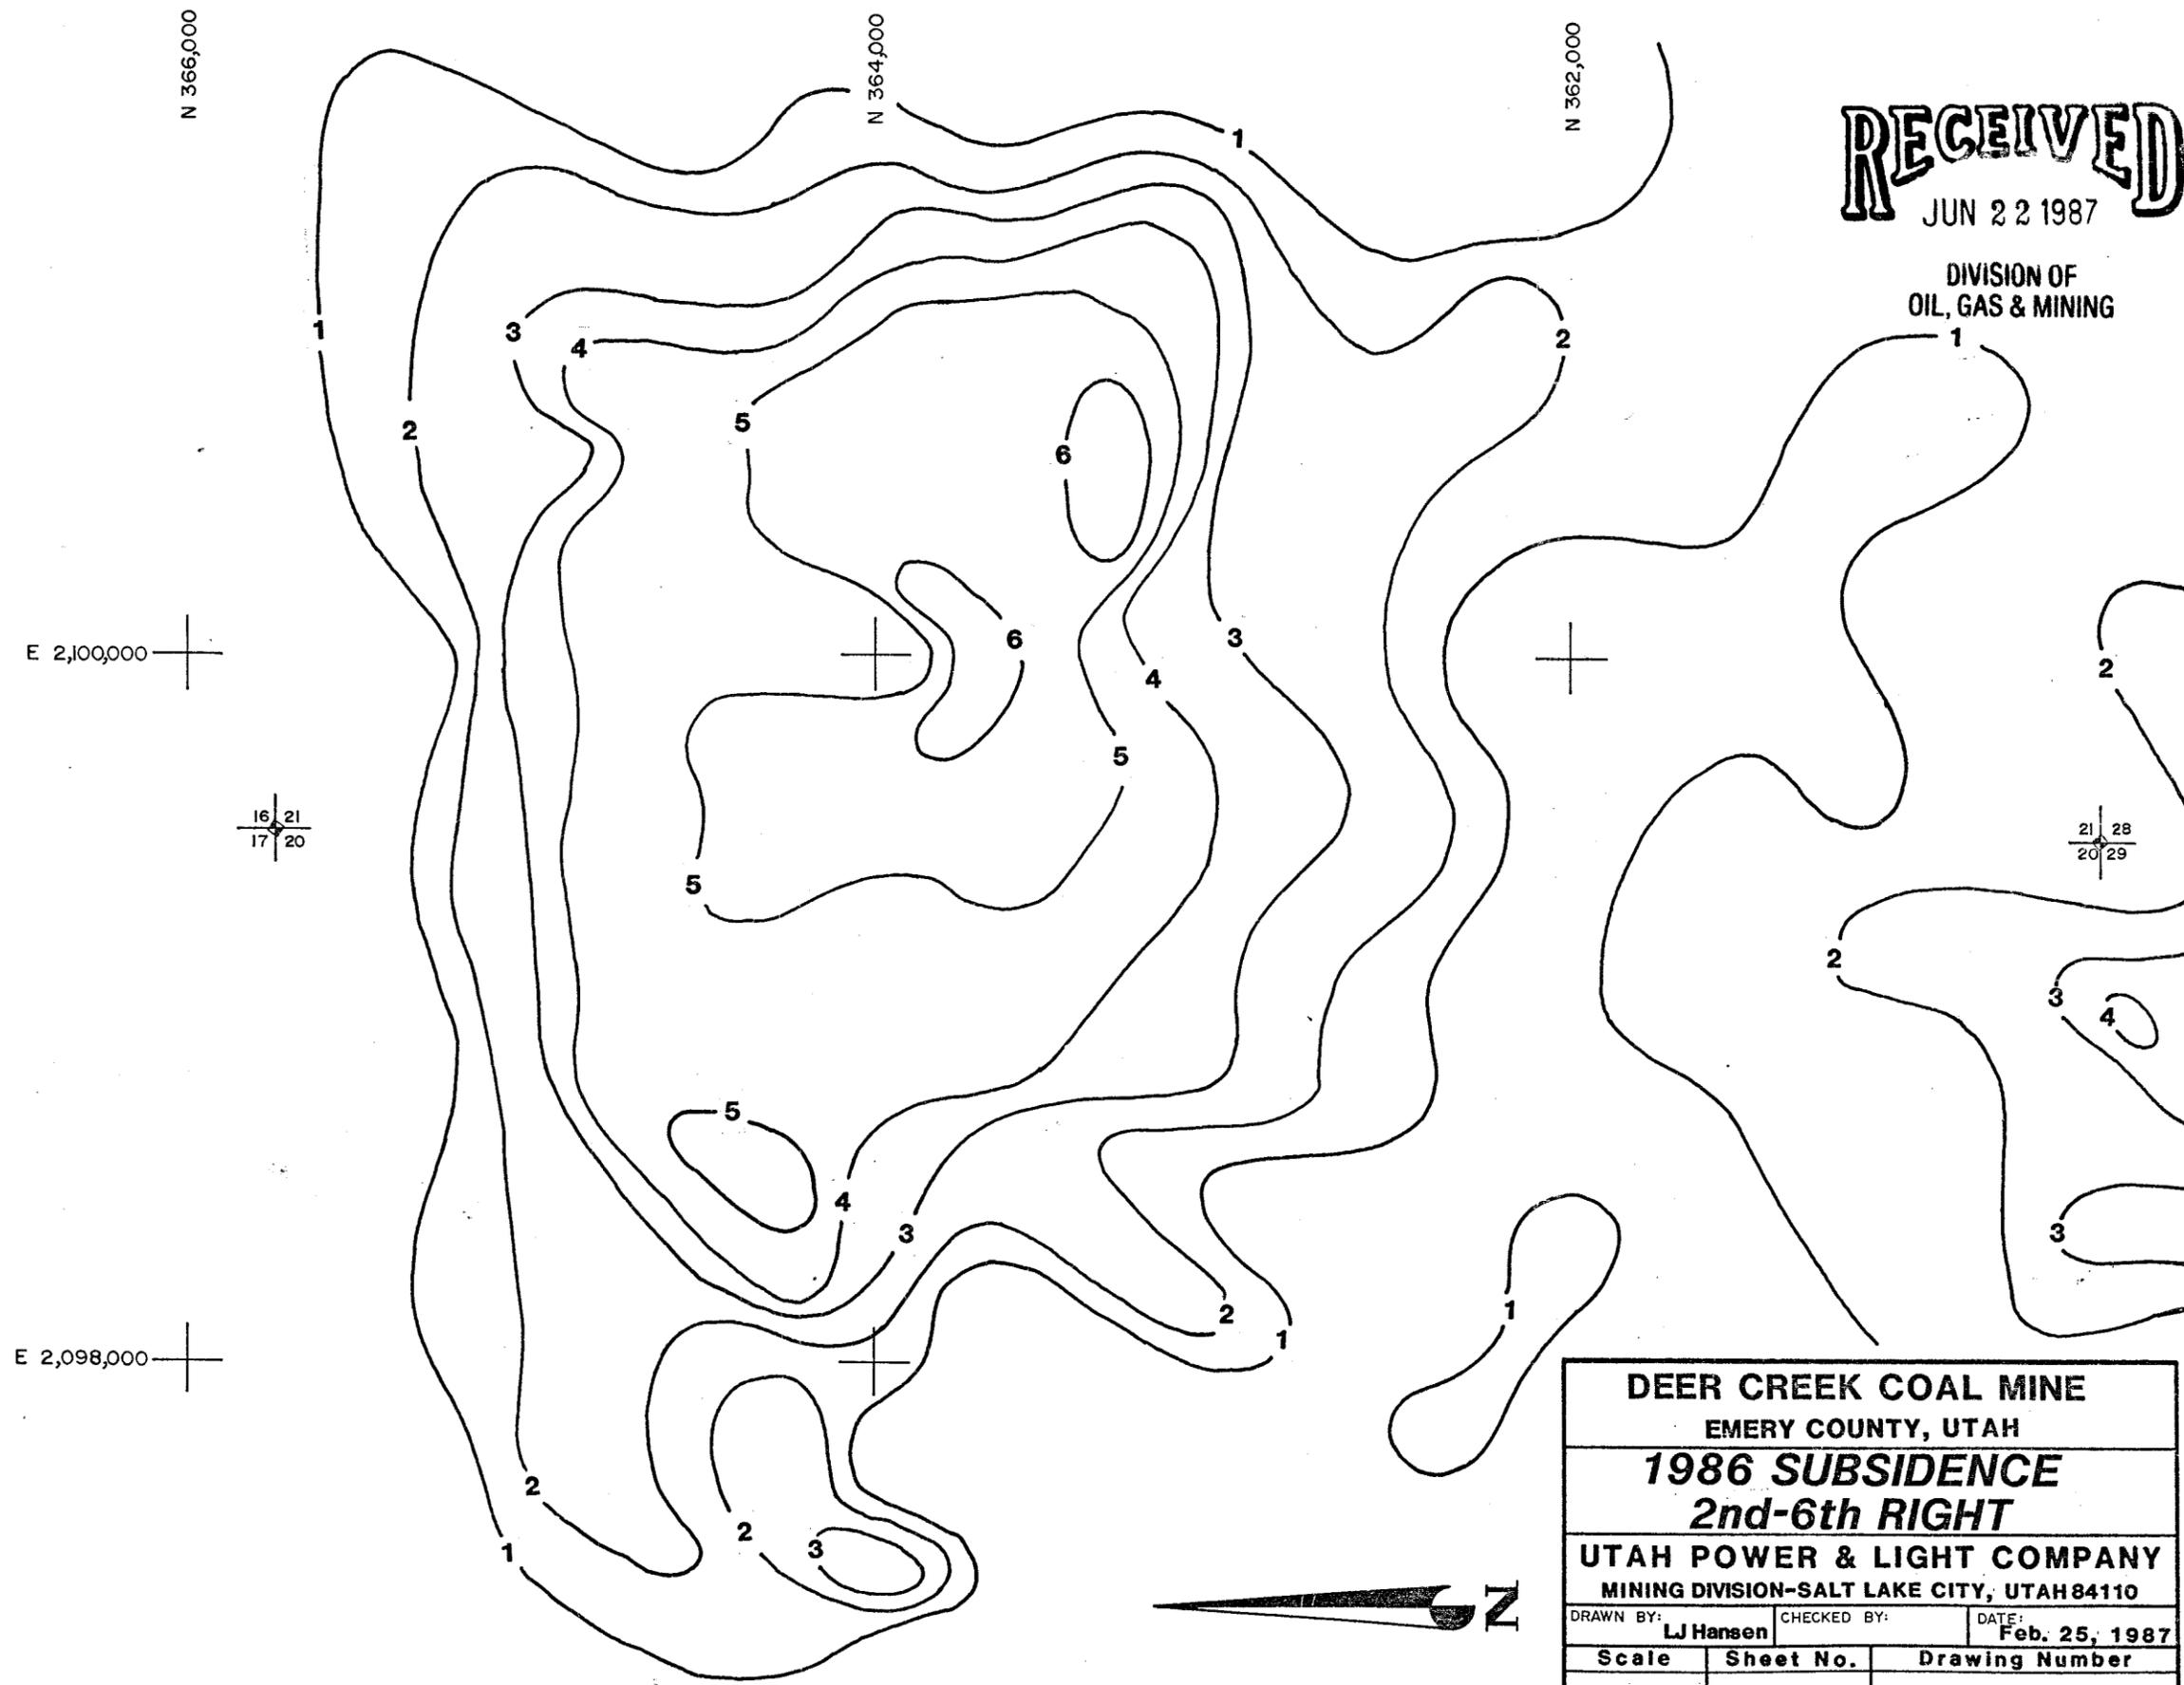
DEER CREEK COAL MINE		
EMERY COUNTY, UTAH		
1986 SUBSIDENCE		
2nd-6th RIGHT		
UTAH POWER & LIGHT COMPANY		
MINING DIVISION-SALT LAKE CITY, UTAH 84110		
DRAWN BY:	CHECKED BY:	DATE:
LJ Hansen		Feb. 25, 1987
Scale	Sheet No.	Drawing Number
1" = 500'		FIGURE 12

The maximum subsidence yet noted is nearly 7 feet over the 3rd and 4th Right longwall panels (Figure 12). Curiously, where subsidence of up to 5 feet was measured in 1985 over two (2) room-and-pillar sections to the west of these panels, 1986 measurement shows only 3 feet. The surface above these sections forms steep slopes, and it is assumed that some type of ground movement has caused the original depressions to fill slightly. However, no slumping or fractures have been noted in any part of the area, either on the ground or from the air. The calculated angle-of-draw of the subsidence ranges from near vertical to about 22° , but more meaningful estimates may be possible when subsidence has stabilized.

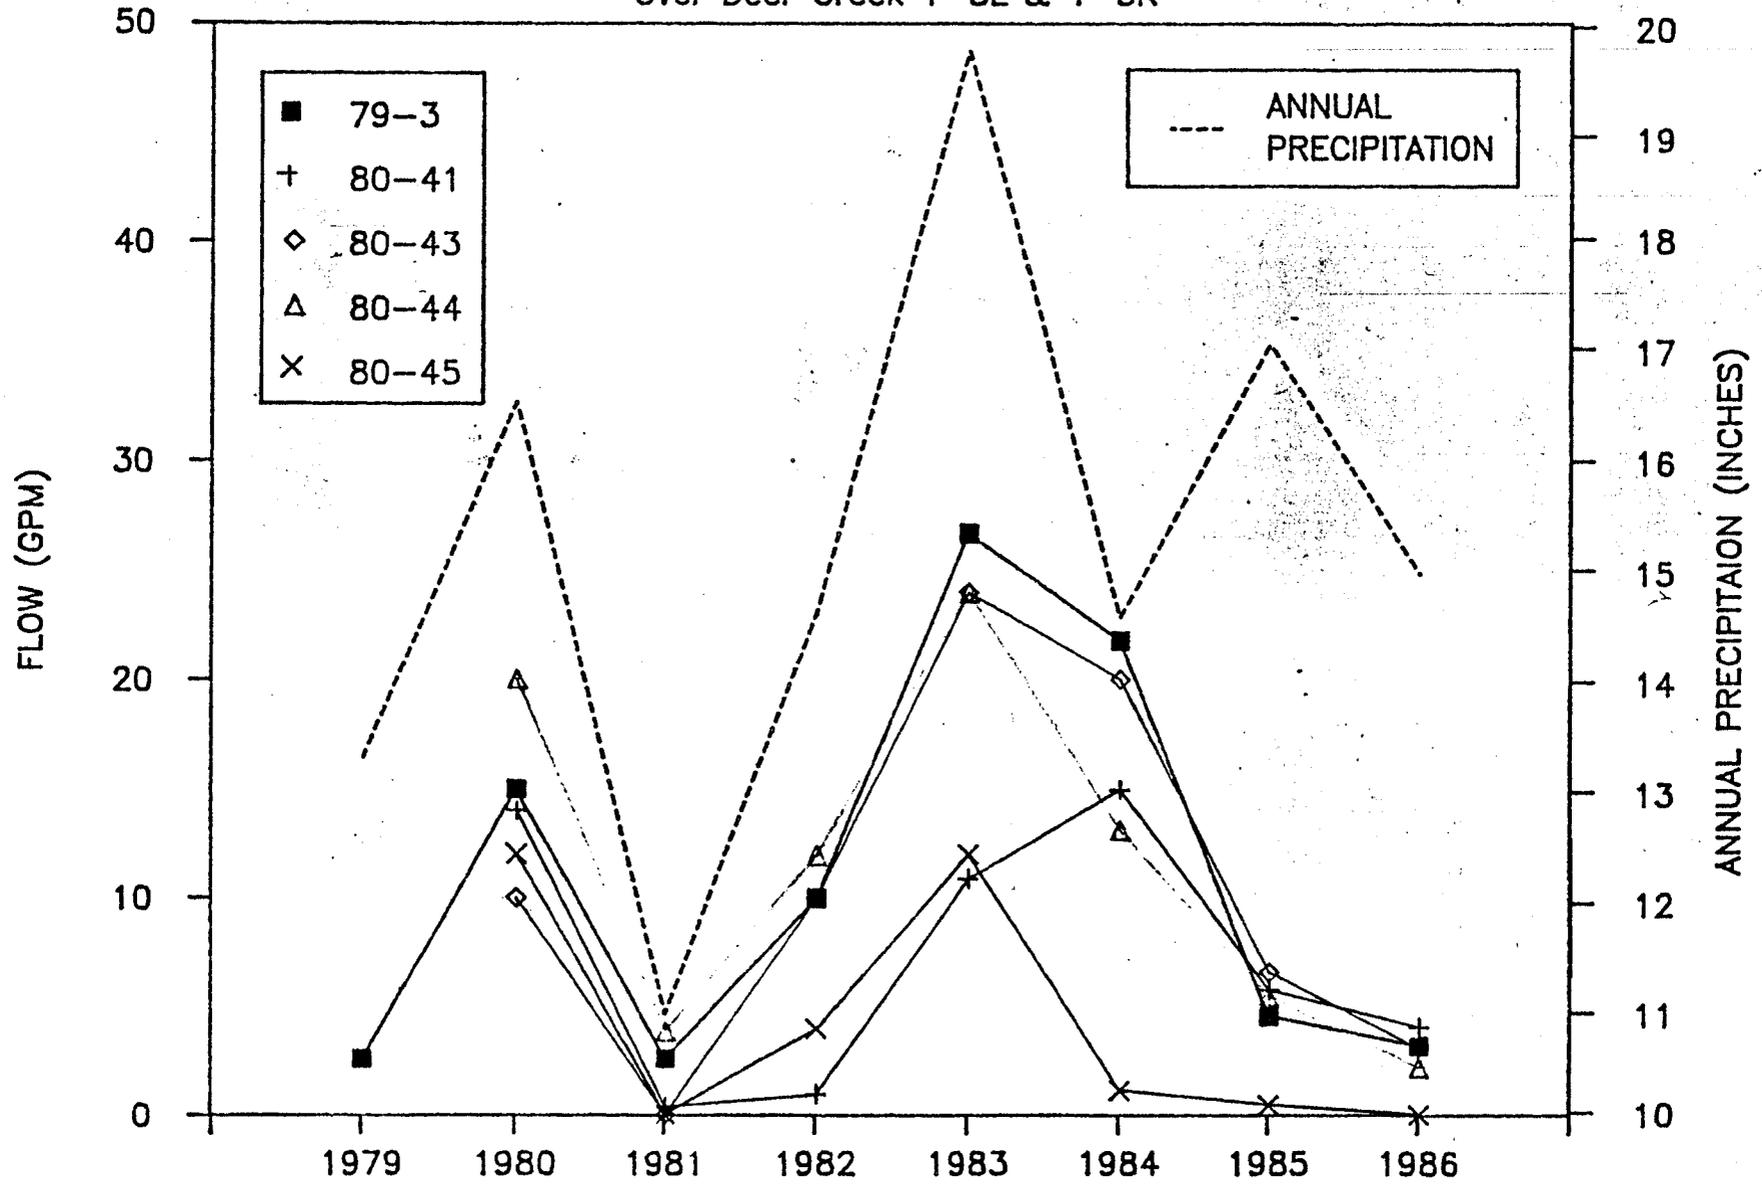
Figure 13
EAST MOUNTAIN SPRINGS
 Over Deer Creek 1-5L & 1-5R

Several springs are located on East Mountain above the Deer Creek 1st through 5th Right and 1st through 5th Left (see Area 5) mine workings. Figure 13 is a graph comparing the discharge from these springs with the annual precipitation on East Mountain. Fluctuations in spring flow appear to be related to variations in precipitation. The relationship appears to hold well for all years except 1985. In examining temperature data obtained from a weather station on East Mountain we found that during the months April and May of 1985

temperatures averaged 7 degrees above normal. The unusually high temperatures caused most of the snow-melt to occur before the springs could be sampled in July, when peak runoff usually occurs, accounting for the lower than expected spring discharges measured in 1985.

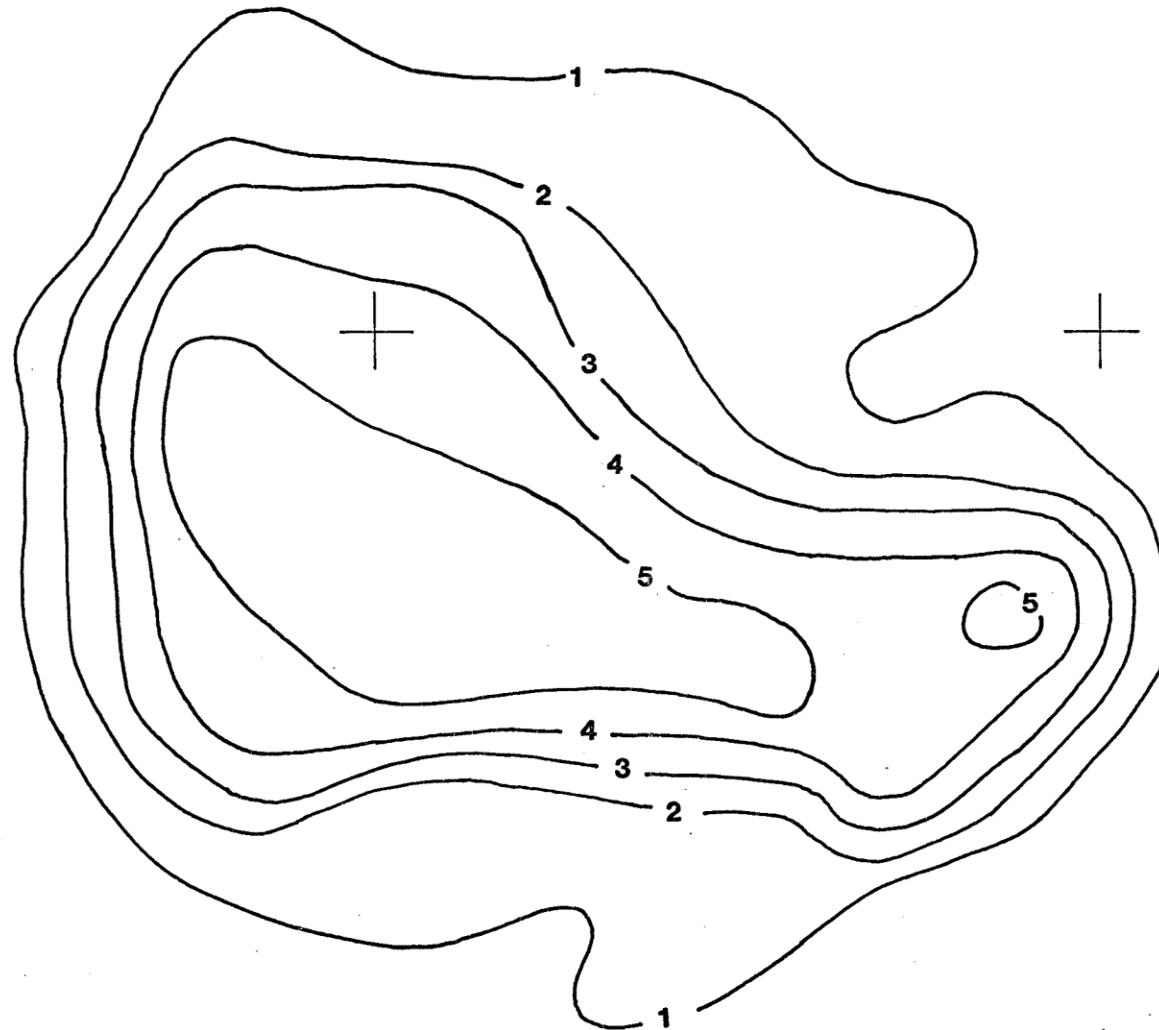
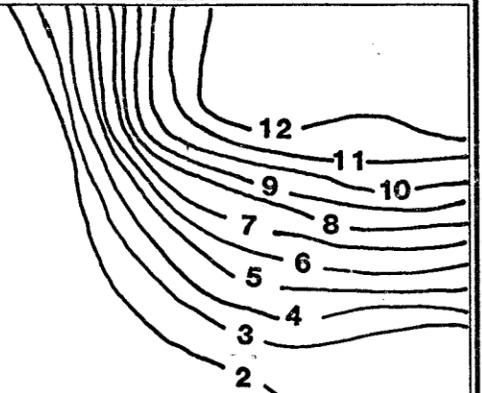
1986 SUBSIDENCE
2nd-5th LEFT

Maximum subsidence over the panels continues to be 5 feet and occurs over much of the 3rd Left panel (Figure 15). The maximum angle-of-draw is now approximately 23° but, since the area may continue to subside for a time, this is not considered a reliable figure. No surface disturbance has been seen.

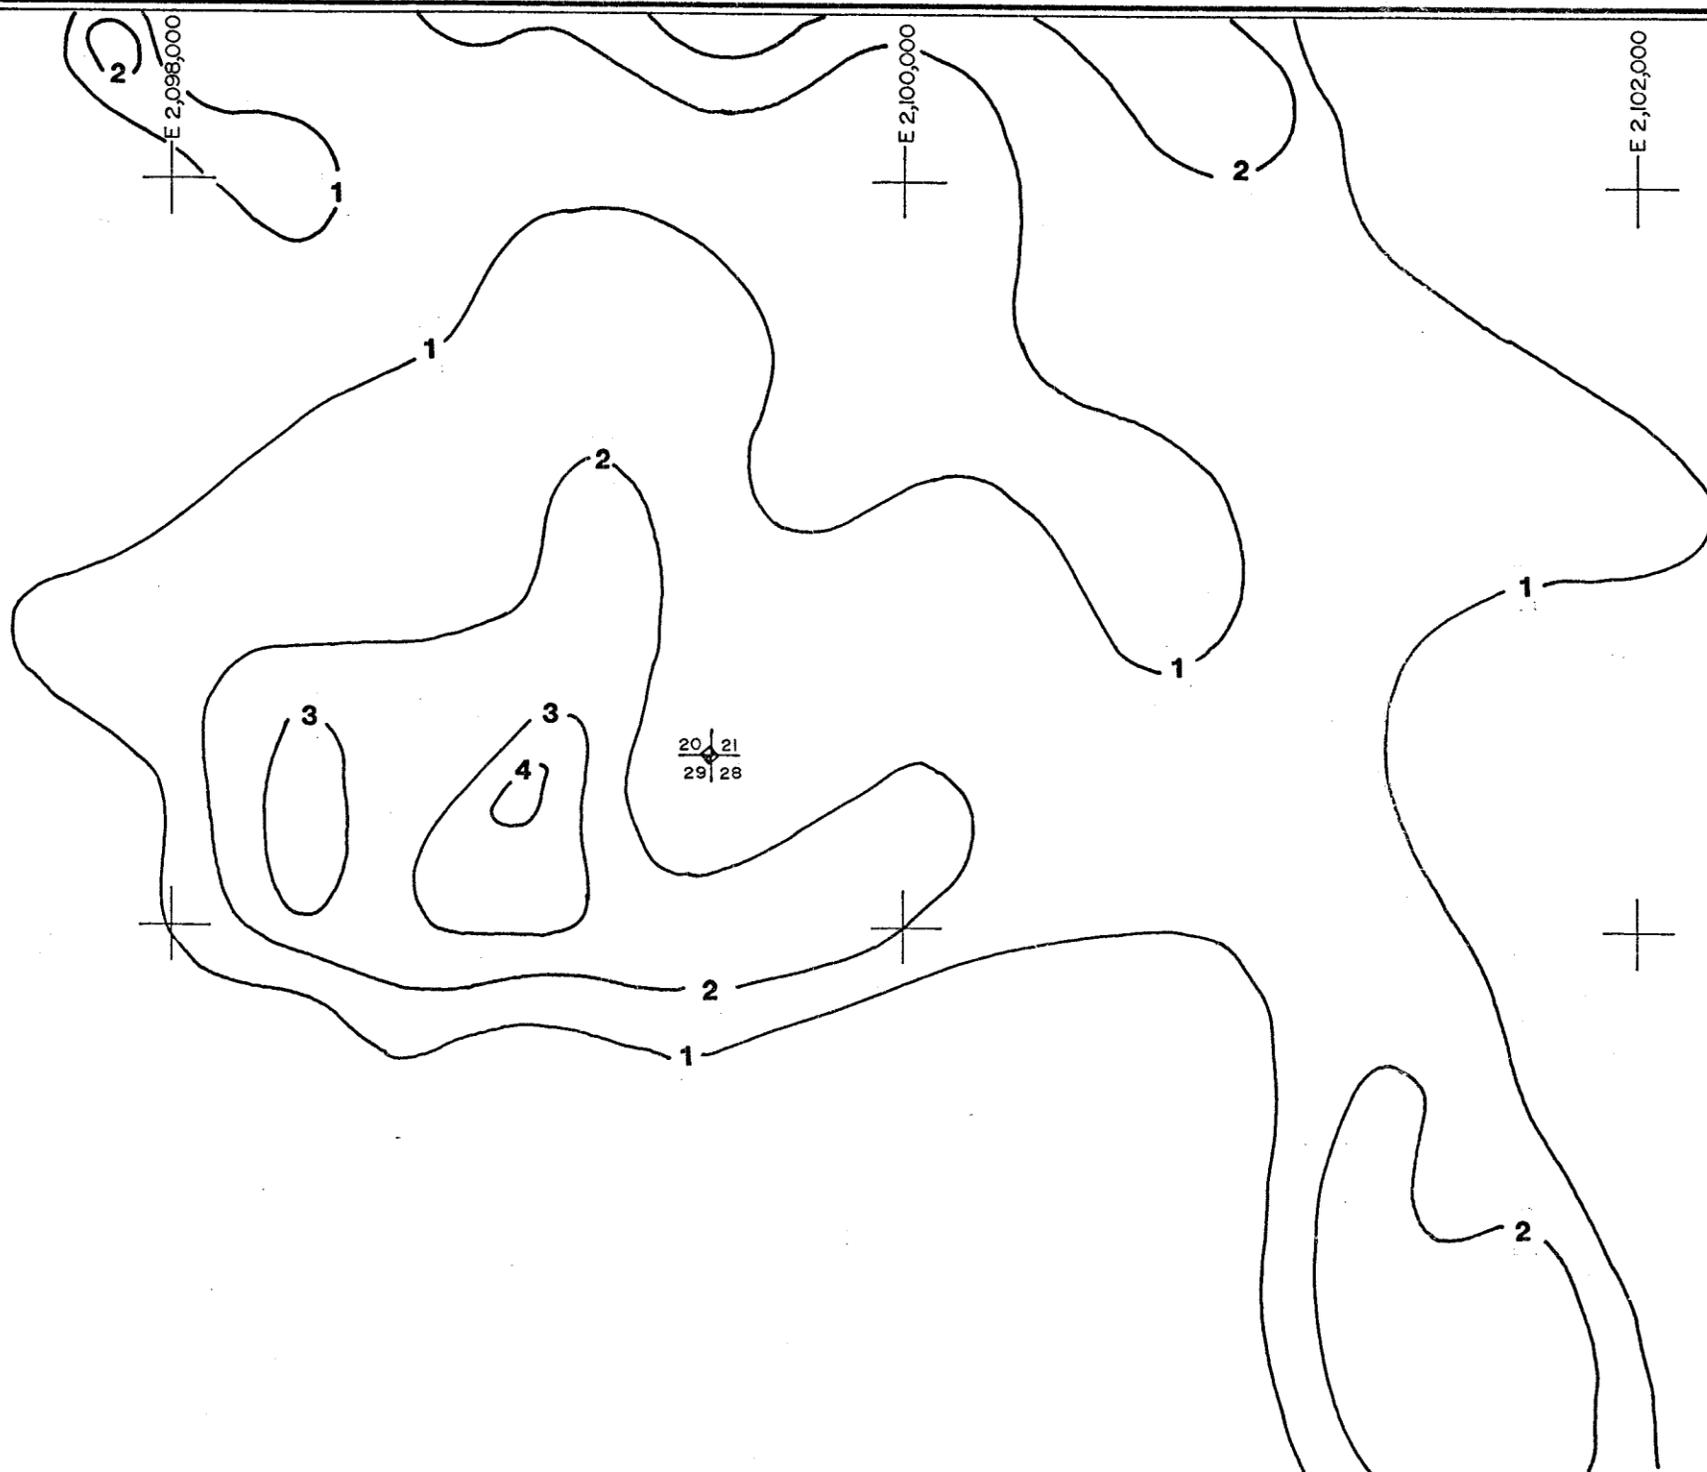
Maximum subsidence reached just over 5 feet (Figure 17); no surface disturbance of any kind has been found. On the south side of the workings the subsidence diminishes to less than 0.5 feet within 1200 feet. With 2000 feet of overburden this equates to an angle-of-draw of 21 degrees.
