UTAH POWER & LIGHT COMPANY
SUBSIDENCE MONITORING PROGRAM
ANNUAL REPORT FOR 1986

April 1987

Submitted to: United States Department of the Interior
Office of Surface Mining
Minerals Management Service
Utah Division of Oil, Gas and Mining

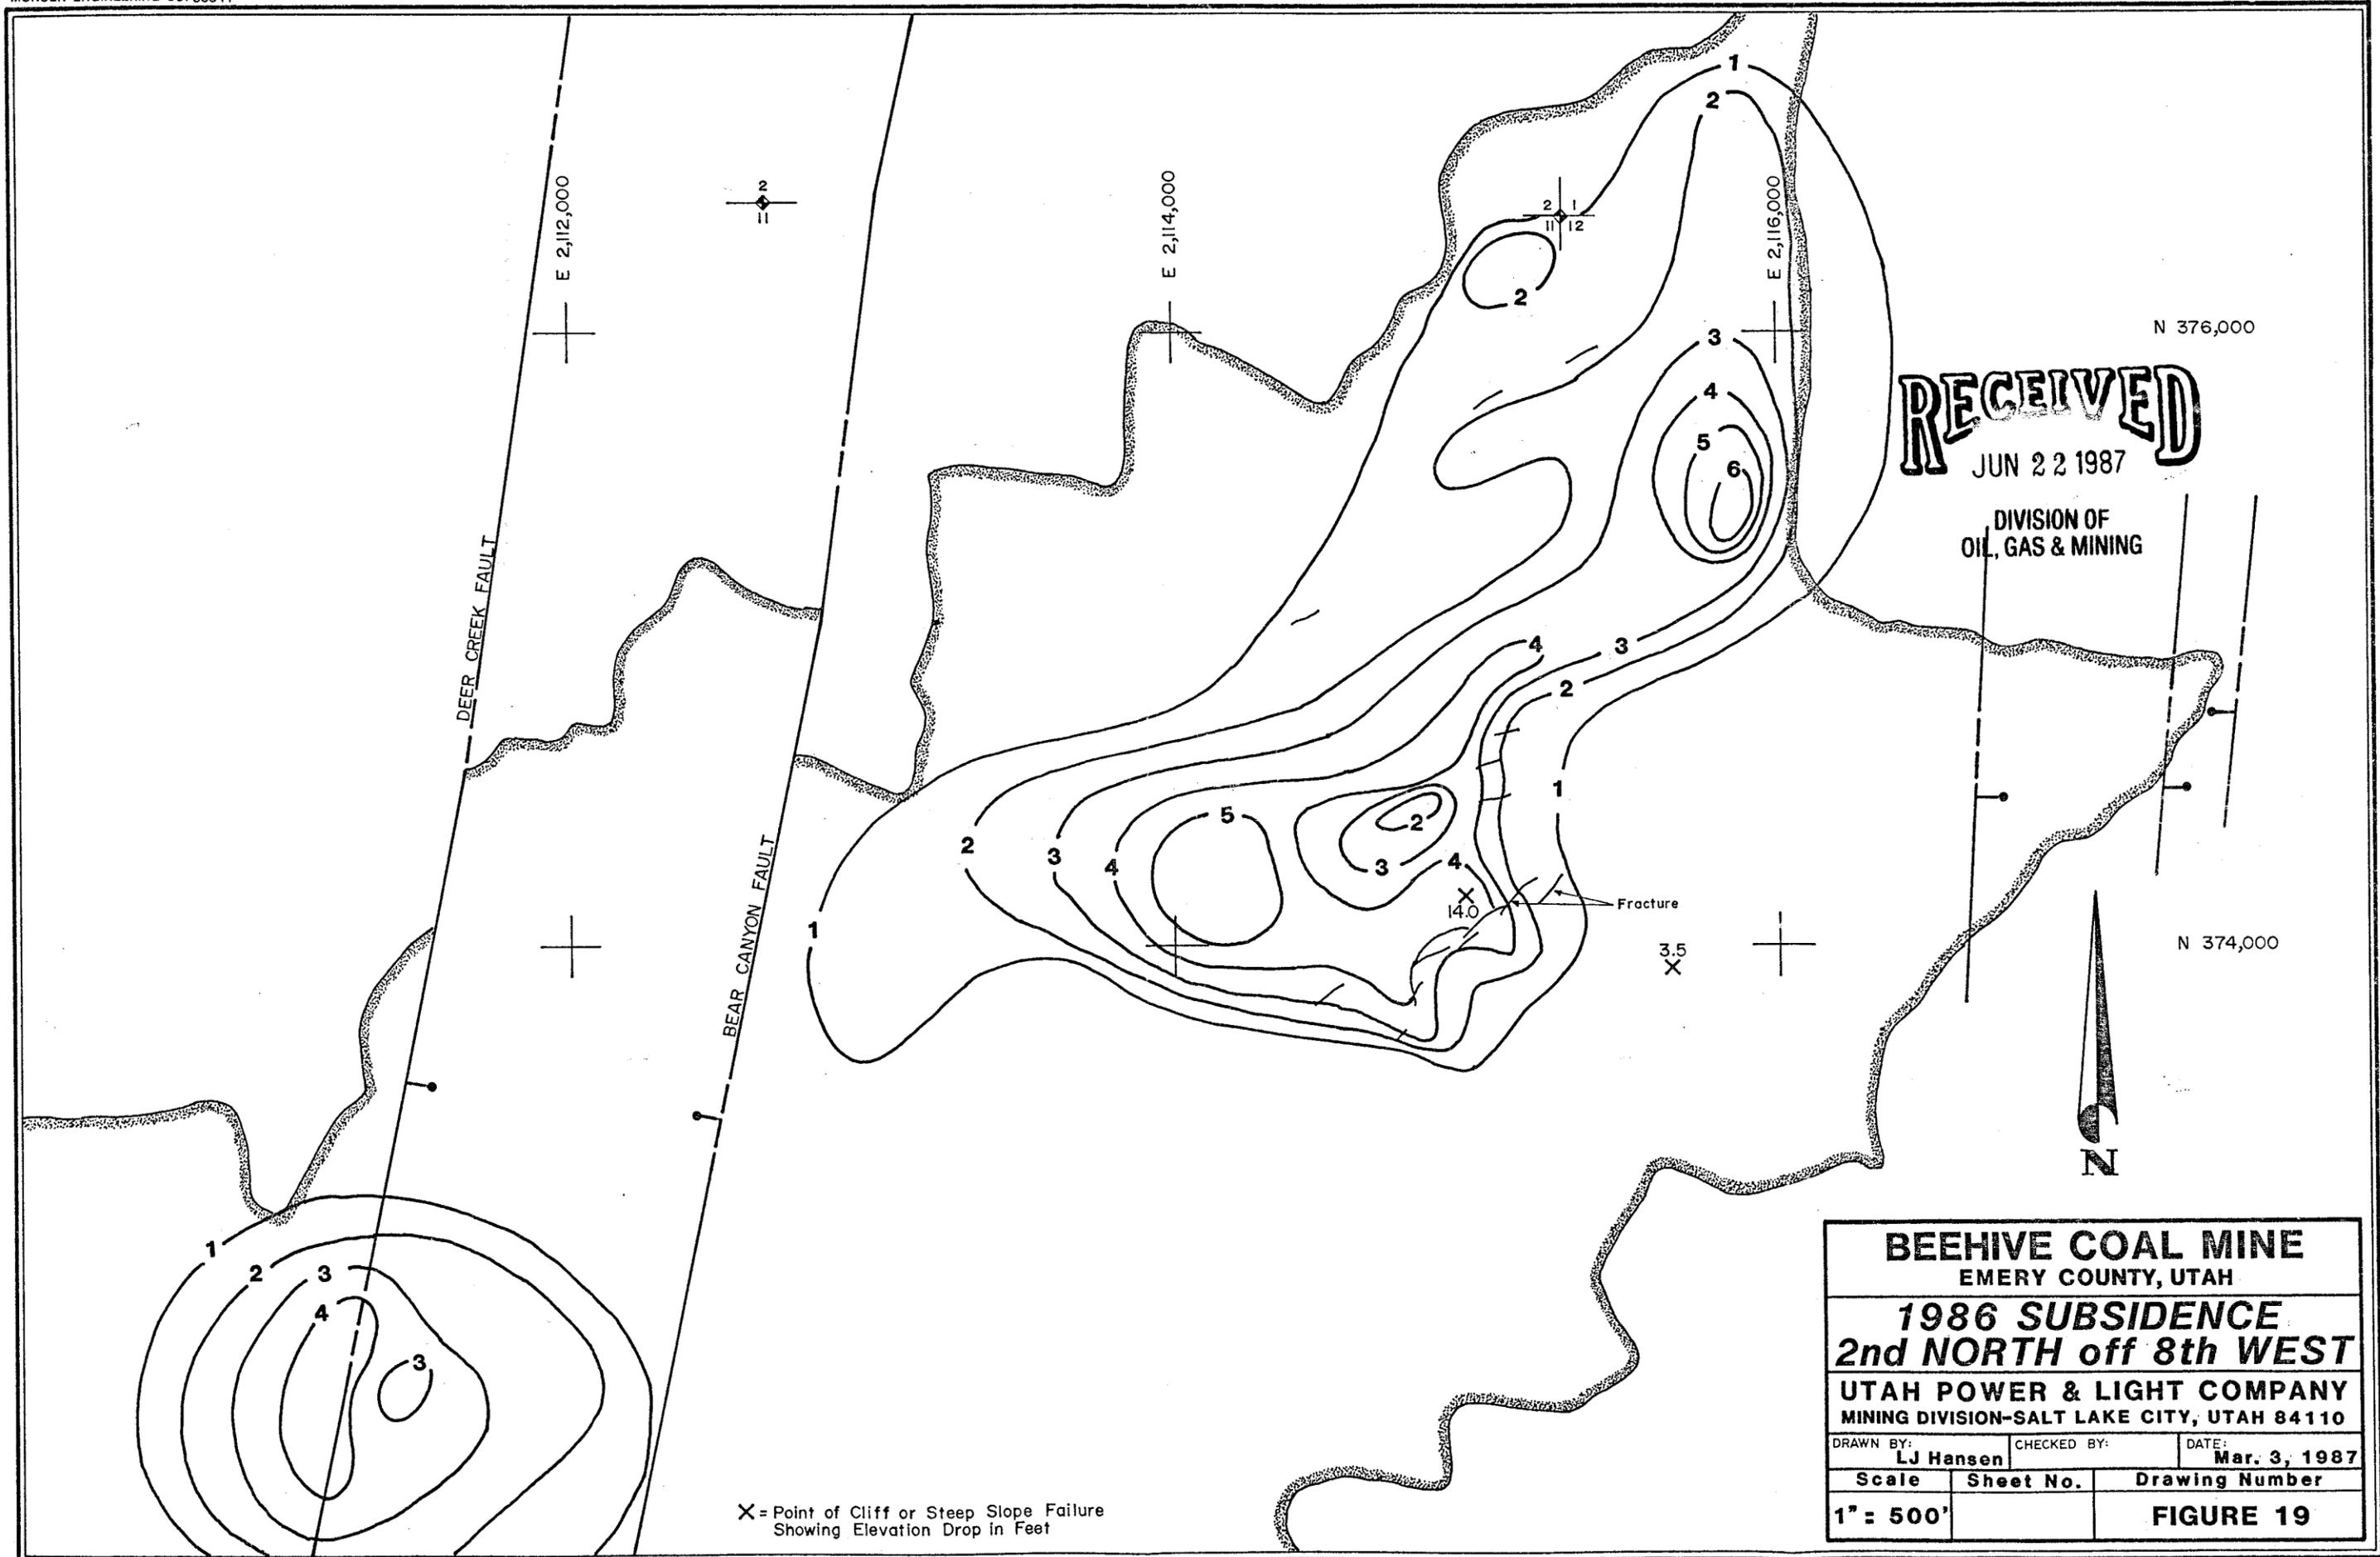
Since late 1984 little additional subsidence has occurred over the workings. Maximum subsidence reached 6 feet and appears to have stopped. Subsidence in this area will now be monitored every second year instead of annually due to the stabilization. Mass wasting of some type, probably movement of large boulders or blocks of sandstone cliff material (Figure 19), occurred at two locations. The rocks on the ridge overlying the workings were highly fractured prior to mining, and, given the fractured nature of the strata on the surface and the fact that the area overlies burned coal, it is probable that other instances of movement may occur.

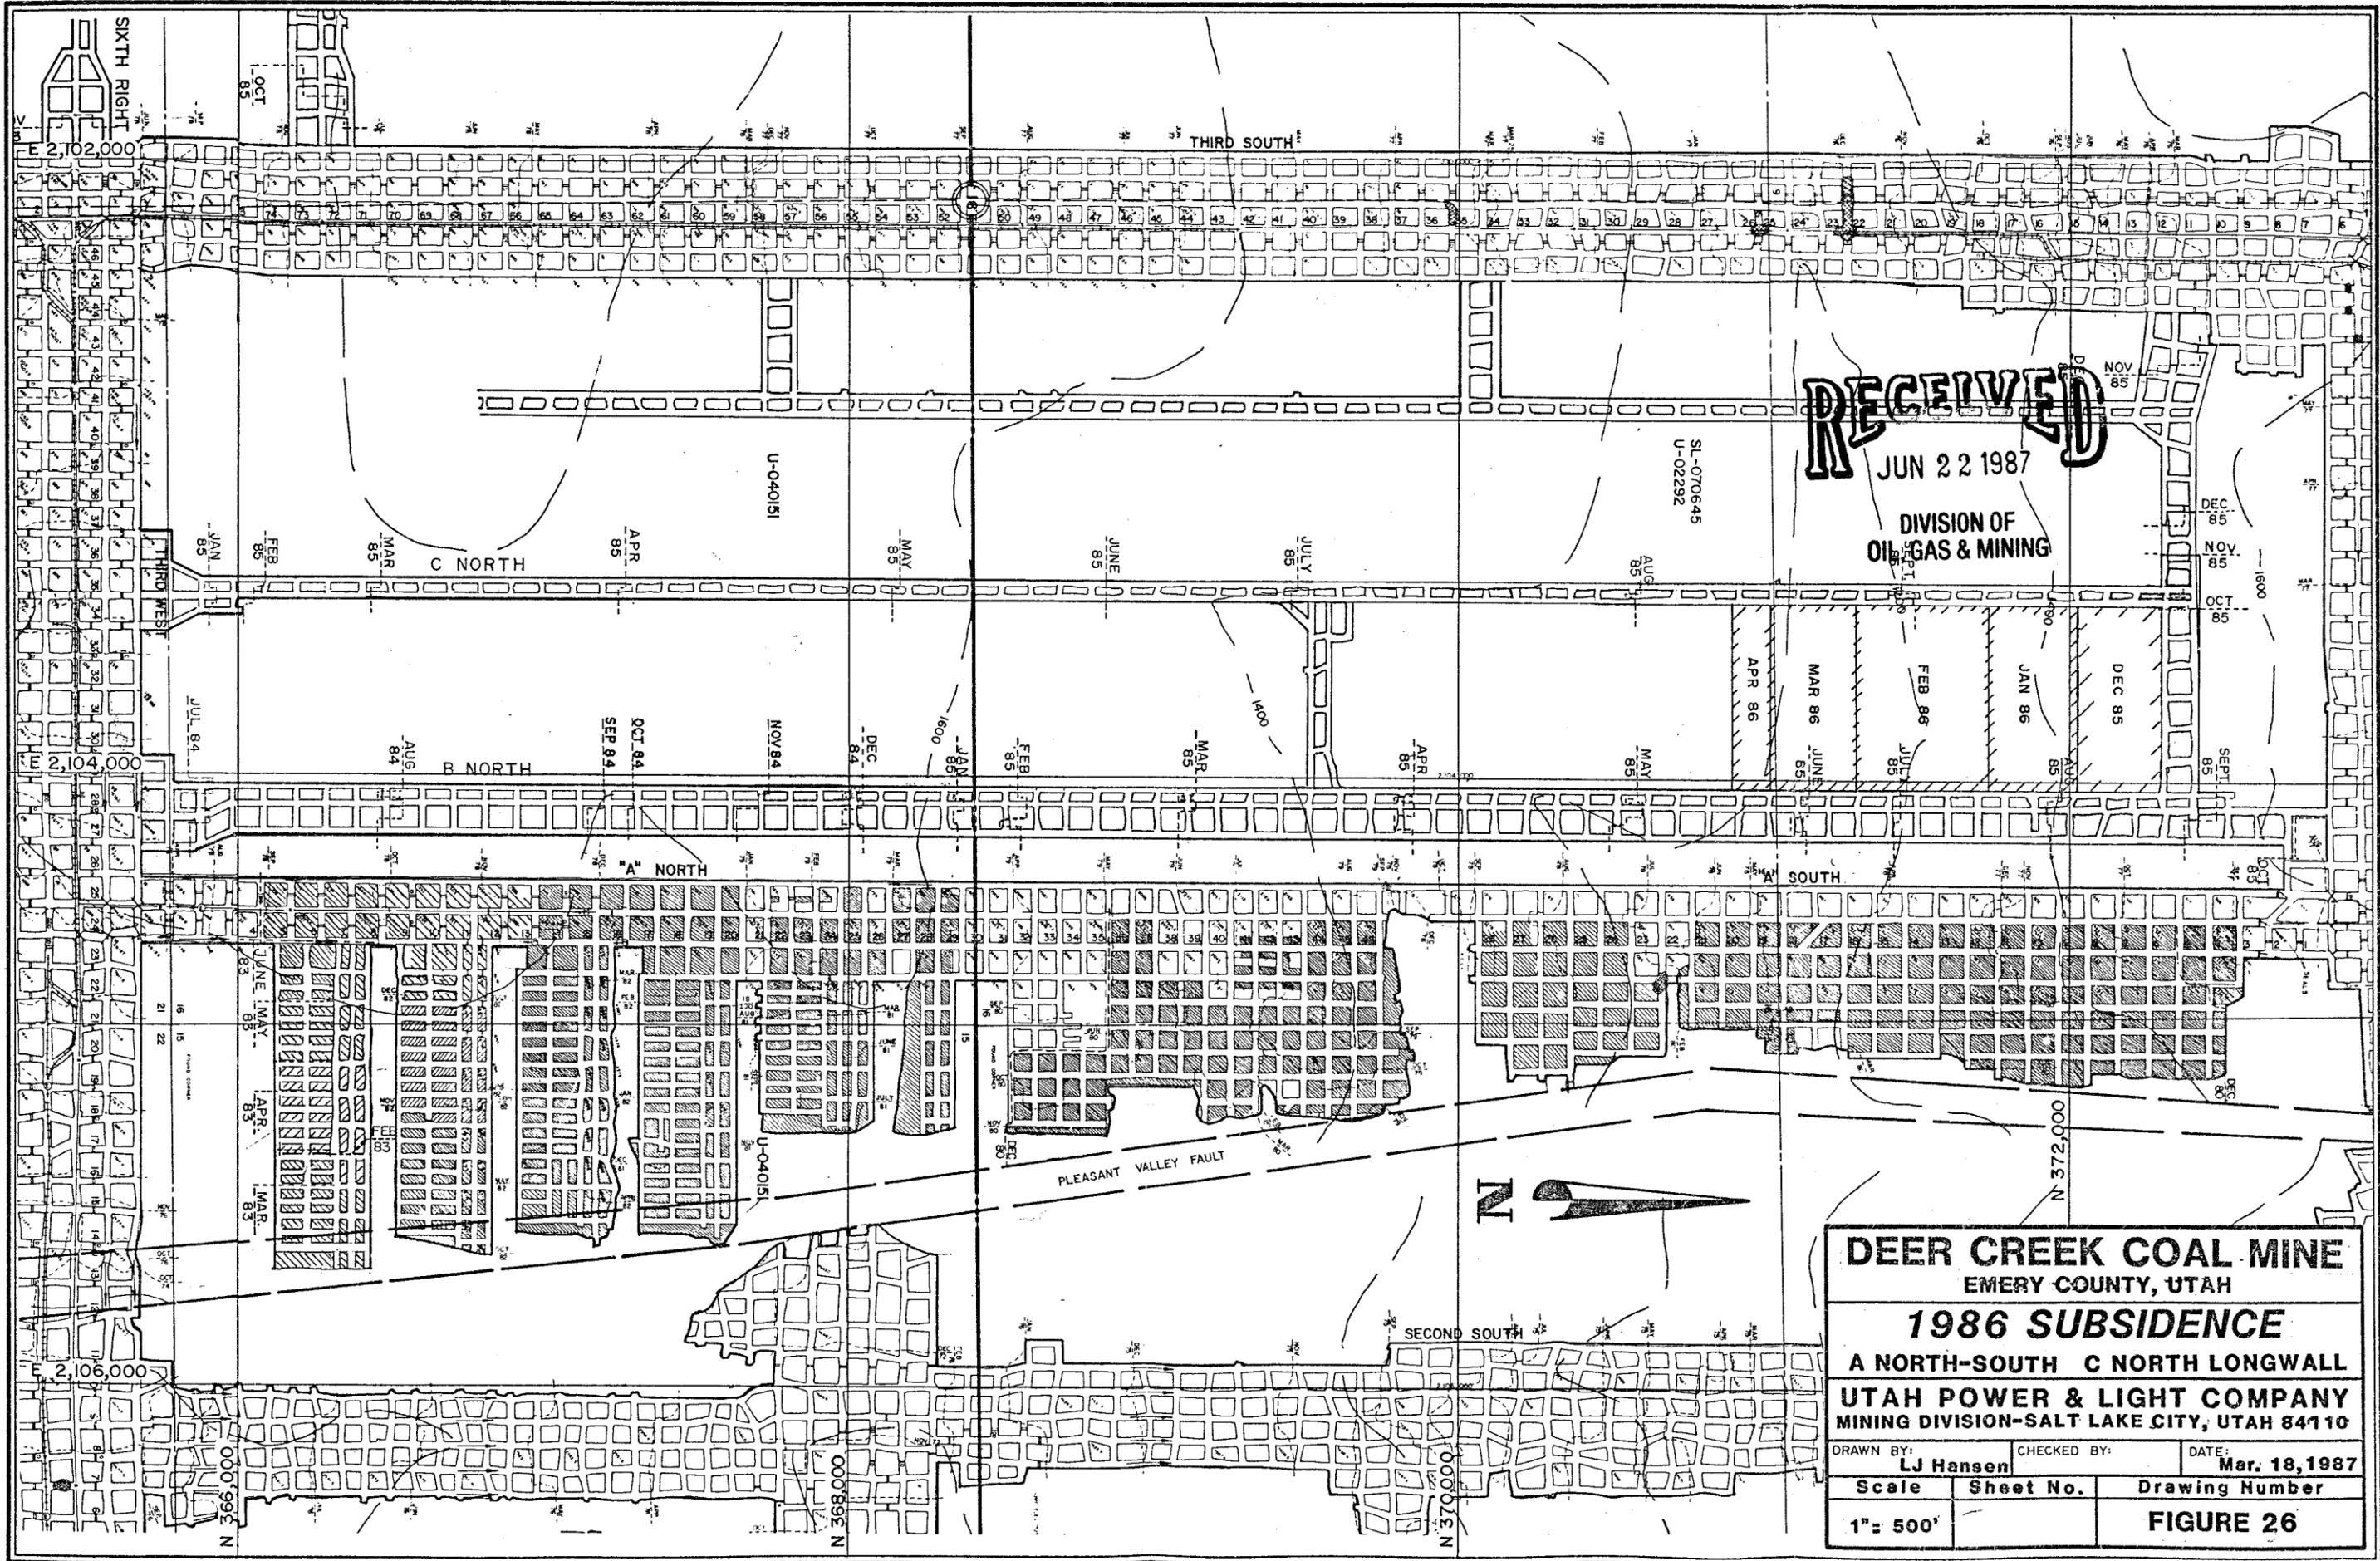
DEER CREEK COAL MINE		
EMERY COUNTY, UTAH		
1986 SUBSIDENCE		
A NORTH-SOUTH C NORTH LONGWALL		
UTAH POWER & LIGHT COMPANY		
MINING DIVISION-SALT LAKE CITY, UTAH 84110		
DRAWN BY: LJ Hansen	CHECKED BY:	DATE: Mar. 18, 1987
Scale 1" = 500'	Sheet No.	Drawing Number
FIGURE 26

No fractures or disturbance of the surface of the area have been observed. No angle-of-draw was calculated since movement on the surface is just beginning.

Three springs are located a few hundred feet to the west of these workings, but none falls within the area of measured subsidence. Their hydrology has shown no effect due to mining.

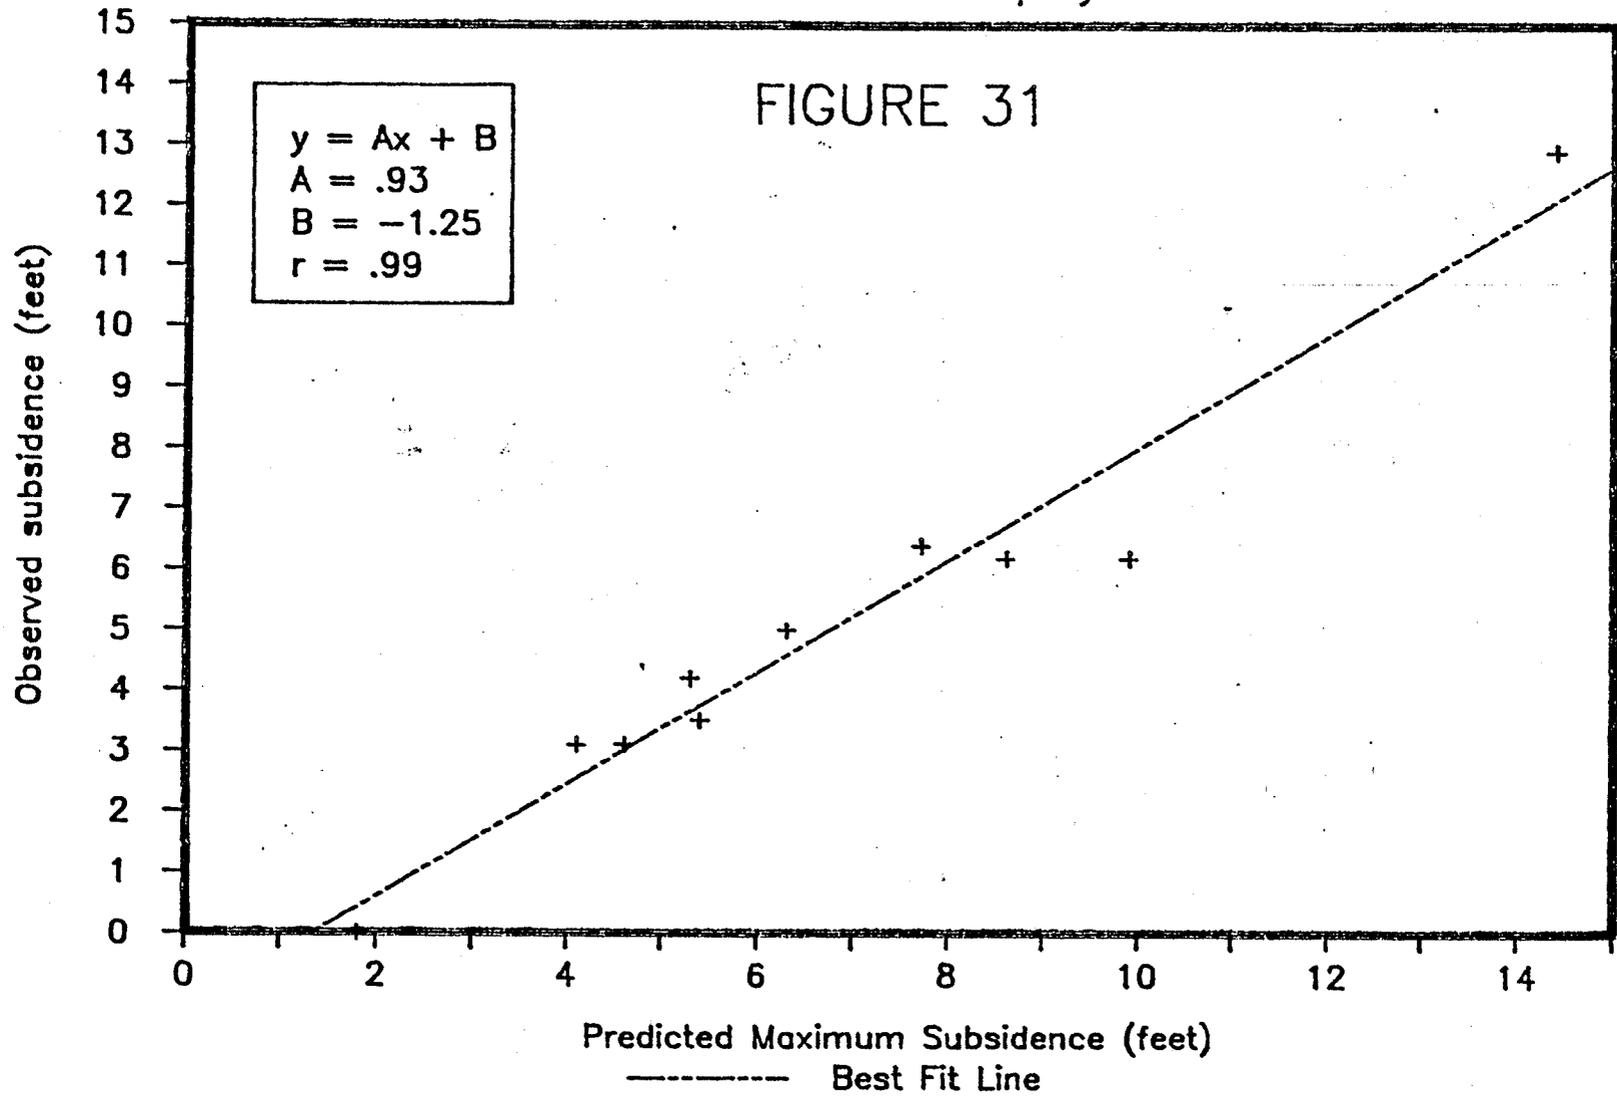
PREDICTED vs OBSERVED SUBSIDENCE

In all areas except one subsidence is less than the maximum predicted by the NCB model. This may be due to the fact that in some areas, such as C North, mining occurred very recently and subsidence has not yet reached its maximum. It could also be that the observed subsidence shown here represents the actual maximum subsidence for these particular geologic conditions. We believe this to be the case since subsidence appears to have ceased in several areas where the NCB predicted maxima were not reached. Figure 31 shows the relationship between predicted and observed subsidence. From the slope of the regression line ($A = .93$) the average observed subsidence is 93% of the NCB predicted maximum.

The one anomalous area is the DC 9th East - Wilberg 1st Right area. This case does not fit the special conditions necessary for prediction by the NCB method. The mine workings there are surrounded by burned coal and bounded on the east by the Deer Creek Fault. As mentioned before, crushing of clinker beds and movement along the fault have added another complication to the subsidence. The maximum subsidence in this area occurs on a steep slope below a cliff, where slumping has occurred. The 25.2 feet measured here is due in part to mass wasting on the steep slope.

off 8th West sections some sort of mass wasting, such as movement of a large boulder, resulted in an elevation drop at one measurement point. The elevation drop at such a point does not, therefore, represent actual subsidence.
