UTAH POWER & LIGHT COMPANY
SUBSIDENCE MONITORING PROGRAM
ANNUAL REPORT FOR 1988

March 1989

United States Department of the Interior
Office of Surface Mining
Minerals Management Service
Utah Division of Oil, Gas and Mining

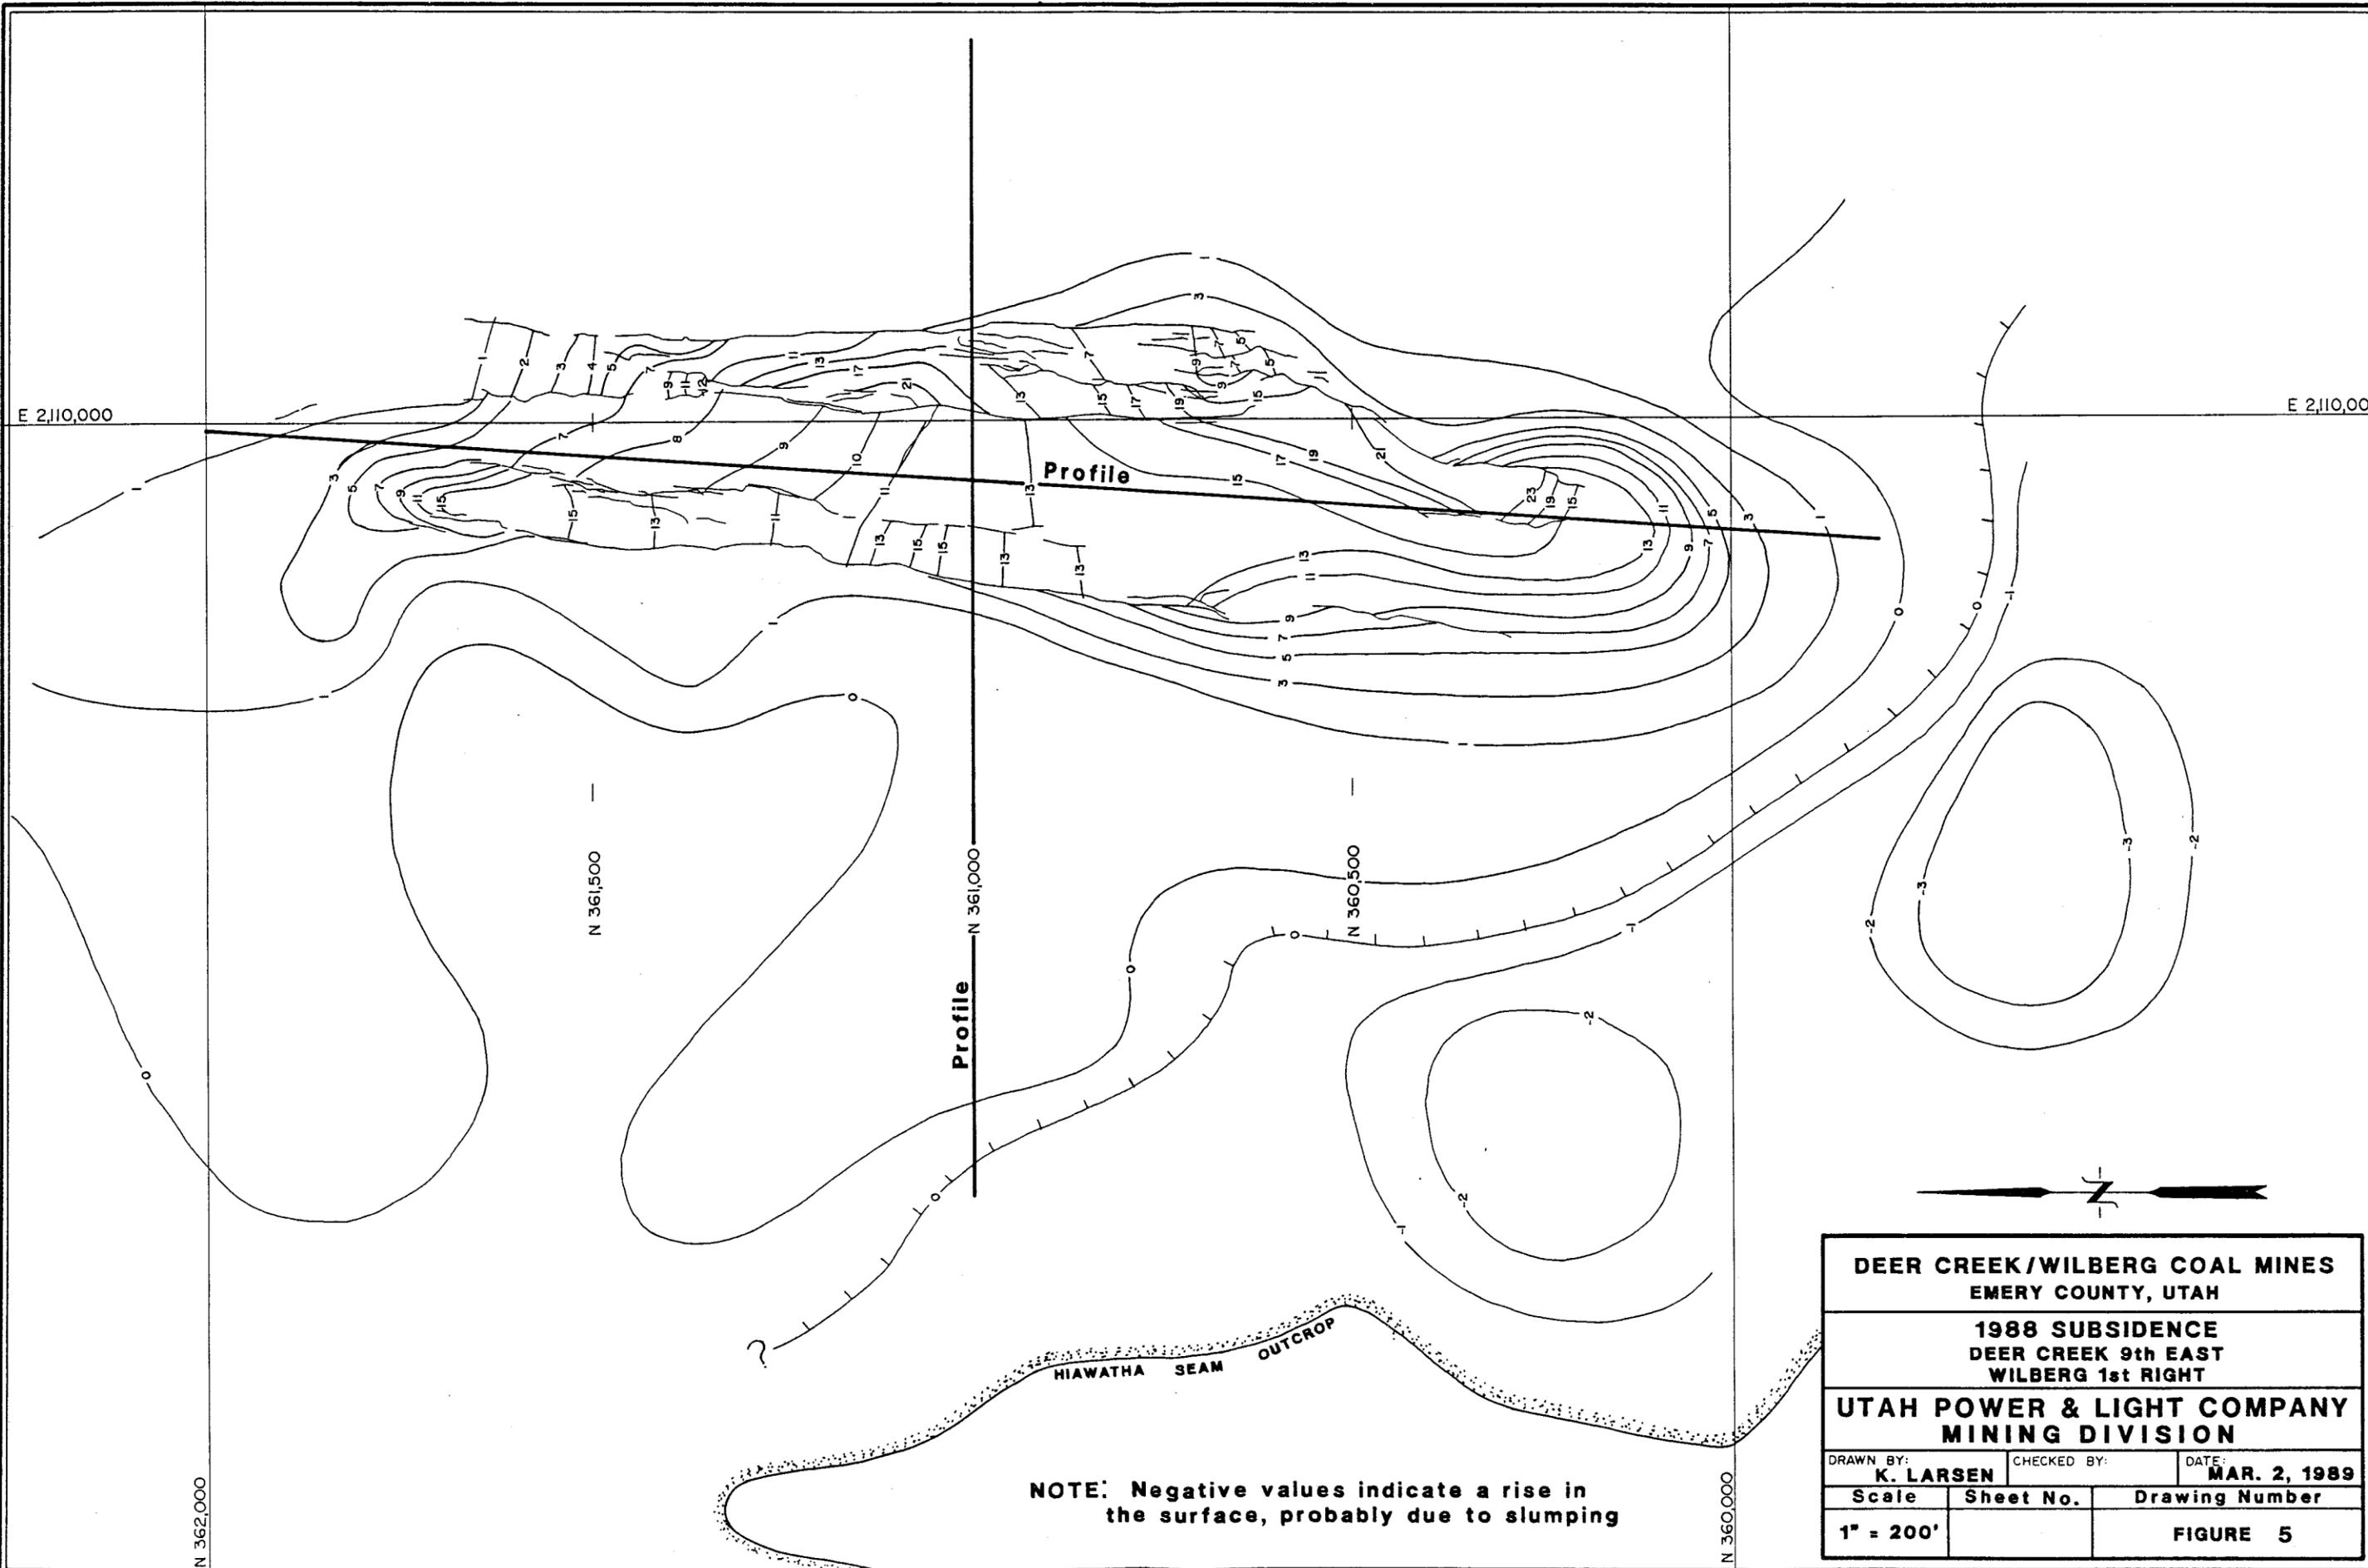
DEER CREEK/WILBERG COAL MINES EMERY COUNTY, UTAH		
1988 SUBSIDENCE DEER CREEK 9th EAST WILBERG 1st RIGHT		
UTAH POWER & LIGHT COMPANY MINING DIVISION		
DRAWN BY: K. LARSEN	CHECKED BY:	DATE: MAR. 2, 1989
Scale 1" = 200'	Sheet No.	Drawing Number FIGURE 5

Figures 6 and 7 are north to south and west to east profiles showing the amount of subsidence in this area during the past seven years. The location of each line is shown on Figure 5. The area has seen little change since 1985. Maximum subsidence remains at about twenty-five (25) feet. A detailed look from a helicopter revealed that the subsidence maximum is located on a steep slope, about 200 feet south of the southernmost mining, where a good-sized rotational slump has occurred. The workings here are also surrounded by burned coal. It is probable that the combination of steep slopes and crushing of clinker beds has allowed subsidence to occur well outside the area of mine workings. An inspection of the area from the ground indicates that many of the open fractures forming the graben-like structure have begun to heal and fill in with soil.

NOTE: Negative values indicate a rise in the surface, probably due to slumping

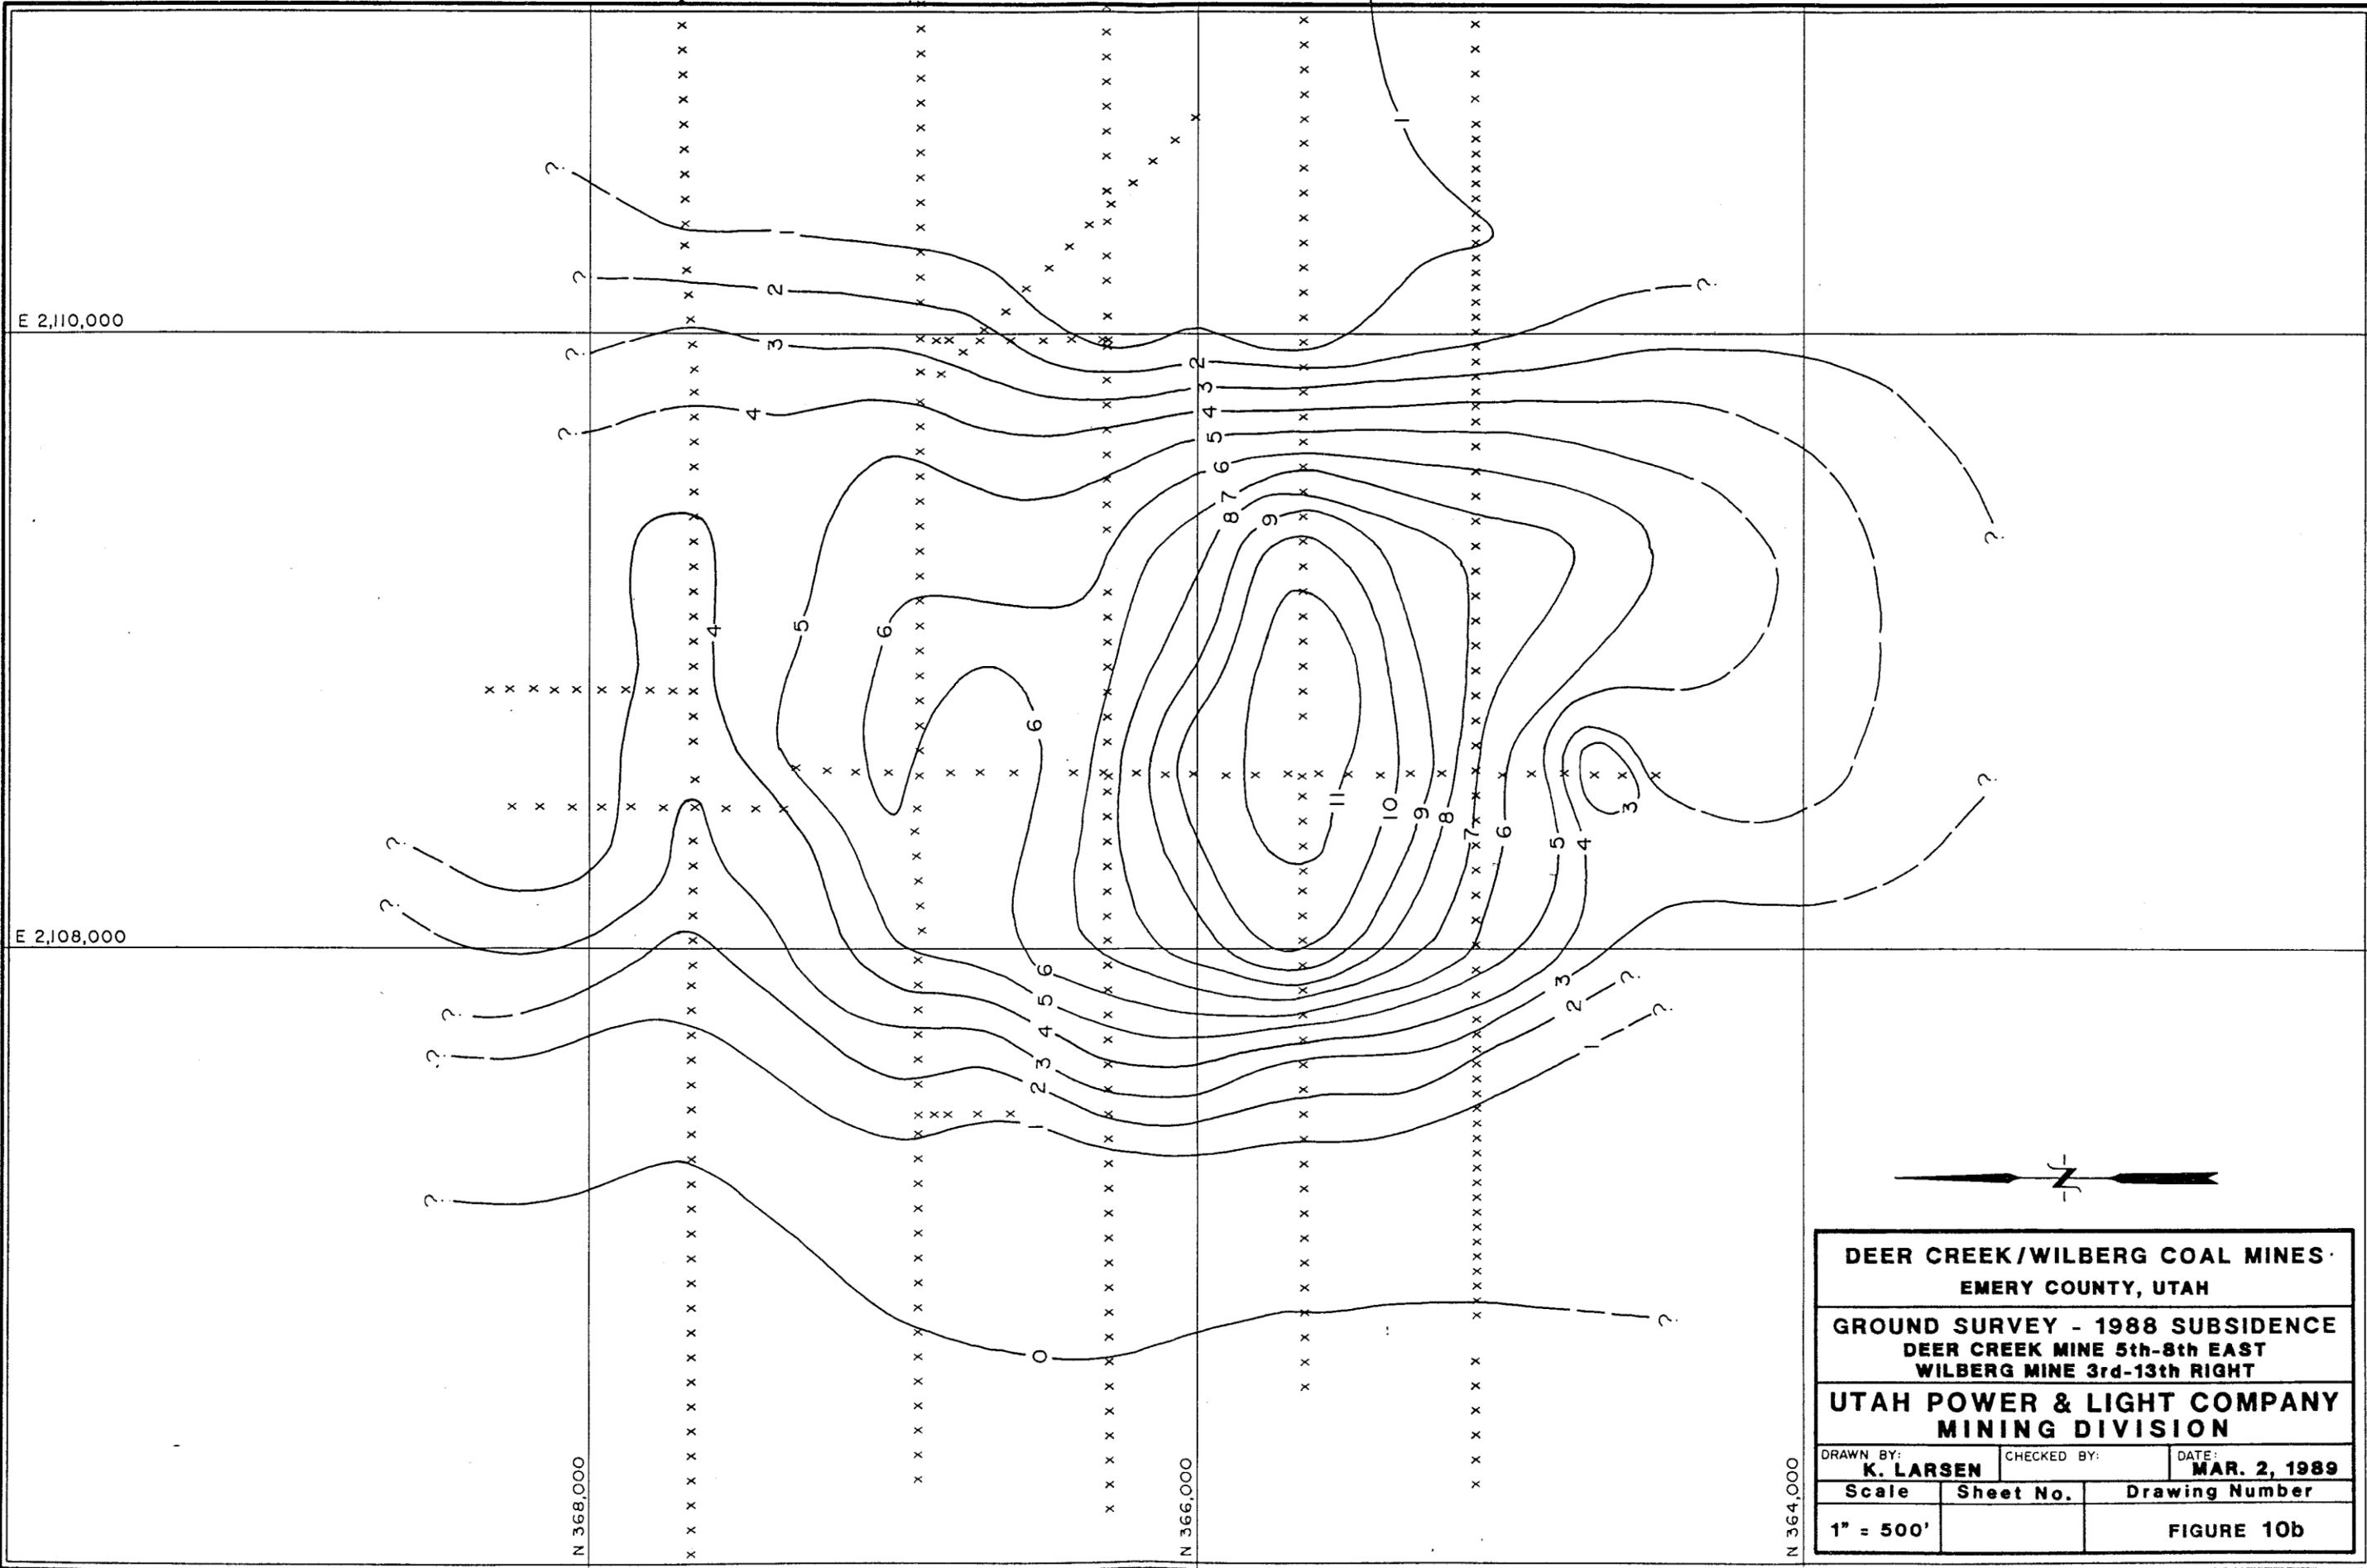
DEER CREEK/WILBERG COAL MINES		
EMERY COUNTY, UTAH		
GROUND SURVEY - 1988 SUBSIDENCE		
DEER CREEK MINE 5th-8th EAST		
WILBERG MINE 3rd-13th RIGHT		
UTAH POWER & LIGHT COMPANY		
MINING DIVISION		
DRAWN BY: K. LARSEN	CHECKED BY:	DATE: MAR. 2, 1989
Scale	Sheet No.	Drawing Number
1" = 500'		FIGURE 10b

In 1988 the area was surveyed by both photogrammetric methods and conventional on-the-ground methods. As usual the two methods show very close correlation but the photogrammetry gives more detail due to tighter grid spacing of the measurement points. UP&L has received permission to stop conventional surveying and use photogrammetry only. Maximum subsidence in Area 2 remains at just under twelve (12) feet and occurs over the Deer Creek 6th East and the Wilberg 6th and 7th Right longwall panels (Figure 10). The subsidence profiles (Figures 11 and 12) indicate that ground movement over much of the area has stabilized, but the subsidence trough continues to elongate over the most recently mined panels. Neither UP&L nor other contracted personnel have detected any surface fissures or other visible disturbance in the area.

Angle-of-draw has been calculated where possible. On the eastern side of Area 2 the angle is influenced by the Deer Creek Fault and the adjacent Little Dove Mine workings across the fault; it ranges from near vertical to 12 degrees. On other sides it ranges from less than zero to 36 degrees.

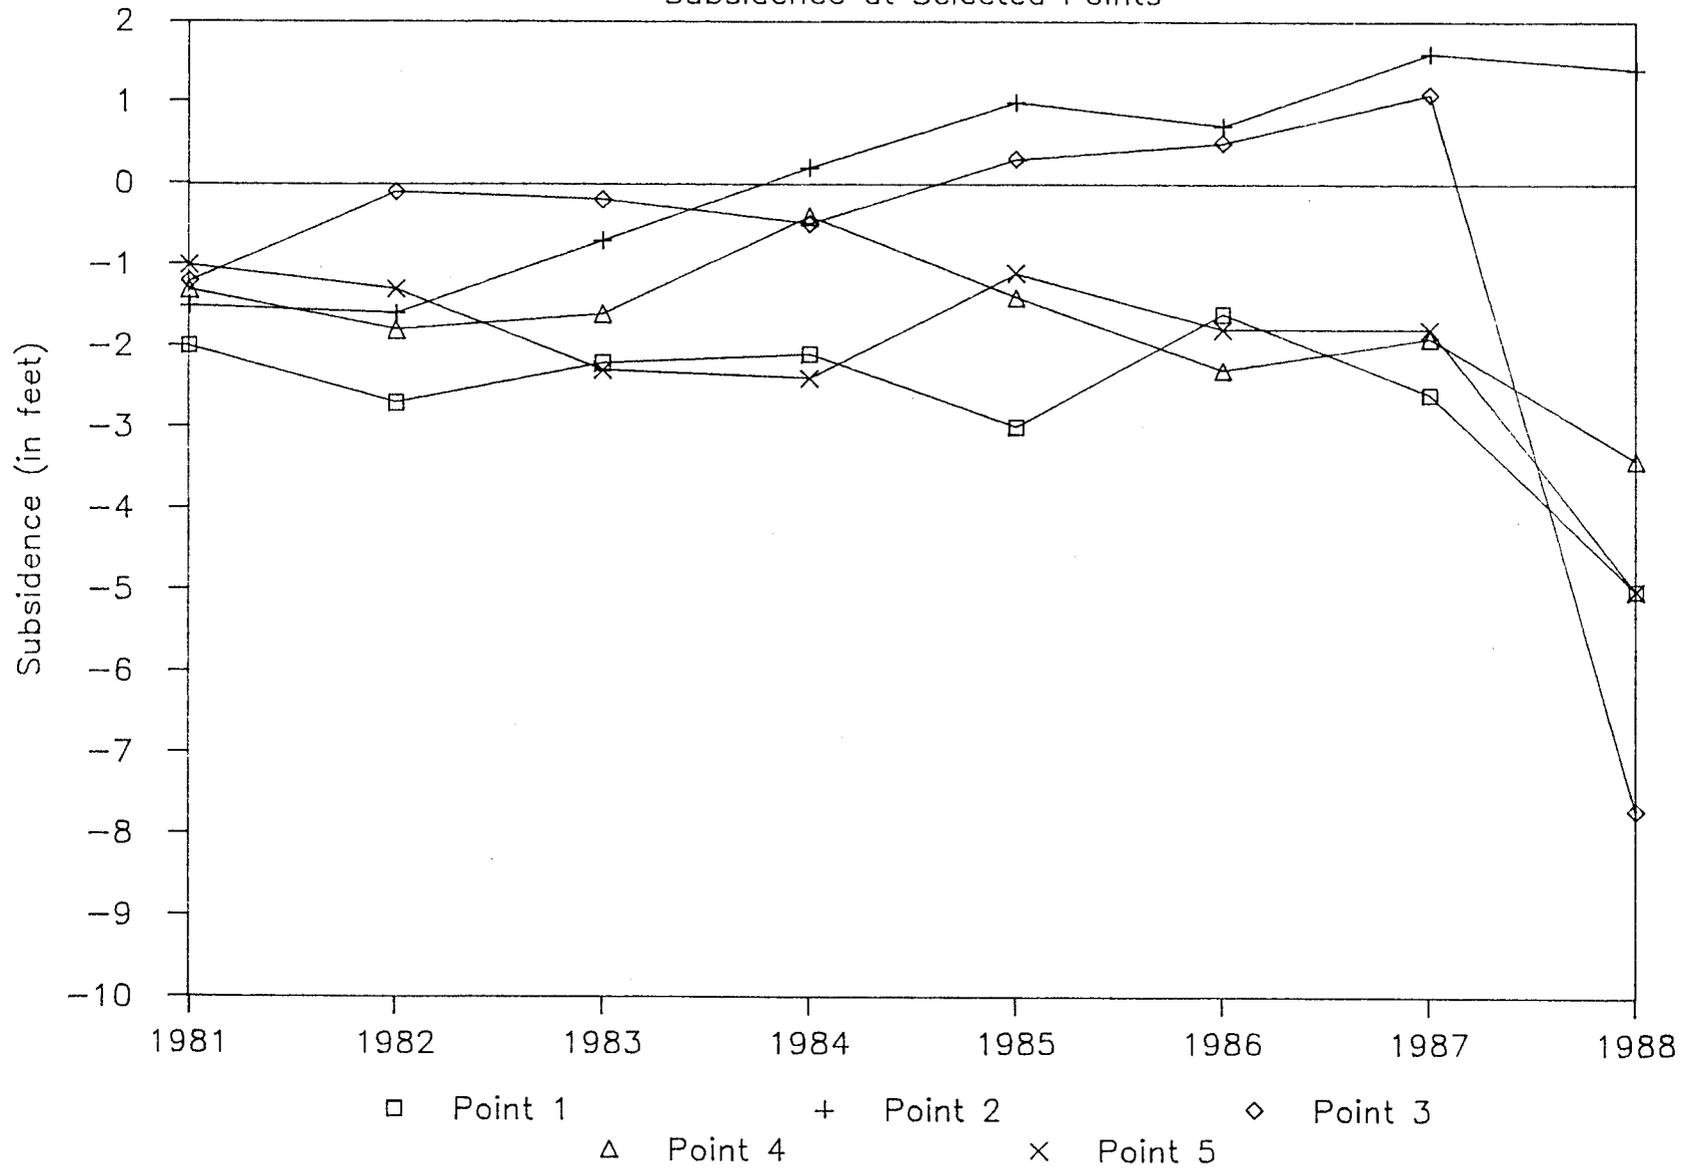
FIGURE 14

Most of the 1st North section of the Deer Creek Mine was abandoned and sealed in 1978 after being mined out. The southern portion is still open and may be used for access to a block of coal which lies to the west. Pillar extraction in the 3rd Left and 1-1/2 North sections was completed early in 1980 (Figure 13). The greatest subsidence measured over these points was over seven (7) feet. The large change at that point may be due to a localized cliff or ledge failure since it appears so anomalous.

It appears that in the 1st North area the ground has not stabilized. The subsidence above 1st North occurs on a narrow ridge capped by a highly fractured sandstone, and a review of the subsidence data indicates that, due to the mode of subsidence, elevation change cannot be depicted accurately with a contour map. Figure 14 is a graph of subsidence as it occurred at several points above the 1st North workings. Elevations are not consistent from year to year at a given point. One explanation is that the magnitude of the subsidence is on the order of the precision of the measurements. Keeping this in mind, all but point 2 showed subsidence in 1988. The large change at point 3 appears anomalous and may be due to a localized cliff or ledge failure.

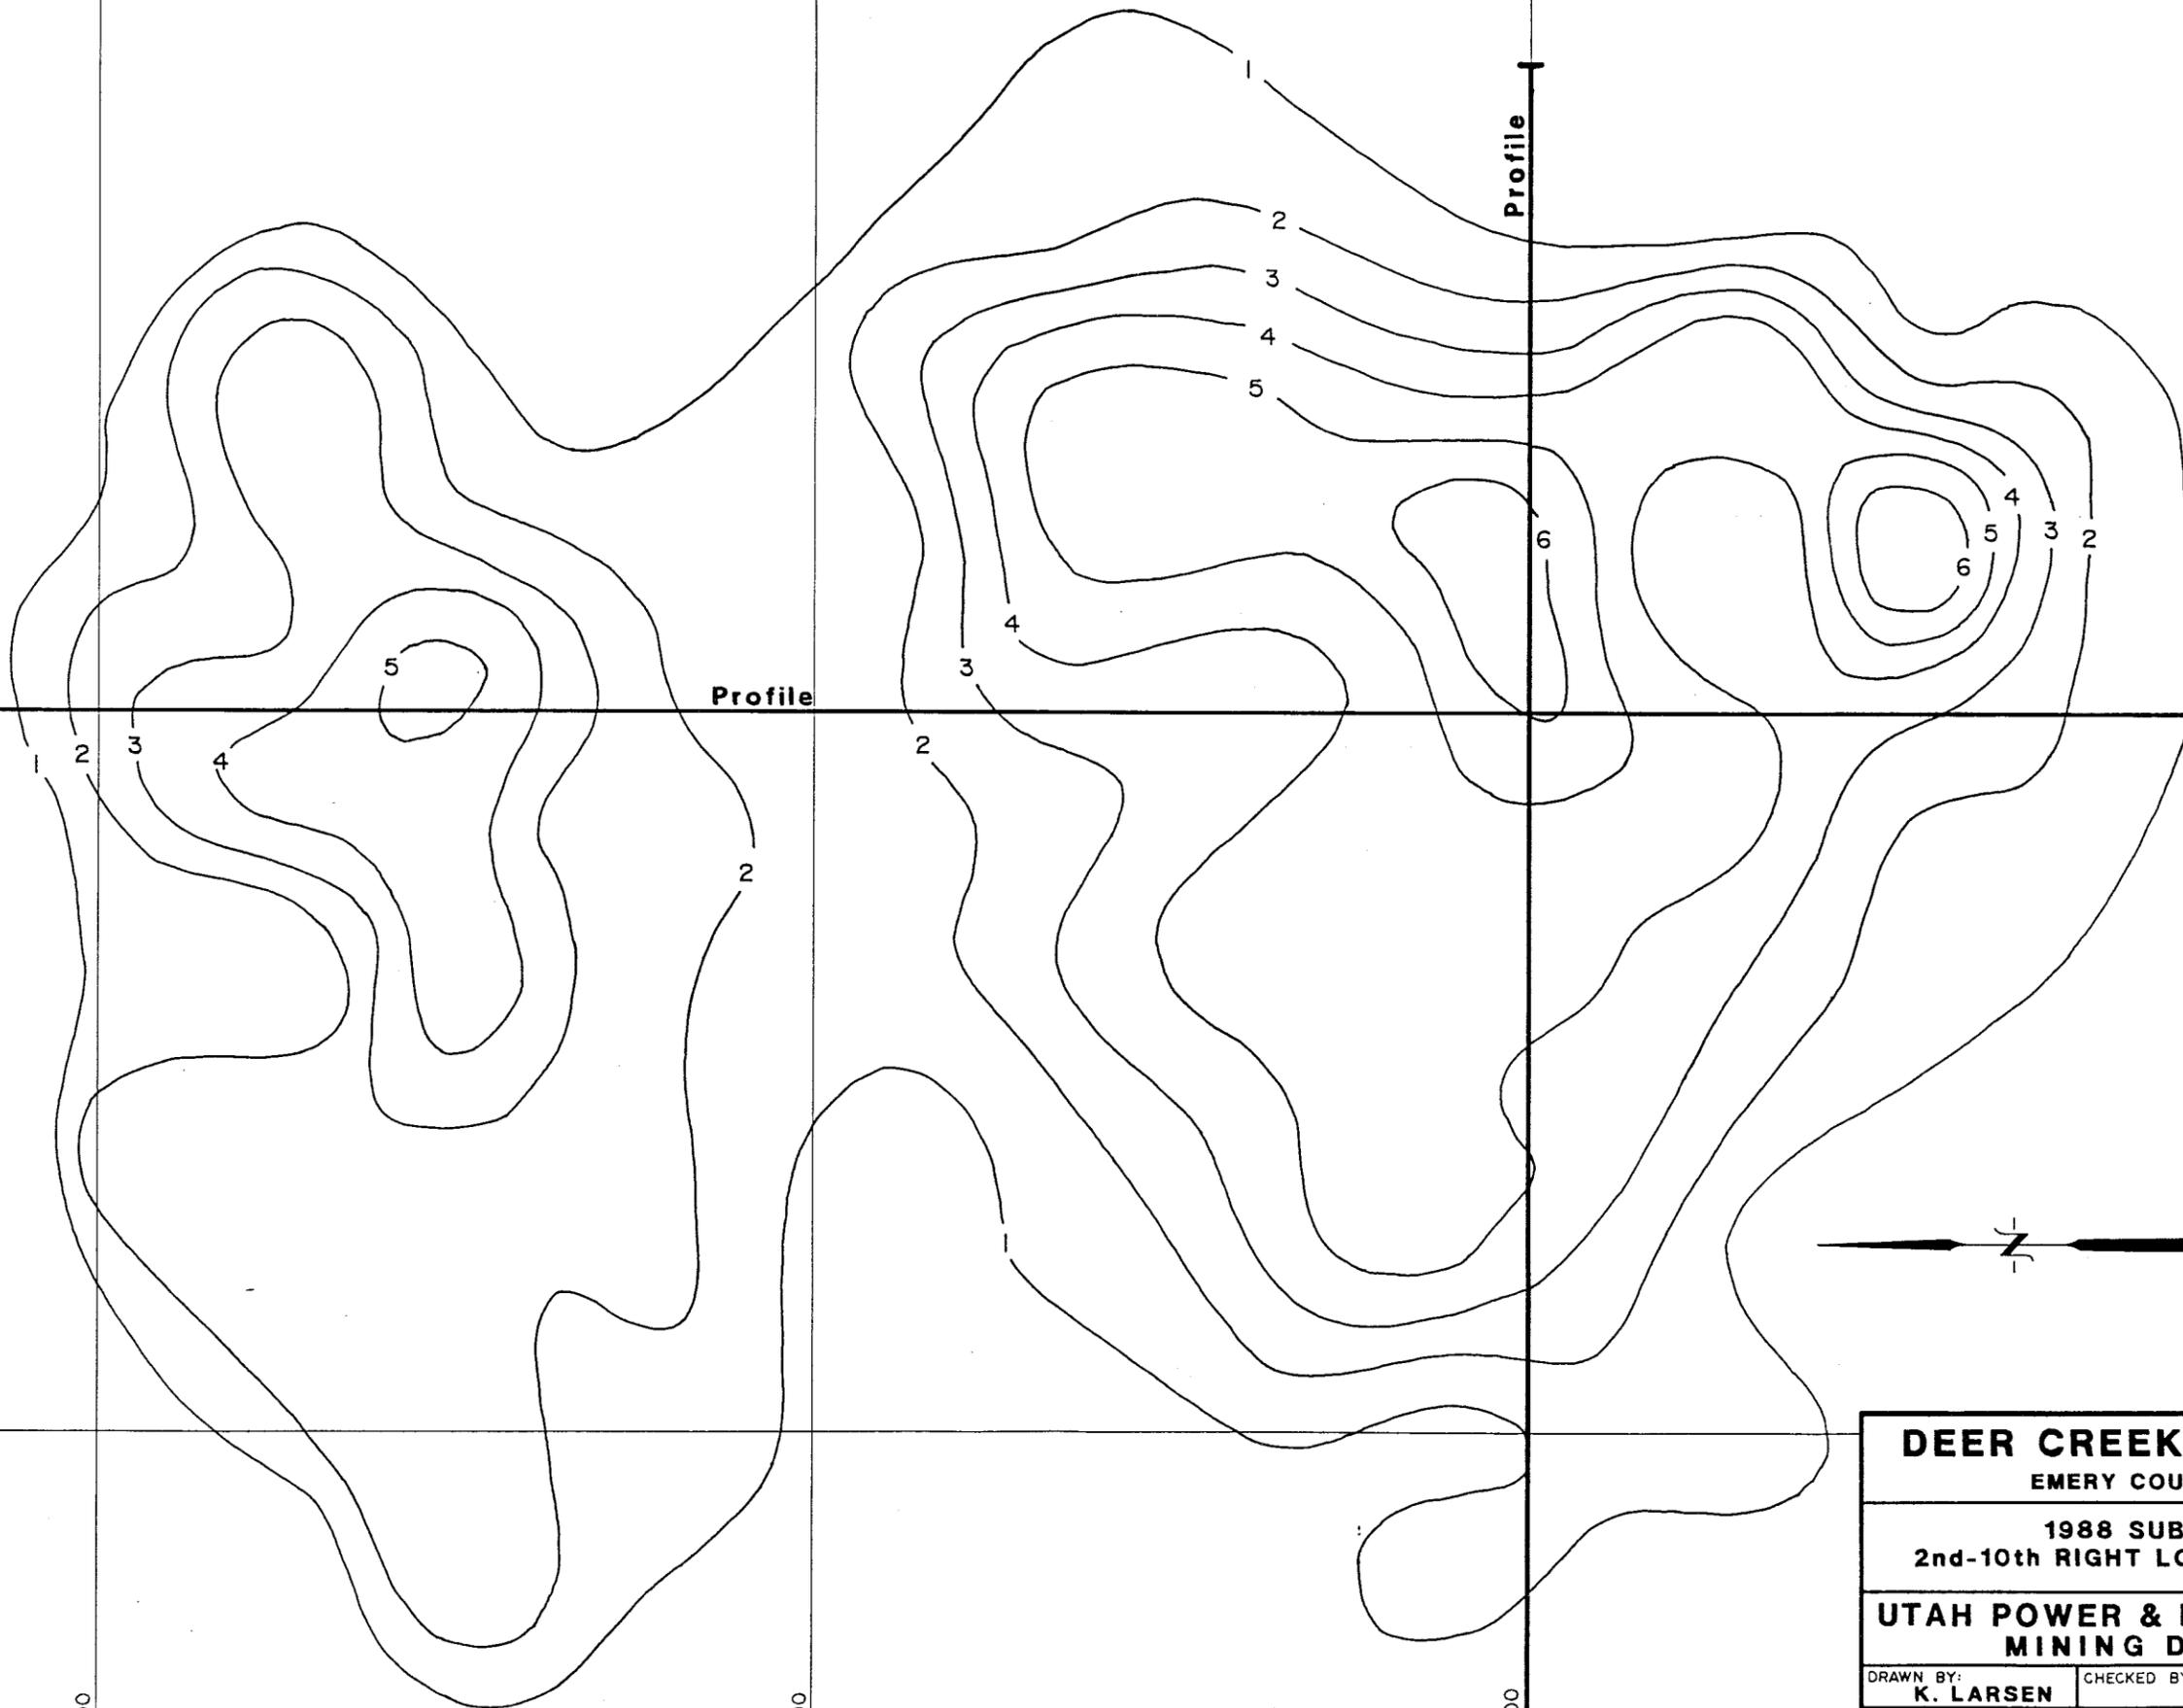
DEER CREEK COAL MINE		
EMERY COUNTY, UTAH		
1988 SUBSIDENCE		
2nd-10th RIGHT LONGWALL PANELS		
UTAH POWER & LIGHT COMPANY		
MINING DIVISION		
DRAWN BY: K. LARSEN	CHECKED BY:	DATE: MAR. 9, 1989
Scale	Sheet No.	Drawing Number
1" = 500'		FIGURE 16

For the third successive year the maximum subsidence is just under seven (7) feet over the 3rd and 4th Right longwall panels (Figure 16), indicating that the maximum subsidence may have been reached for this area. The subsidence trough continues to extend northward over the most recent 9th and 10th Right longwall panels (see Subsidence Profiles, Figures 17 and 18). The calculated angle-of-draw of the subsidence ranges from less than zero to 18 degrees.

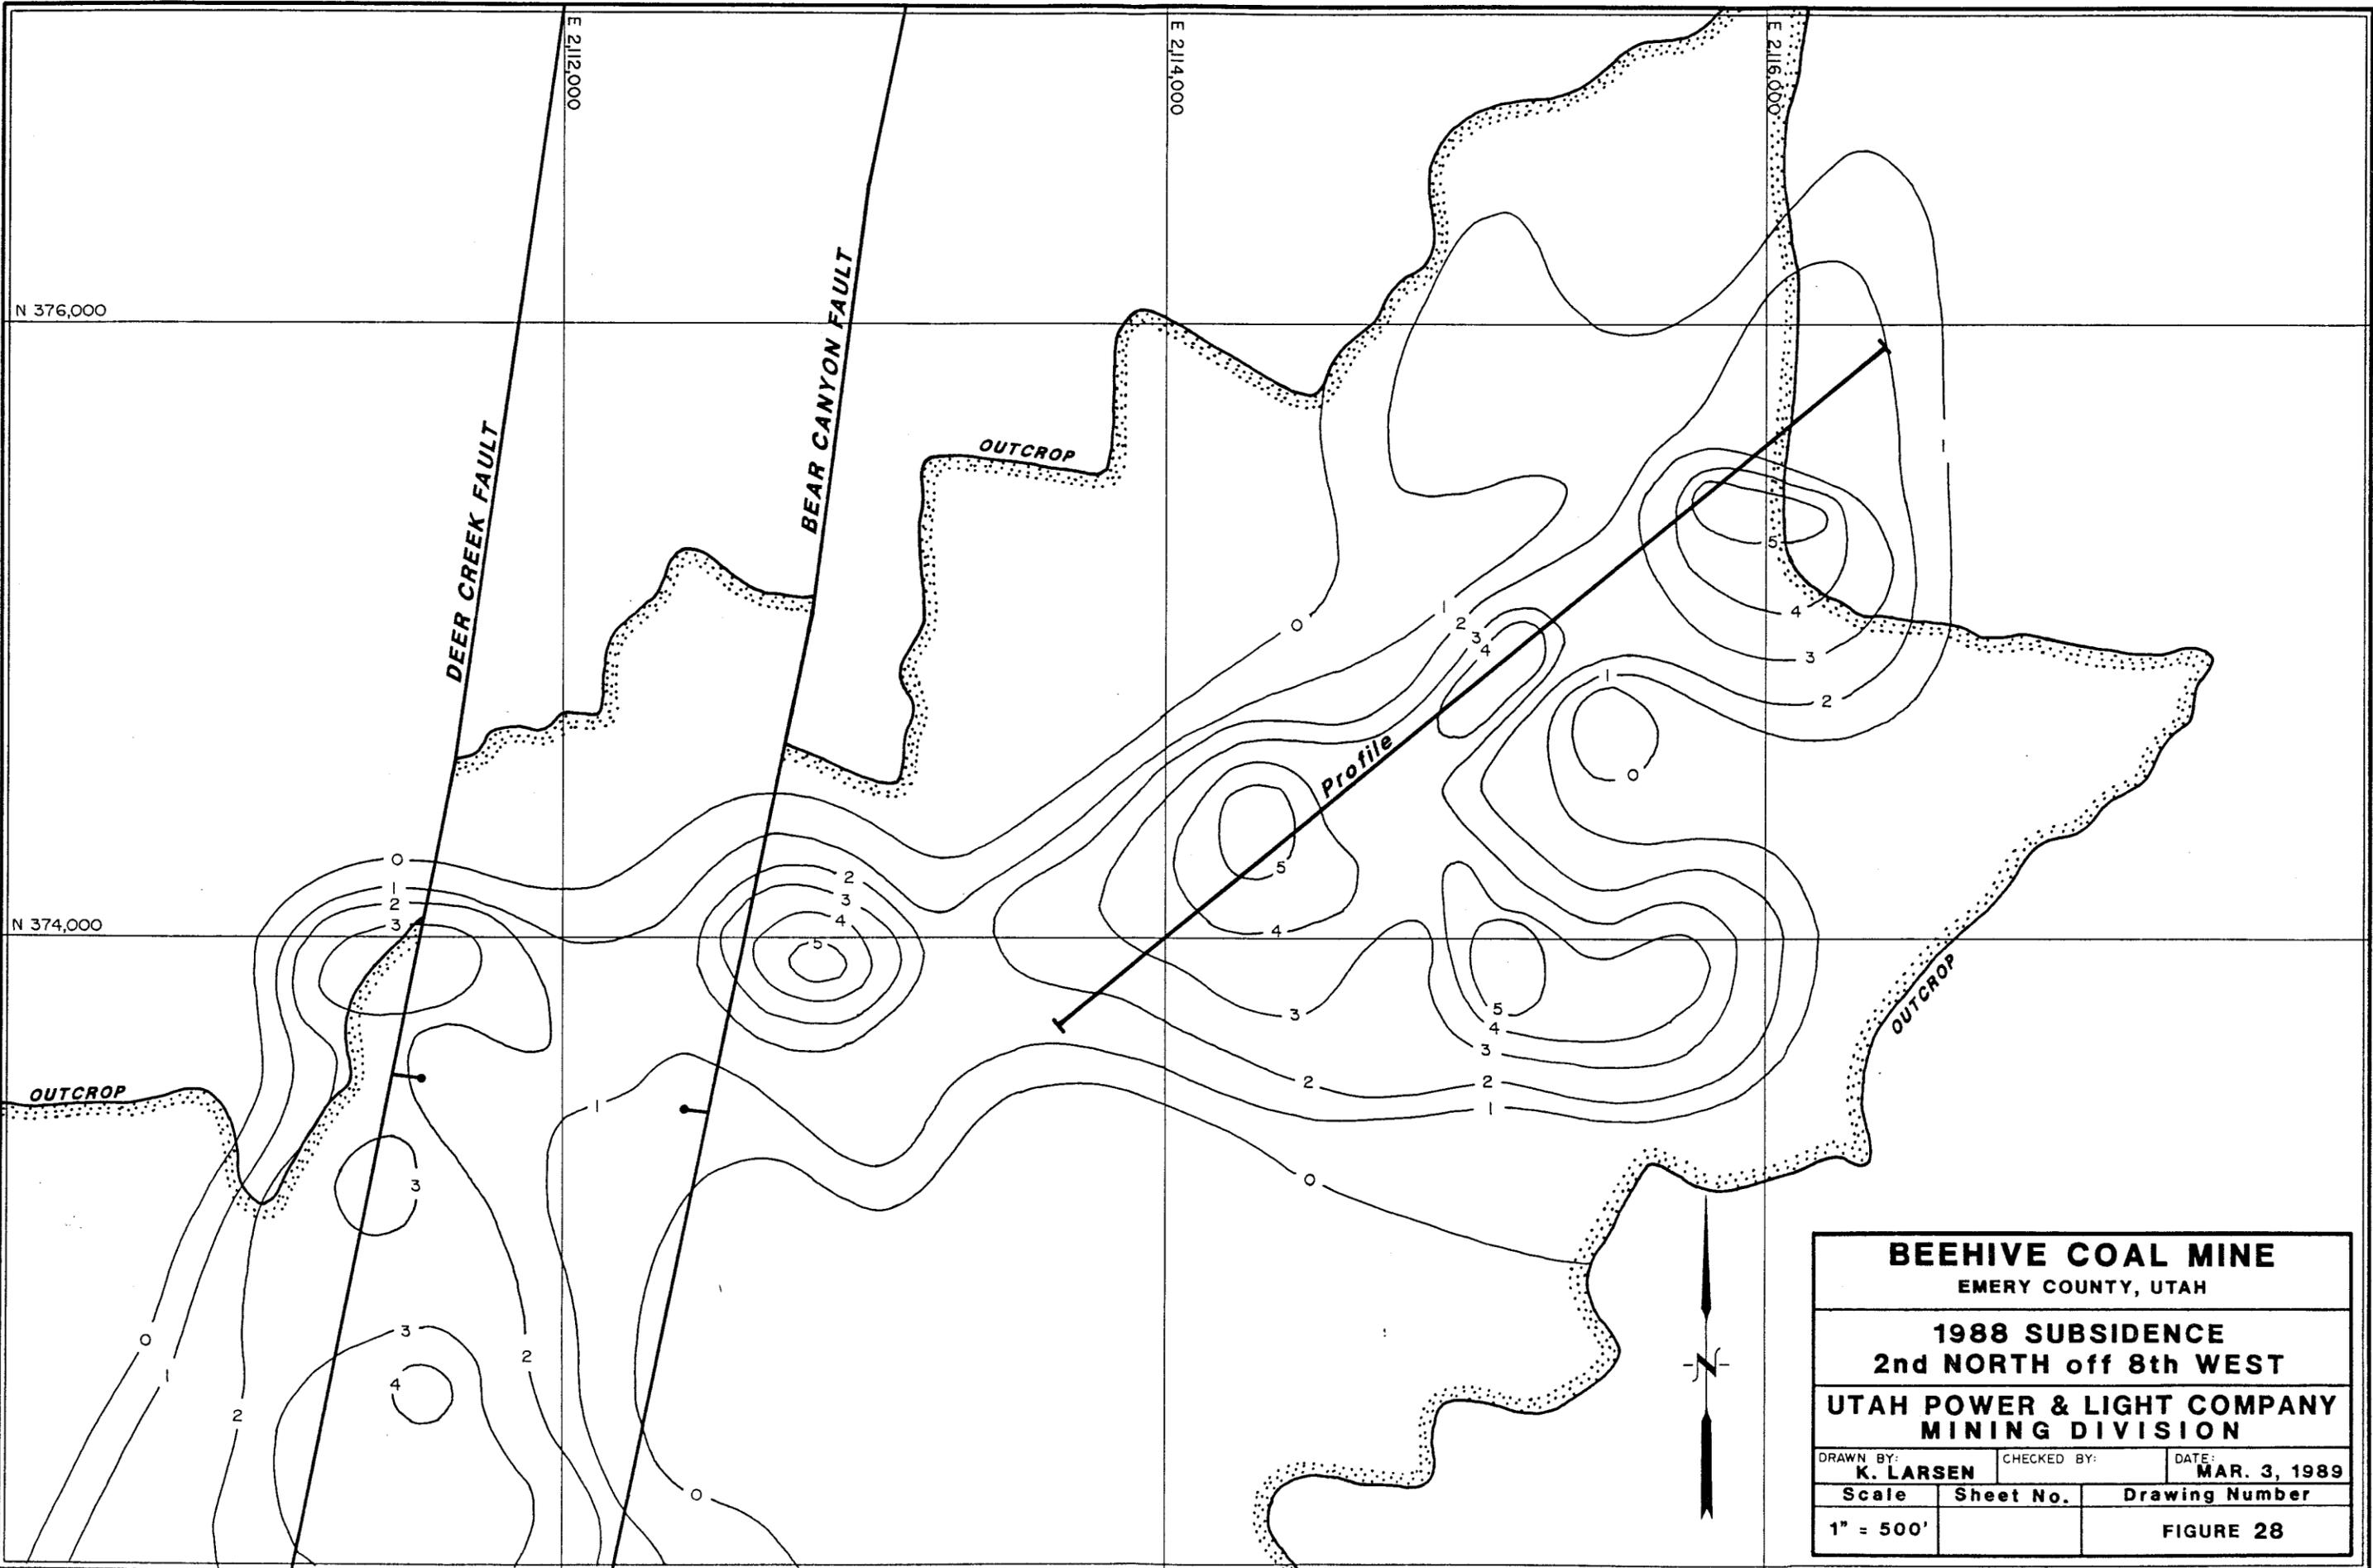
BEEHIVE COAL MINE		
EMERY COUNTY, UTAH		
1988 SUBSIDENCE		
2nd NORTH off 8th WEST		
UTAH POWER & LIGHT COMPANY		
MINING DIVISION		
DRAWN BY: K. LARSEN	CHECKED BY:	DATE: MAR. 3, 1989
Scale	Sheet No.	Drawing Number
1" = 500'		FIGURE 28

Pillar extraction mining in 2nd North was completed in 1983 and, as shown in Figures 28 and 29, little additional subsidence has occurred over the workings since 1984. Subsidence remains at about six (6) feet and, owing to this stability, we also wish to discontinue annual monitoring of this area. For a more complete discussion of subsidence in Area 7, consult the 1986 or a previous report.

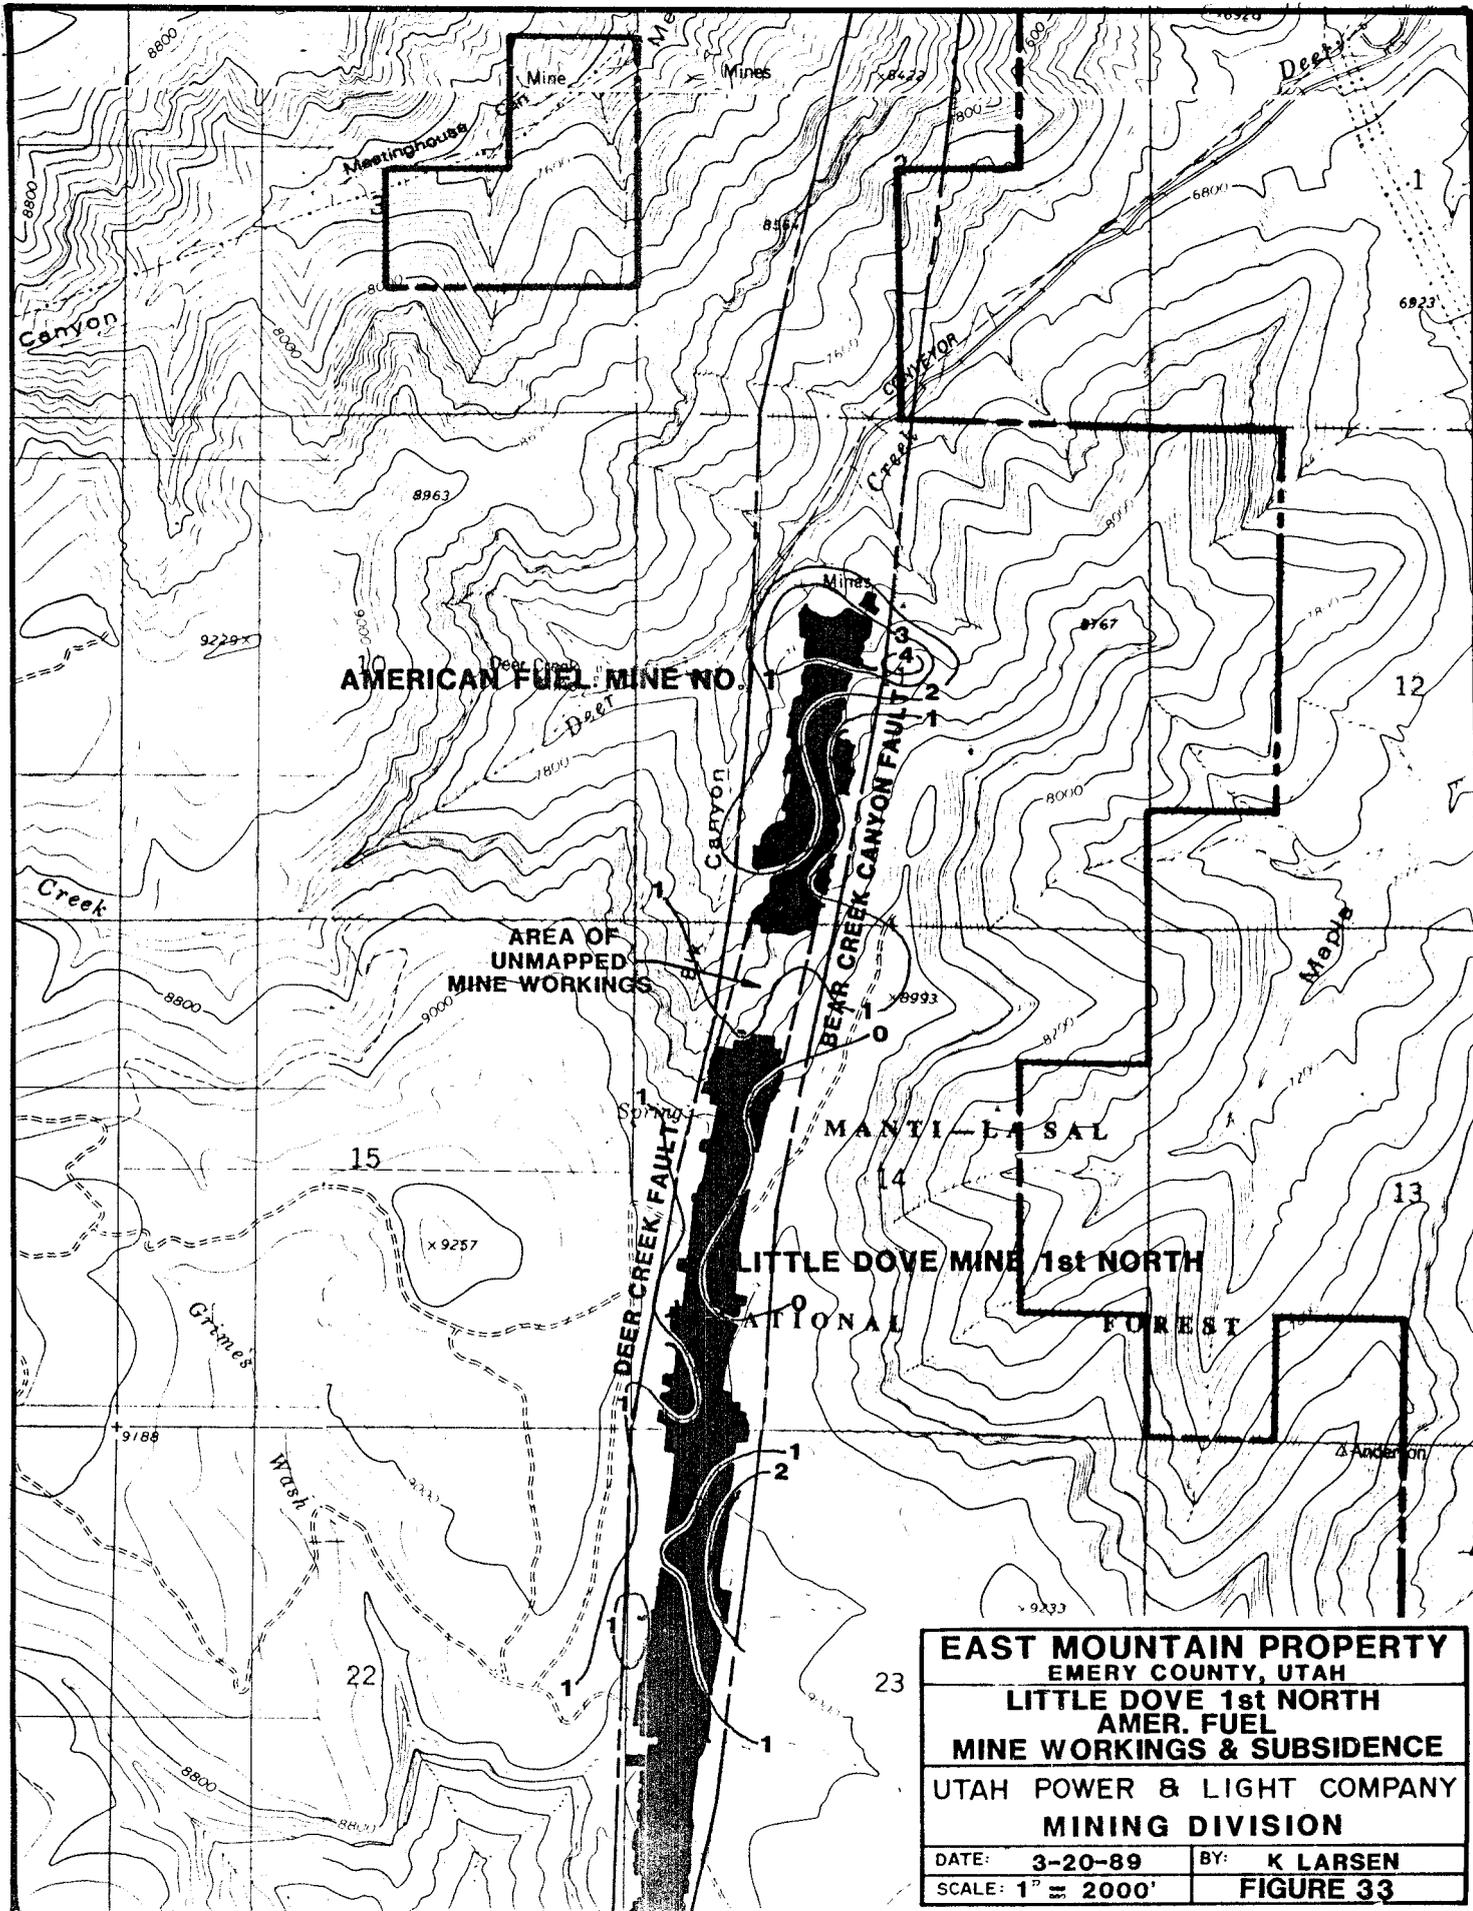
The 1st North section of the Little Dove Mine and the American Fuel Mine workings are located in a graben formed by the Deer Creek and Bear Creek Canyon faults (Figure 33). In August 1982 the Little Dove workings, mining in a northerly direction, intersected the old workings of the American Fuel Mine about 1000 feet south of where available maps indicated they extend. Mining conditions in that area of Little Dove revealed that strata were highly stressed. In some cases pillars were crushed before they could be extracted. At that time pillar extraction mining was begun in 1st North and continued to the south with minor interruptions from 1982 through much of 1987.

To date the maximum observed subsidence over 1st North is about two (2) feet, occurring over some of the most recently extracted pillars (Figure 33). The northern portions of the 1st North workings and subsidence are included in Area 8, which appears to have stabilized.
