UTAH POWER & LIGHT COMPANY
SUBSIDENCE MONITORING PROGRAM
ANNUAL REPORT FOR 1988

March 1989

United States Department of the Interior
Office of Surface Mining
Minerals Management Service
Utah Division of Oil, Gas and Mining

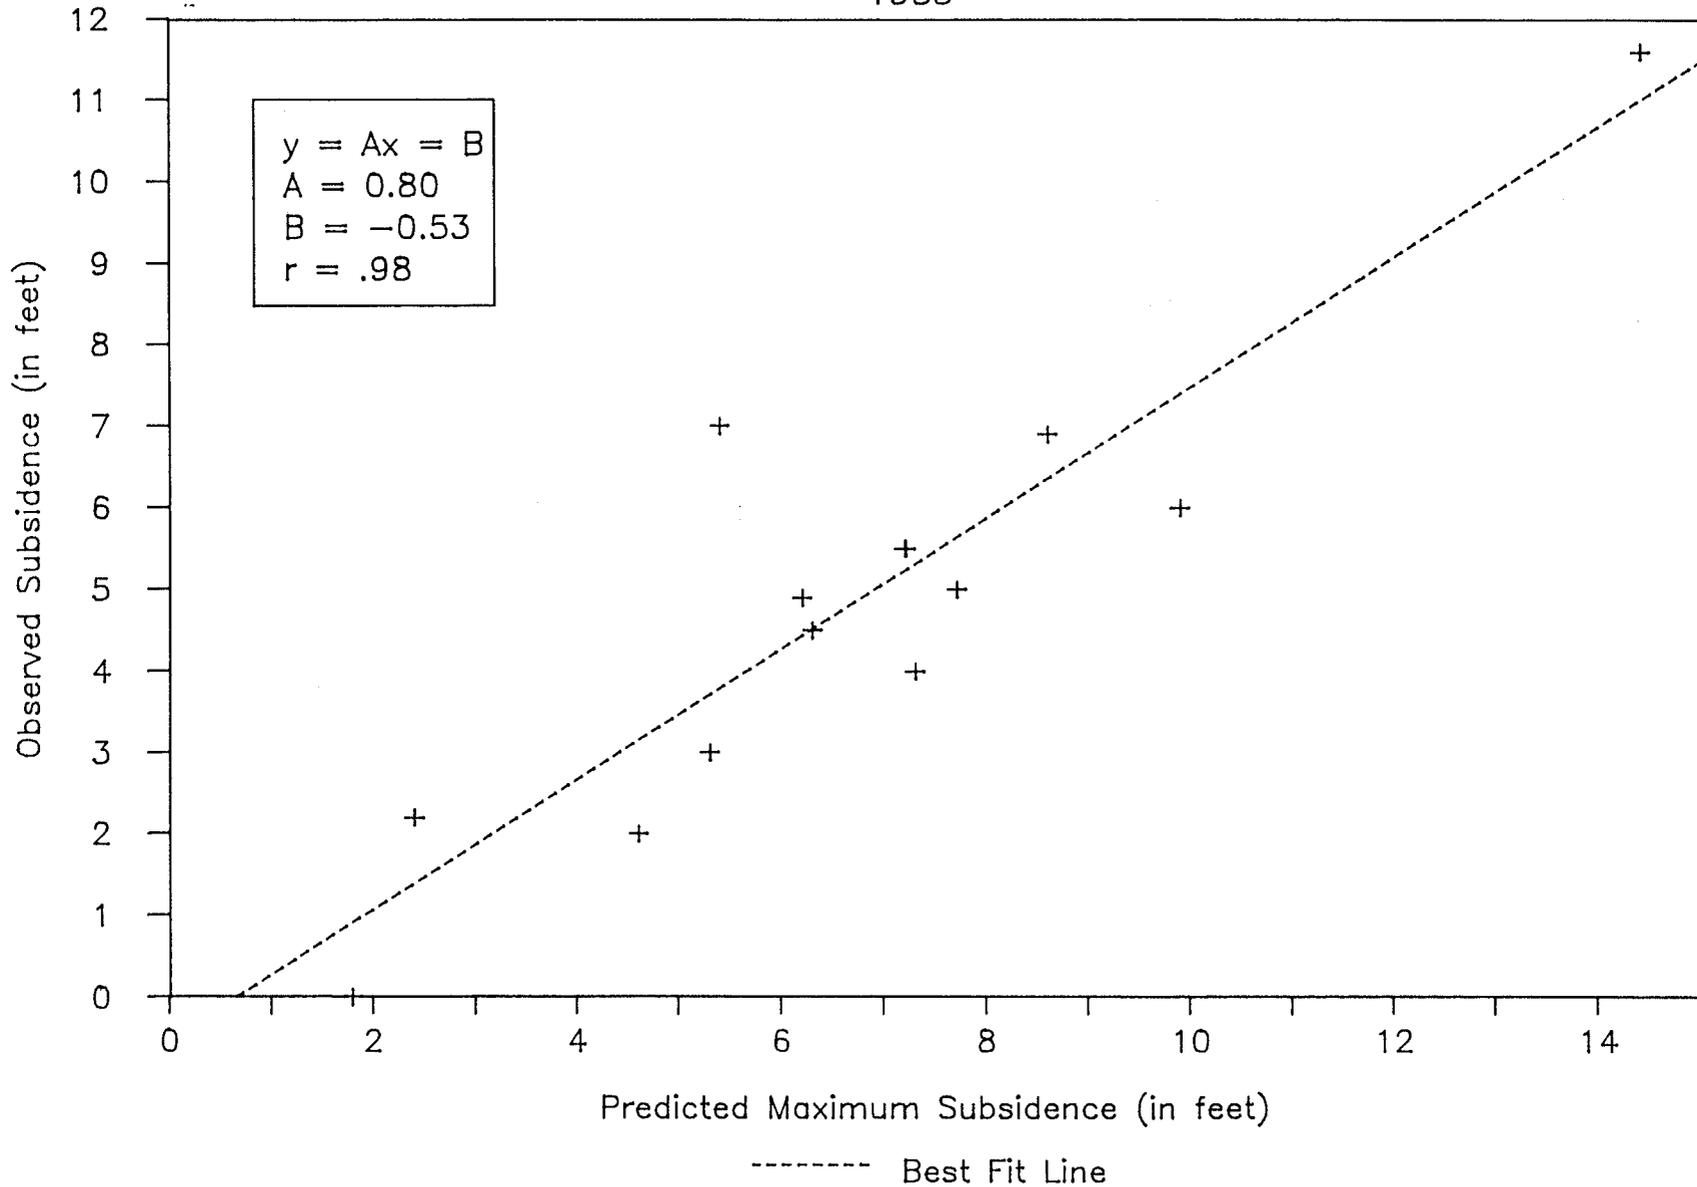
FIGURE 50

In all areas except one subsidence is less than the maximum predicted by the NCB model, possibly due to the fact that in some areas mining occurred very recently and subsidence has not yet reached its maximum. It could also be that the observed subsidence shown here represents the actual maximum subsidence for the particular geologic conditions -- probably the case in some areas since subsidence appears to have ceased in several areas where the NCB predicted maxima were not reached. Figure 50 shows the relationship between predicted and observed subsidence. From the slope of the regressions line ($A = .80$) the average observed subsidence is eighty percent (80%) of the NCB predicted maximum. (Area 1 excluded from graph data.)

Area 1 (DC 9th East - Wilberg 1st Right) is the one anomalous area; it does not fit the special conditions necessary for prediction by the NCB method. The mine workings are surrounded by burned coal and bounded on the east by the Deer Creek Fault. As mentioned before, crushing of clinker beds and movement along the fault have added another complication to the subsidence. The maximum subsidence in the area occurs on a steep slope below a cliff, where slumping has occurred. The twenty-five (25) feet measured here must be due in part to mass wasting on the steep slope.
