**CENTRAL ENGINEERING
ANNUAL SUBSIDENCE MONITORING REPORT
EAST MOUNTAIN PROPERTY
1990**

**PACIFICORP - FUEL RESOURCES
SUBSIDENCE MONITORING PROGRAM
ANNUAL REPORT FOR 1990**

**United States Department of the Interior
Office of Surface Mining
Minerals Management Service
Utah Division of Oil, Gas and Mining**

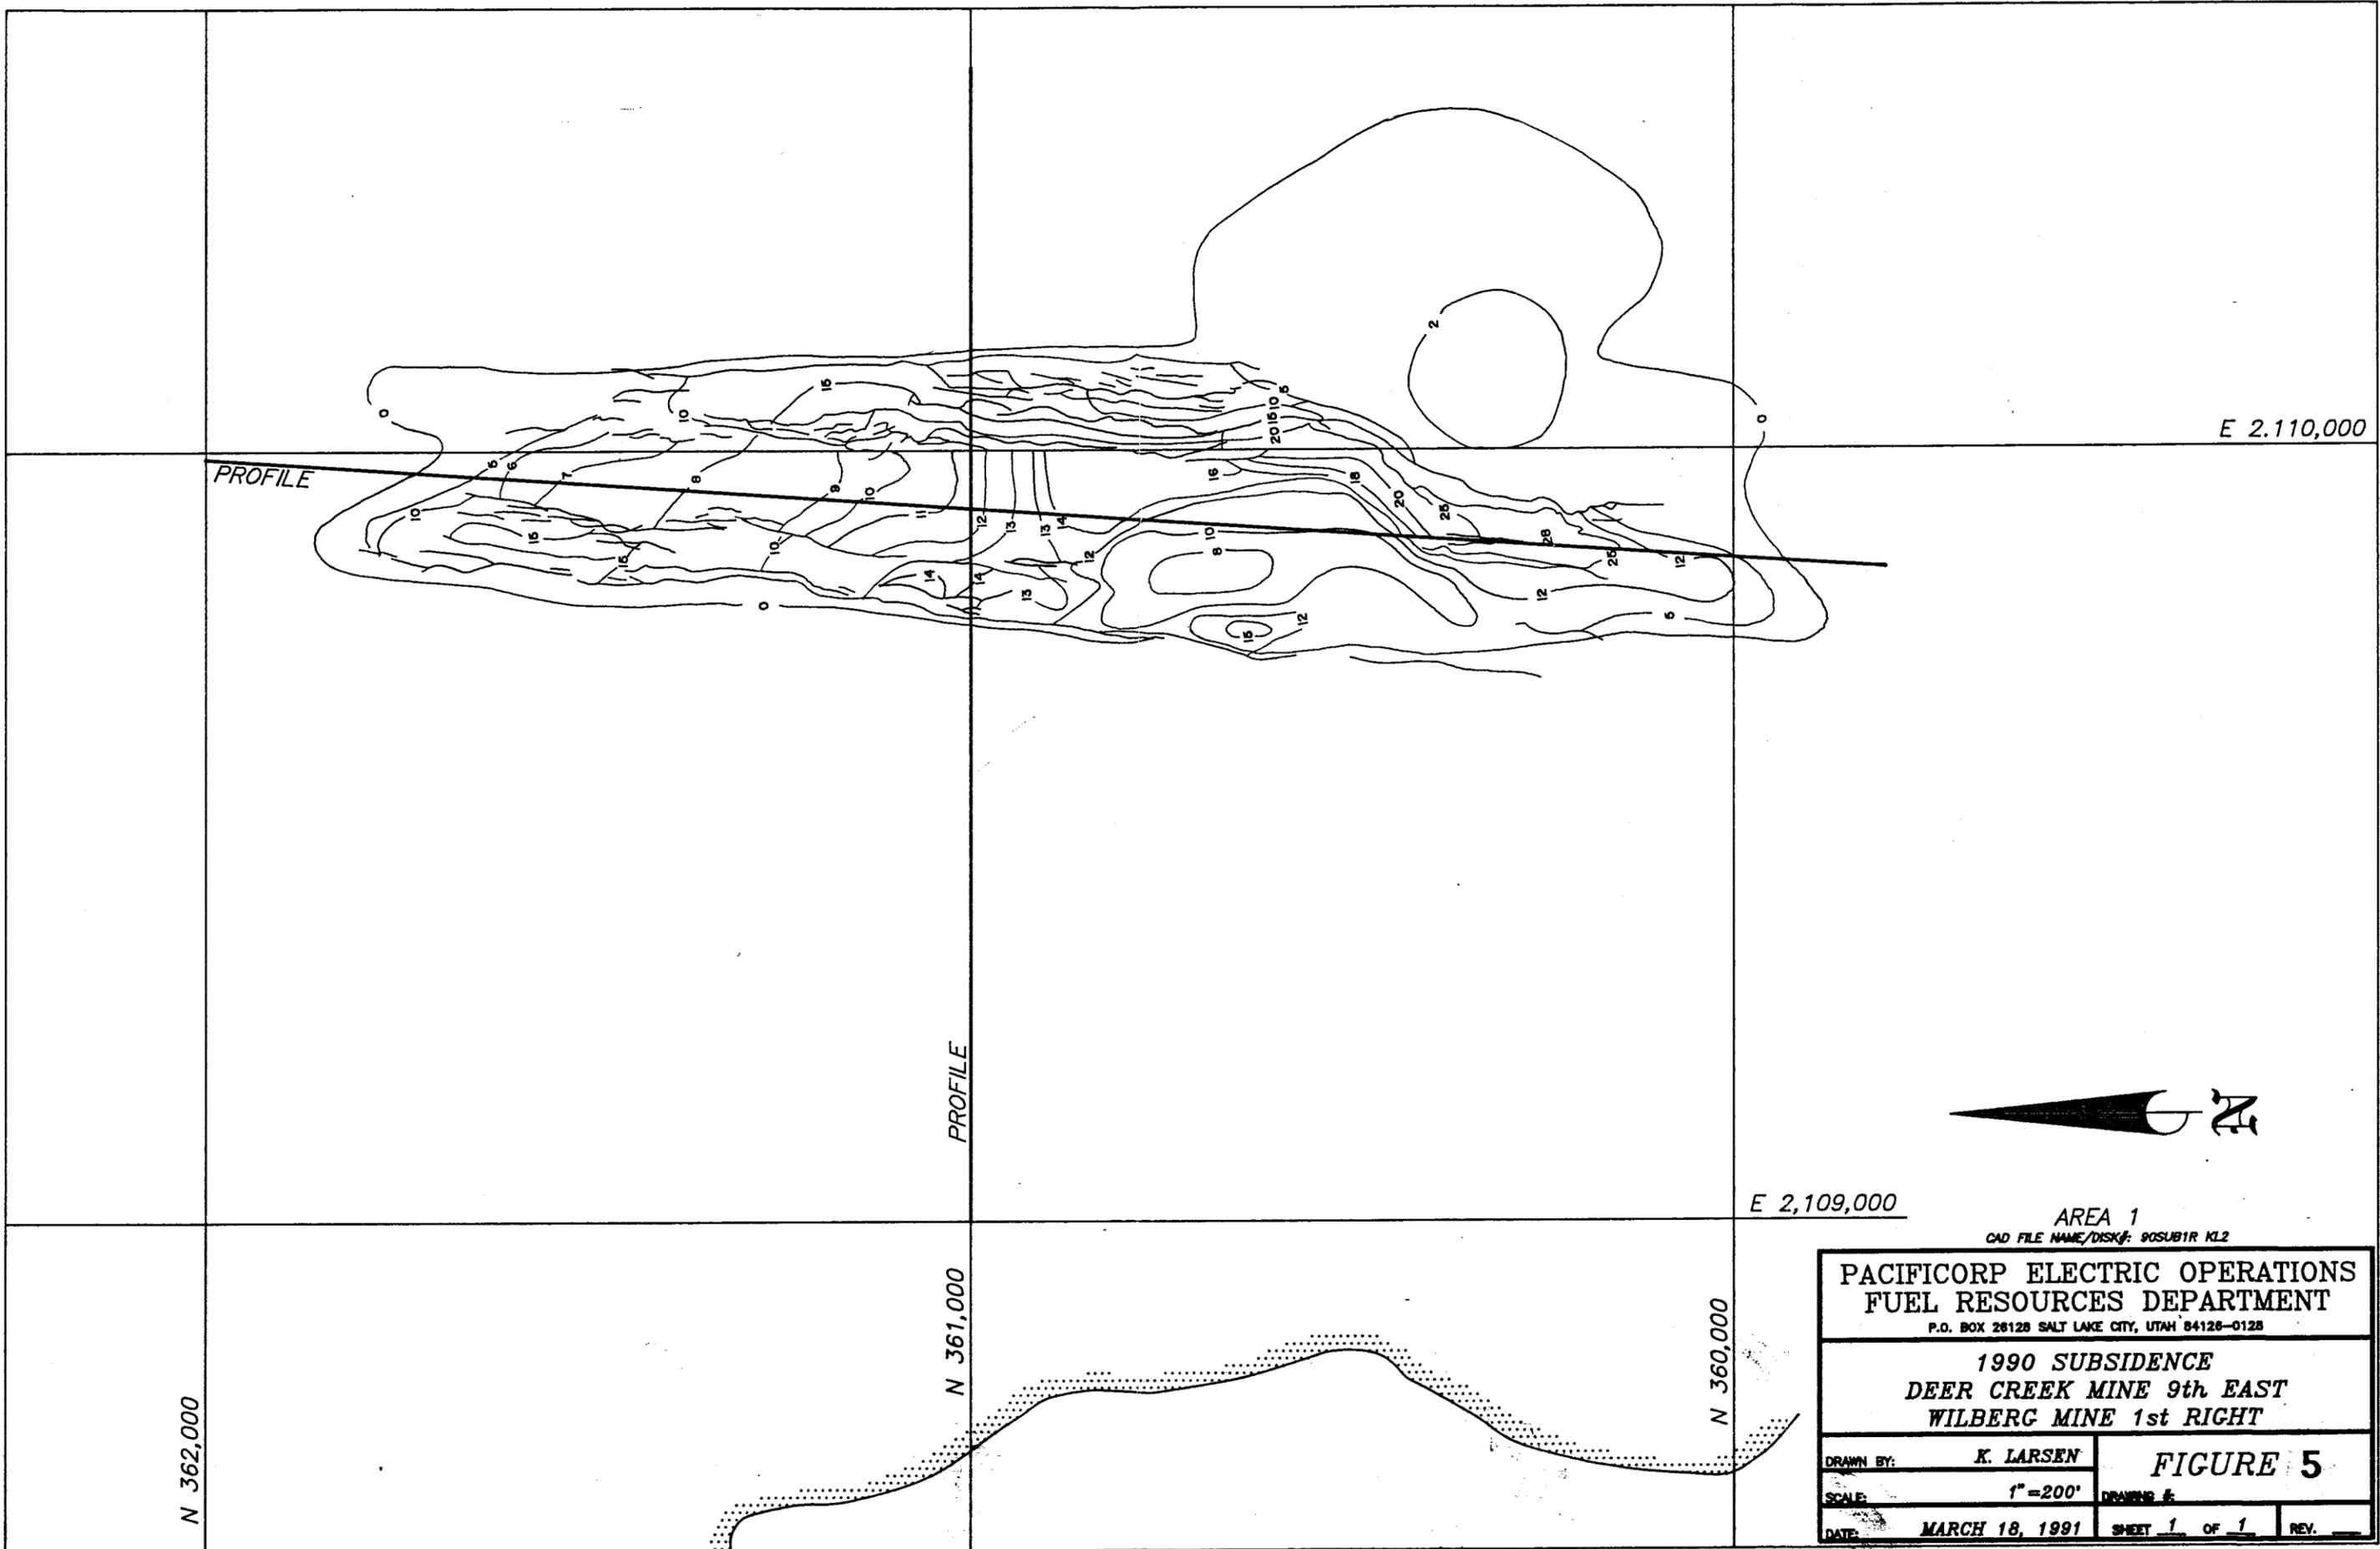
DRAWN BY: K. LARSEN	FIGURE 5
SCALE: 1" = 200'	DRAWING #
DATE: MARCH 18, 1991	SHEET 1 OF 1 REV.

Figures 6 and 7 are north to south and west to east profiles showing the amount of subsidence in this area during the past seven years. The location of each line is shown on Figure 5. The area has seen little change since 1985. Maximum subsidence remains at about twenty-eight (28) feet. A detailed look from a helicopter revealed that the subsidence maximum is located on a steep slope, about 200 feet south of the southernmost mining, where a good-sized rotational slump has occurred. The workings here are also surrounded by burned coal. It is probable that the combination of steep slopes and crushing of clinker beds has allowed subsidence to occur well outside the area of mine workings. An inspection of the area from the ground indicates that many of the open fractures forming the graben-like structure have begun to heal and fill in with soil.

3599

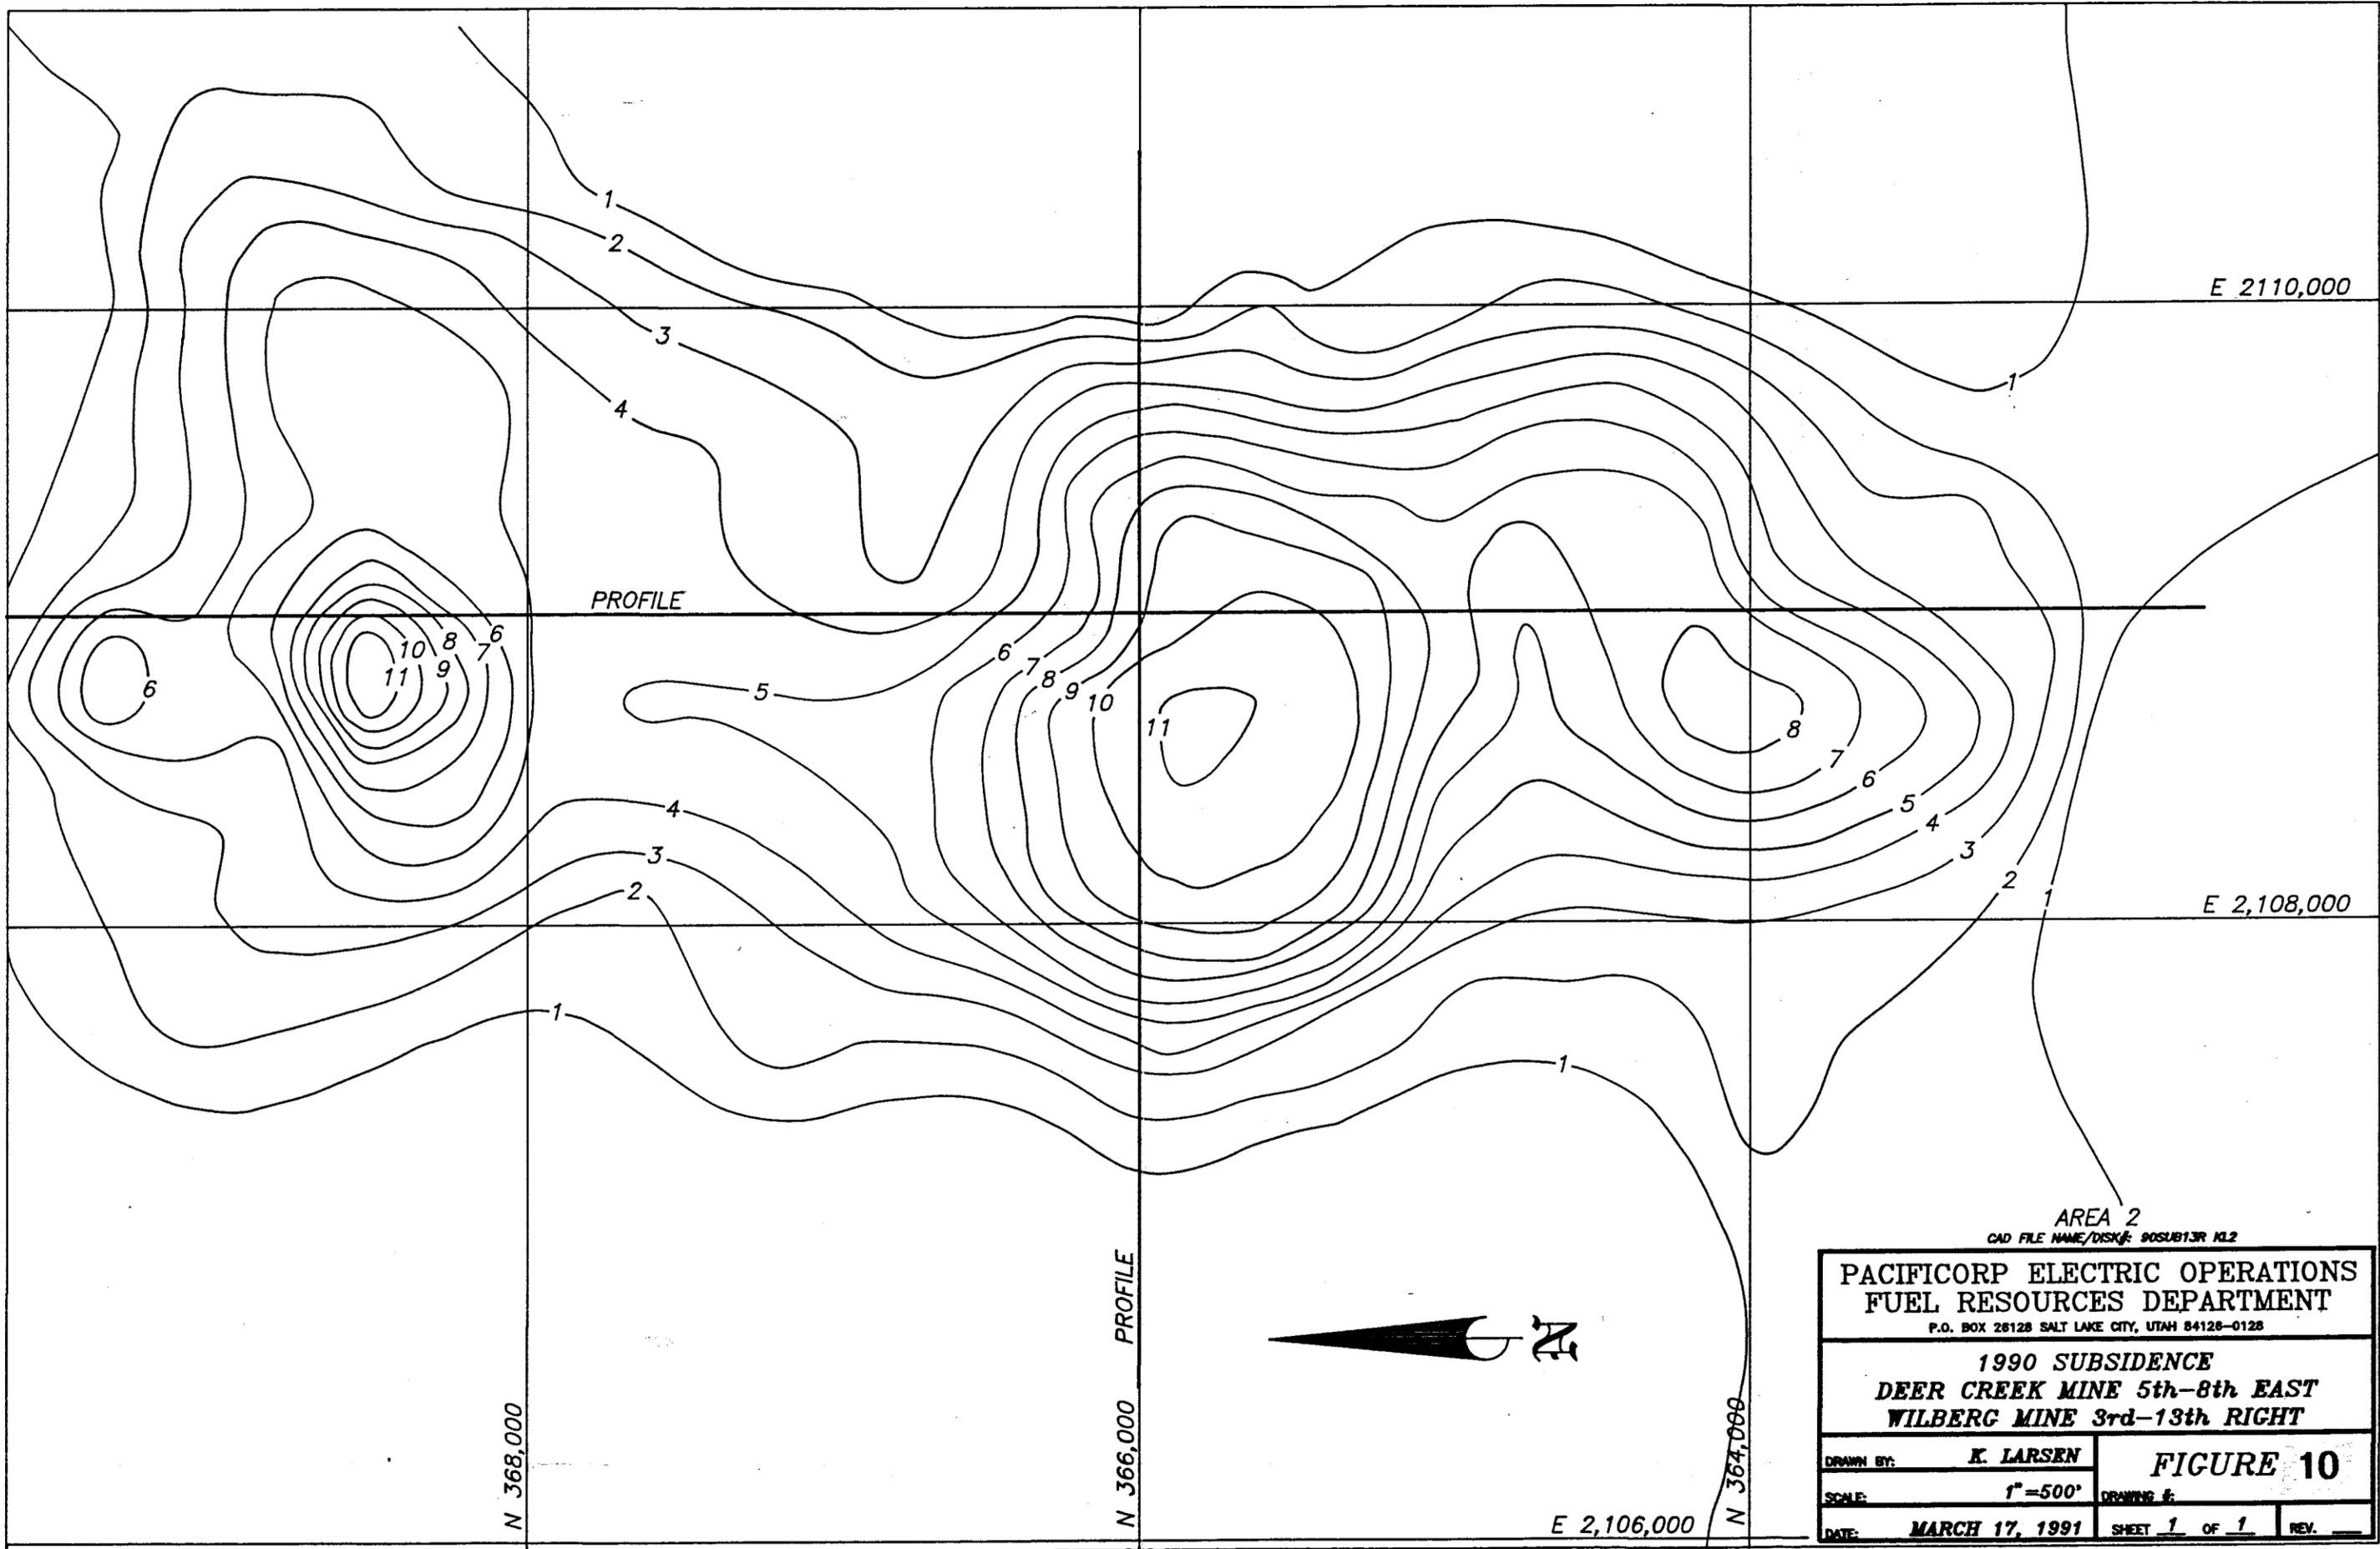
FIGURE 10

Maximum subsidence in Area 2 remains at just under twelve (12) feet and occurs in two places, one over the Deer Creek 6th East and the Wilberg 6th and 7th Right longwall panels (Figure 10) and the other over the Deer Creek 2nd East pillar section and the Wilberg 13th Right longwall panel. The subsidence profiles (Figures 11 and 12) indicate that the subsidence trough continues to elongate over the most recently mined panels. Neither PacifiCorp nor other contracted personnel have detected any surface fissures or other visible disturbance in the area.

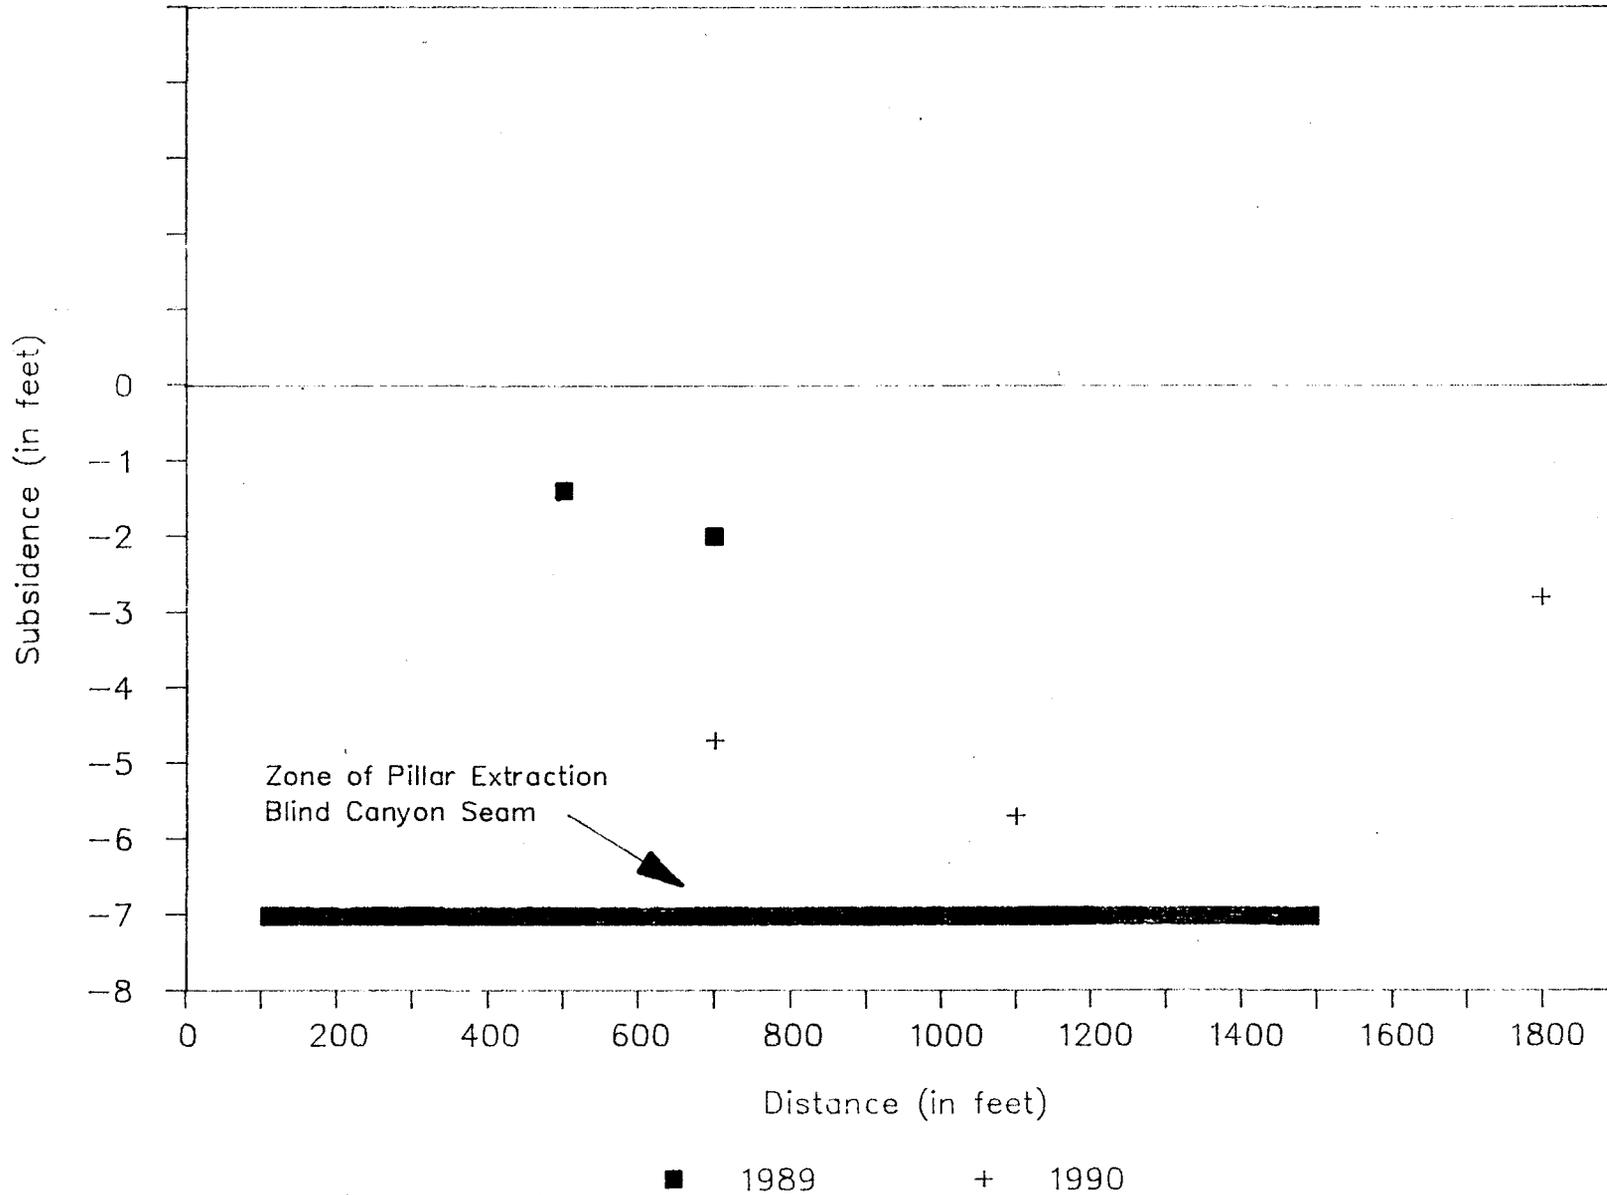
FIGURE 14

The subsidence above 1st North occurs on a narrow ridge capped by a highly fractured sandstone, and a review of the subsidence data indicates that, due to the mode of subsidence, elevation change cannot be depicted accurately with a contour map. Figure 14 is a profile of total subsidence as it occurred along a line of points above the workings.

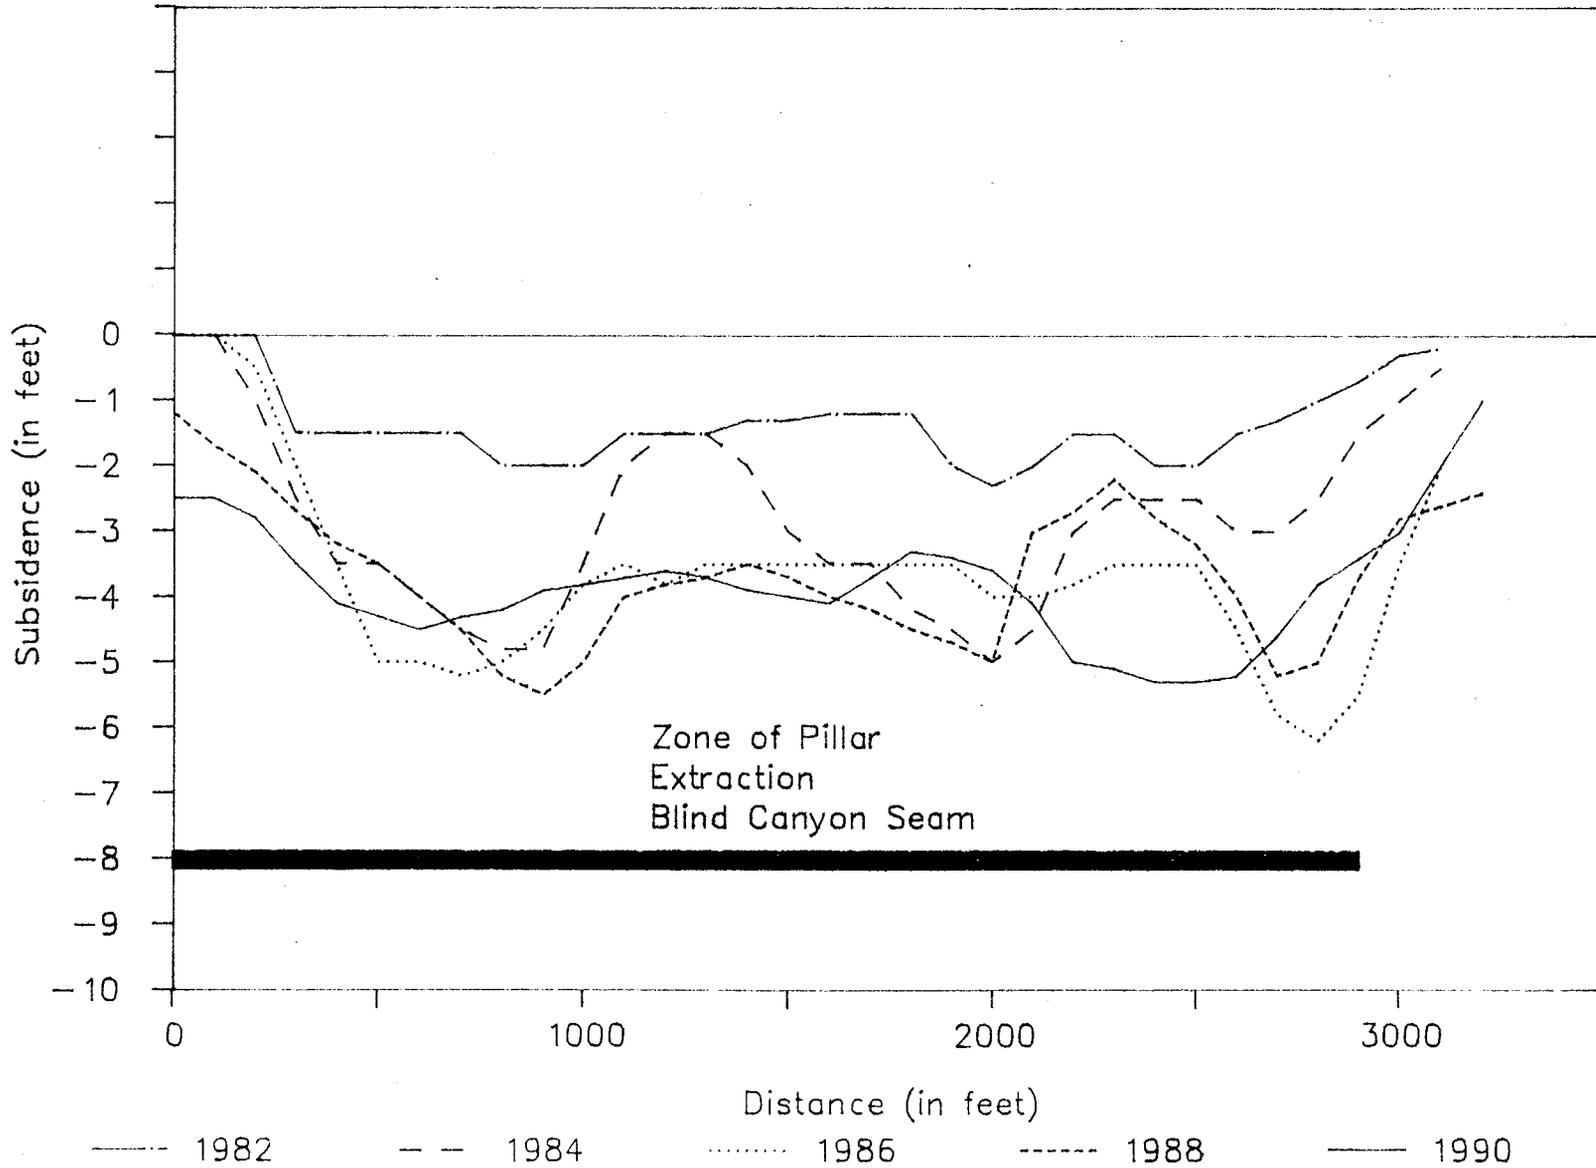
FIGURE 29

Maximum subsidence remains at about six (6) feet. In examining the area by helicopter and aerial photography it is apparent that much of the elevation change measured was due to cliff failure and mass wasting on the steep slopes above the workings, where the rocks were highly fractured prior to mining.

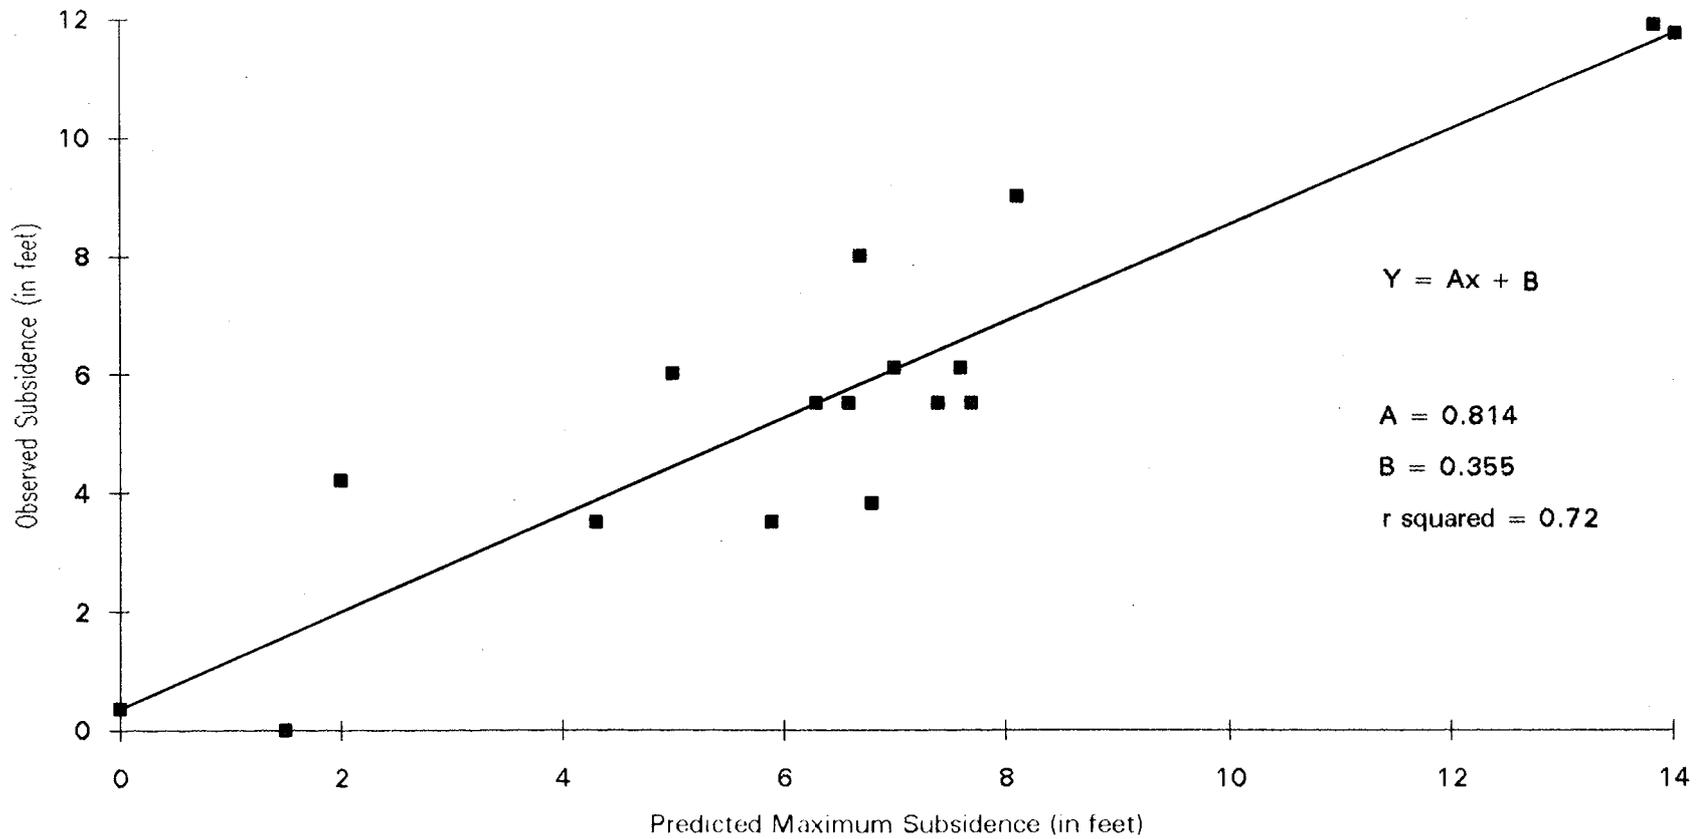
FIGURE 55

In most areas subsidence is less than the maximum predicted by the NCB model, possibly due to the fact that in some areas mining occurred very recently and subsidence has not yet reached its maximum. It could also be that the observed subsidence shown here represents the actual maximum subsidence for the particular geologic conditions -- probably the case in some areas since subsidence appears to have ceased in several areas where the NCB predicted maxima were not reached. In areas showing greater than expected subsidence, chain pillars or barriers between sections are probably crushing so that strata above the working caves as it would if a wider zone had been mined. Figure 55 shows the relationship between predicted and observed subsidence. From the slope of the regression line ($A = .81$) the average observed subsidence is eighty-one percent of the NCB predicted maximum. (Area 1 excluded from graph data.)

Area 1 (DC 9th East - Wilberg 1st Right) is anomalous because it does not fit the special conditions necessary for prediction by the NCB method. The mine workings are surrounded by burned coal and bounded on the east by the Deer Creek Fault. As mentioned before, crushing of clinker beds and movement along the fault have added another complication to the subsidence. The maximum subsidence in the area occurs on a steep slope below a cliff, where slumping has occurred. The twenty-eight (28) feet measured here must be due in part to mass wasting on the steep slope.
