ANNUAL SUBSIDENCE MONITORING REPORT
EAST MOUNTAIN PROPERTY
1993

PACIFICORP
TECHNICAL SERVICES REPORT
RODGER C. FRY

PACIFICORP
SUBSIDENCE MONITORING PROGRAM
ANNUAL REPORT FOR 1993

**United States Department of the Interior
Office of Surface Mining
Minerals Management Service
Utah Division of Oil, Gas and Mining**

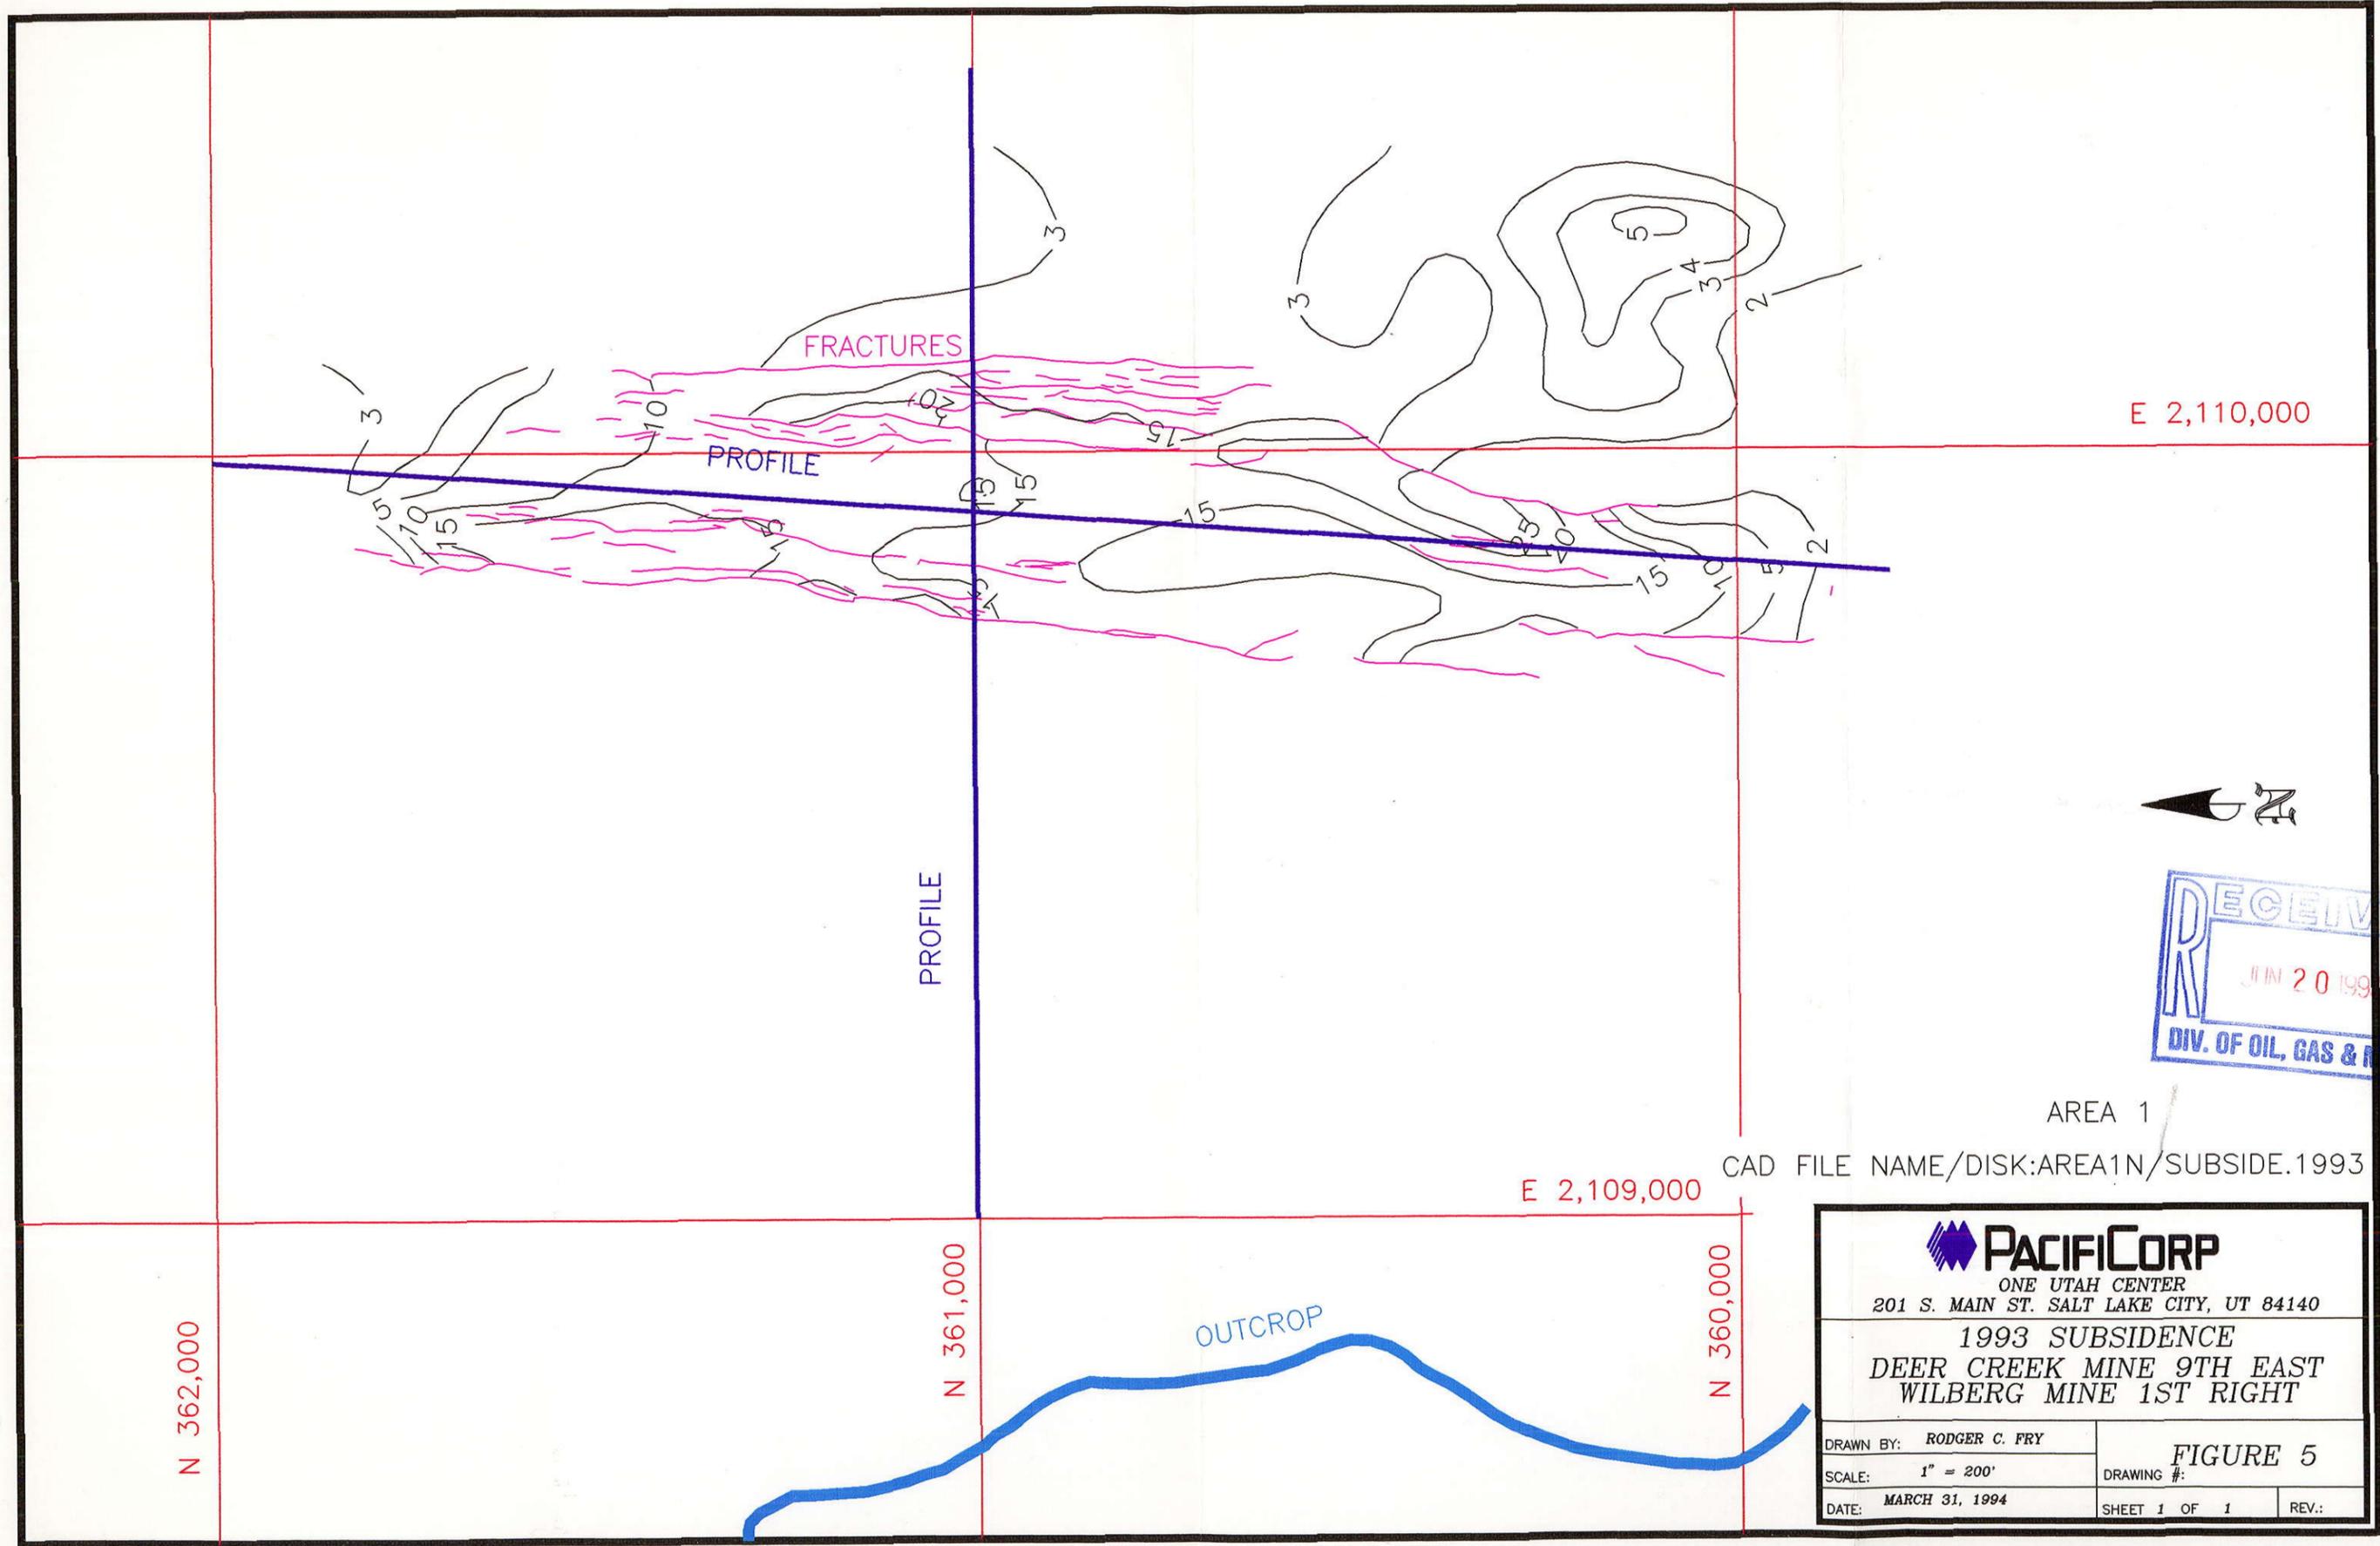
ONE UTAH CENTER 201 S. MAIN ST. SALT LAKE CITY, UT 84140		
1993 SUBSIDENCE DEER CREEK MINE 9TH EAST WILBERG MINE 1ST RIGHT		
DRAWN BY: RODGER C. FRY	FIGURE 5	
SCALE: 1" = 200'	DRAWING #:	
DATE: MARCH 31, 1994	SHEET 1 OF 1	REV.:

Figures 6 and 7 are north to south and west to east profiles showing the amount of subsidence in this area during the past eight years. The location of each line is shown on Figure 5. The area has seen little change since 1985 and appears to have totally stabilized. Maximum subsidence remains at about twenty-eight (28) feet. A detailed look from a helicopter revealed that the subsidence maximum is located on a steep slope, about 200 feet south of the southernmost mining, where a good-sized rotational slump has occurred. The workings here are also surrounded by burned coal. It is probable that the combination of steep slopes and crushing of clinker beds has allowed subsidence to occur well outside the area of mine workings. An inspection of the area from the ground indicates that many of the open fractures forming the graben-like structure have begun to heal and fill in with soil.

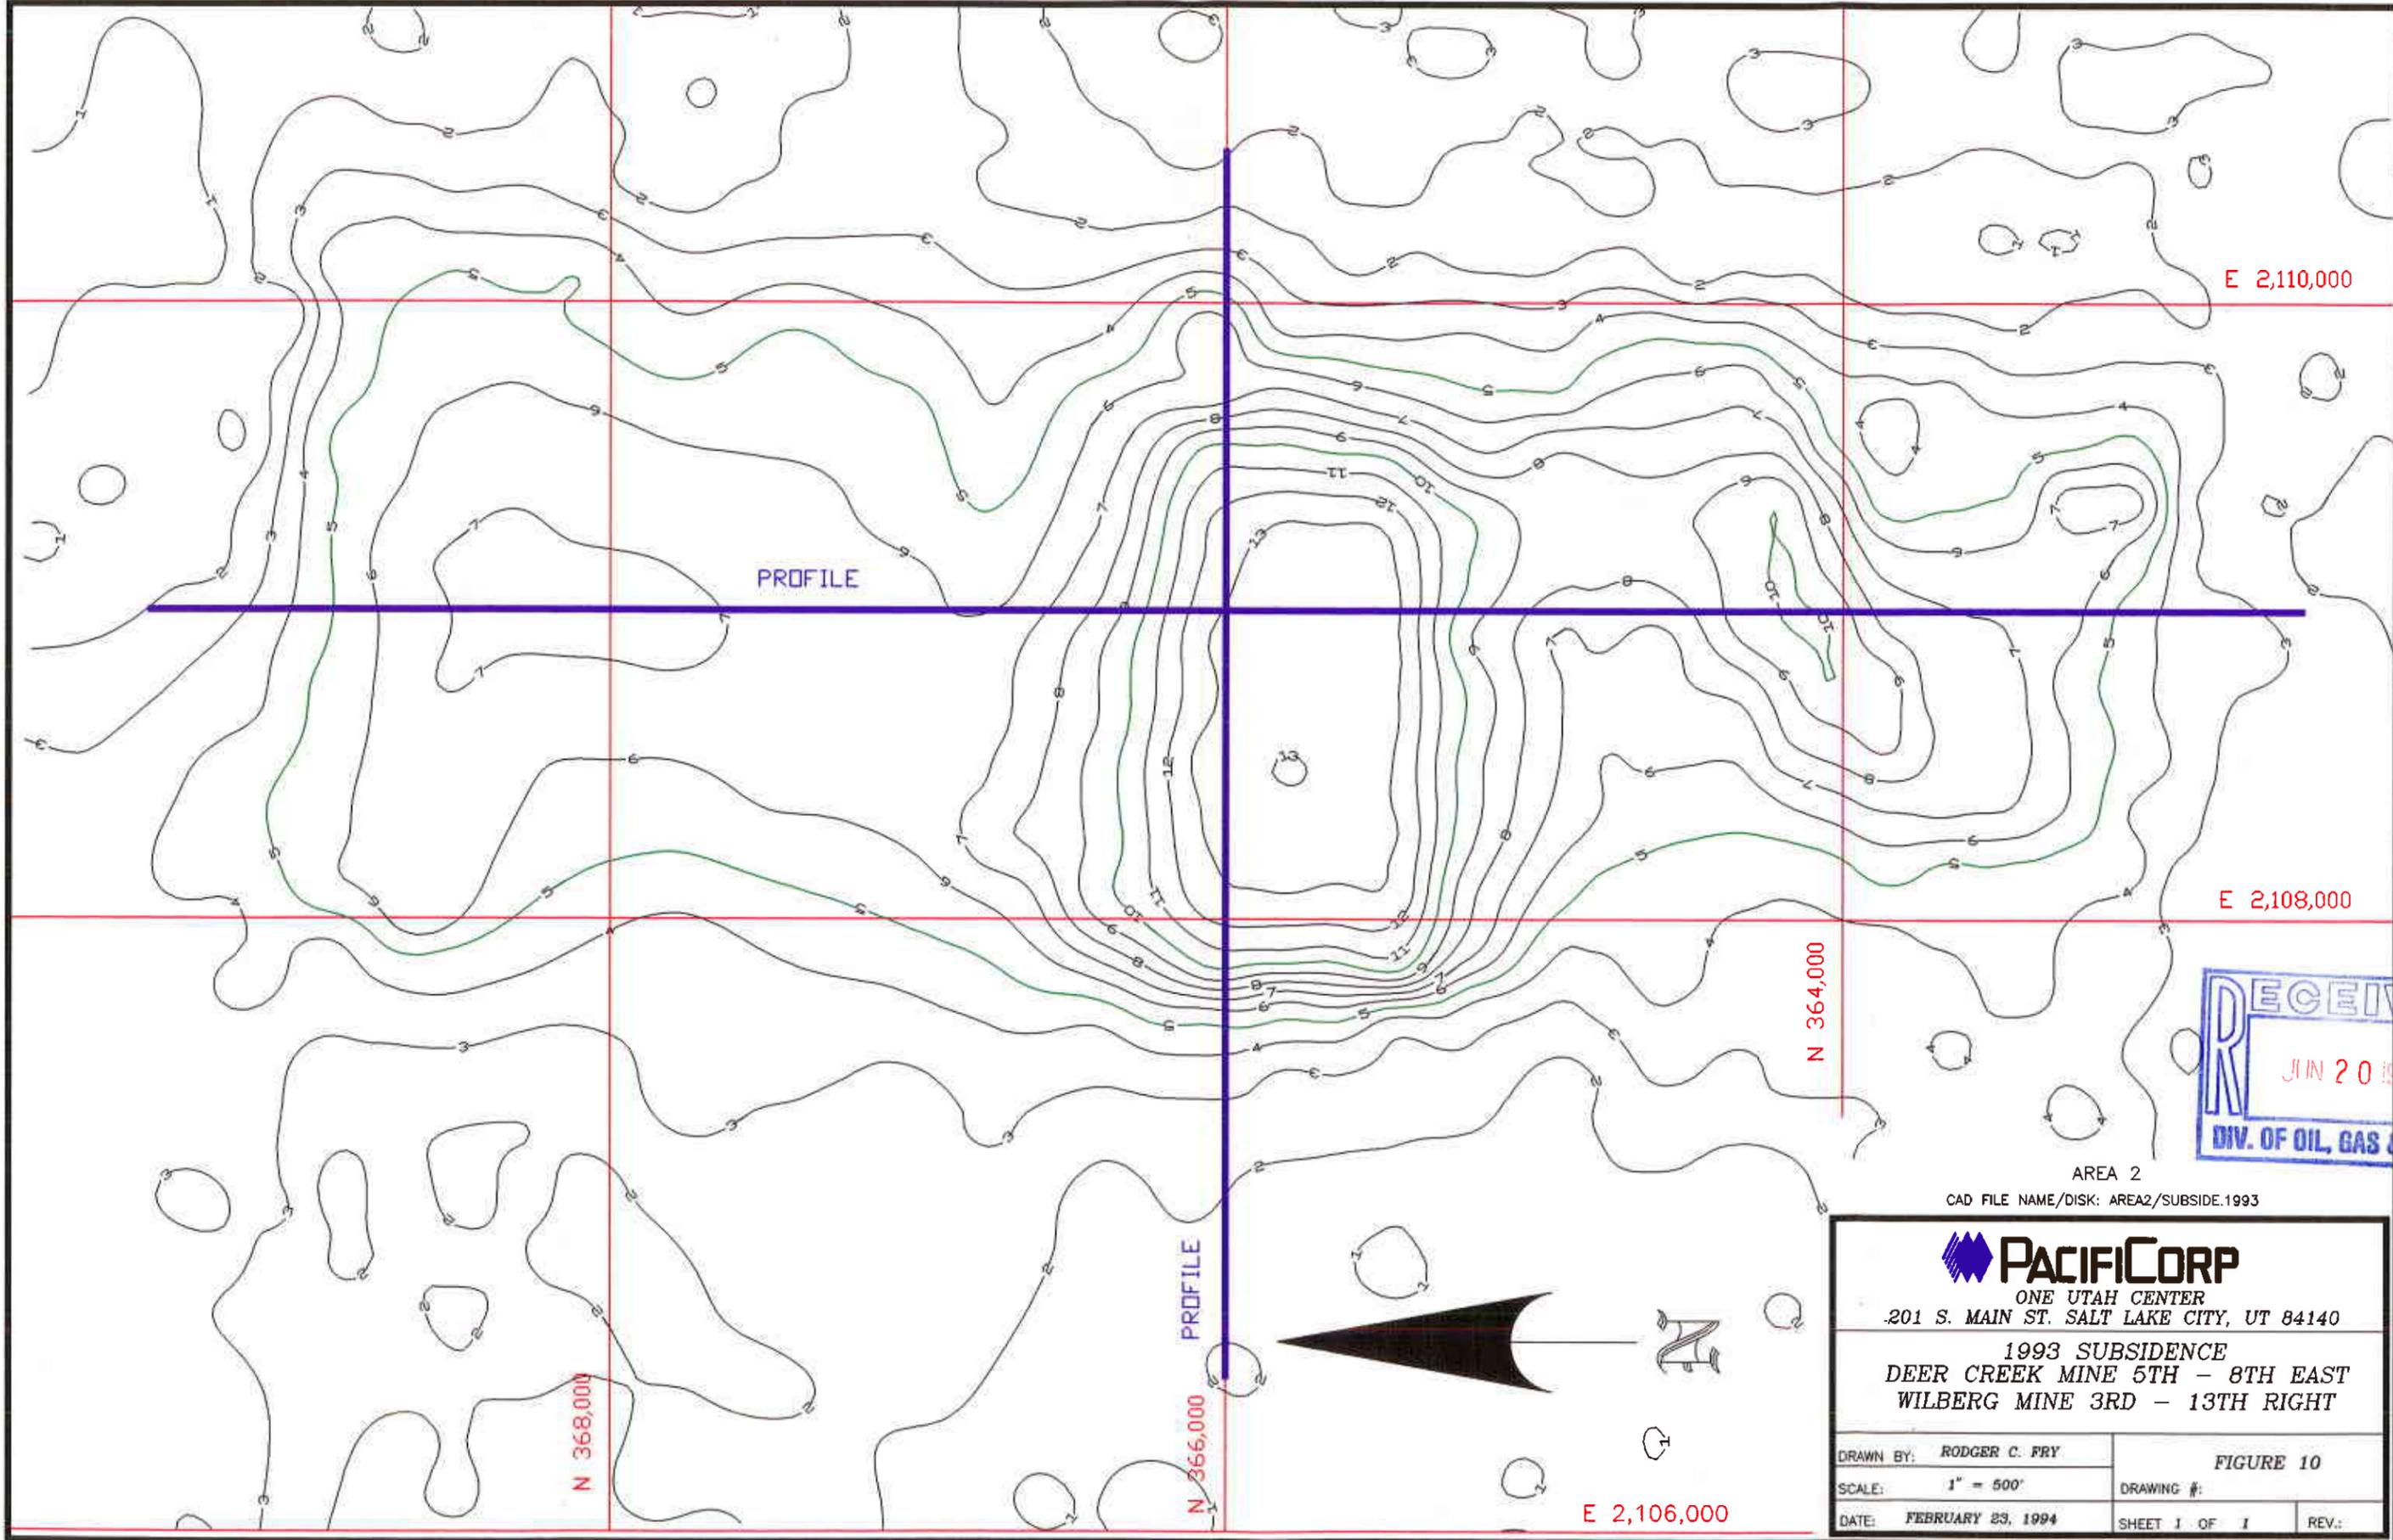
ONE UTAH CENTER 201 S. MAIN ST. SALT LAKE CITY, UT 84140		
1993 SUBSIDENCE DEER CREEK MINE 5TH - 8TH EAST WILBERG MINE 3RD - 13TH RIGHT		
DRAWN BY: RODGER C. FRY	FIGURE 10	
SCALE: 1" = 500'	DRAWING #:	
DATE: FEBRUARY 23, 1994	SHEET 1 OF 1	REV.:

Maximum subsidence in Area 2 has increased to 13 feet in one area above the center of the multiple seam mining area (Figure 10). The subsidence profiles (Figures 11 and 12) indicate that the subsidence trough has deepened slightly in the last 3 years. Neither PacifiCorp nor other contracted personnel have detected any surface fissures or other visible disturbance in the area.

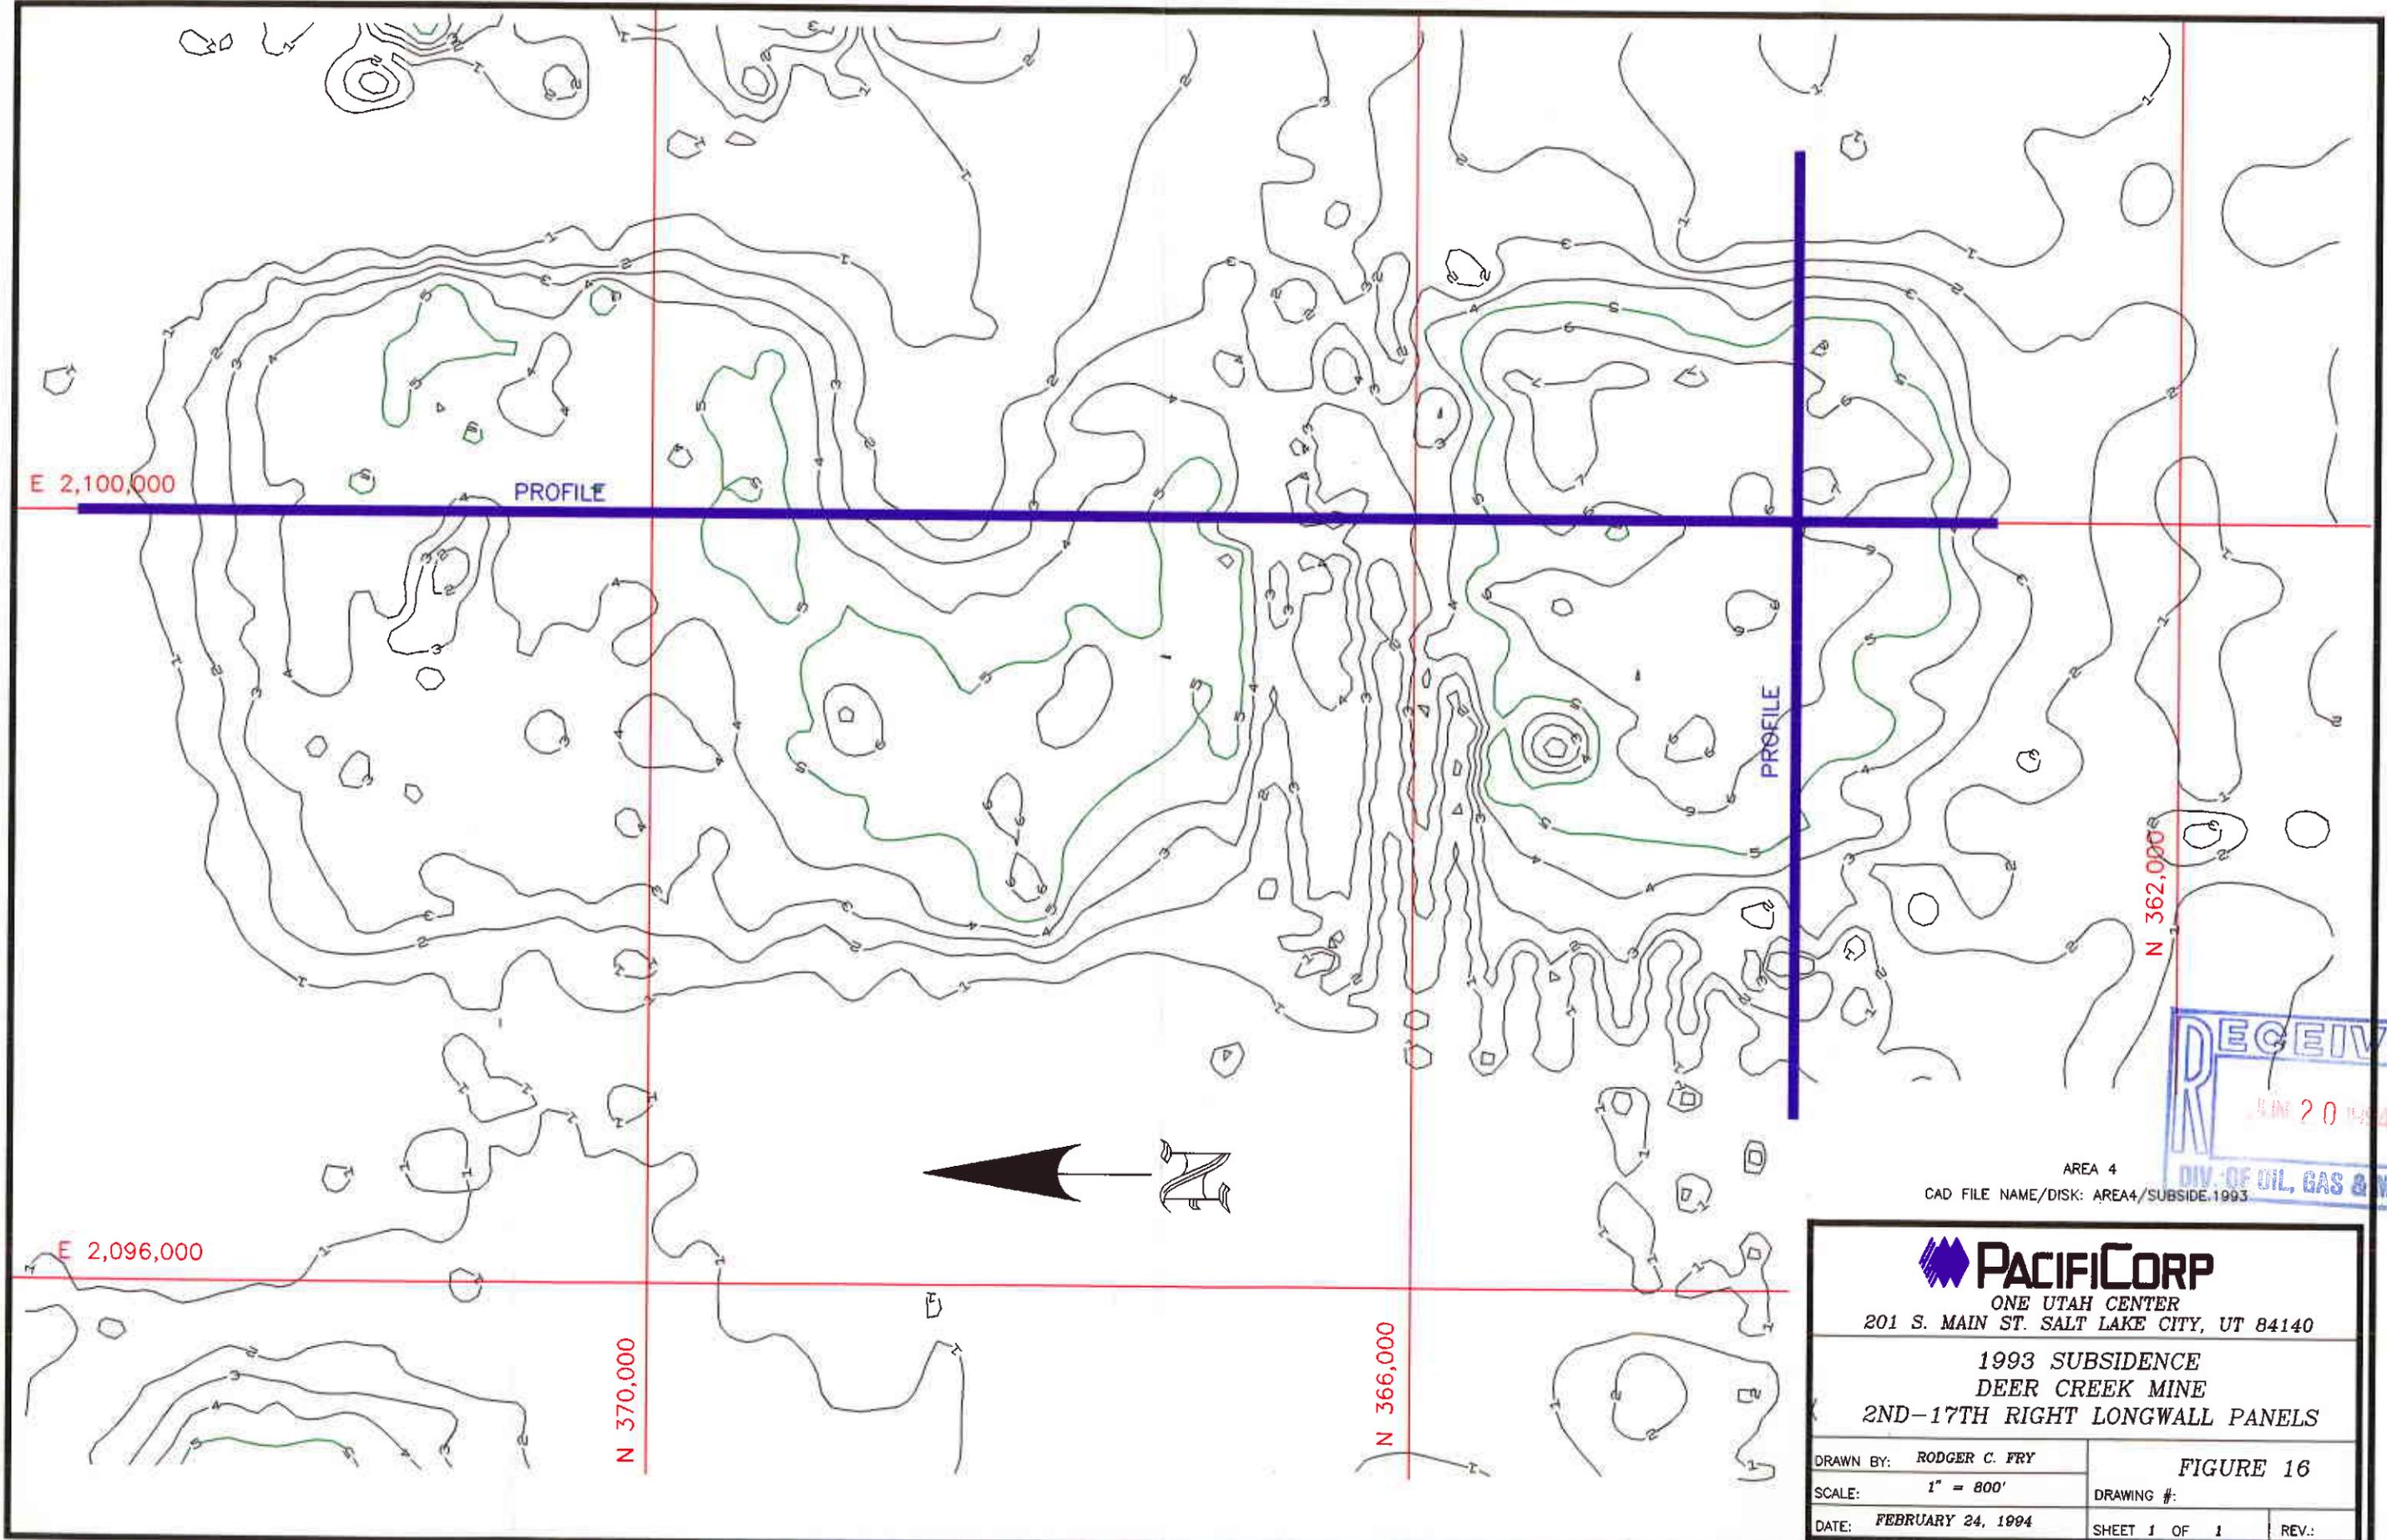
DRAWN BY: RODGER C. FRY	FIGURE 16
SCALE: 1" = 800'	DRAWING #:
DATE: FEBRUARY 24, 1994	SHEET 1 OF 1
	REV.:

Maximum subsidence is just over seven (7) feet over the 5th Right longwall panel (Figure 16). The profiles, Figures 17 and 18 show some variability from year to year. This area is heavily vegetated and it is thought that this creates difficulties in obtaining consistent readings from year to year. The calculated angle-of-draw of the subsidence ranges from less than zero to 22 degrees.

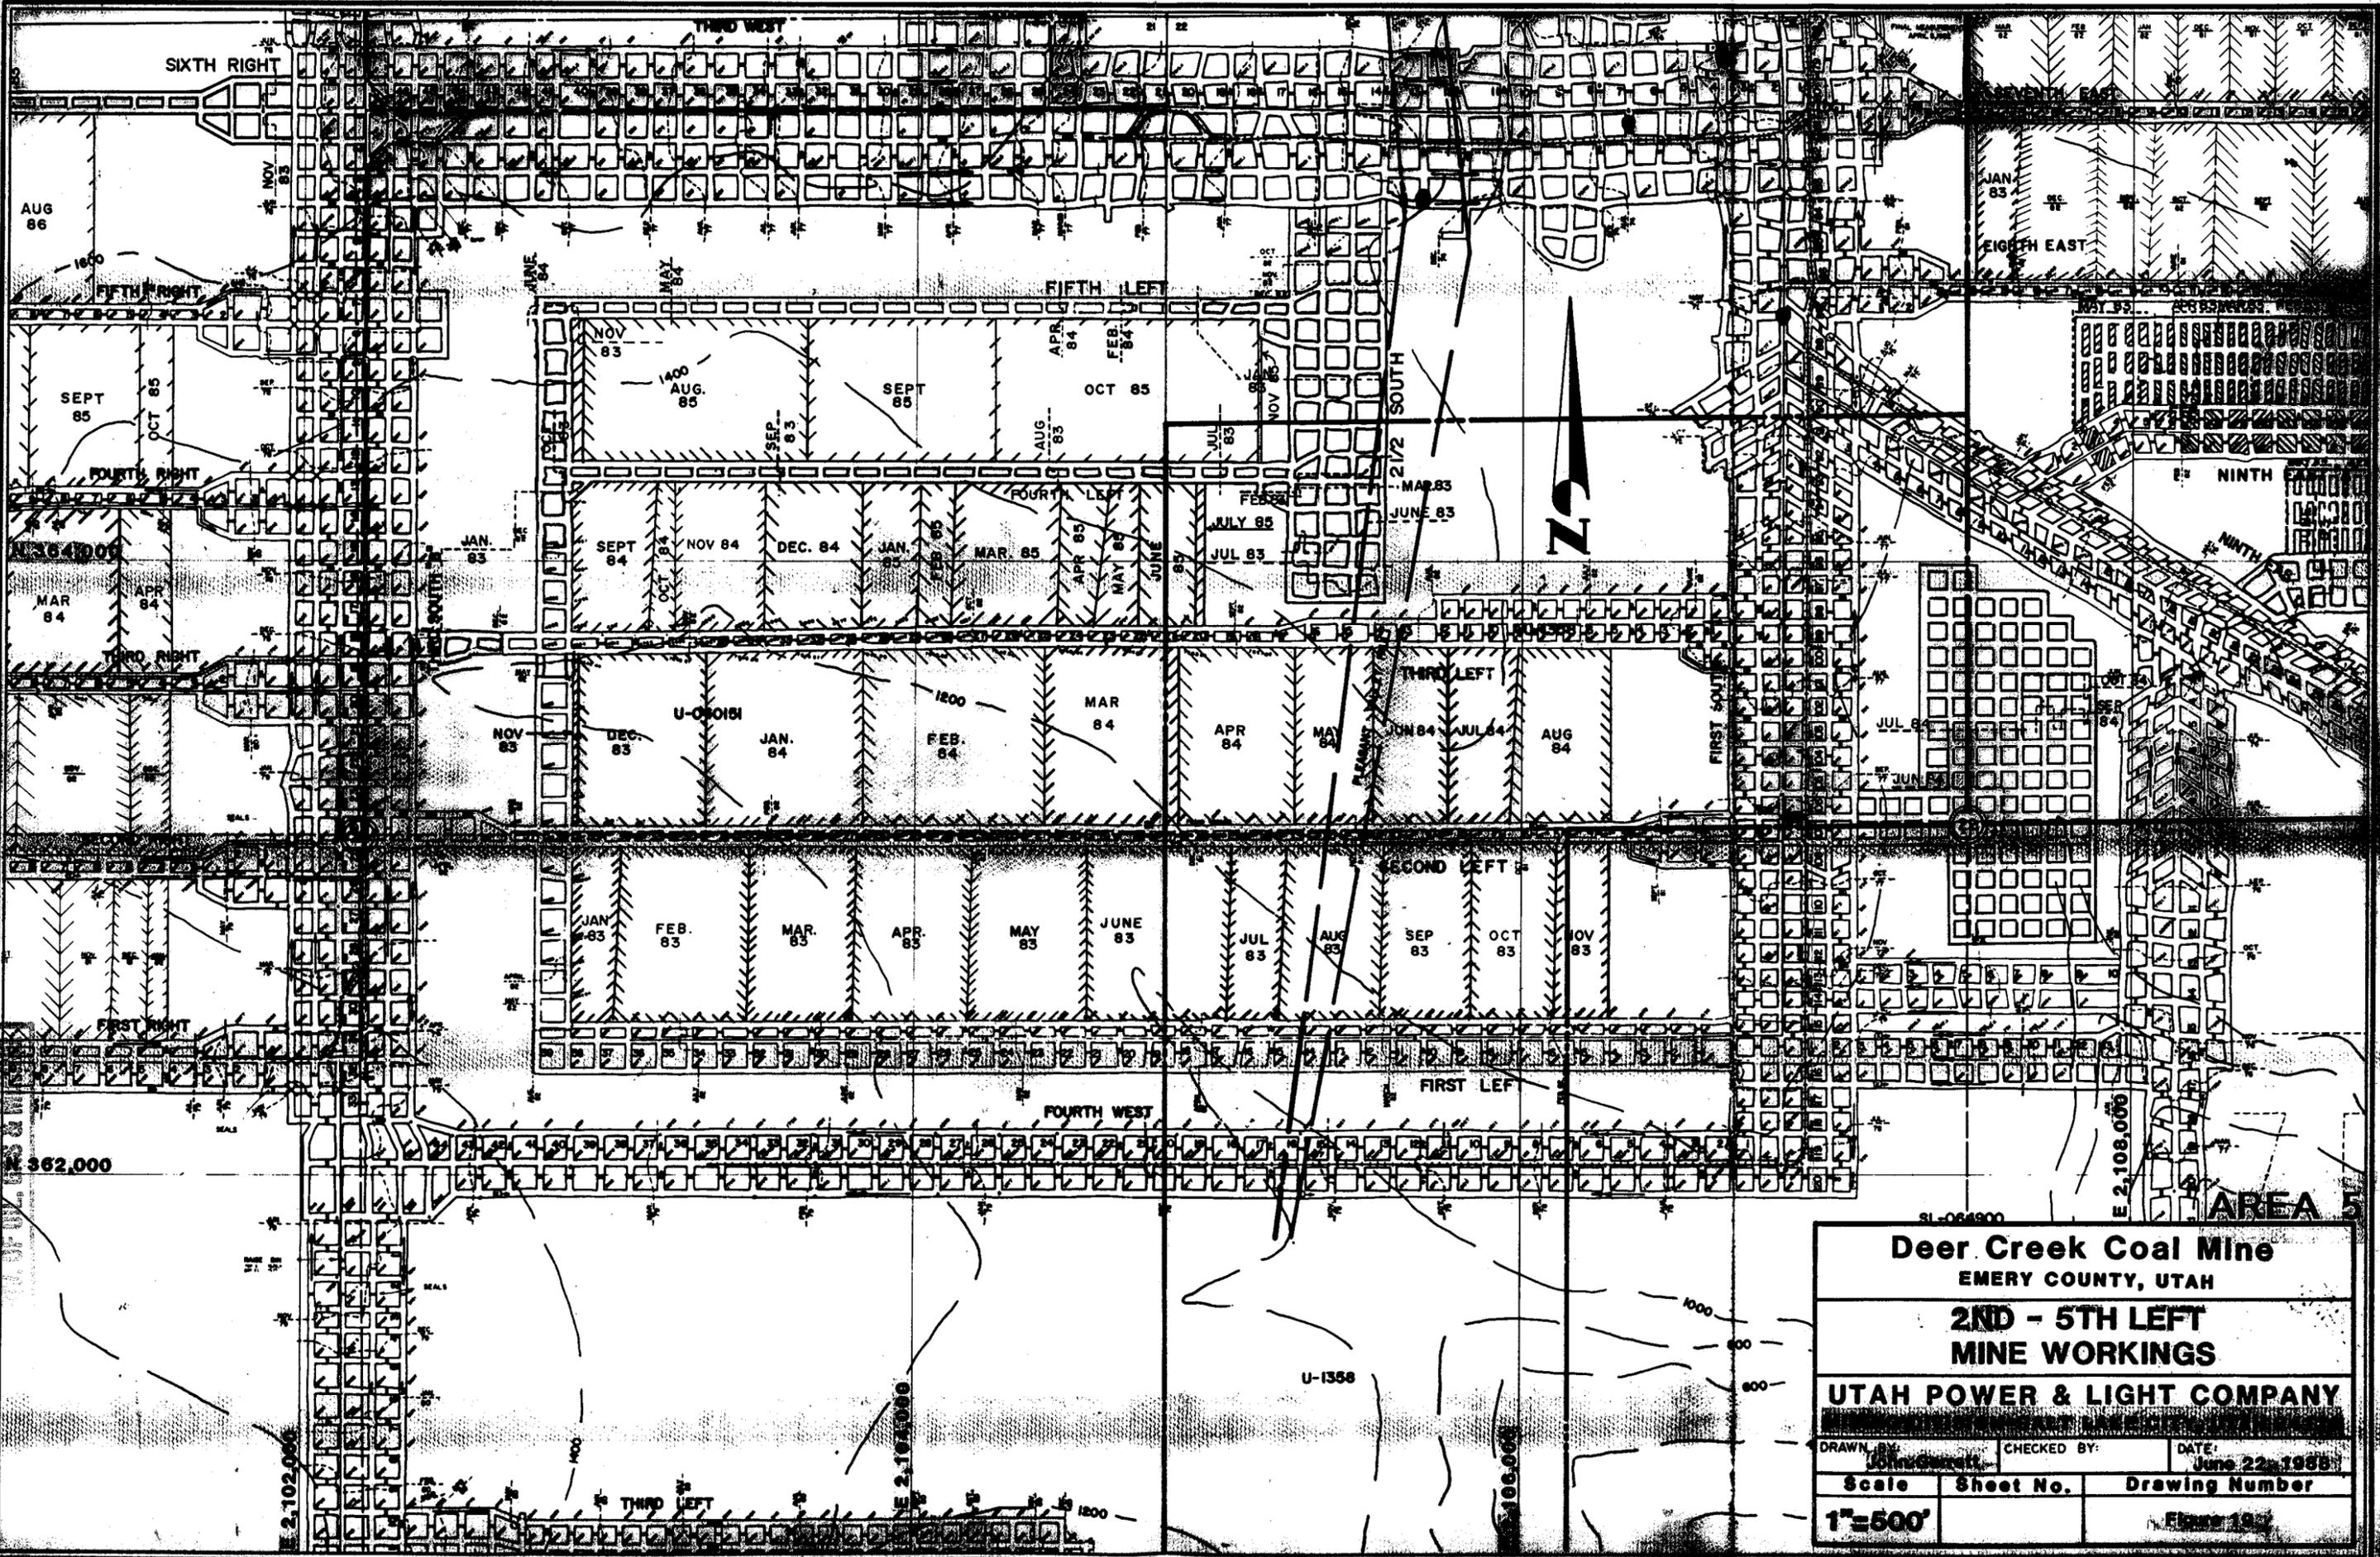
PACIFICORP ONE UTAH CENTER 201 S. MAIN ST. SALT LAKE CITY, UT 84140		
1993 SUBSIDENCE DEER CREEK MINE 2ND - 5TH LEFT LONGWALL PANELS		
DRAWN BY: RODGER C. FRY	FIGURE 20	
SCALE: 1" = 500'	DRAWING #:	
DATE: FEBRUARY 24, 1994	SHEET 1 OF 1	REV.:

Maximum subsidence over the panels is about seven (7) feet (Figure 20). The maximum subsidence shows an increase since 1991 over the center of the panels (Figures 21 and 22). No surface disturbance has been identified over the panels.

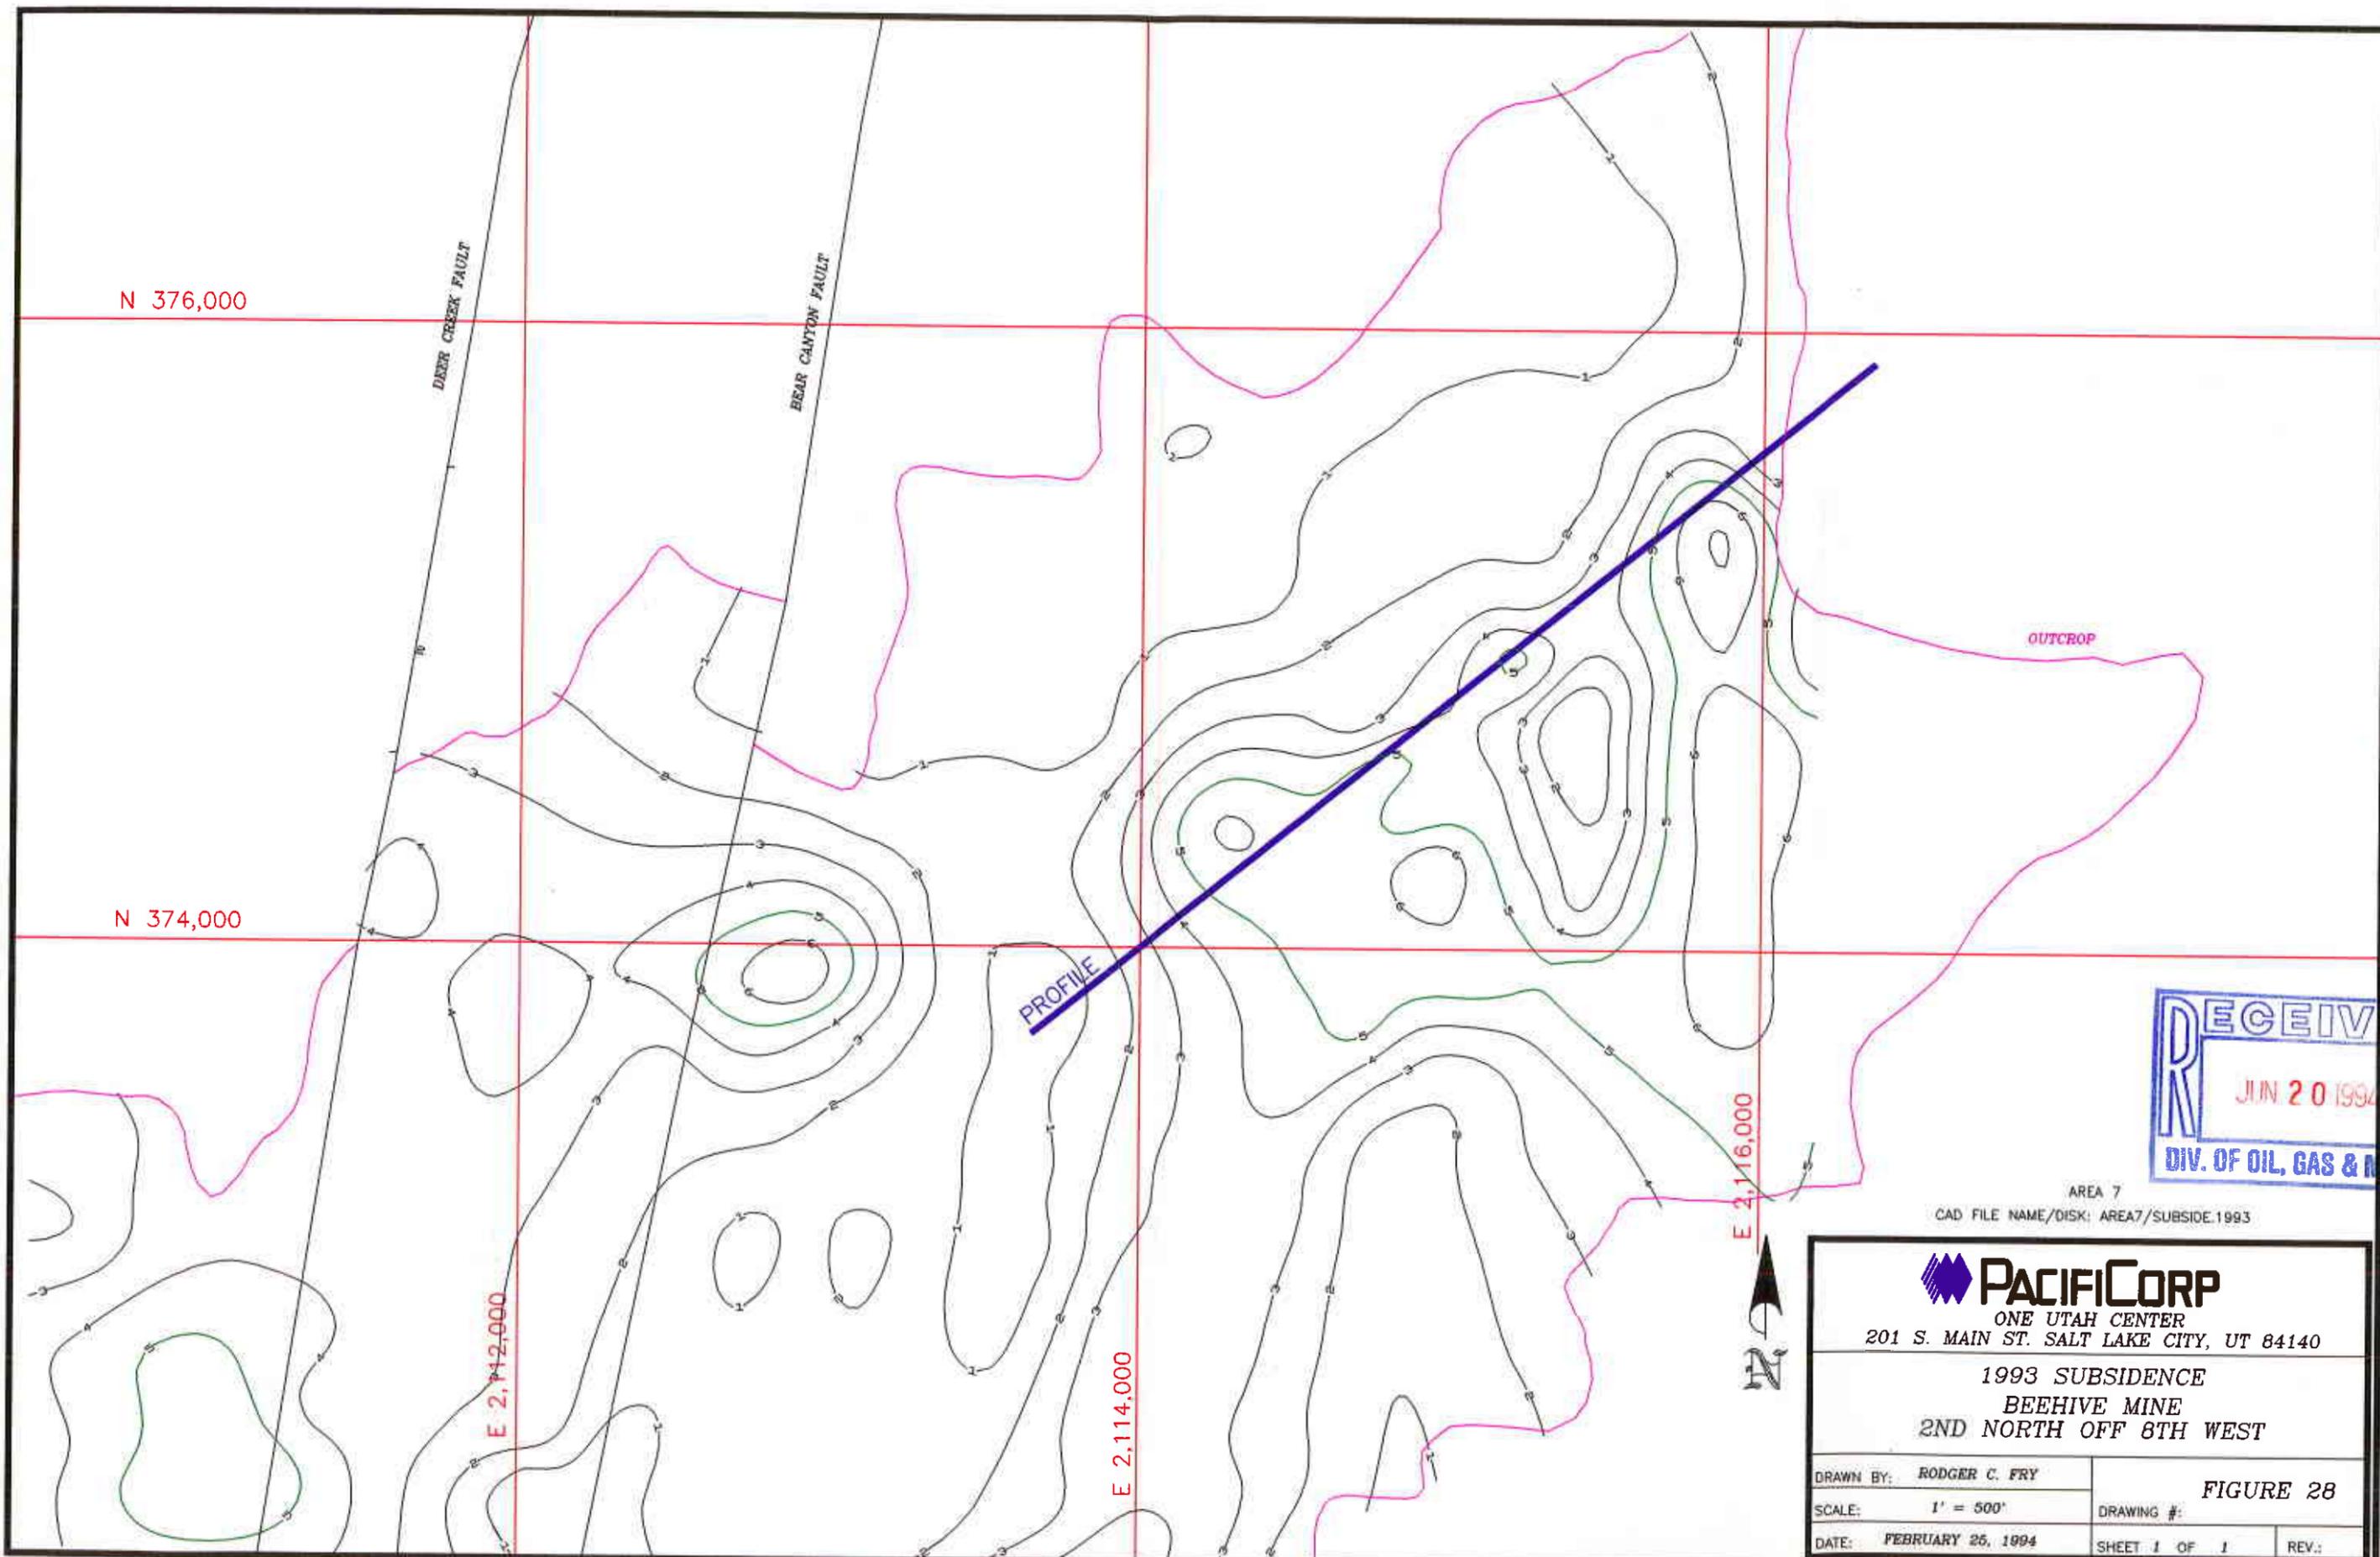
PACIFICORP ONE UTAH CENTER 201 S. MAIN ST. SALT LAKE CITY, UT 84140		
1993 SUBSIDENCE BEEHIVE MINE 2ND NORTH OFF 8TH WEST		
DRAWN BY: RODGER C. FRY	FIGURE 28	
SCALE: 1" = 500'	DRAWING #:	
DATE: FEBRUARY 25, 1994	SHEET 1 OF 1	REV.:

Pillar extraction mining in 2nd North was completed in 1983 and, as shown in Figures 27, 28, and 29, little additional subsidence has occurred over the workings since 1984. The workings are surrounded by burned coal.

Maximum subsidence is as much as six (6) feet. In examining the area by helicopter and aerial photography it is apparent that much of the elevation change measured was due to cliff failure and mass wasting on the steep slopes above the workings, where the rocks were highly fractured prior to mining.

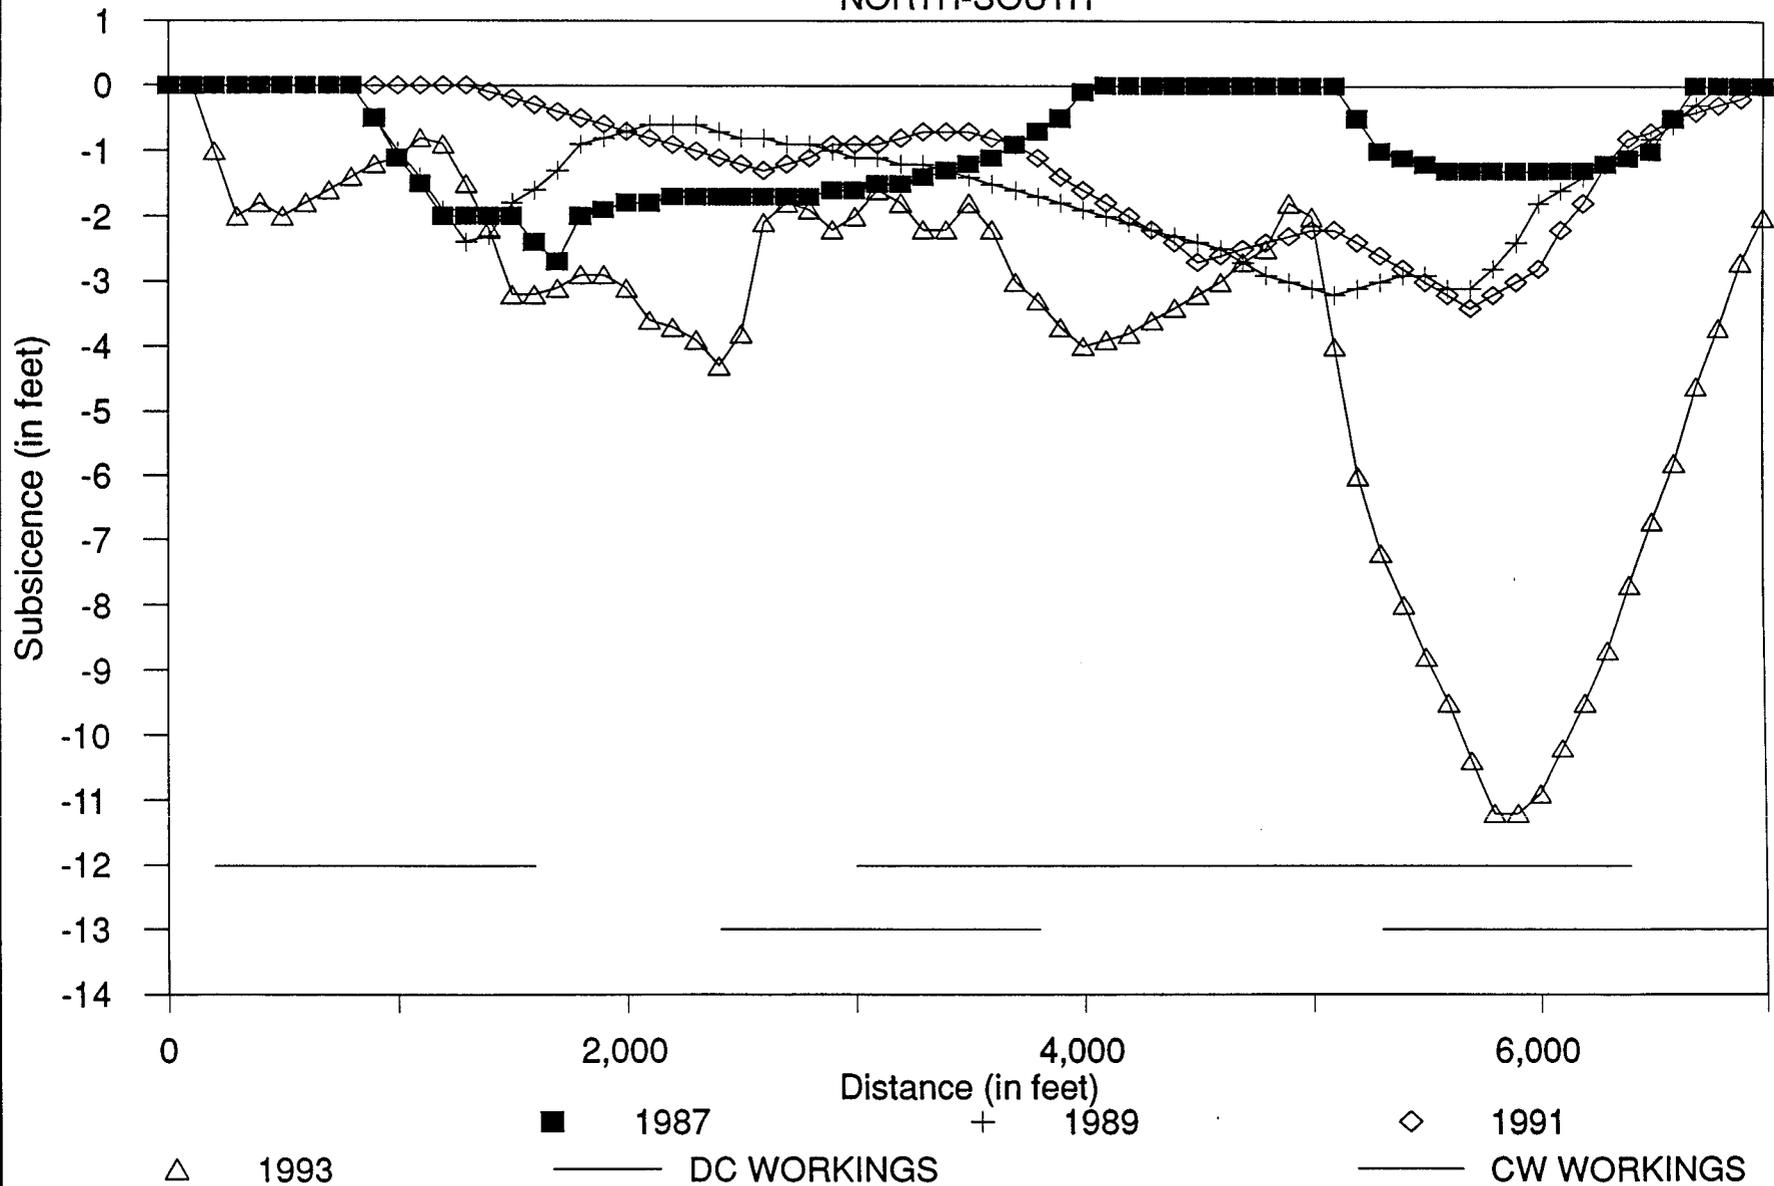
FIGURE 37
 AREA 11 SUBSIDENCE PROFILE
 NORTH-SOUTH

Measurable subsidence to date has exceeded twelve (12) in the area of multiple seam mining above the 6th and 7th Right Longwall Panels in the Cottonwood mine (Figures 36, 37, and 38).

Fractures were discovered at the western end of coal extraction above the 7th Right Longwall Panel. The fractures were first discovered on June 17, 1993. Mining of the longwall panel was completed on May 12, 1993. An aerial reconnaissance of the area on May 18, 1993 revealed no surface fractures at that time. This places the occurrence of the fractures between May 18, 1993 and June 17, 1993. Burnt Tree Springs is located approximately 800 feet to the southeast of the fractures. Measurements of the spring discharge throughout the summer of 1993 indicated that the fracturing has had no effect on the spring. The angle-of-draw measured ranges from less than zero to 28 degrees.
