ANNUAL SUBSIDENCE MONITORING REPORT
EAST MOUNTAIN PROPERTY
1993

PACIFICORP
TECHNICAL SERVICES REPORT
RODGER C. FRY

PACIFICORP
SUBSIDENCE MONITORING PROGRAM
ANNUAL REPORT FOR 1993

**United States Department of the Interior
Office of Surface Mining
Minerals Management Service
Utah Division of Oil, Gas and Mining**

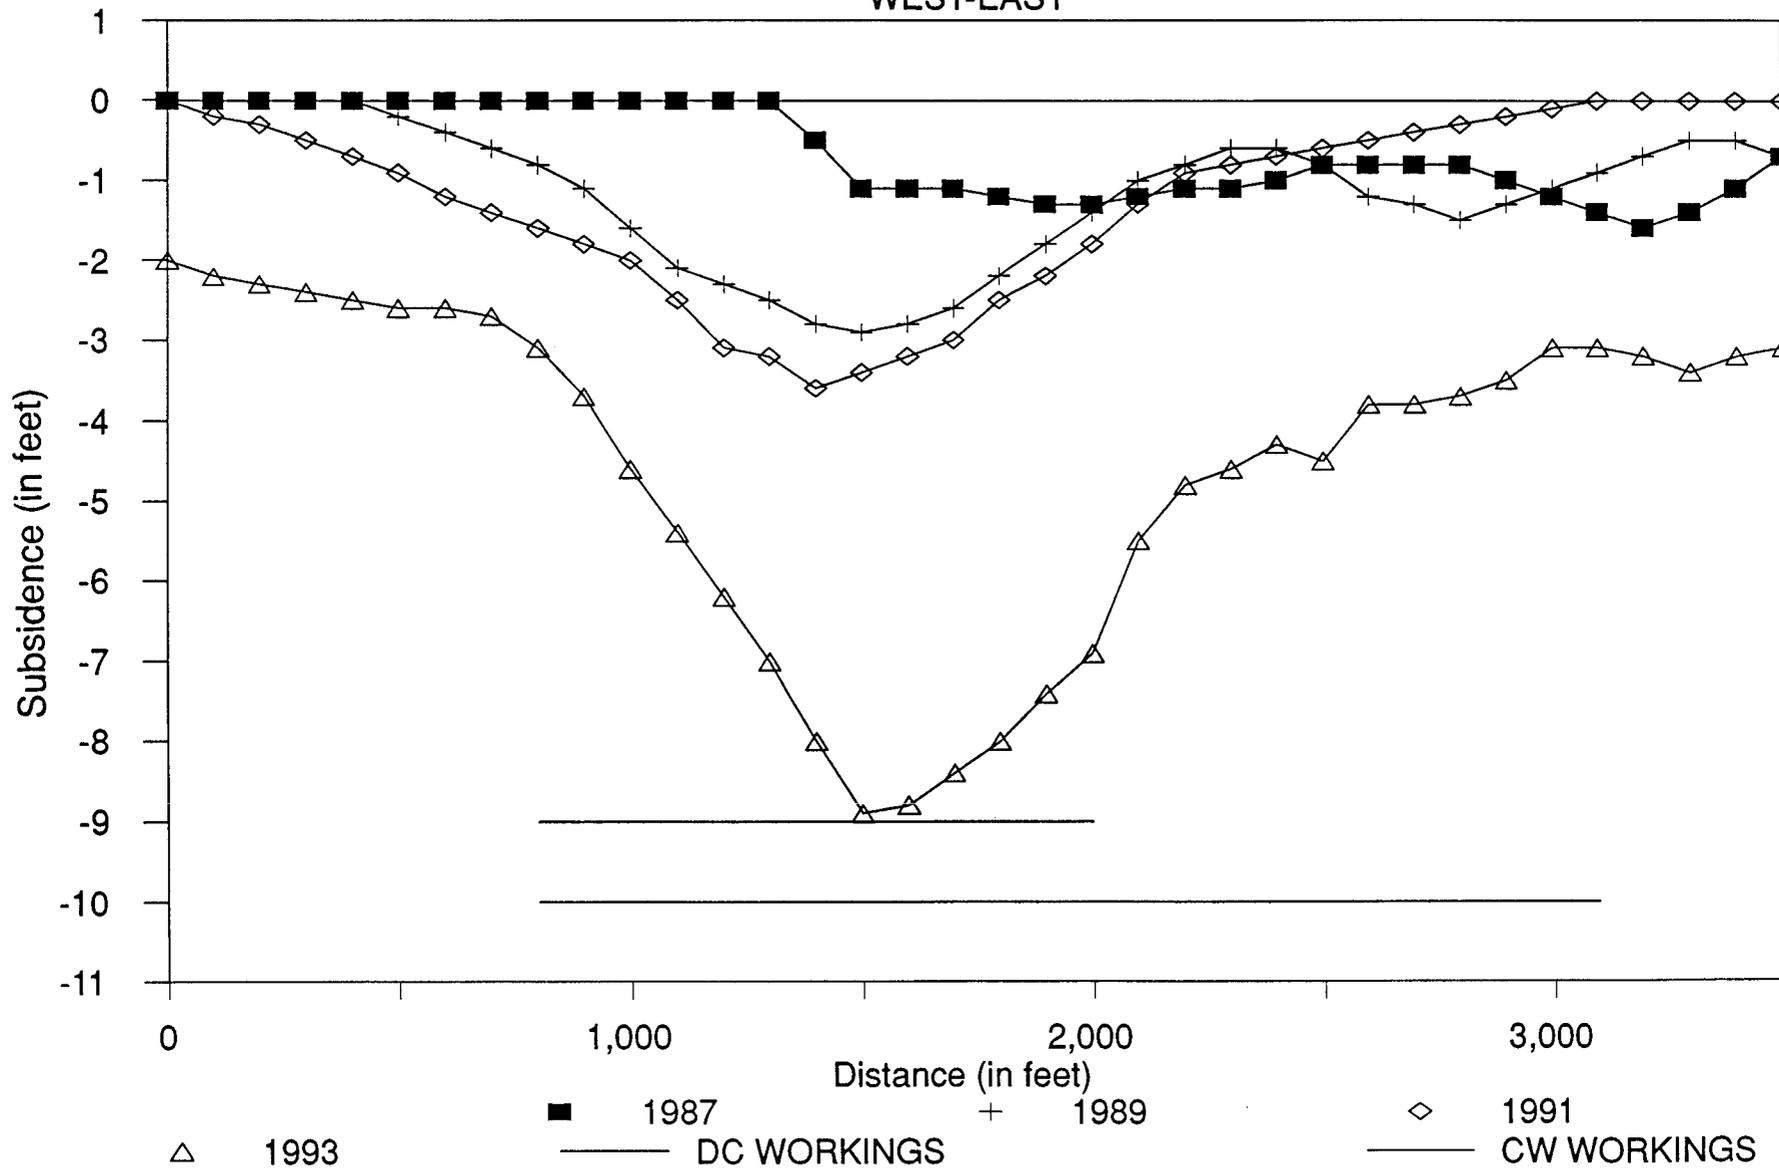
FIGURE 38
AREA 11 SUBSIDENCE PROFILE
WEST-EAST

Measurable subsidence to date has exceeded twelve (12) in the area of multiple seam mining above the 6th and 7th Right Longwall Panels in the Cottonwood mine (Figures 36, 37, and 38).

Fractures were discovered at the western end of coal extraction above the 7th Right Longwall Panel. The fractures were first discovered on June 17, 1993. Mining of the longwall panel was completed on May 12, 1993. An aerial reconnaissance of the area on May 18, 1993 revealed no surface fractures at that time. This places the occurrence of the fractures between May 18, 1993 and June 17, 1993. Burnt Tree Springs is located approximately 800 feet to the southeast of the fractures. Measurements of the spring discharge throughout the summer of 1993 indicated that the fracturing has had no effect on the spring. The angle-of-draw measured ranges from less than zero to 28 degrees.
