ANNUAL SUBSIDENCE MONITORING REPORT
EAST MOUNTAIN PROPERTY
1993

PACIFICORP
TECHNICAL SERVICES REPORT
RODGER C. FRY

PACIFICORP
SUBSIDENCE MONITORING PROGRAM
ANNUAL REPORT FOR 1993

June 1994

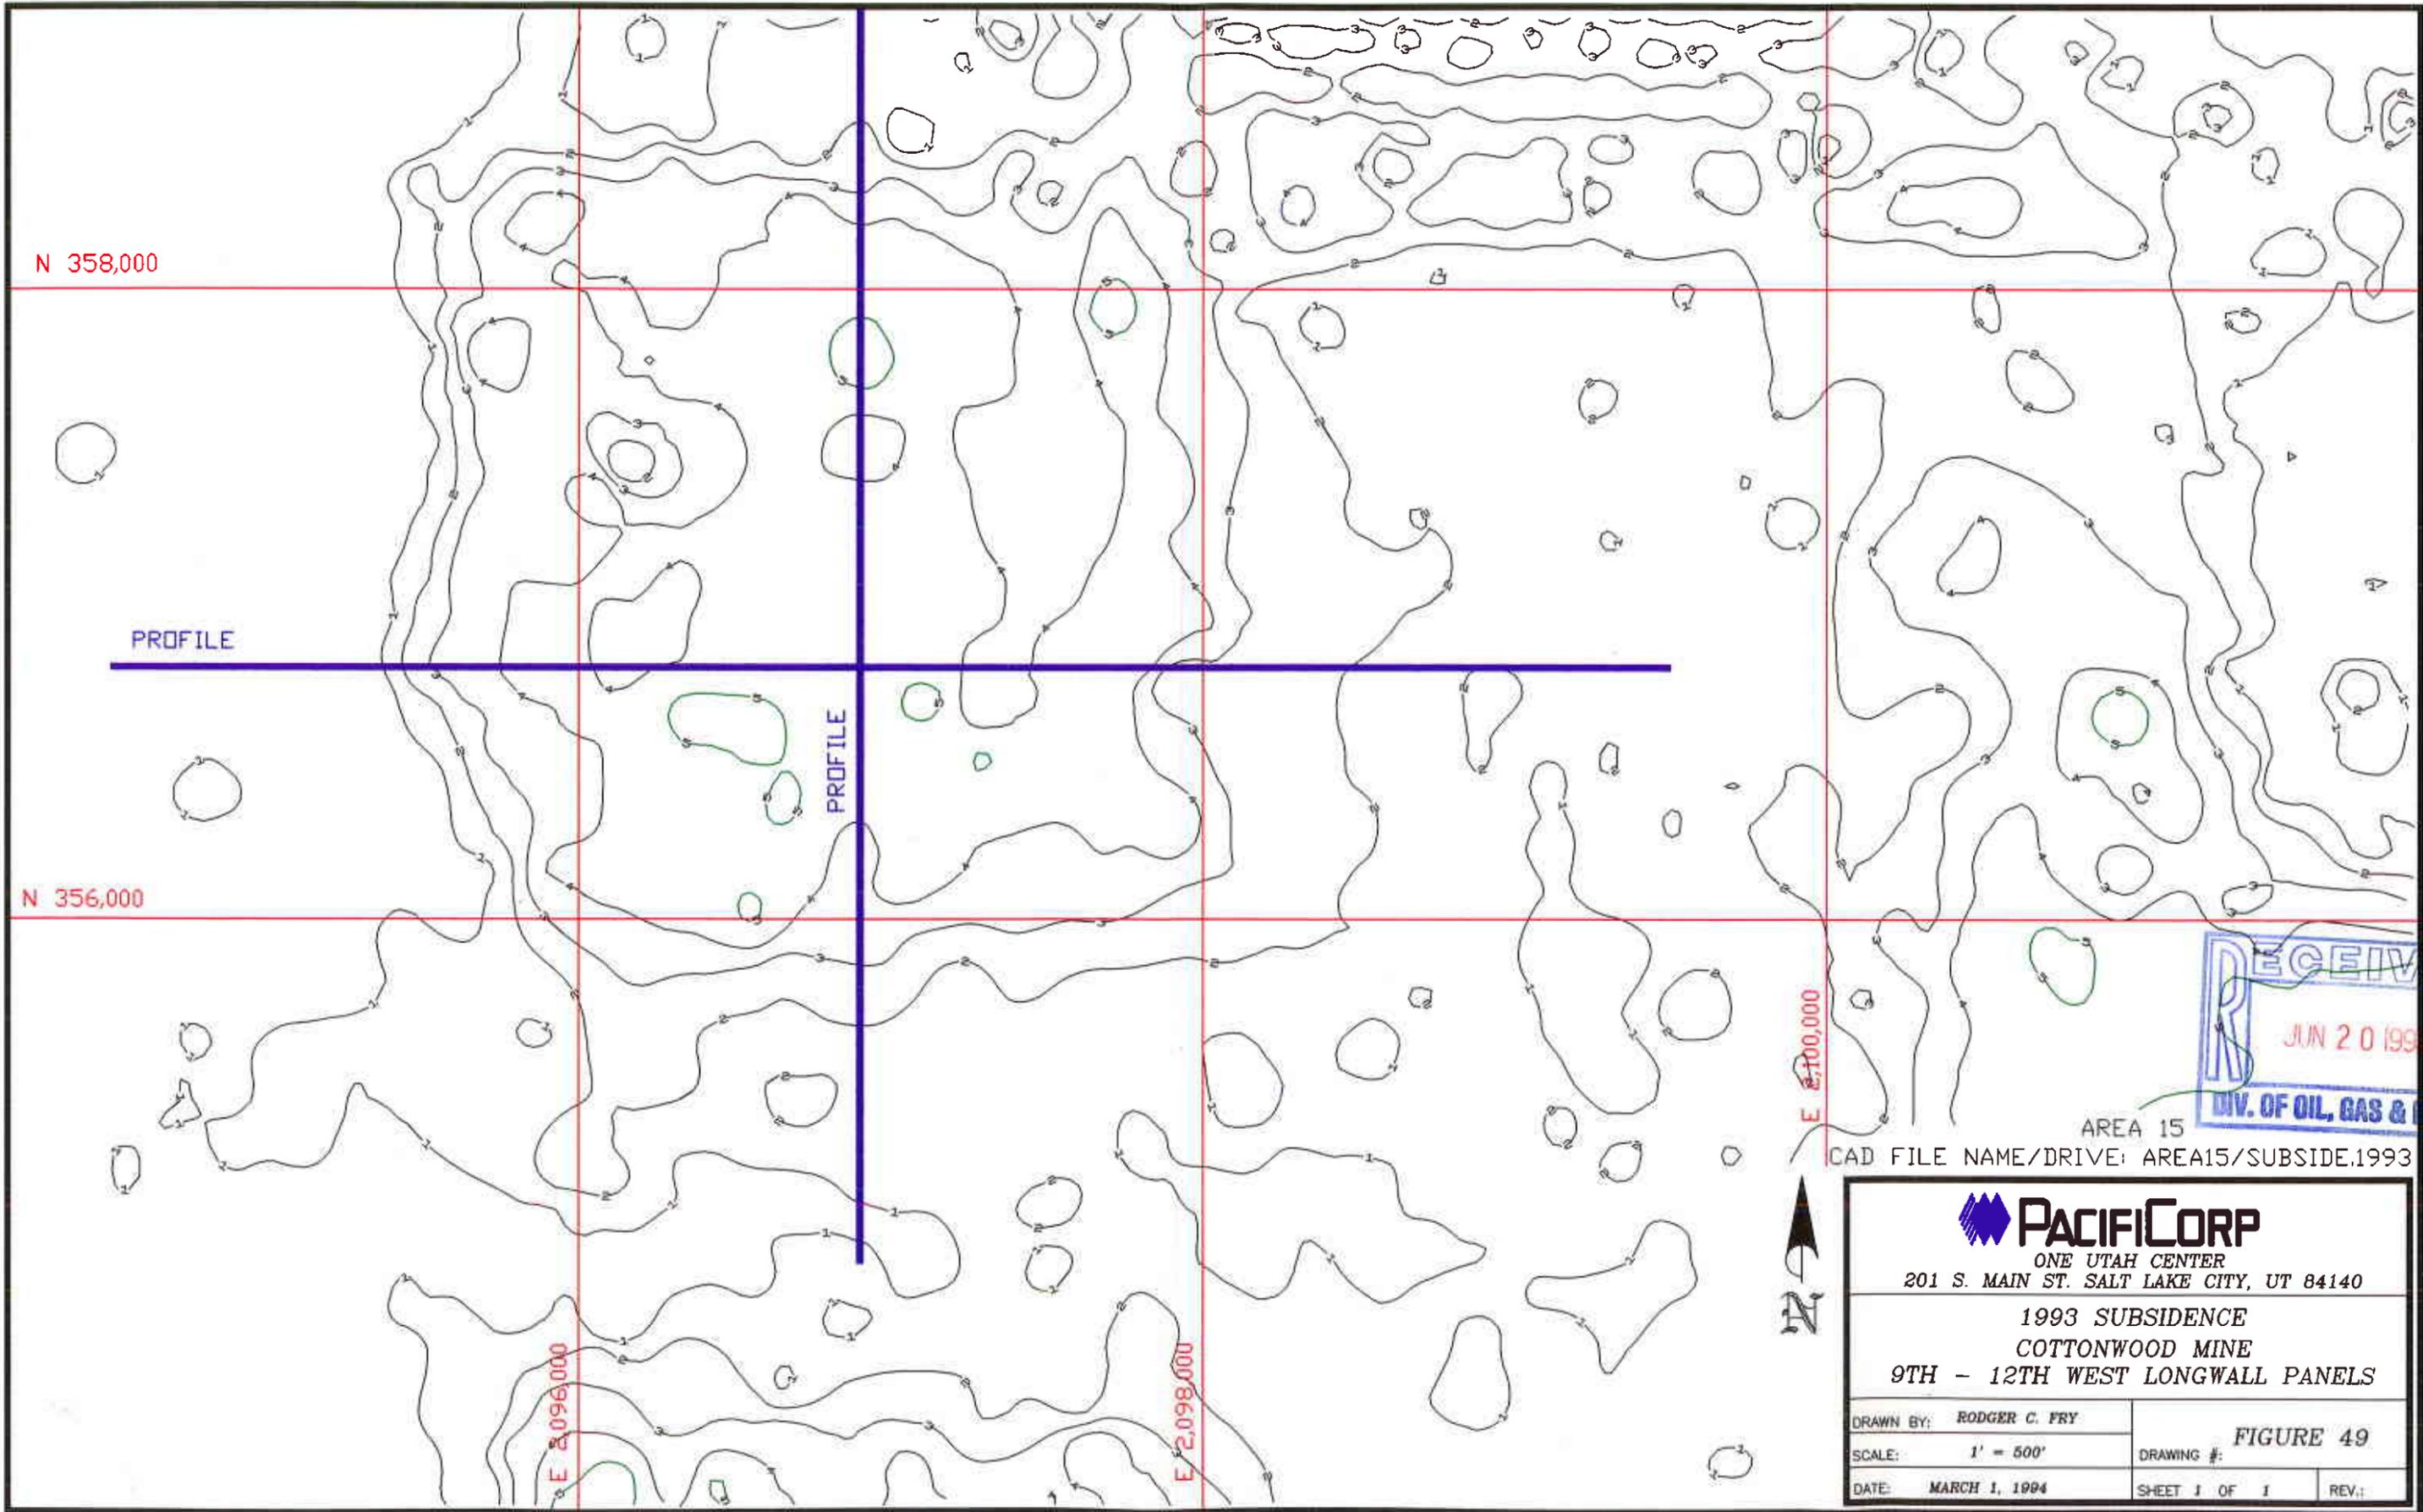
PACIFICORP ONE UTAH CENTER 201 S. MAIN ST. SALT LAKE CITY, UT 84140	
1993 SUBSIDENCE COTTONWOOD MINE 9TH - 12TH WEST LONGWALL PANELS	
DRAWN BY: RODGER C. FRY SCALE: 1" = 500' DATE: MARCH 1, 1994	FIGURE 49 DRAWING #: SHEET 1 OF 1 REV.:

Maximum measured subsidence to date is over five (5) feet above 11th West (Figures 49, 50, and 51).

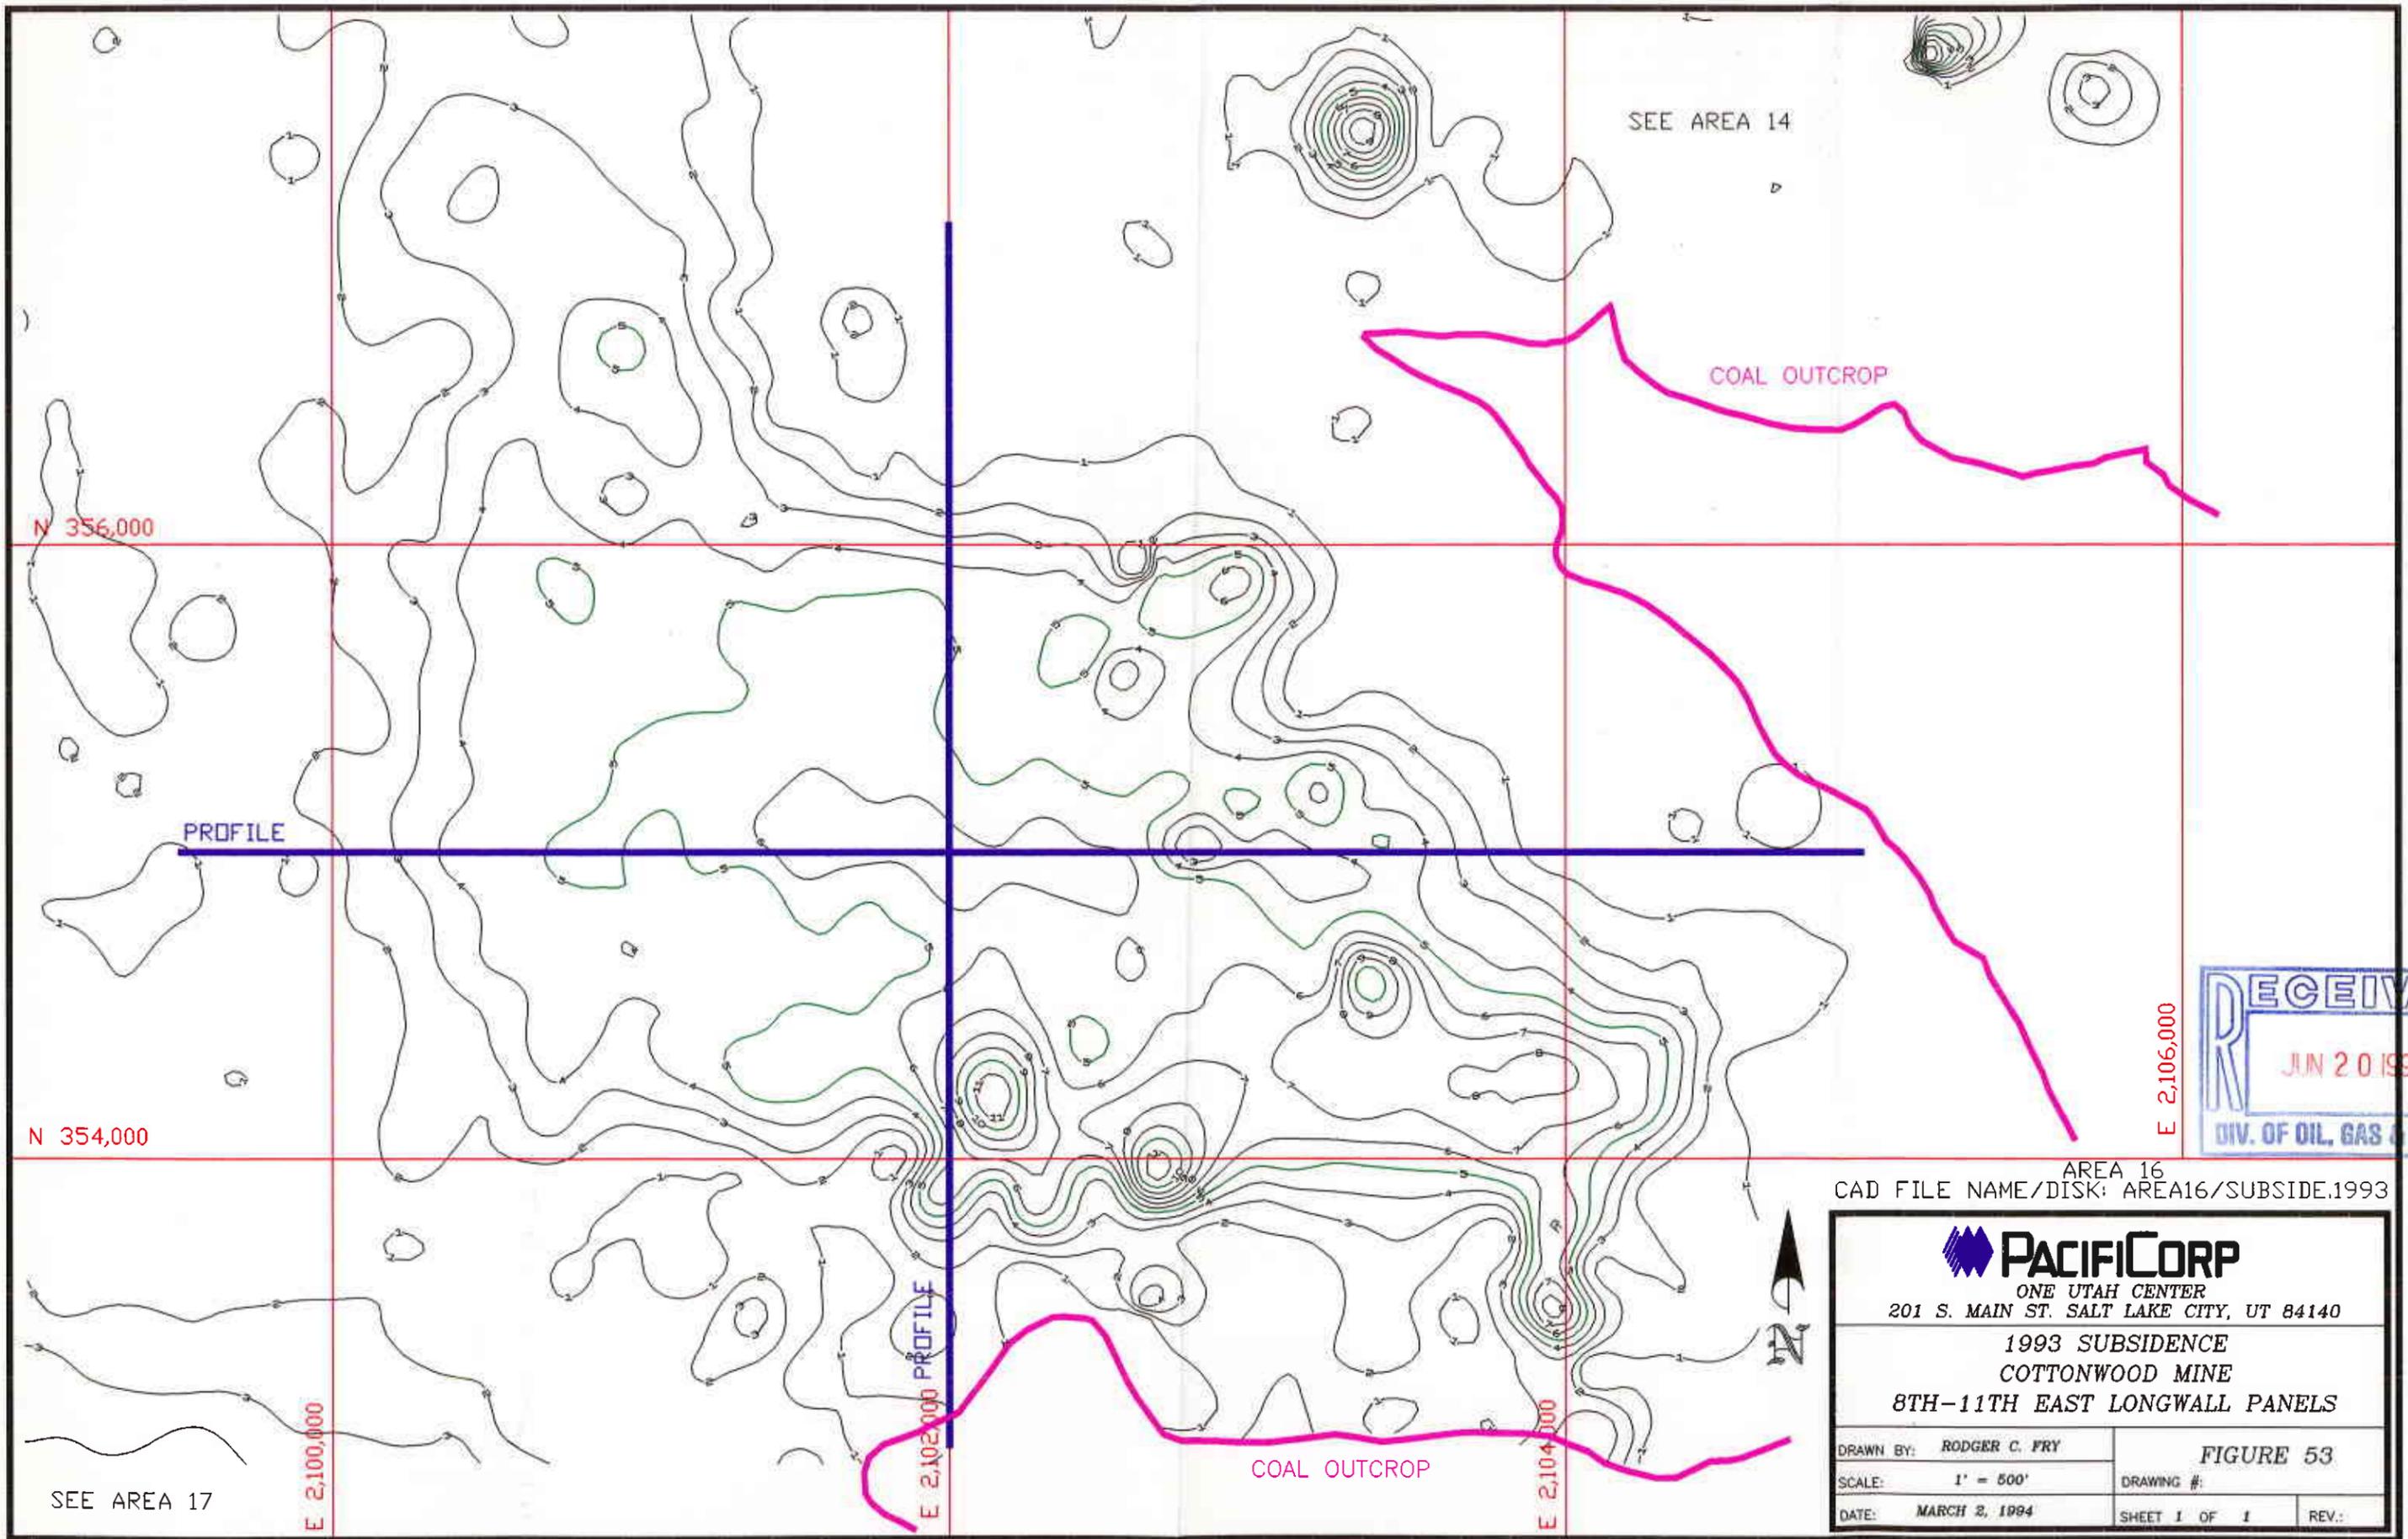
<p>PACIFICORP ONE UTAH CENTER 201 S. MAIN ST. SALT LAKE CITY, UT 84140</p>		
<p>1993 SUBSIDENCE COTTONWOOD MINE 8TH-11TH EAST LONGWALL PANELS</p>		
<p>DRAWN BY: RODGER C. FRY</p>	<p>FIGURE 53</p>	
<p>SCALE: 1" = 500'</p>	<p>DRAWING #:</p>	
<p>DATE: MARCH 2, 1994</p>	<p>SHEET 1 OF 1</p>	<p>REV.:</p>

Maximum subsidence observed to date is eleven (11) feet and occurs over the 11th East panel where the overburden is less than 600 feet (Figure 53, 54, and 55).

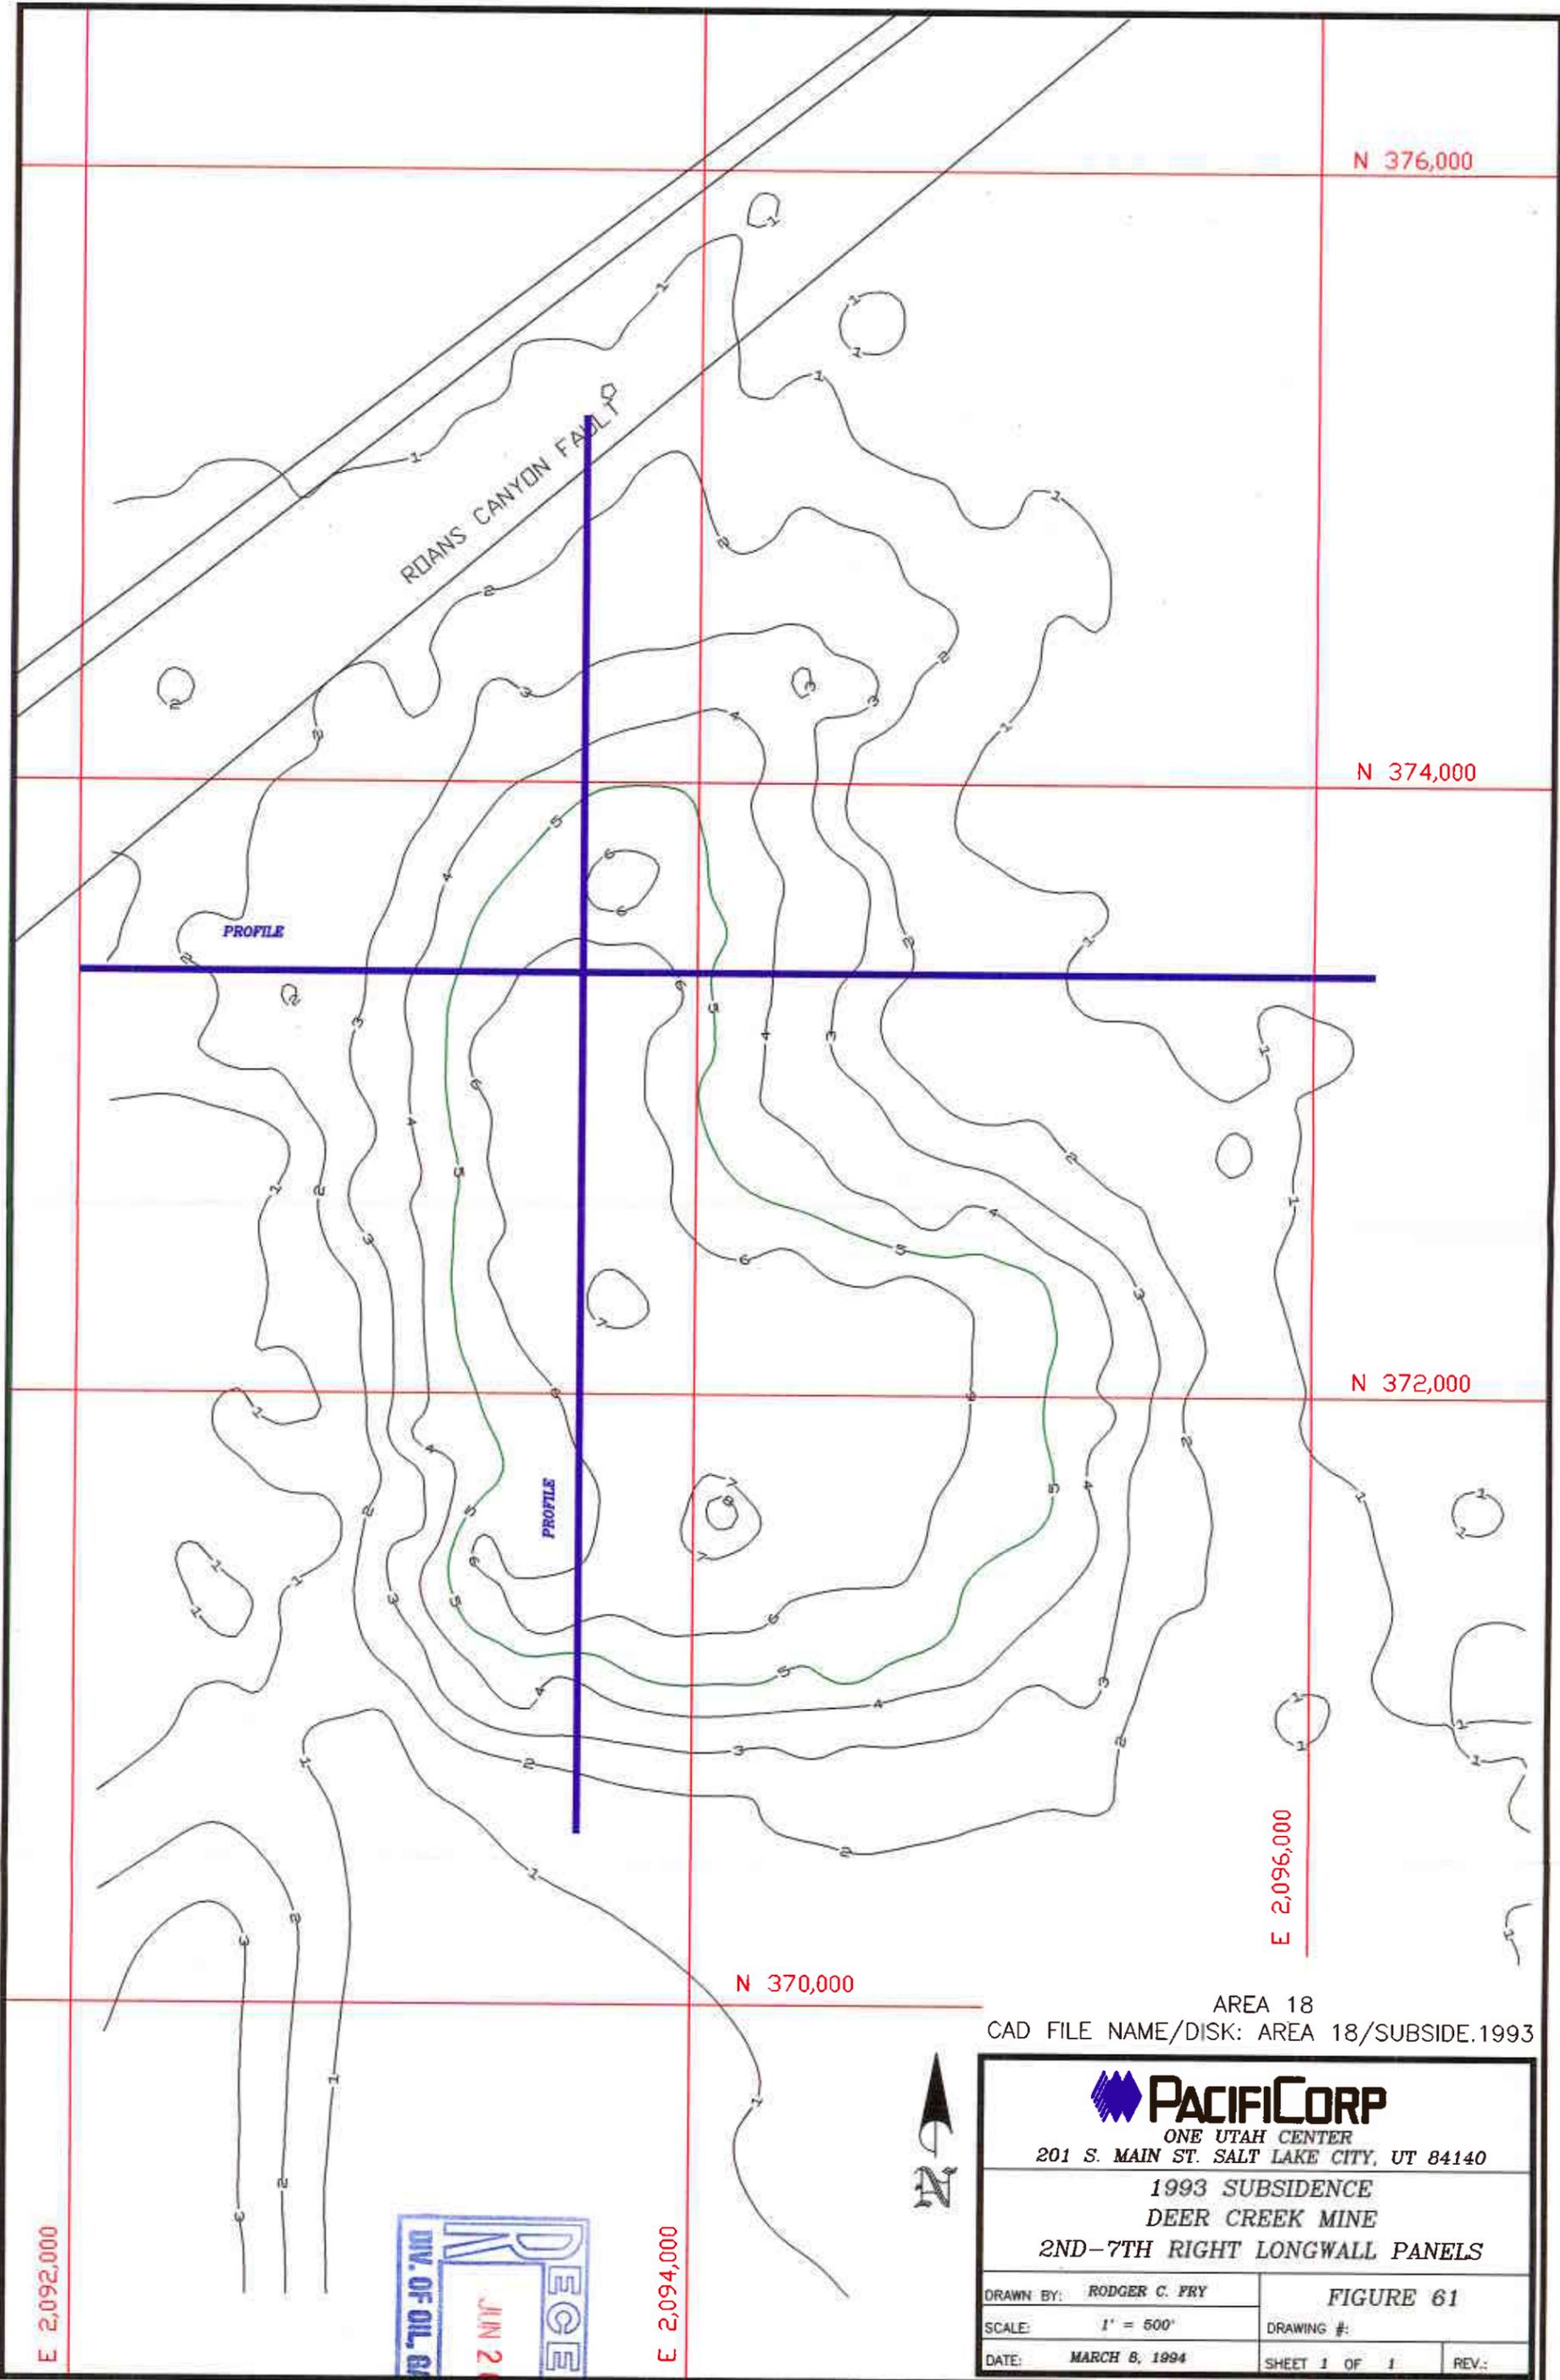
DRAWN BY: RODGER C. FRY	FIGURE 61	
SCALE: 1" = 500'	DRAWING #:	
DATE: MARCH 8, 1994	SHEET 1 OF 1	REV.:

Subsidence in this area has reached a maximum of eight (8) feet (Figures 61, 62, and 63). The subsidence zone is a broad trough running in a north - south direction. This area is overlain by several springs. Monitoring of these springs has shown no change in the quality or quantity of water discharged from these springs (see appendix and the 1992 Hydrologic Monitoring report).

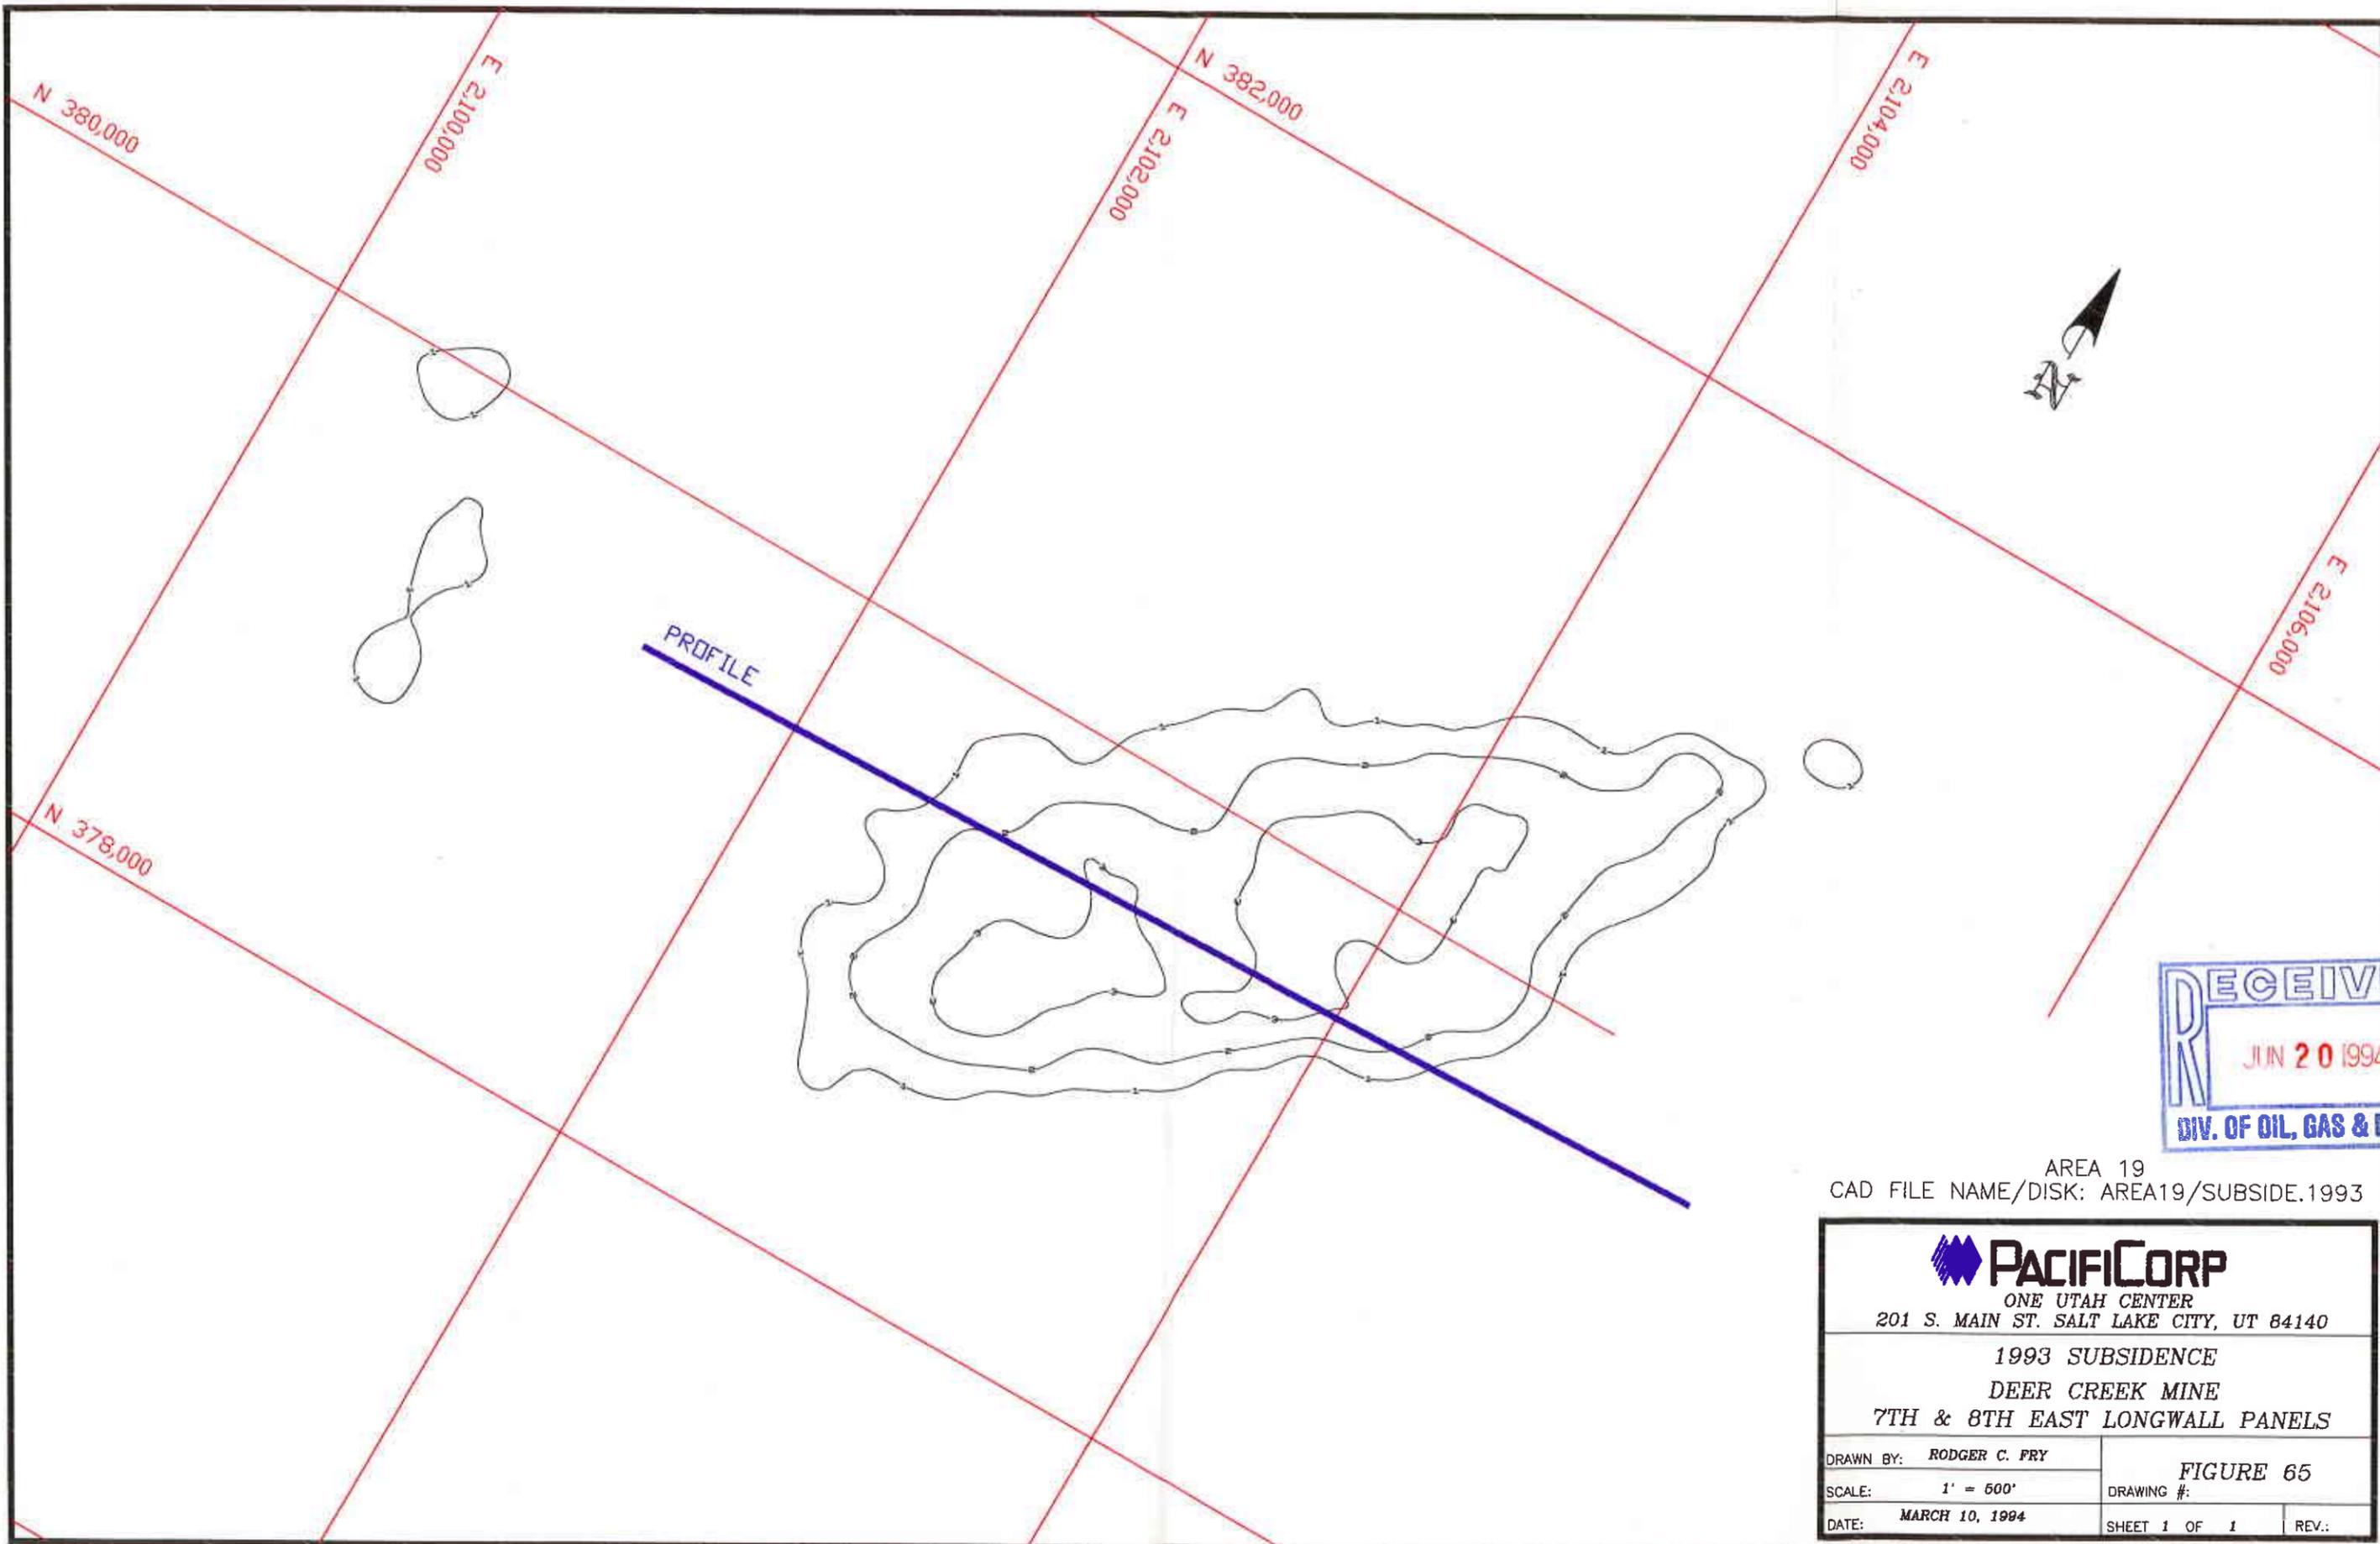
ONE UTAH CENTER 201 S. MAIN ST. SALT LAKE CITY, UT 84140		
1993 SUBSIDENCE DEER CREEK MINE 7TH & 8TH EAST LONGWALL PANELS		
DRAWN BY: RODGER C. FRY SCALE: 1' = 500' DATE: MARCH 10, 1994	DRAWING #: FIGURE 65	SHEET 1 OF 1 REV.:

Subsidence in this area has increased from slightly over one foot in 1992 to over three feet in 1993 (Figures 65 and 66).

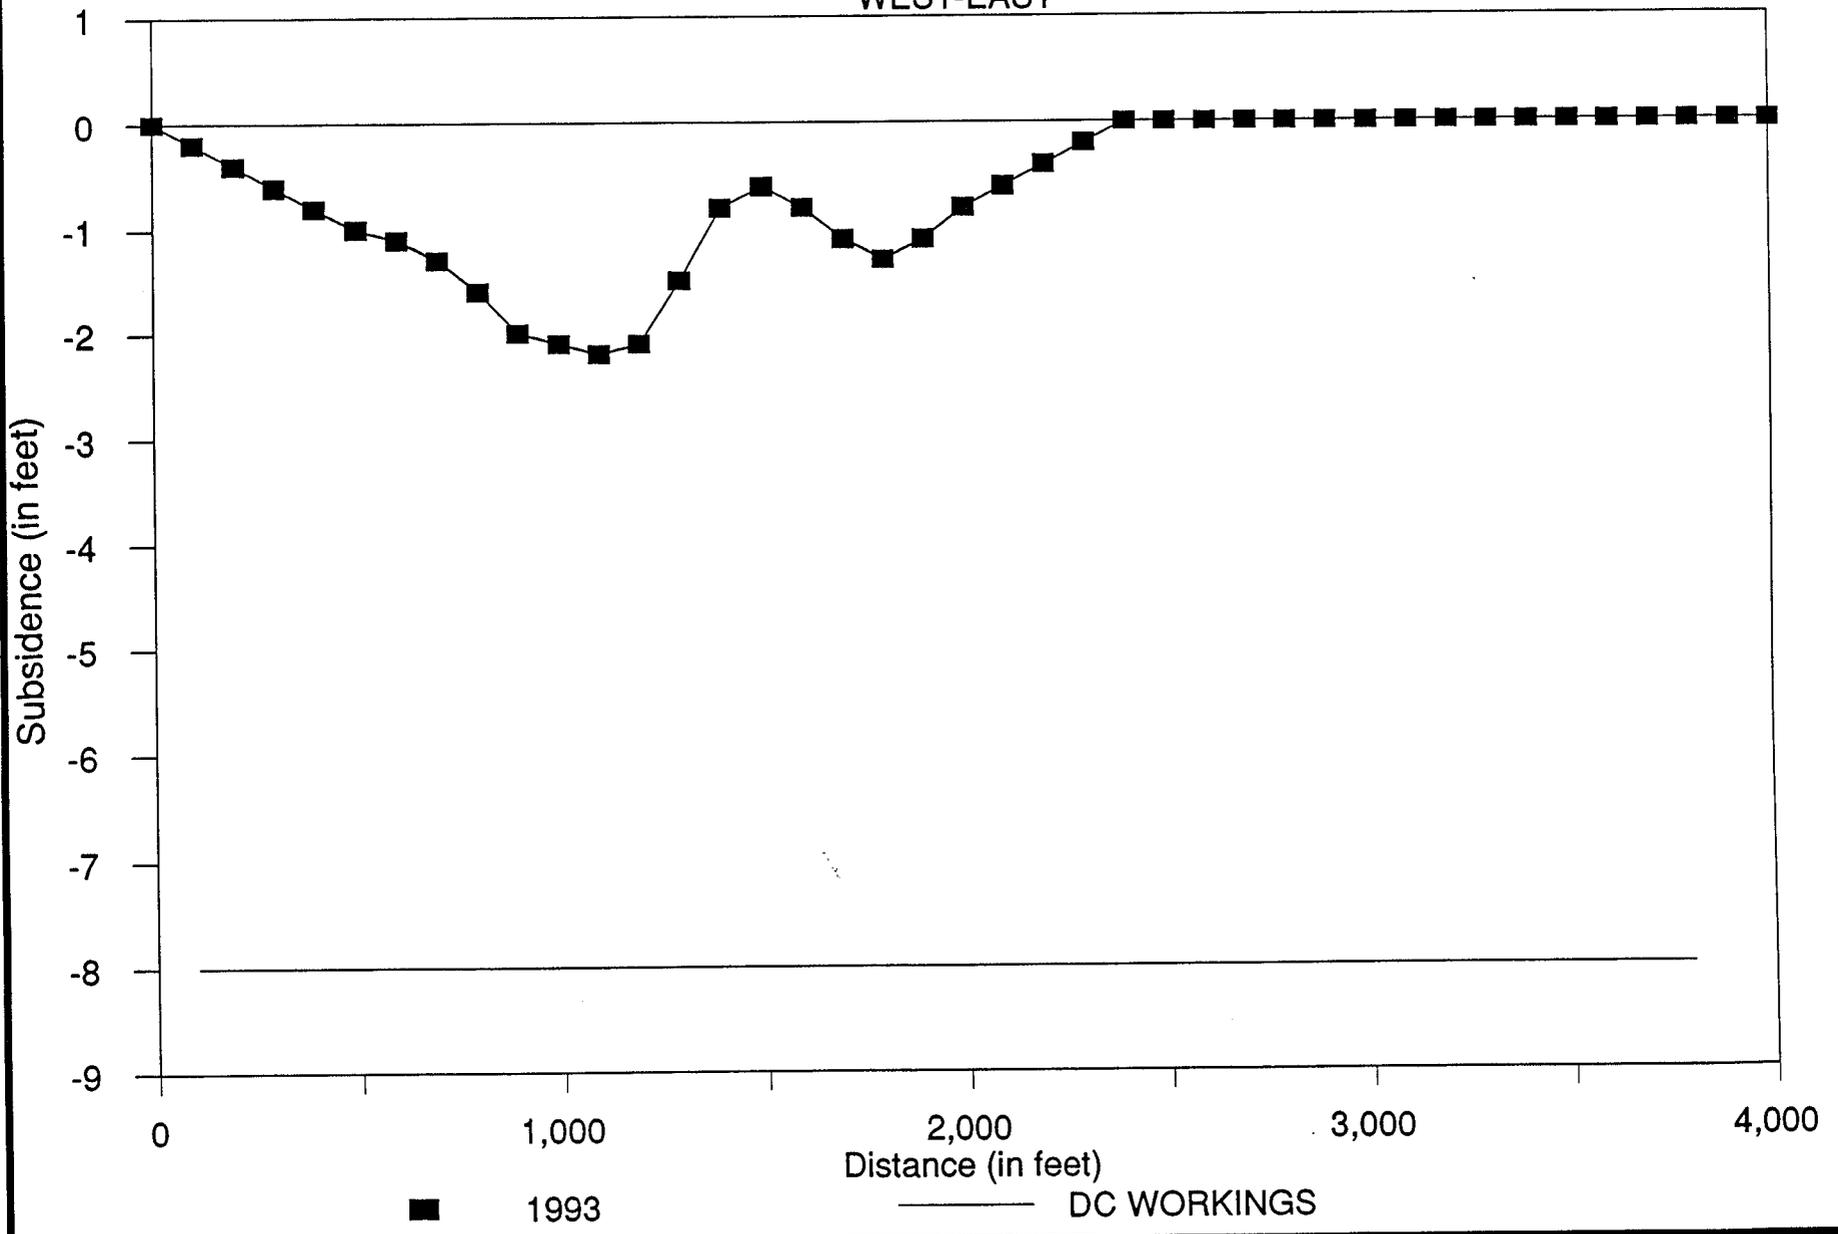
FIGURE 69
AREA 20 SUBSIDENCE PROFILE
WEST-EAST

The monitoring detected a maximum of slightly over four (4) feet of subsidence above the 2nd Left Longwall Panel (Figures 68 and 69). It is anticipated that additional subsidence will occur in this area in the coming year. No angle of draw was calculated because subsidence is still thought to be in progress.

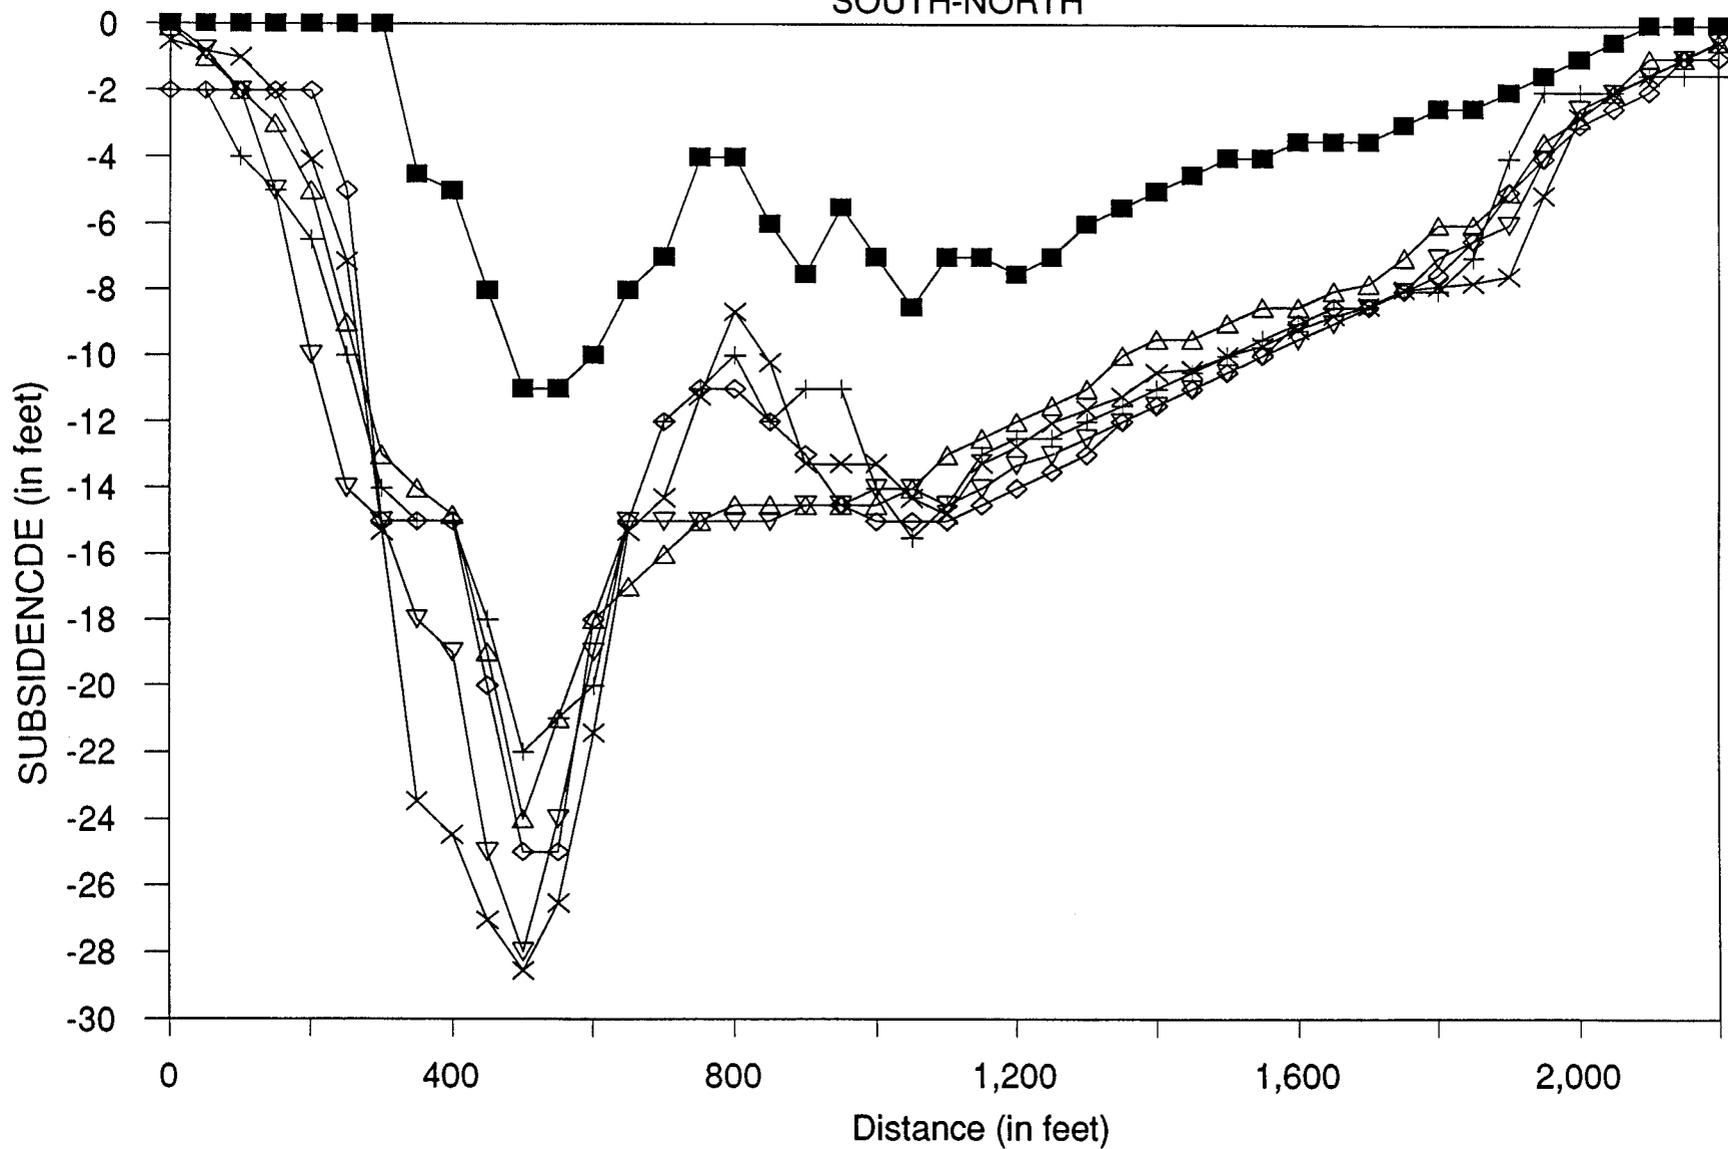
FIGURE 6
AREA 1 SUBSIDENCE PROFILE
SOUTH-NORTH

Figures 6 and 7 are north to south and west to east profiles showing the amount of subsidence in this area during the past eight years. The location of each line is shown on Figure 5. The area has seen little change since 1985 and appears to have totally stabilized. Maximum subsidence remains at about twenty-eight (28) feet. A detailed look from a helicopter revealed that the subsidence maximum is located on a steep slope, about 200 feet south of the southernmost mining, where a good-sized rotational slump has occurred. The workings here are also surrounded by burned coal. It is probable that the combination of steep slopes and crushing of clinker beds has allowed subsidence to occur well outside the area of mine workings. An inspection of the area from the ground indicates that many of the open fractures forming the graben-like structure have begun to heal and fill in with soil.
