ANNUAL SUBSIDENCE MONITORING REPORT
EAST MOUNTAIN PROPERTY
1993

PACIFICORP
TECHNICAL SERVICES REPORT
RODGER C. FRY

PACIFICORP
SUBSIDENCE MONITORING PROGRAM
ANNUAL REPORT FOR 1993

June 1994

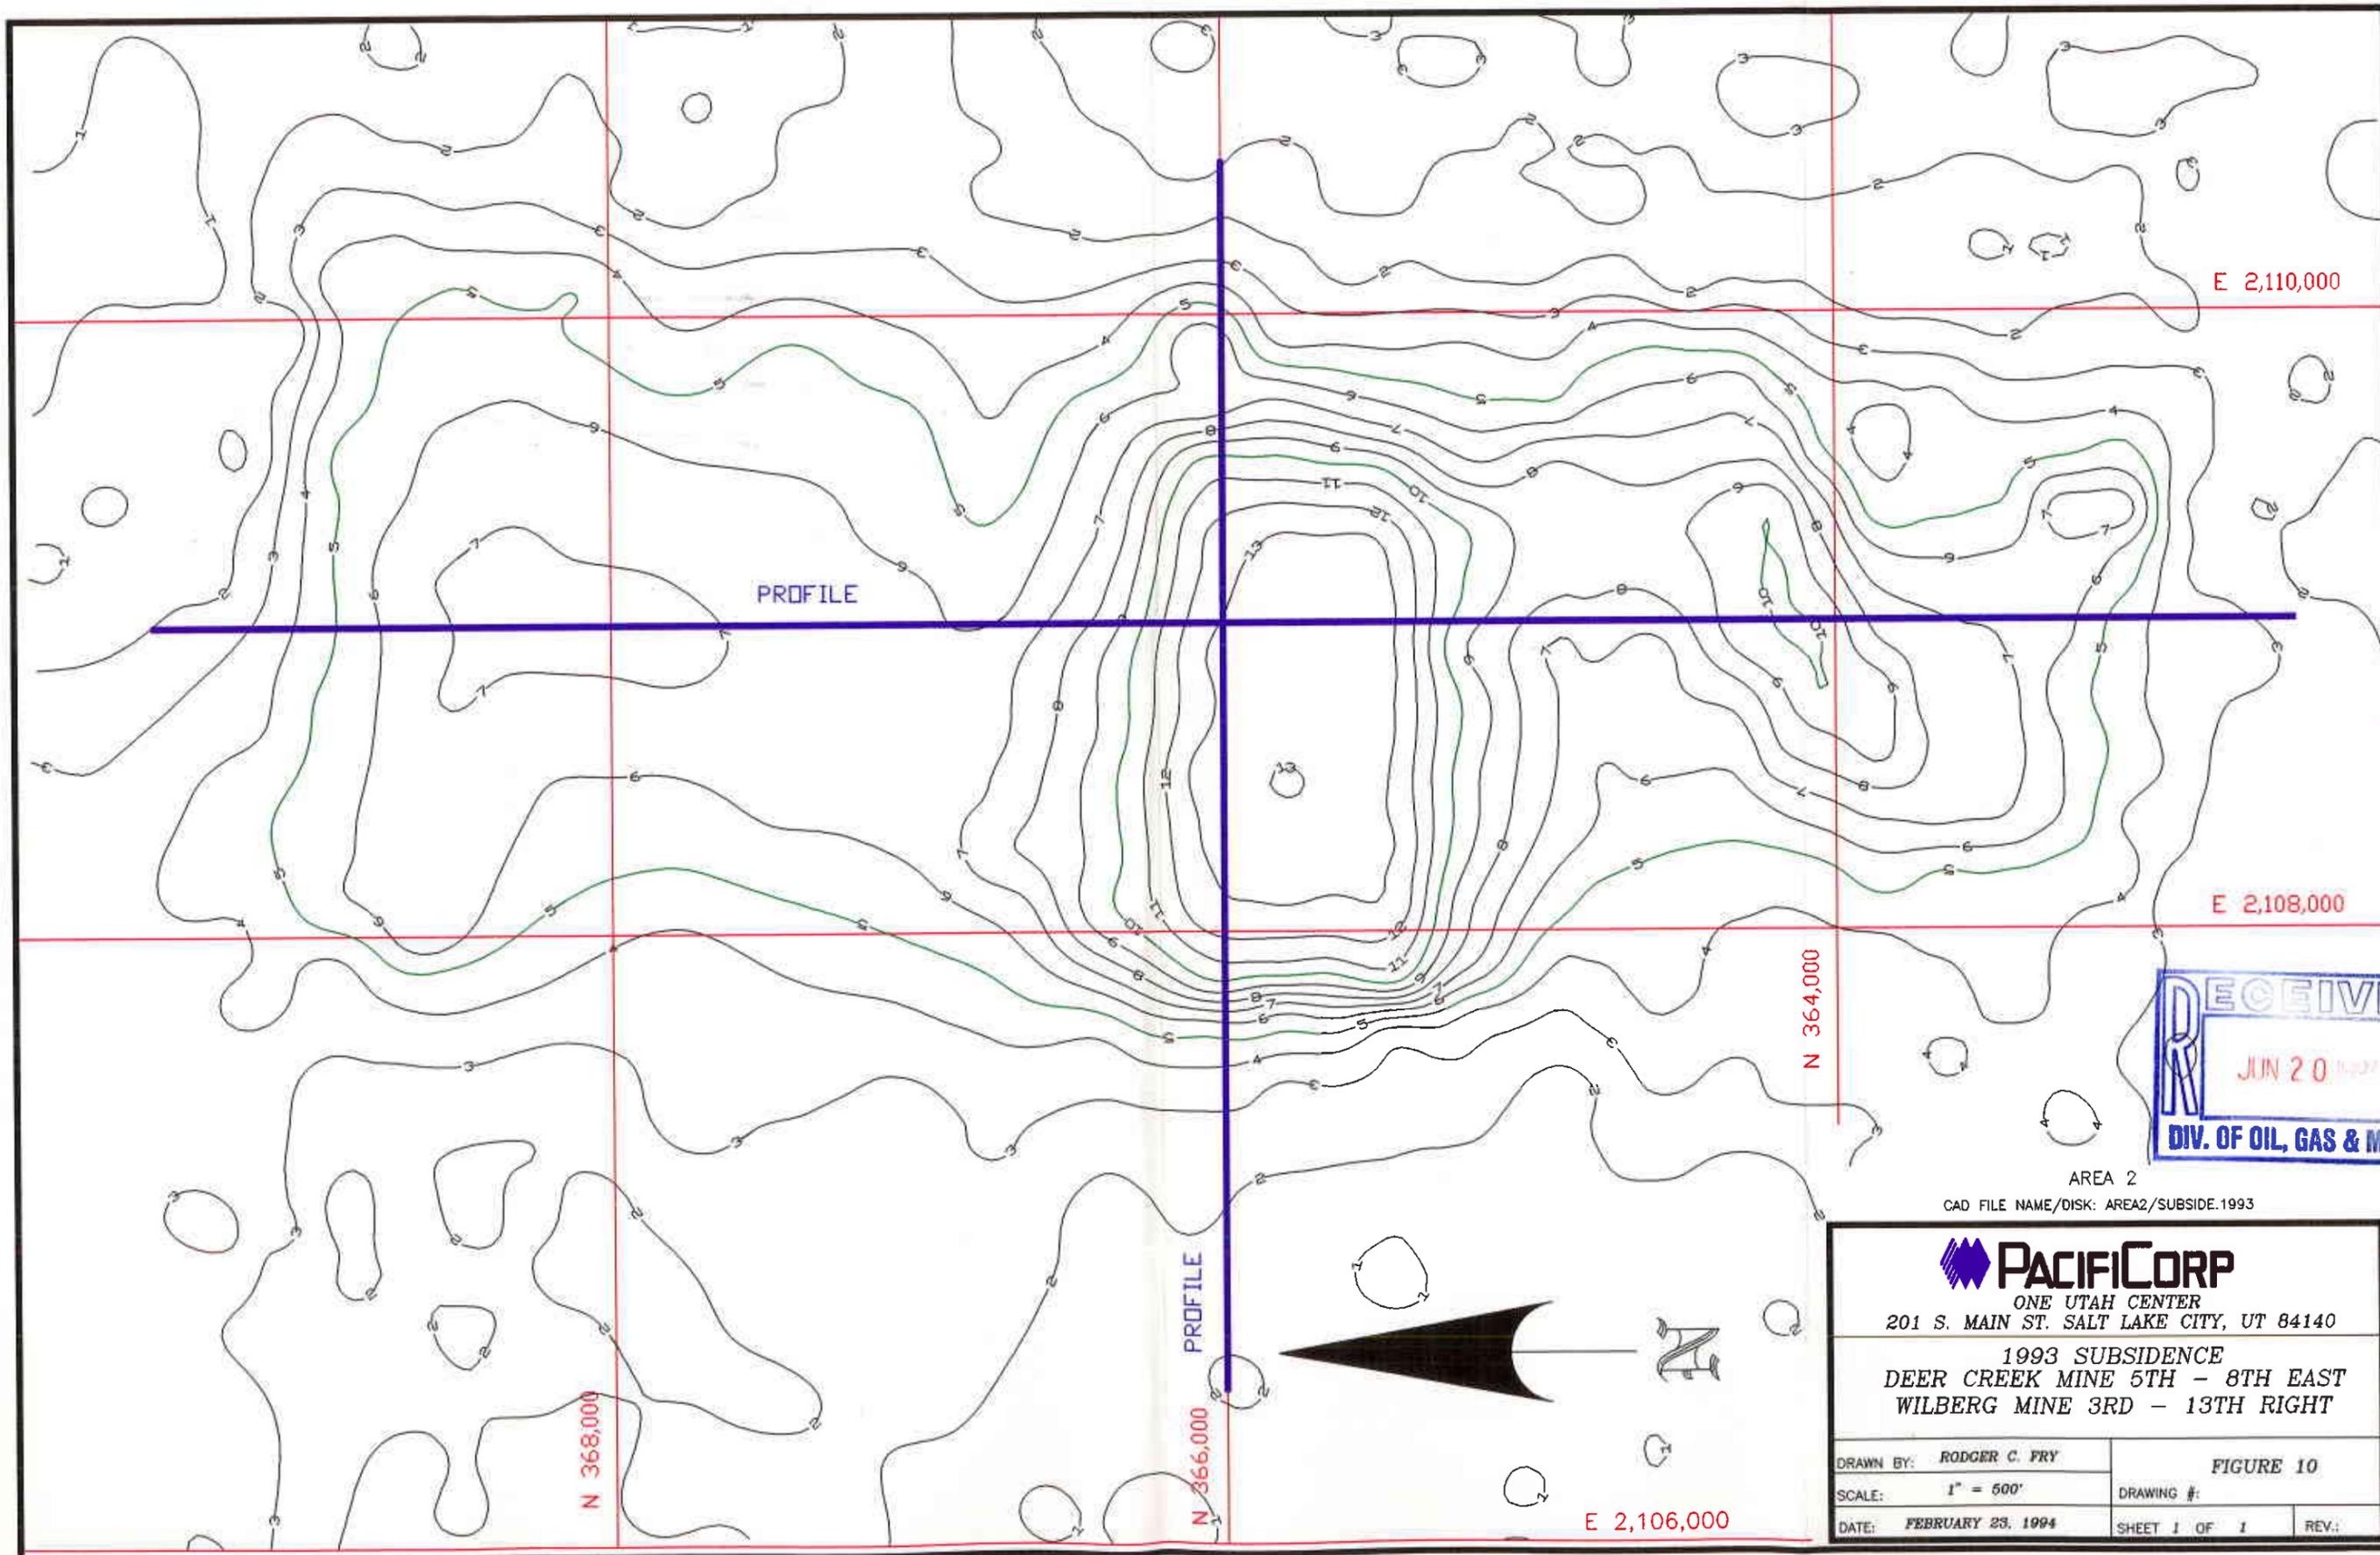
DRAWN BY: RODGER C. FRY	FIGURE 10
SCALE: 1" = 500'	DRAWING #:
DATE: FEBRUARY 23, 1994	SHEET 1 OF 1
	REV:

Maximum subsidence in Area 2 has increased to 13 feet in one area above the center of the multiple seam mining area (Figure 10). The subsidence profiles (Figures 11 and 12) indicate that the subsidence trough has deepened slightly in the last 3 years. Neither PacifiCorp nor other contracted personnel have detected any surface fissures or other visible disturbance in the area.

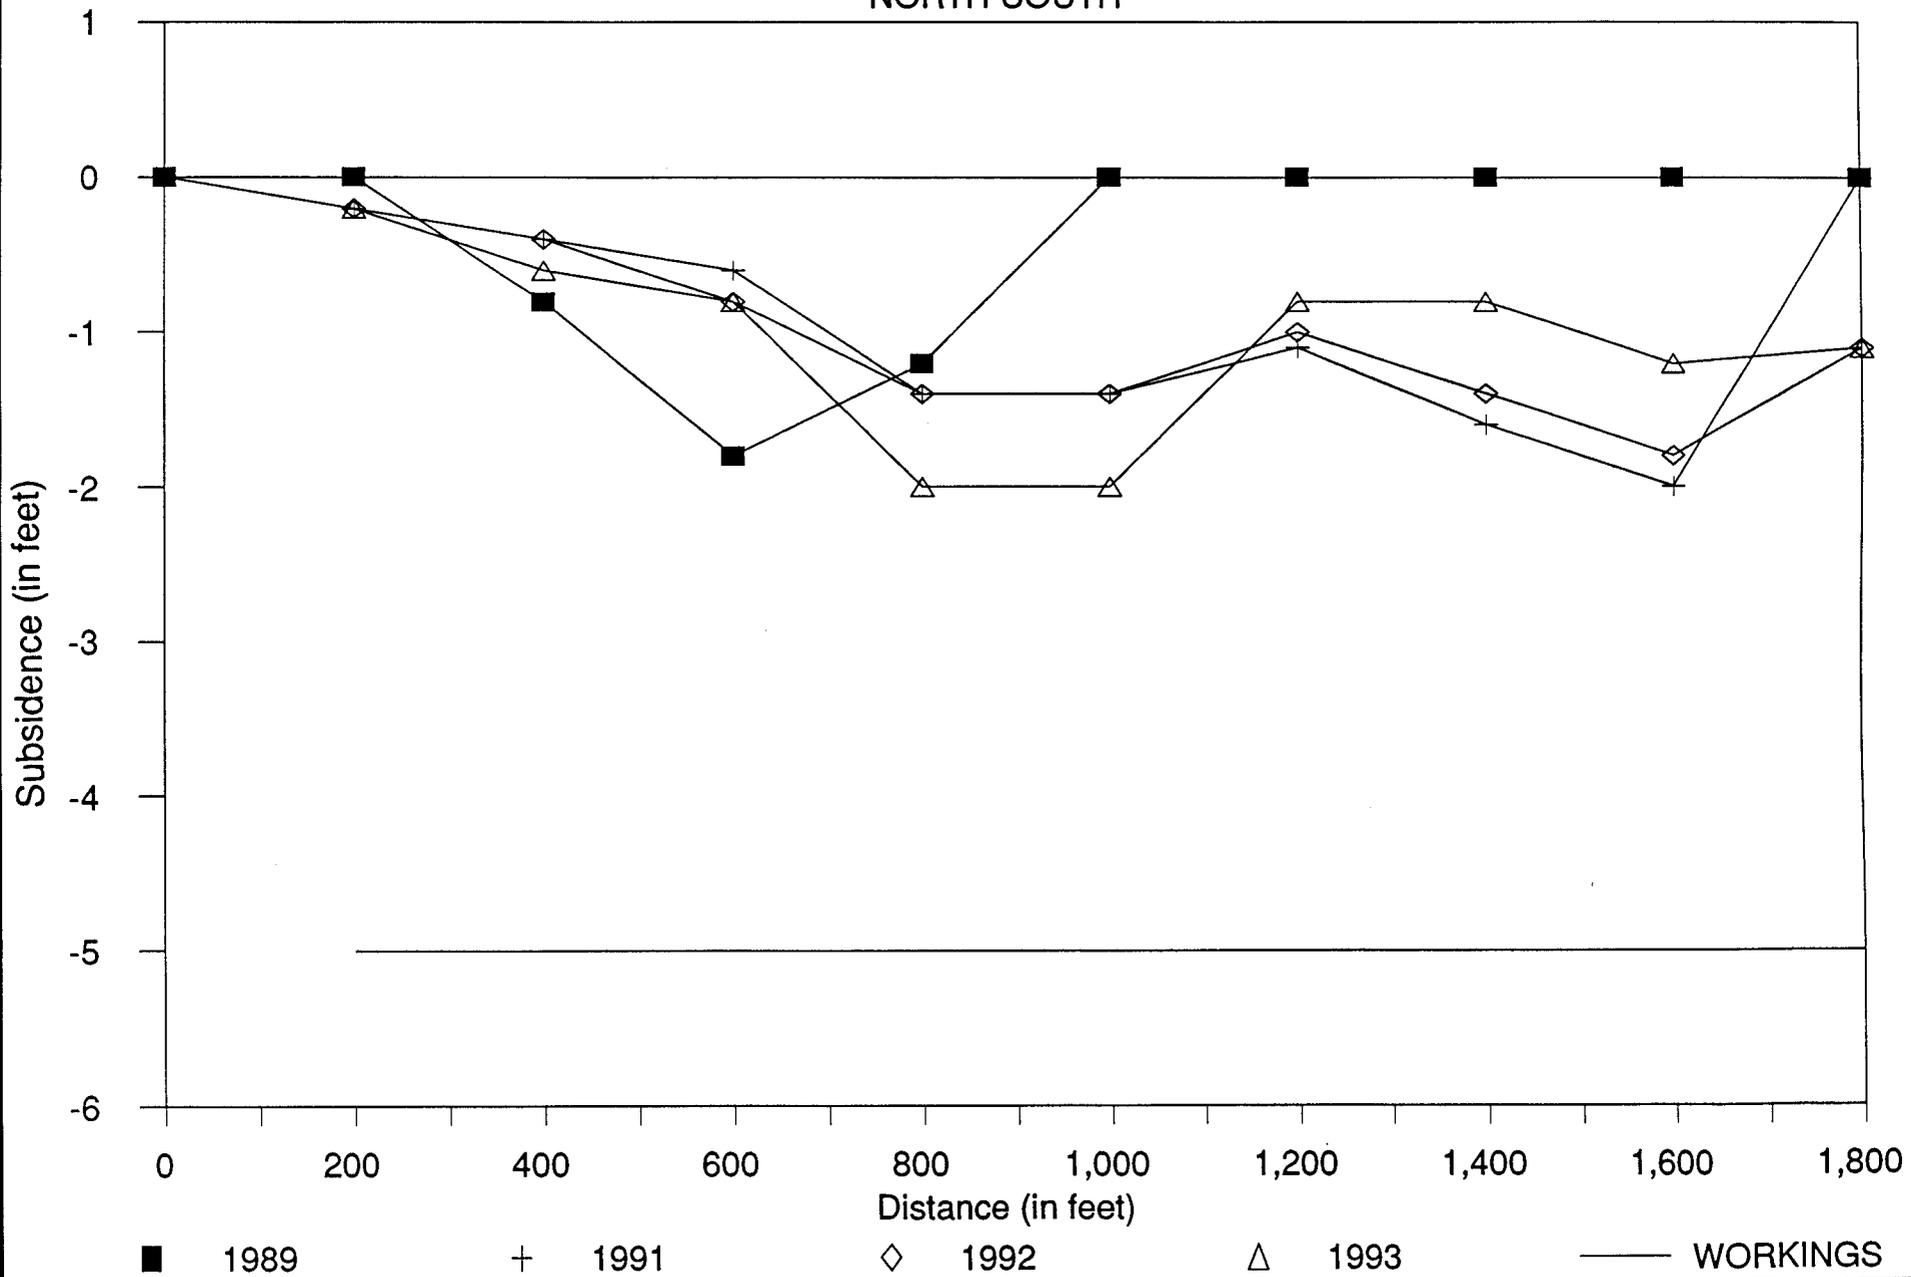
FIGURE 14
AREA 3 SUBSIDENCE PROFILE
NORTH-SOUTH

The subsidence above 1st North occurs on a narrow ridge capped by a highly fractured sandstone. The subsidence measured is depicted in Figure 13A. Figure 14 is a profile of total subsidence as it occurred along a line of points above the workings.

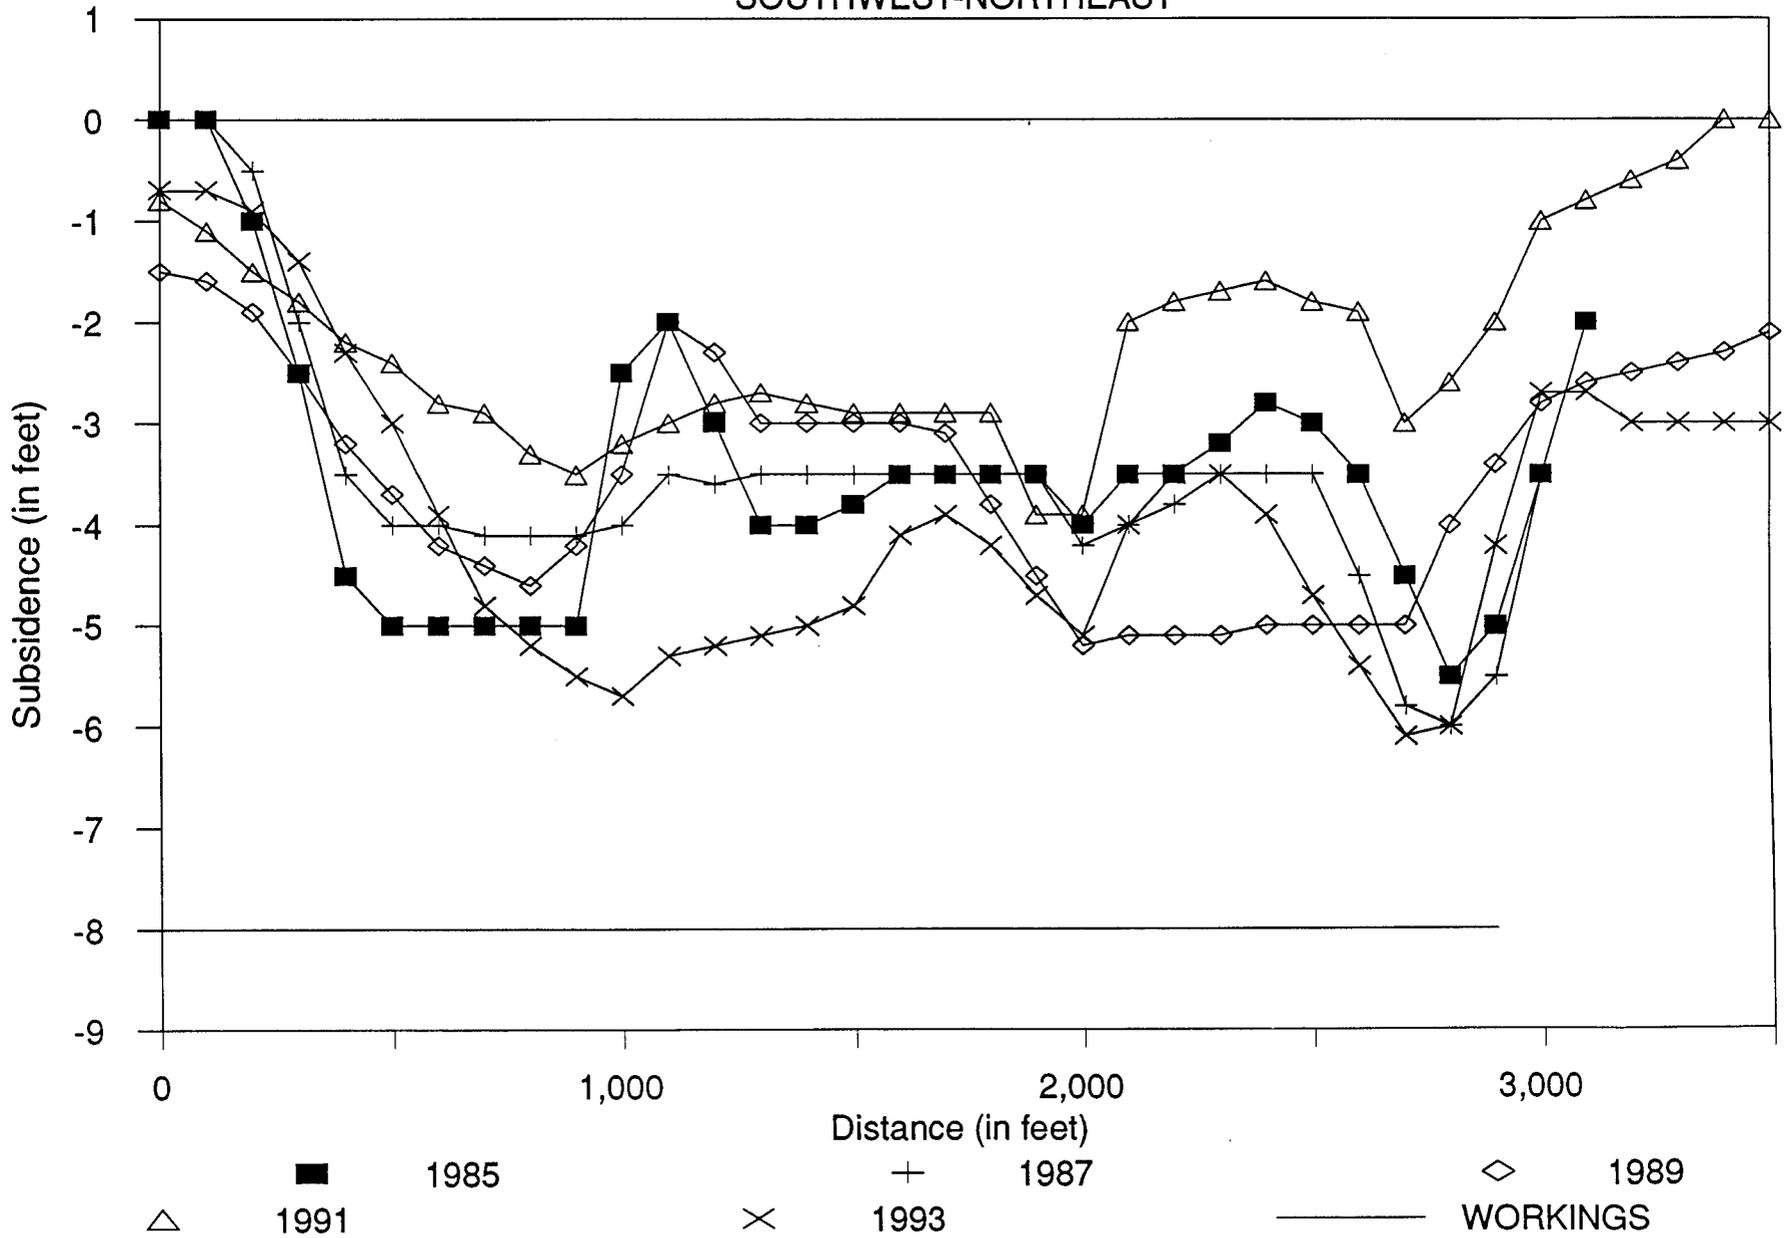
FIGURE 29
AREA 7 SUBSIDENCE PROFILE
 SOUTHWEST-NORTHEAST

Pillar extraction mining in 2nd North was completed in 1983 and, as shown in Figures 27, 28, and 29, little additional subsidence has occurred over the workings since 1984. The workings are surrounded by burned coal.

Maximum subsidence is as much as six (6) feet. In examining the area by helicopter and aerial photography it is apparent that much of the elevation change measured was due to cliff failure and mass wasting on the steep slopes above the workings, where the rocks were highly fractured prior to mining.
