ANNUAL SUBSIDENCE MONITORING REPORT
EAST / TRAIL MOUNTAIN PROPERTIES
1995

PACIFICORP
TECHNICAL SERVICES REPORT
RODGER C. FRY

MARCH 29, 1996

PACIFICORP
SUBSIDENCE MONITORING PROGRAM
ANNUAL REPORT FOR 1995

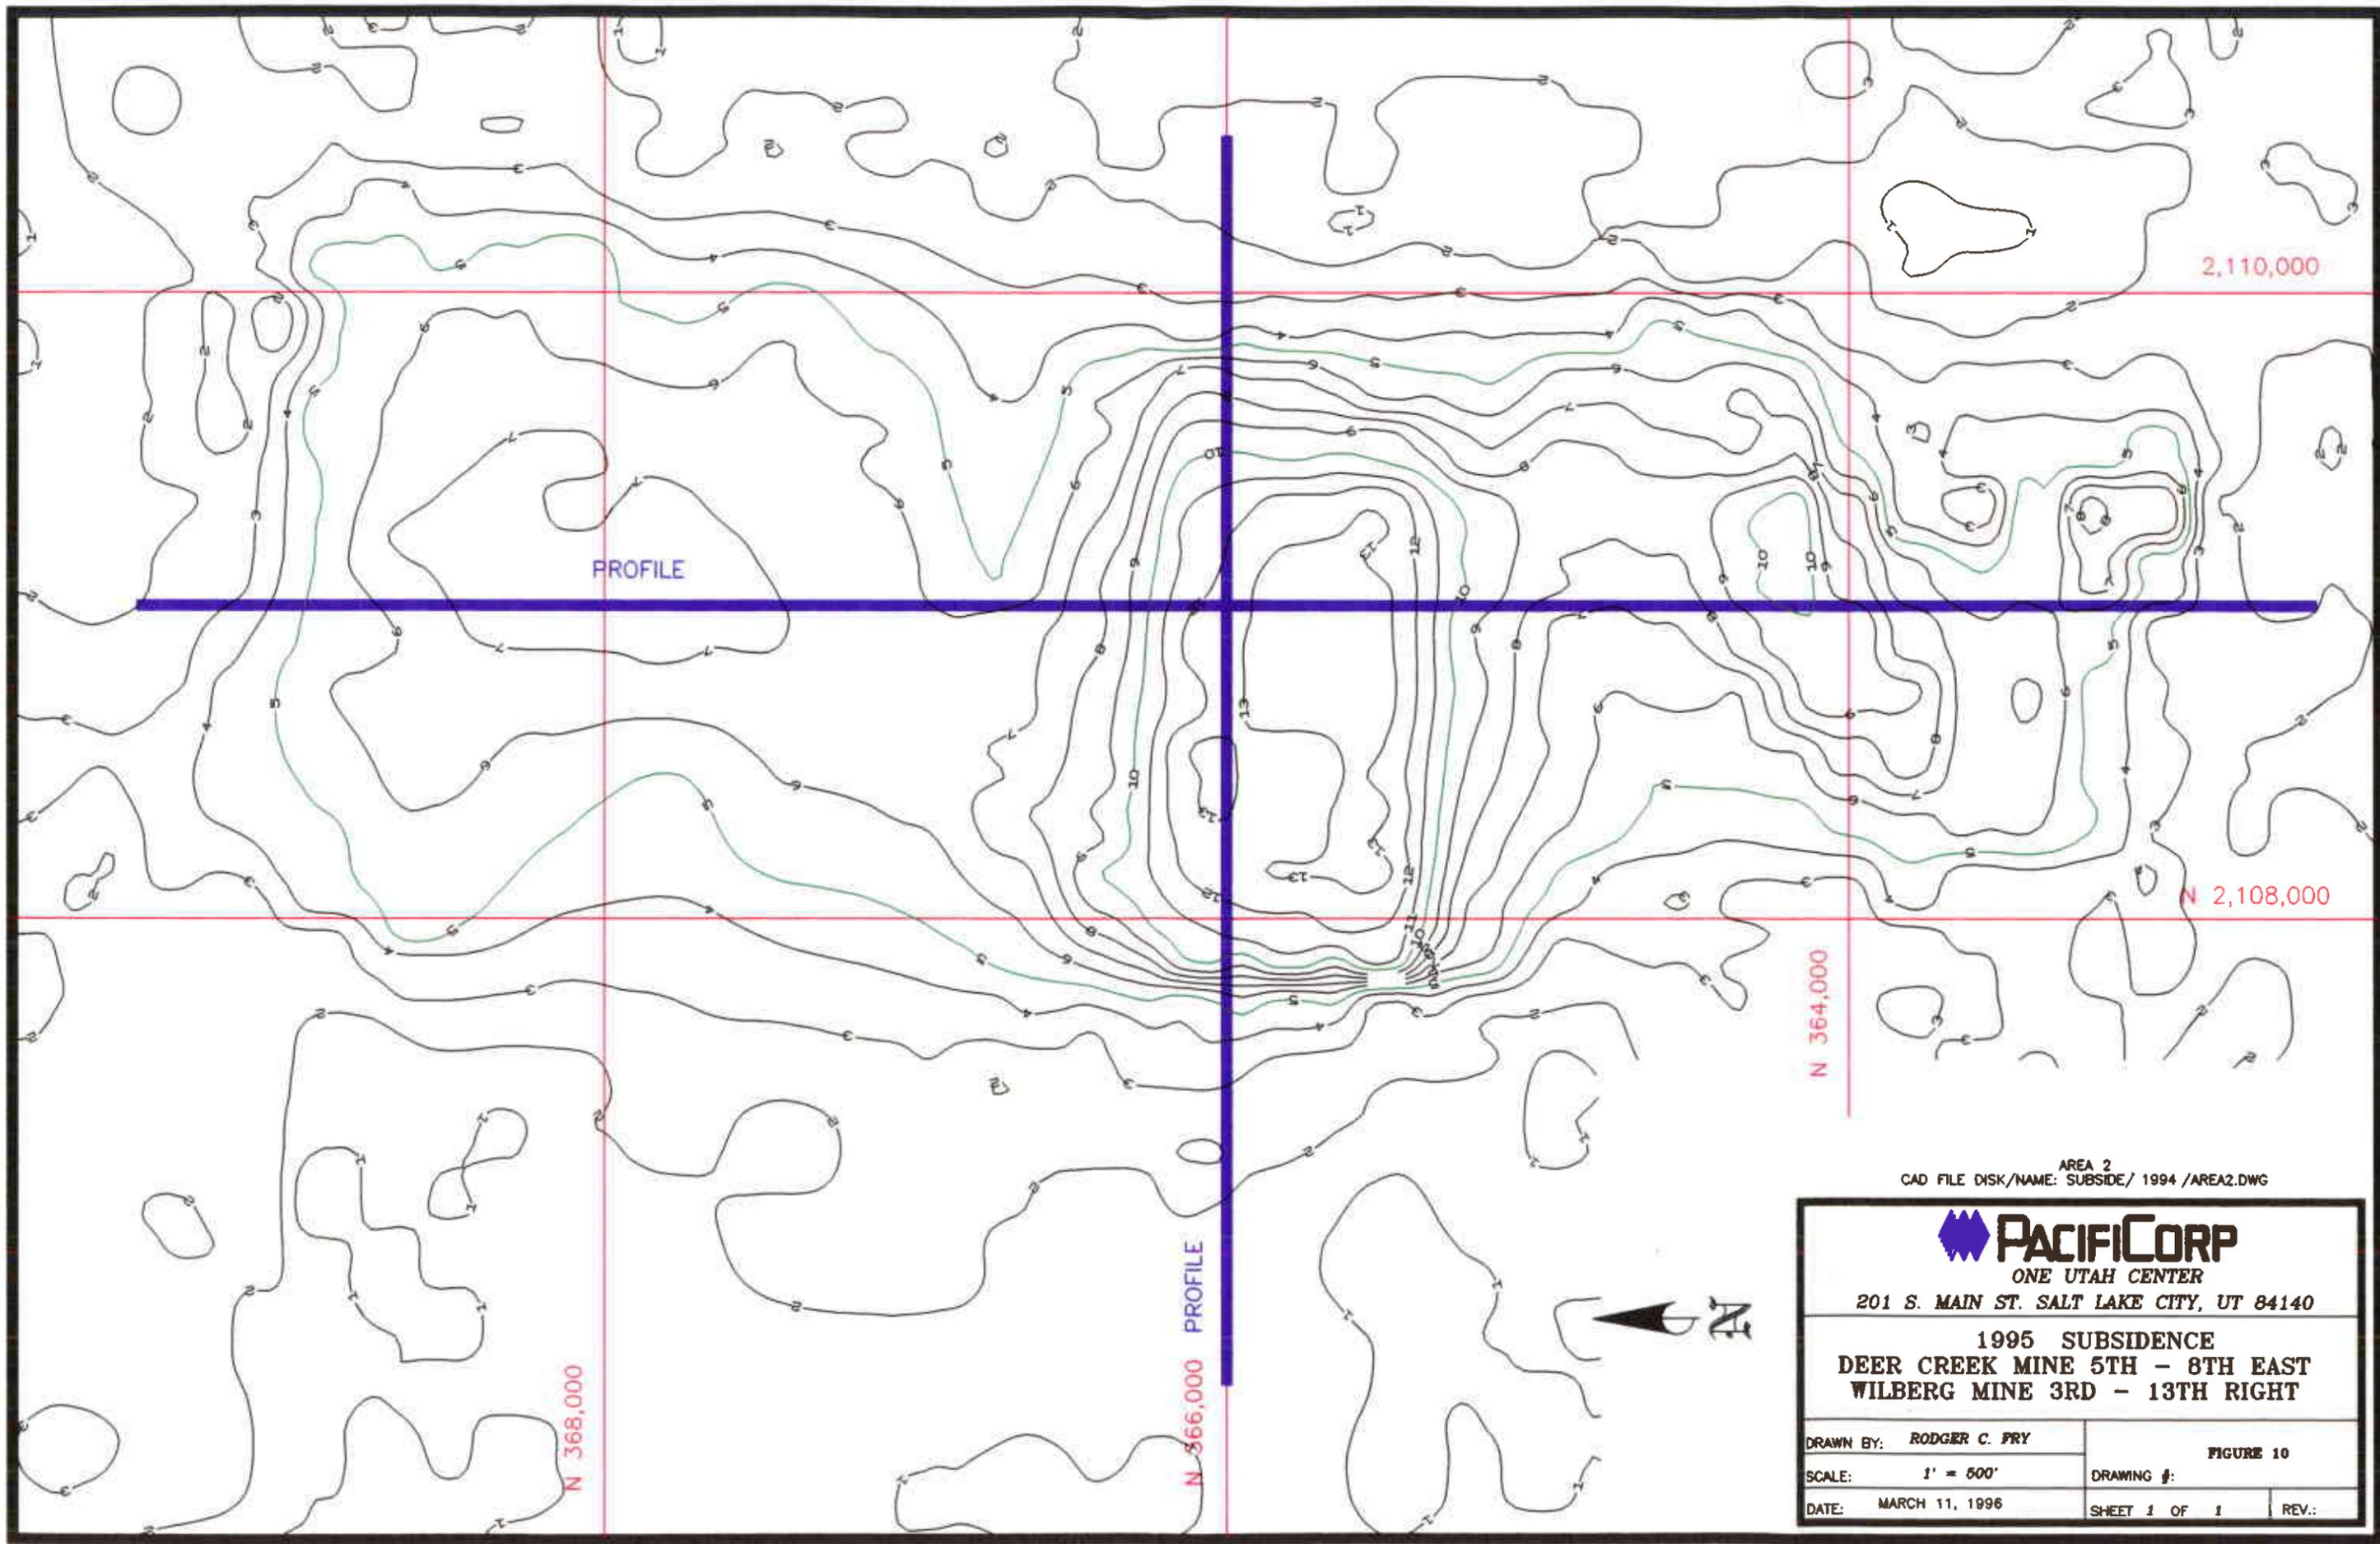
DRAWN BY: RODGER C. FRY	FIGURE 10	
SCALE: 1" = 500'	DRAWING #:	
DATE: MARCH 11, 1996	SHEET 1 OF 1	REV.:

Maximum subsidence in Area 2 has stabilized at 13 feet in one area above the center of the multiple seam mining area (Figure 10). The subsidence profiles (Figures 11 and 12) indicate that the subsidence has been stable for the past 4 years or more. Neither PacifiCorp nor other contracted personnel have detected any surface fissures or other visible disturbance in the area.

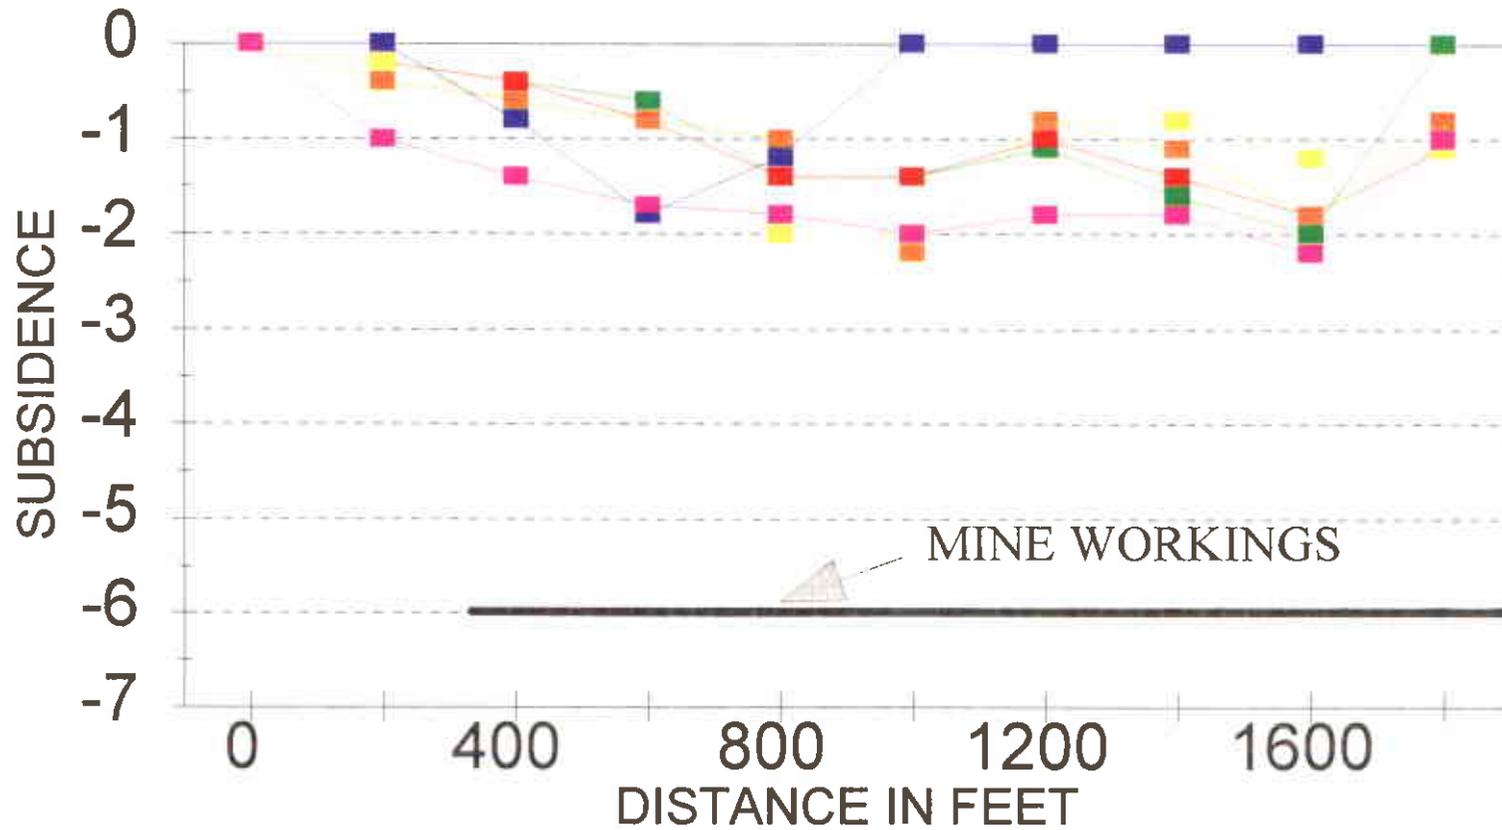
FIGURE 14

The subsidence above 1st North occurs on a narrow ridge capped by a highly fractured sandstone. The subsidence measured is depicted in Figure 13A. Figure 14 is a profile of total subsidence as it occurred along a line of points above the workings. The subsidence in area 3 has shown no significant change in the past 4 years.

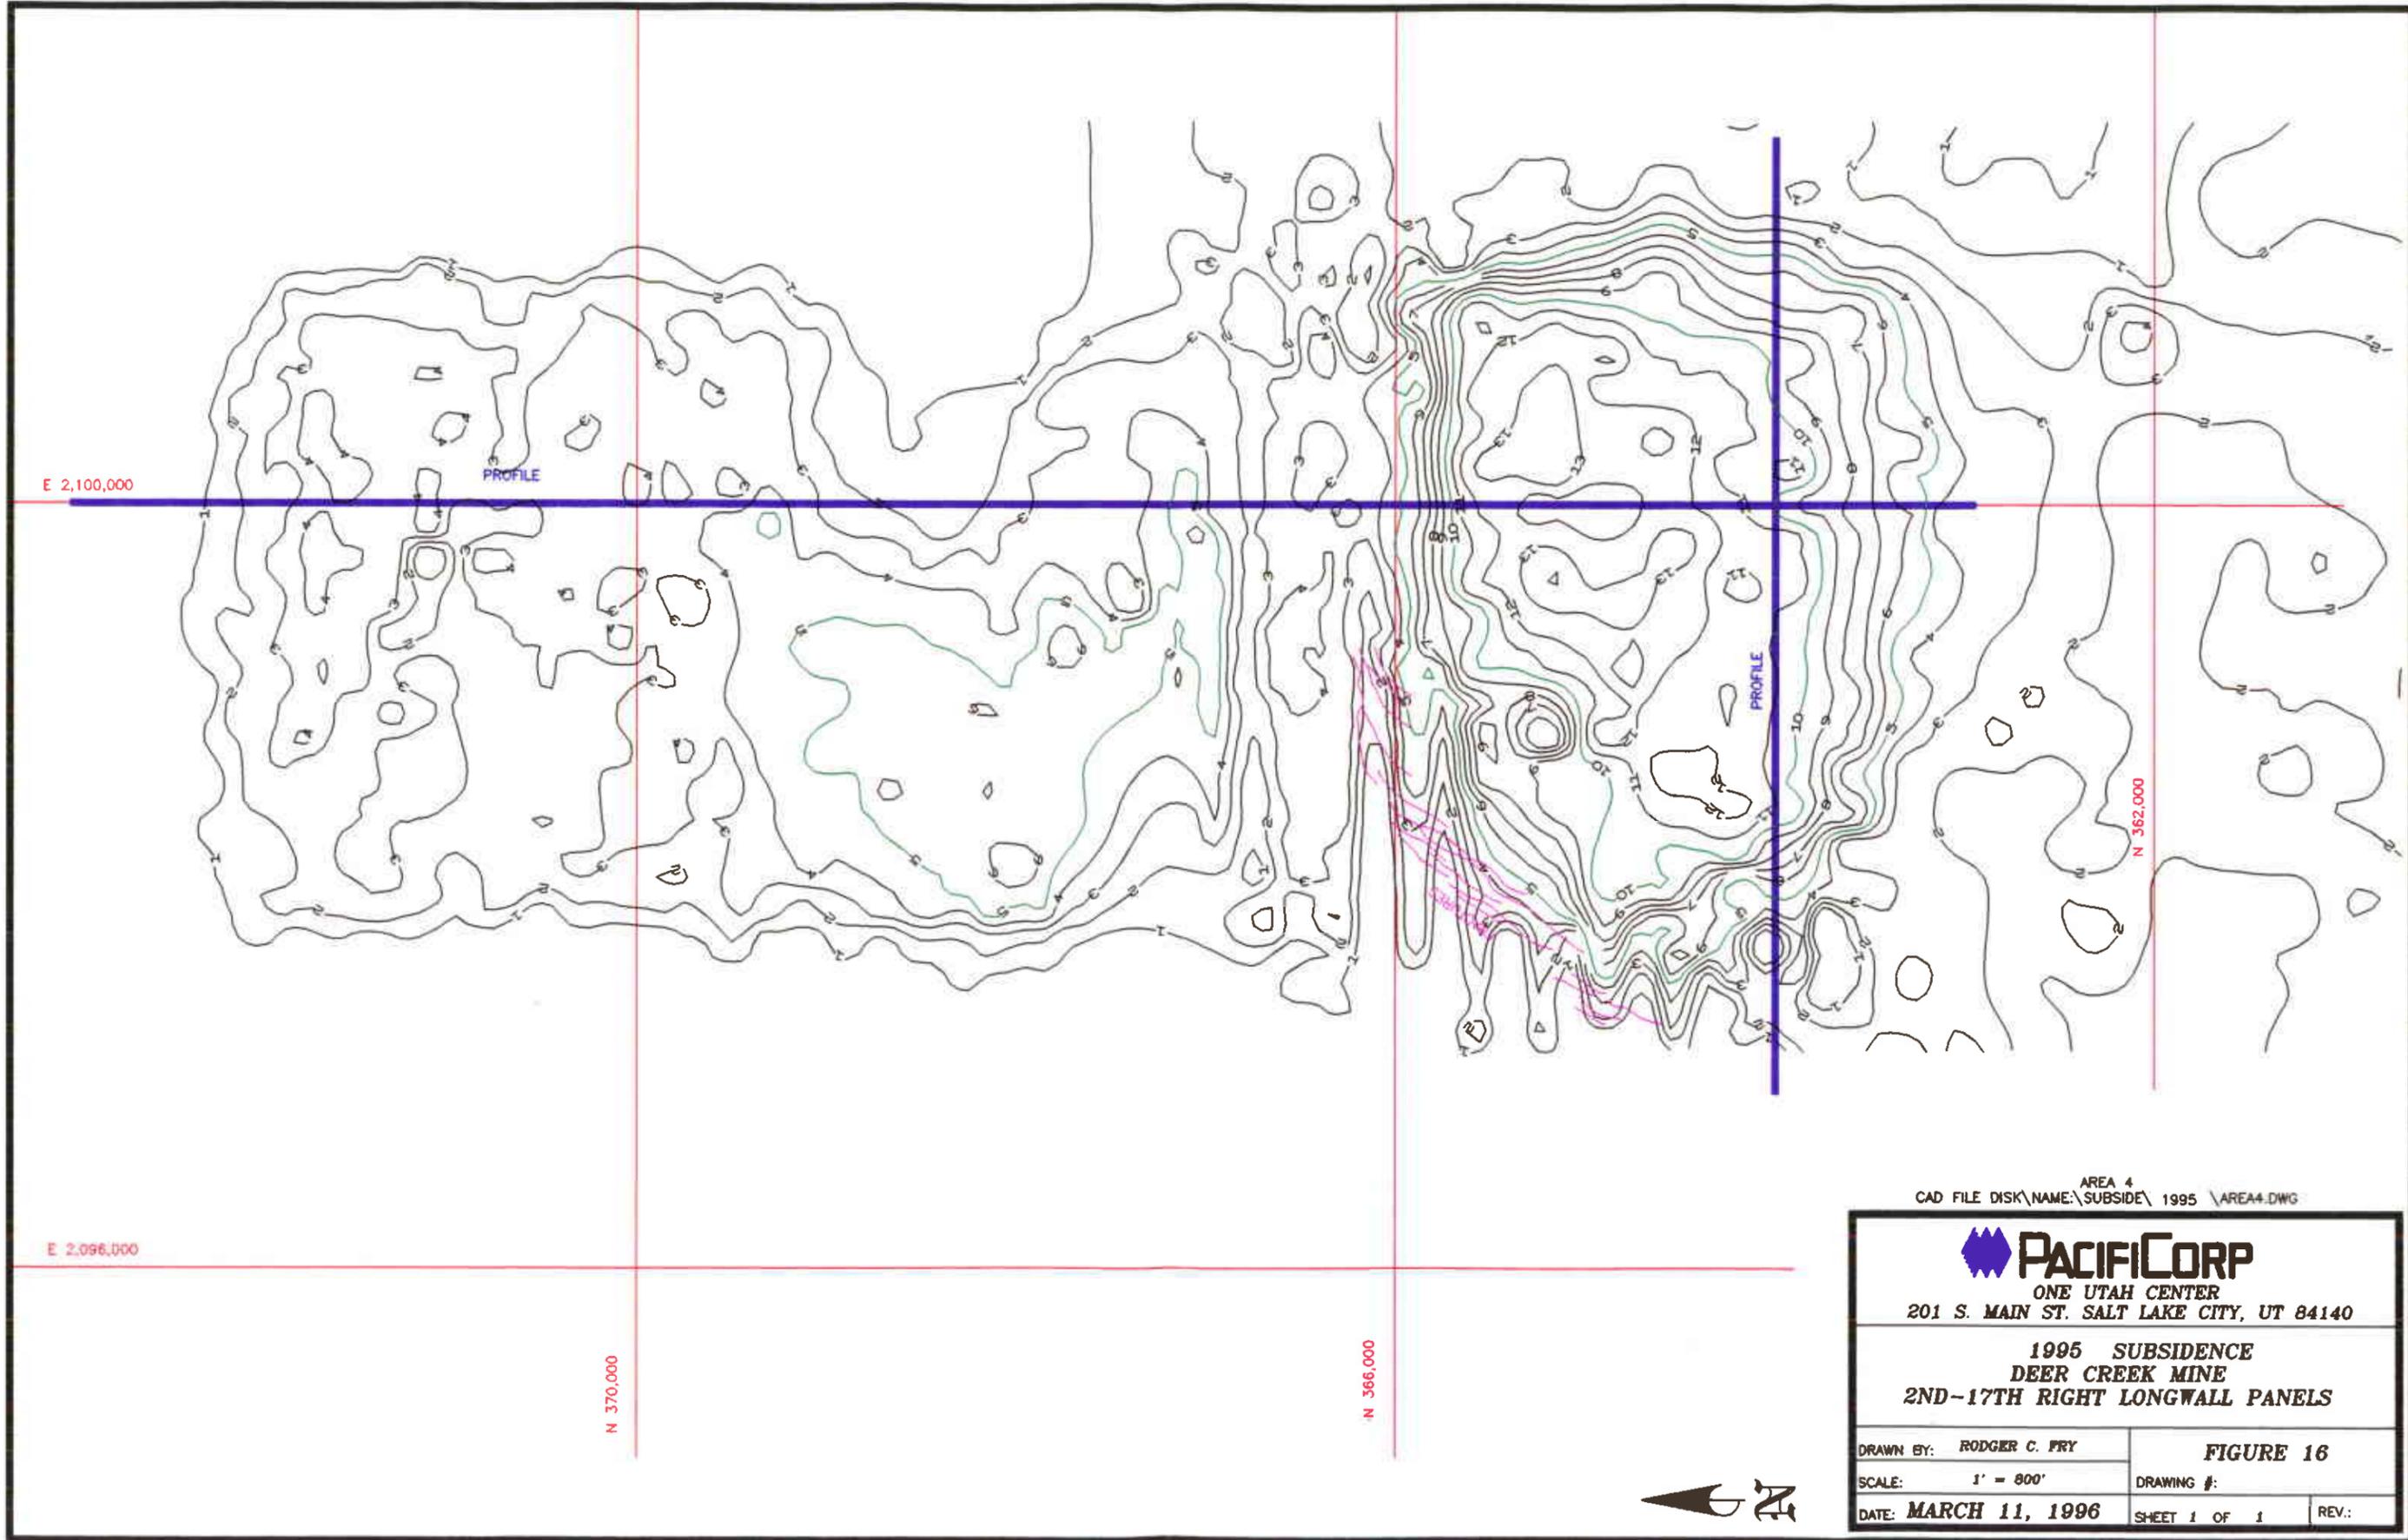
FIGURE 16
 DRAWING #:
 SHEET 1 OF 1
 REV.:

Surface fractures were identified in the field in late May of 1995. These fractures were located on Fee surface land and PacifiCorp filled in the fractures with a motor grader and reseeded the area. The location of the fractures are shown on figure 16.
