## Area 18

### Deer Creek Mine 2nd through 7th Right Longwall Panels

1995 SUBSIDENCE  
 DEER CREEK MINE  
 2ND-7TH RIGHT LONGWALL PANELS

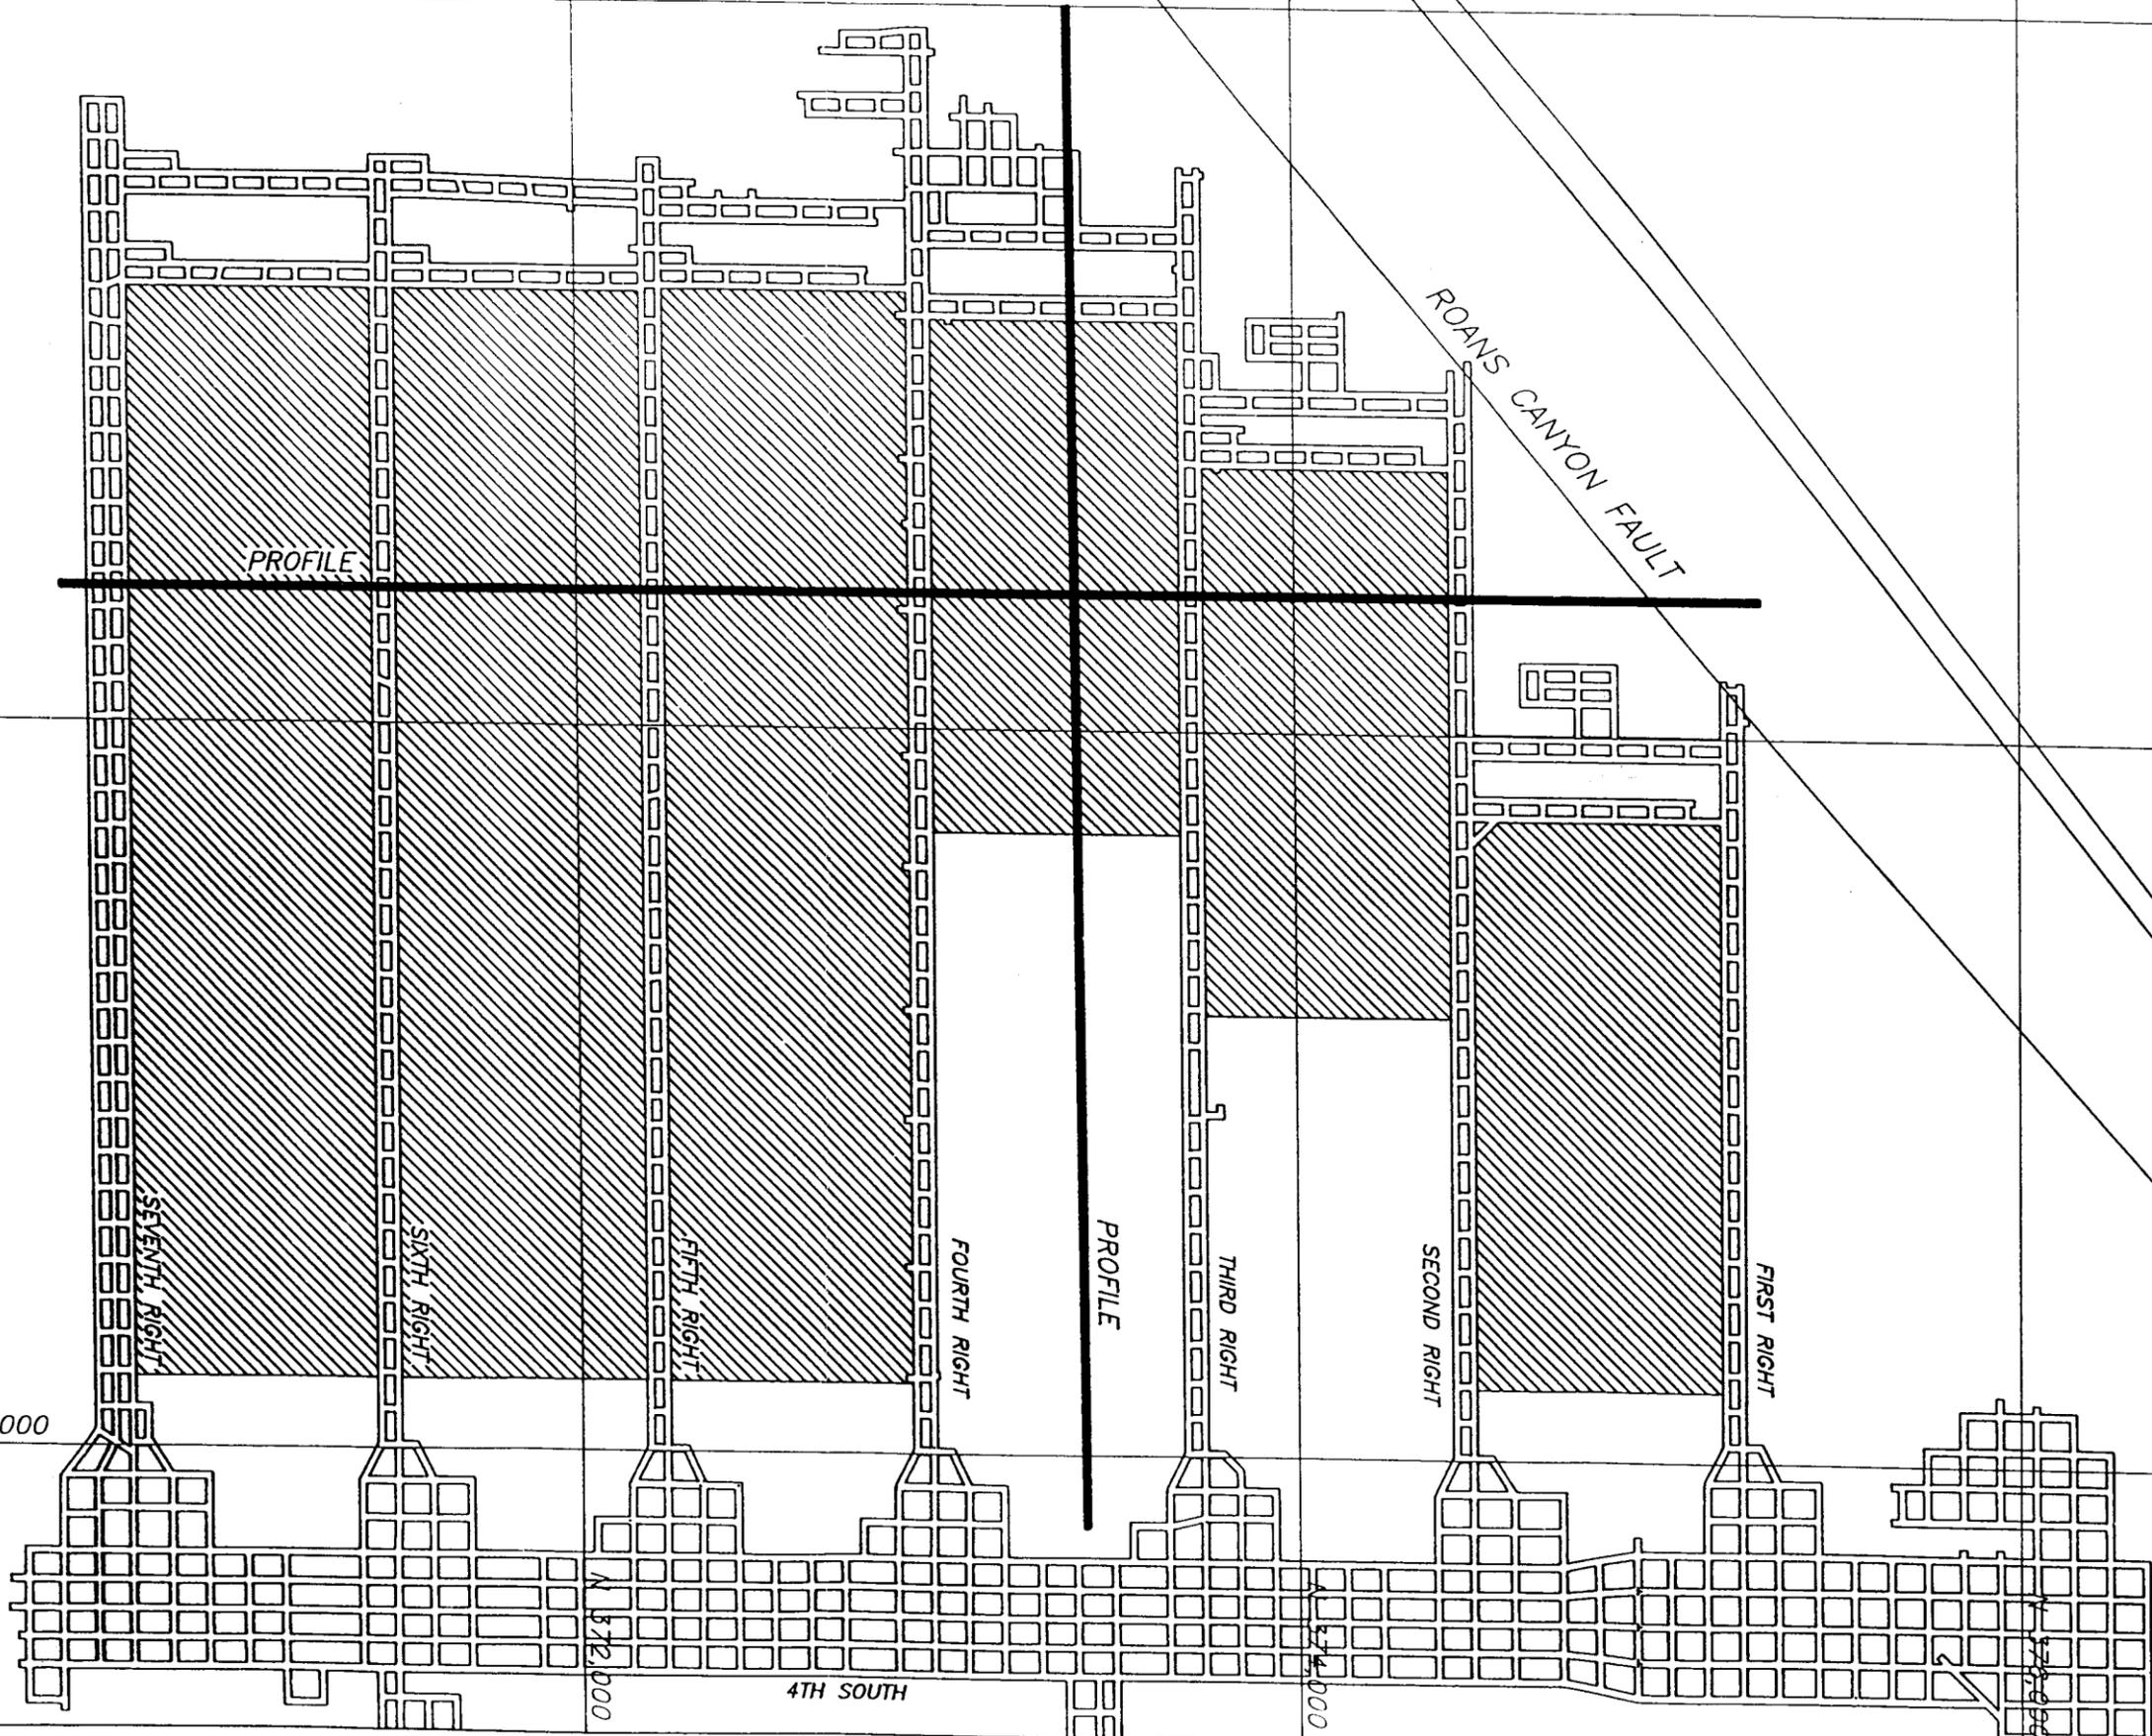
PACIFICORP ELECTRIC OPERATIONS FUEL RESOURCES DEPARTMENT <small>P.O. BOX 26128 SALT LAKE CITY, UTAH 84126-0128</small>		AREA 18 OLD FILE NAME/DISK# 915UB7R
DEER CREEK MINE 2nd-7th RIGHT LONGWALL PANELS		
DRAWN BY: J. GARRETT SCALE: 1"=500' DATE: MARCH 16, 1993	DRAWING #: SHEET 1 OF 1	FIGURE 60 REV.

Longwall mining in this area was completed in May, 1992 with the extraction of six adjacent longwall panels (figure 60). The 3rd and 4th Right panels were terminated short of the entire panel due to geologic complications. The land surface in the area of these panels contains steep slopes covered by conifer and aspen trees, and sagebrush. The longwall panels have overburden ranging from 1,800 feet on the west end of the panels to 2,000 feet on the east side of the panels.

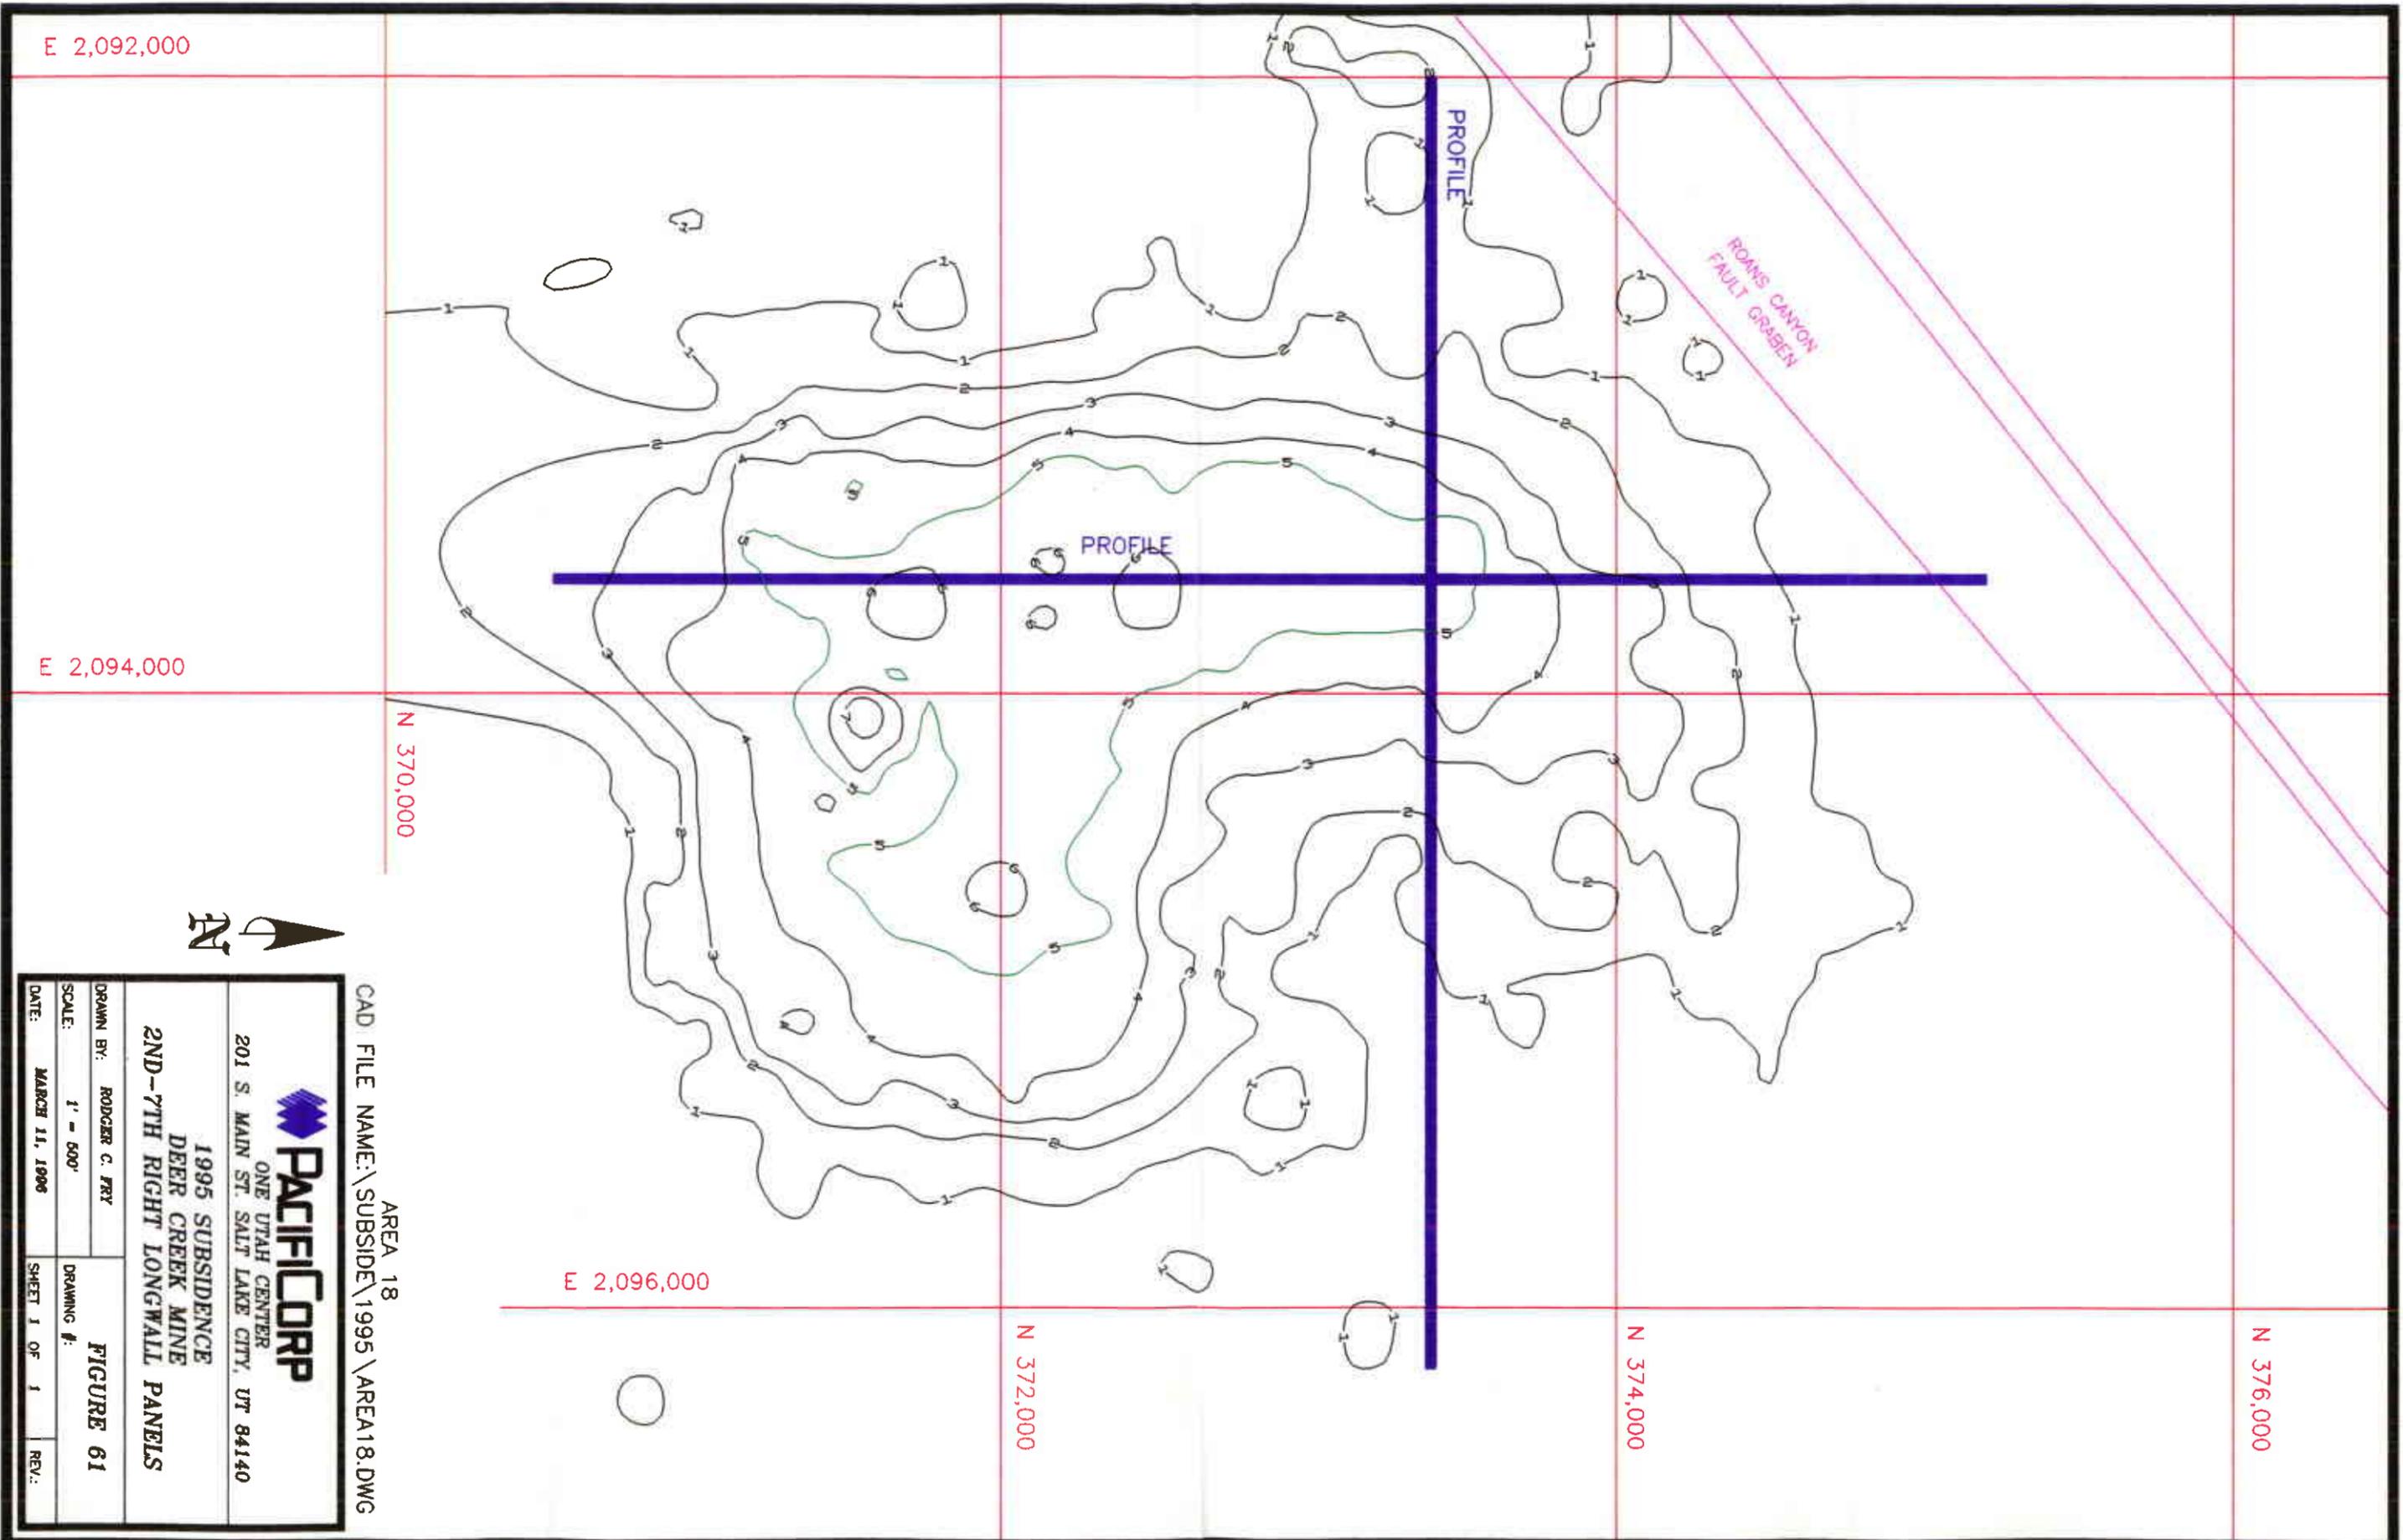
DRAWN BY: RODGER C. FRY	DRAWING #:	FIGURE 61	REV.:
SCALE: 1" = 500'	SHEET 1 OF 1		
DATE: MARCH 11, 1996

Subsidence in this area has reached a maximum of seven (7) feet (Figures 61, 62, and 63) and has been stable since 1992. The subsidence zone is a broad trough running in a north - south direction. This area is overlain by several springs. Monitoring of these springs has shown no change in the quality or quantity of water discharged from them (see appendix and the 1995 Hydrologic Monitoring report).

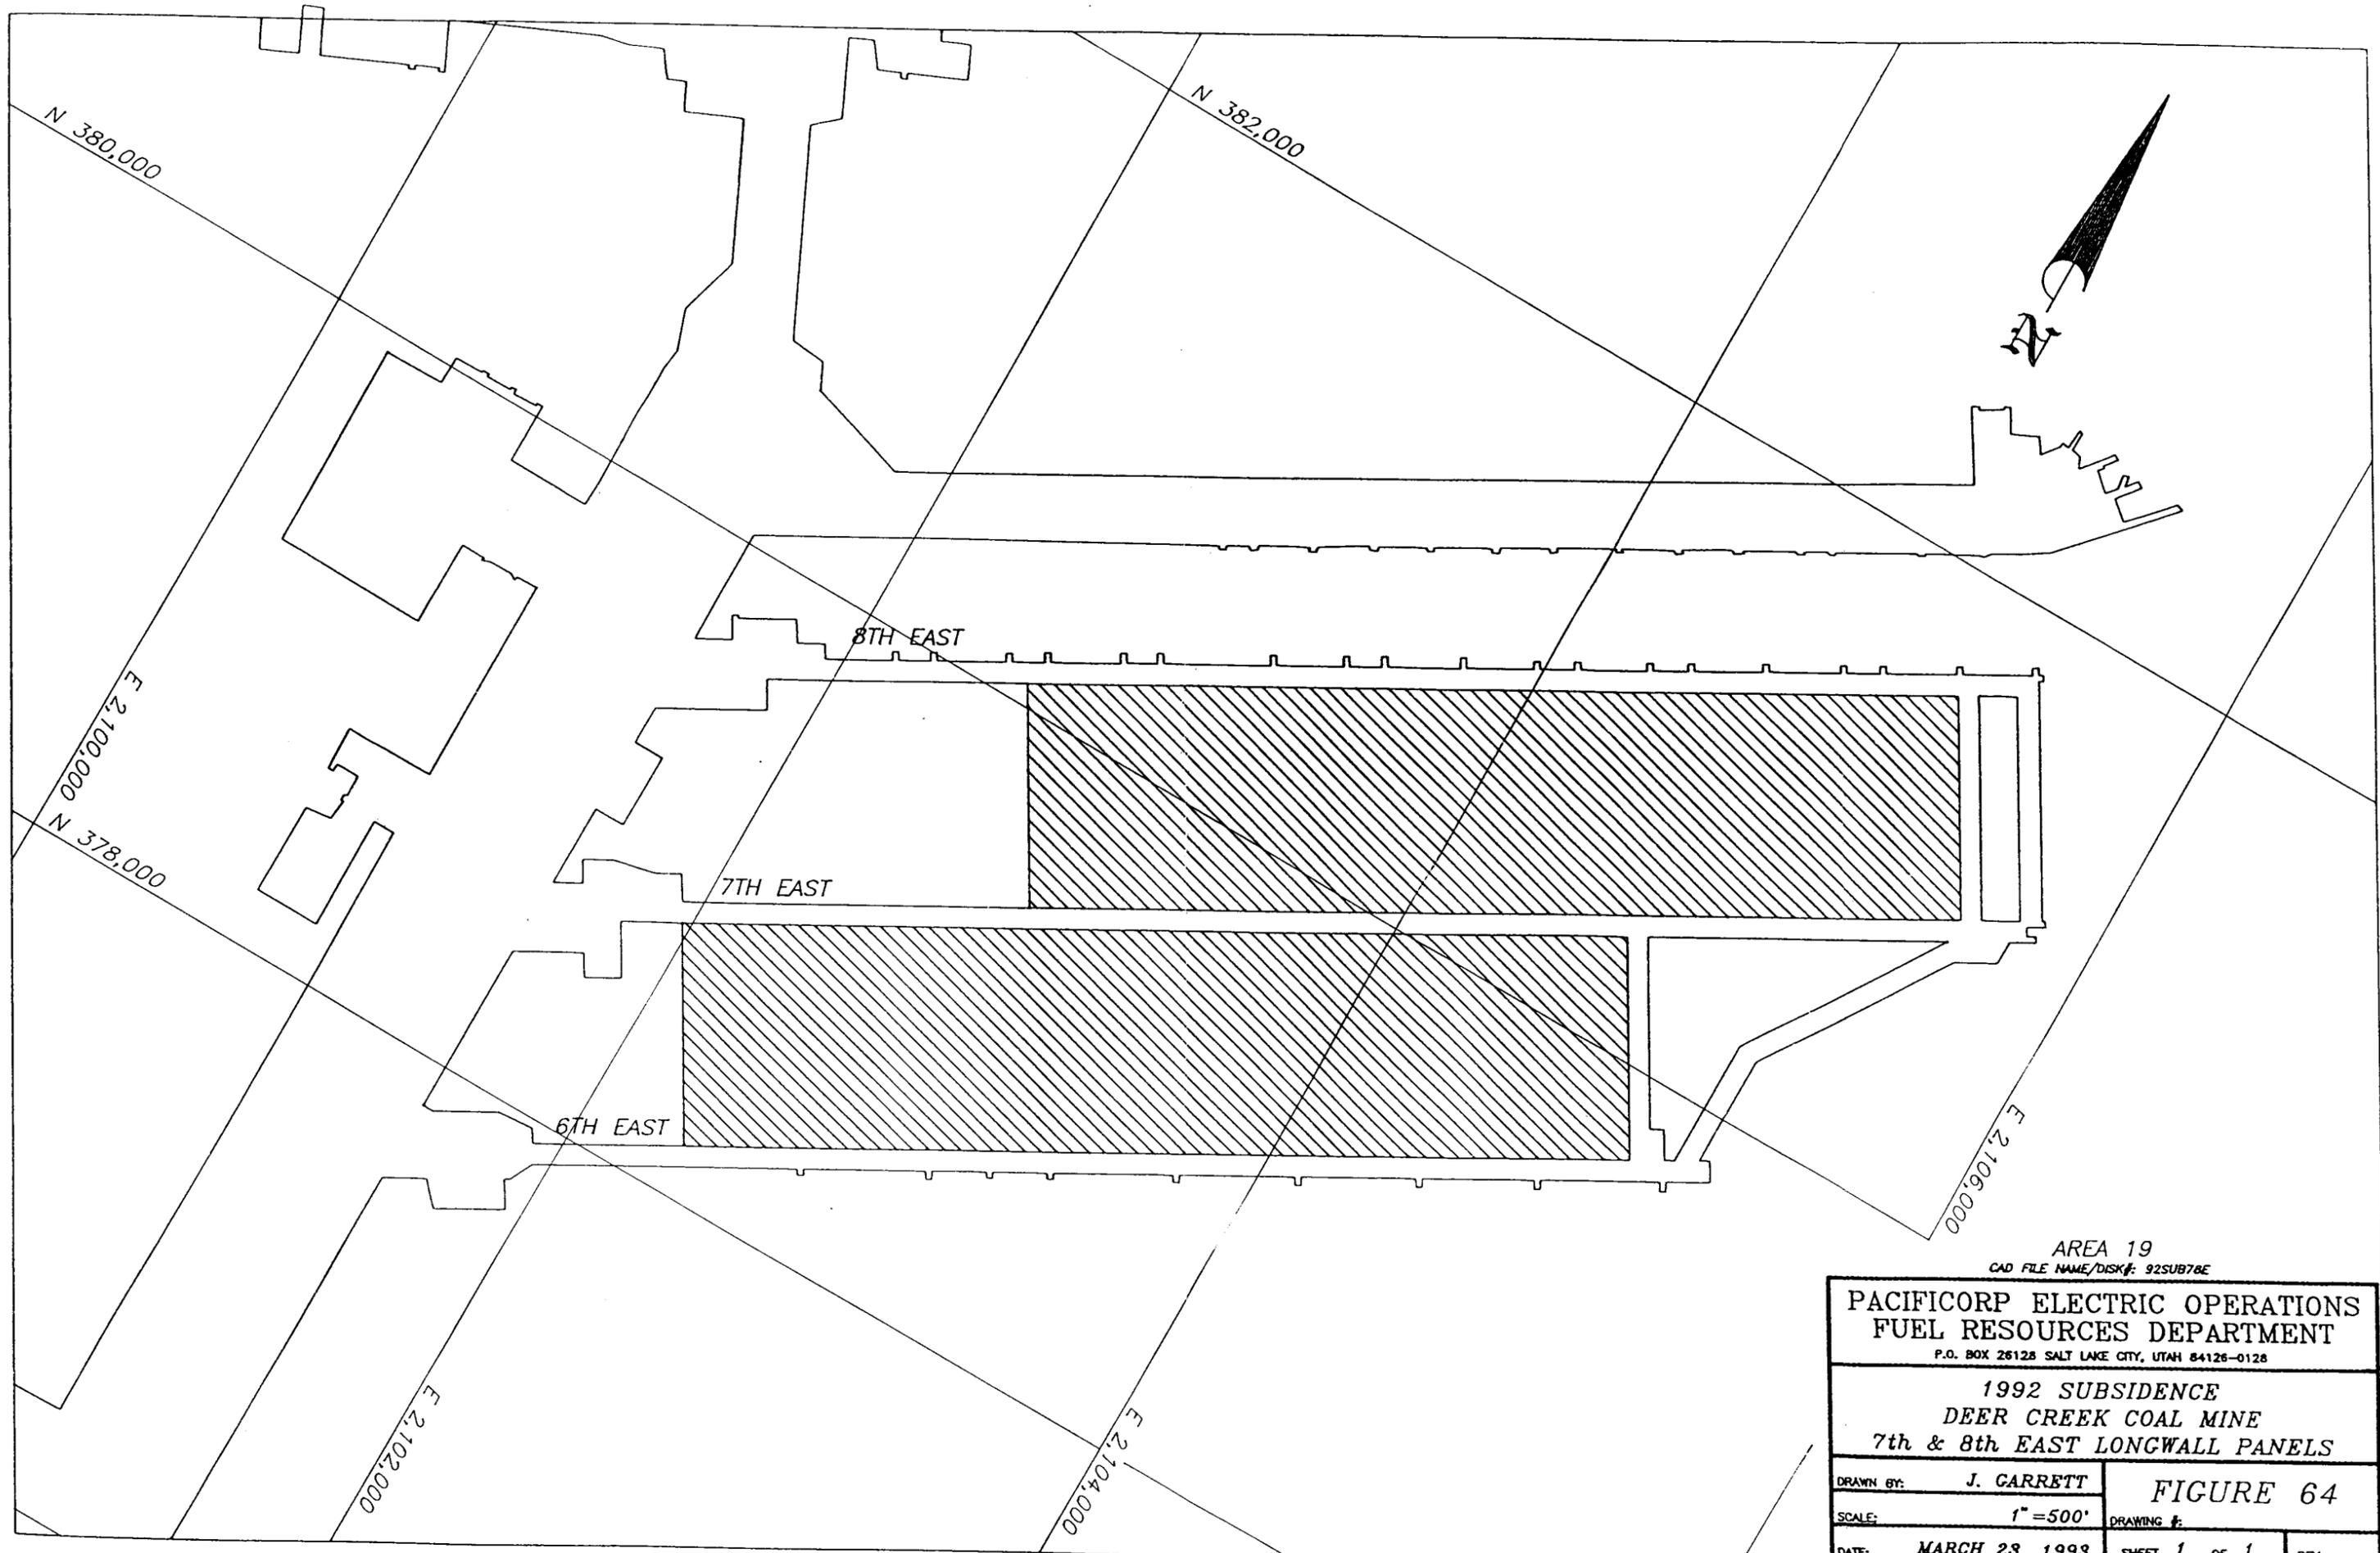
Mining in the 7th East Longwall Panel began in May, 1992 and by January 1993 mining was completed in the 8th East Longwall Panel (Figure 64).

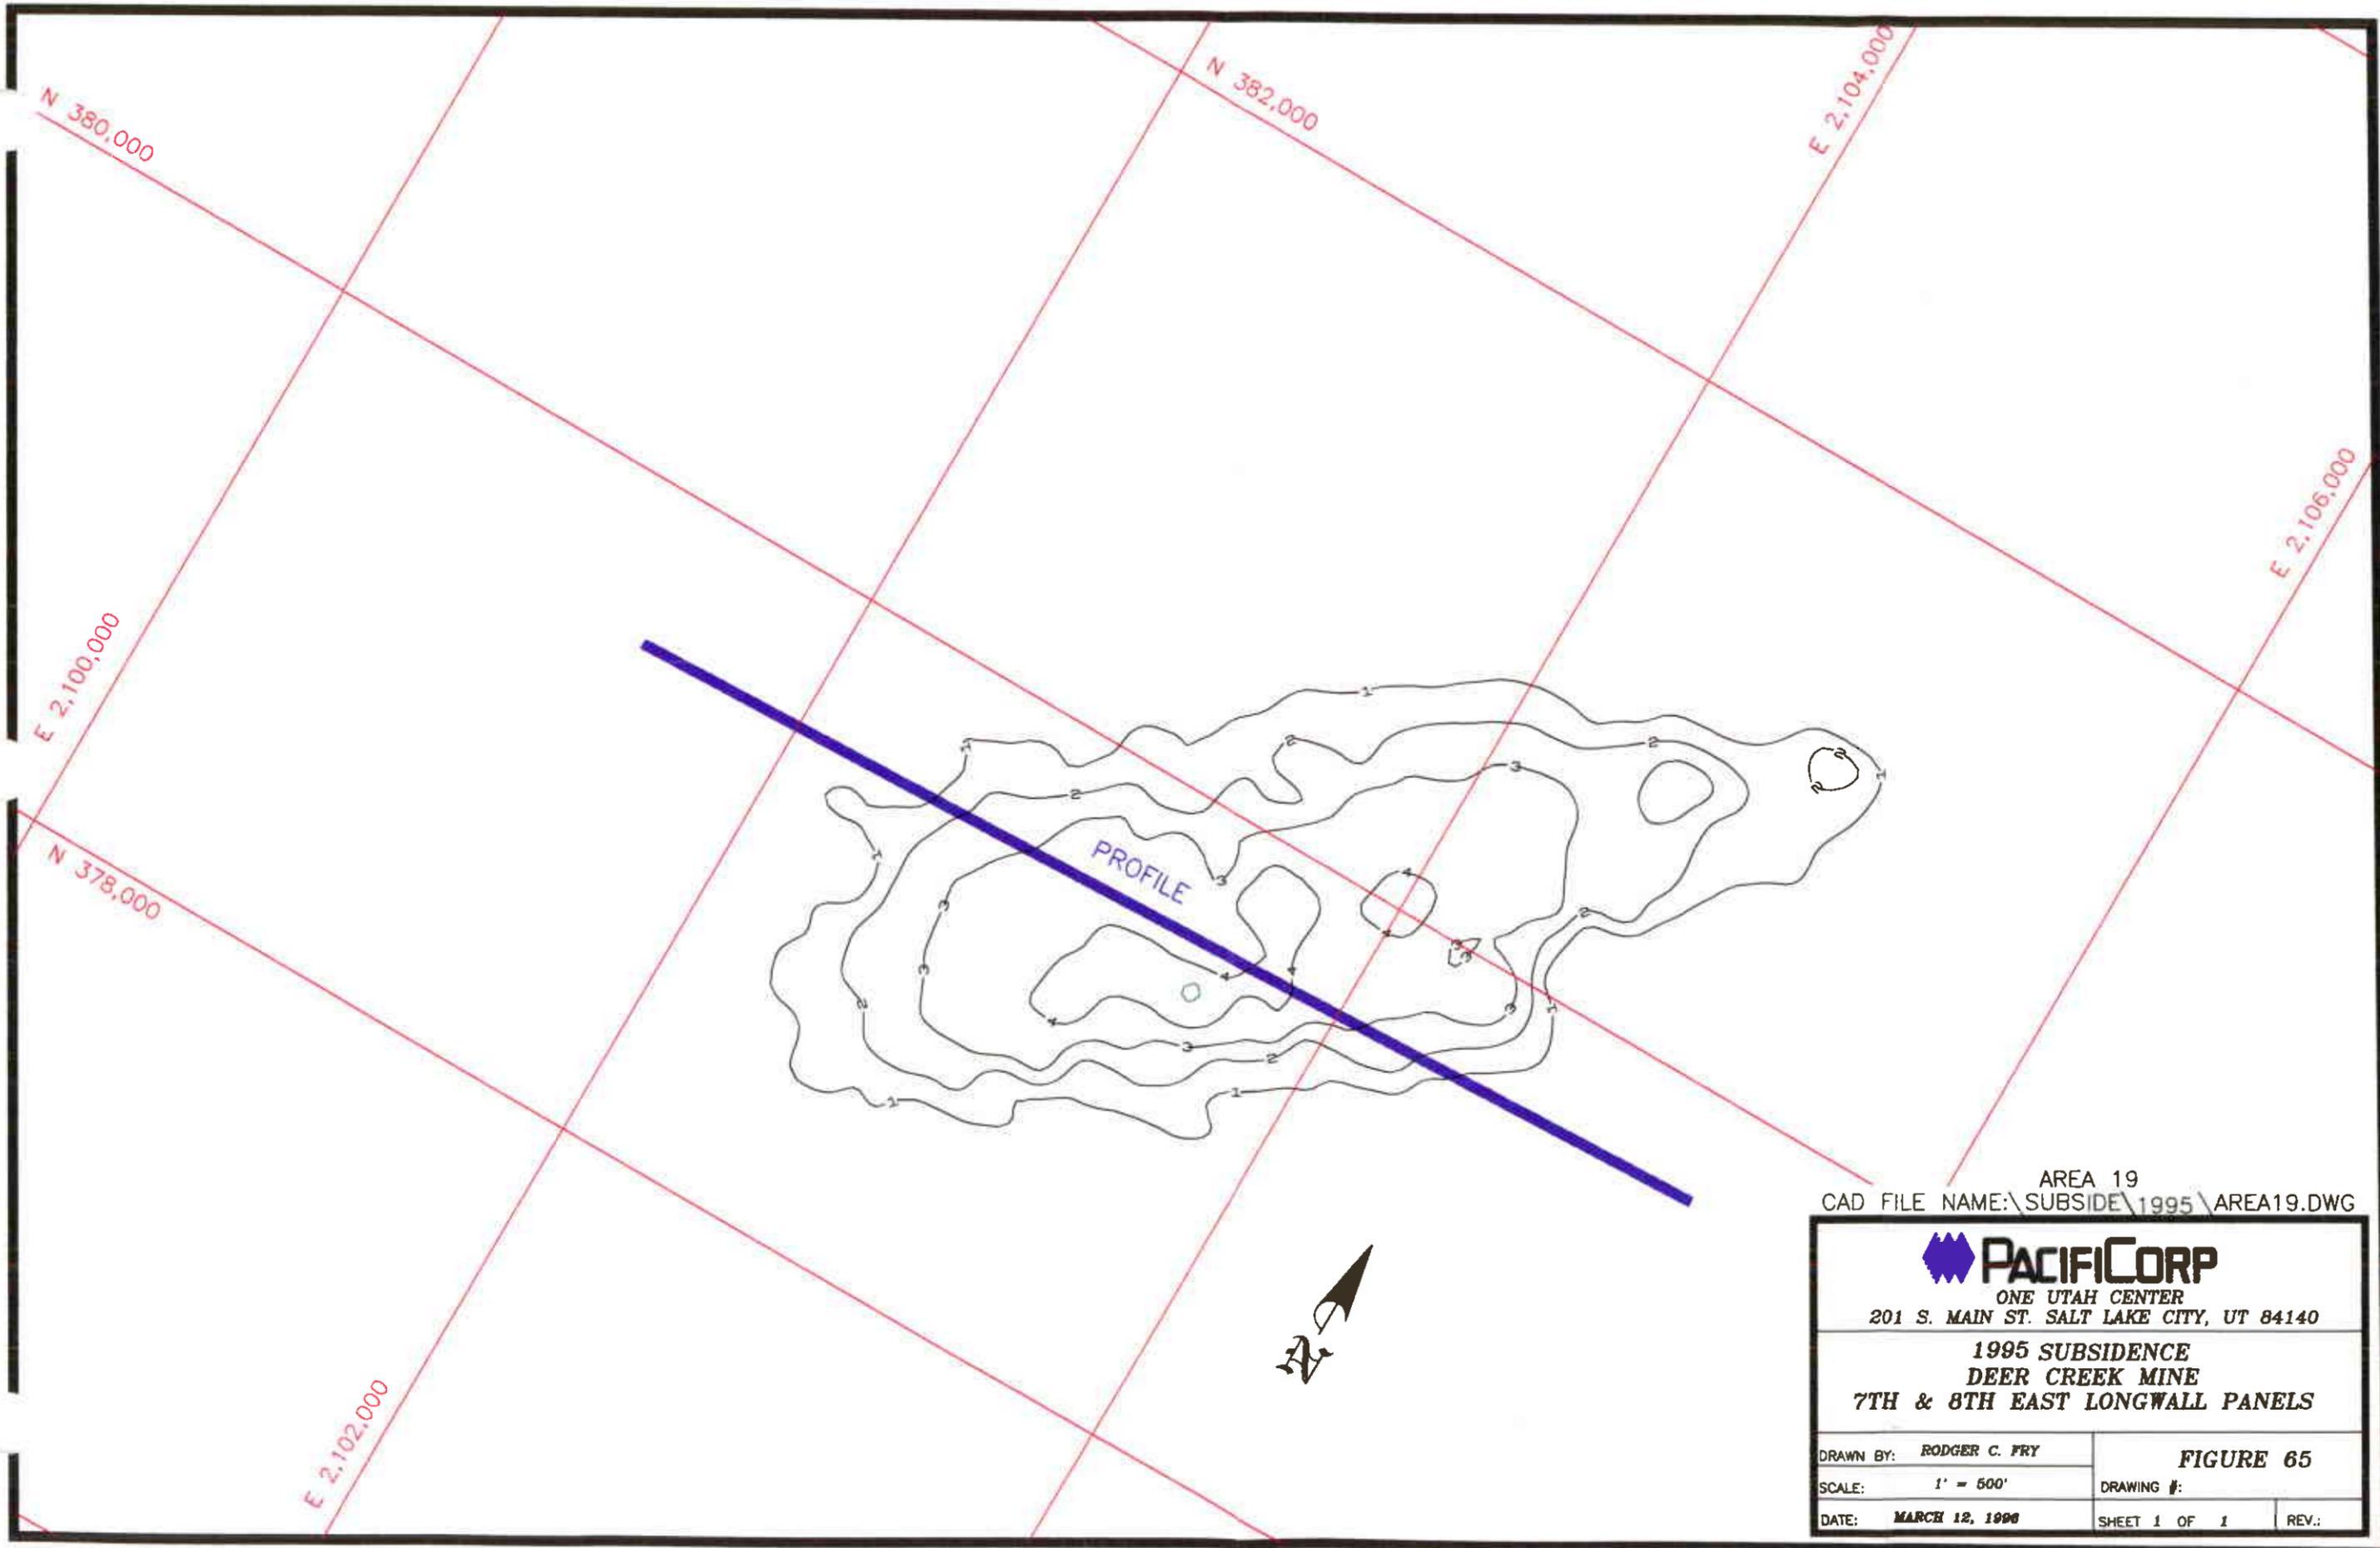
DRAWN BY: <b>RODGER C. FRY</b>		<b>FIGURE 65</b>	
SCALE: <b>1' = 500'</b>		DRAWING #:	
DATE: <b>MARCH 12, 1998</b>	SHEET <b>1</b> OF <b>1</b>	REV.:

Subsidence in this area has increased from slightly over one foot in 1992 to over three feet in 1993 but has been stable between 1993 and 1995 (Figures 65 and 66).

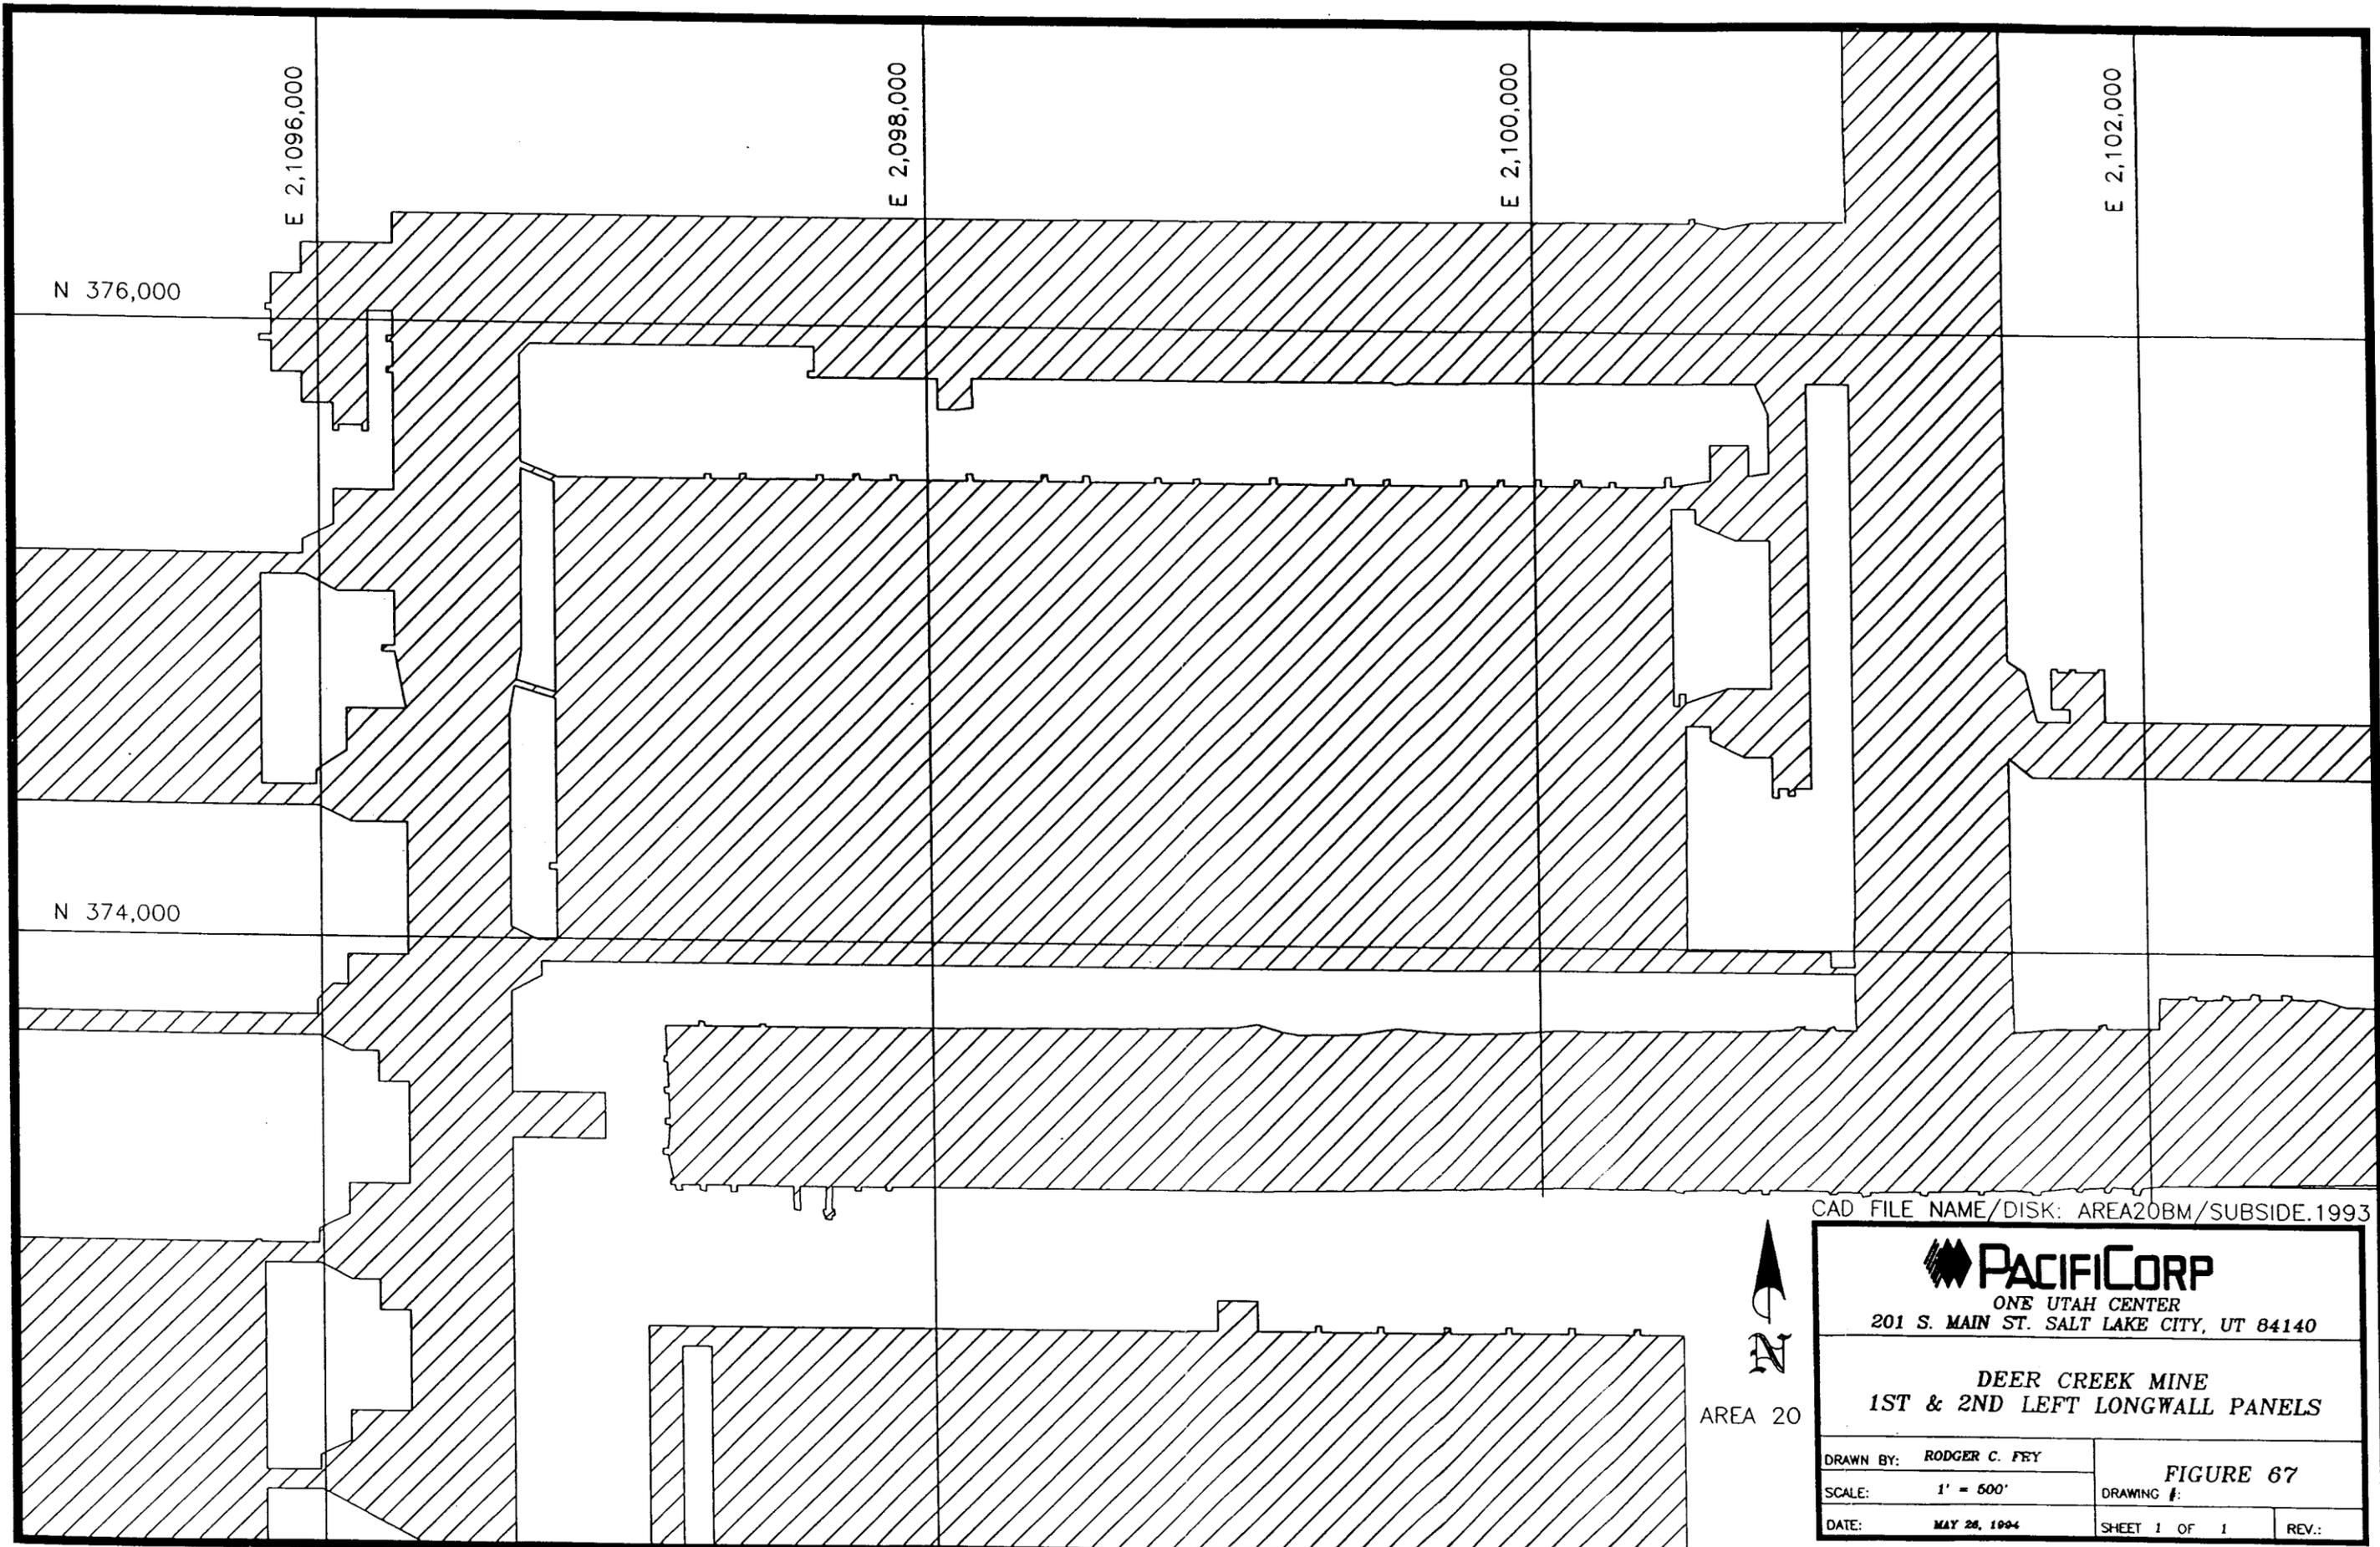
<b>PACIFICORP</b> ONE UTAH CENTER 201 S. MAIN ST. SALT LAKE CITY, UT 84140	
<b>DEER CREEK MINE</b> <b>1ST &amp; 2ND LEFT LONGWALL PANELS</b>	
DRAWN BY: RODGER C. FEY	<b>FIGURE 67</b>
SCALE: 1" = 500'	DRAWING #:
DATE: MAY 28, 1994	SHEET 1 OF 1    REV.:

Mining in the 2nd Left Longwall Panel began in February 1993 and was completed in June 1993. Mining then started in the 1st Left Longwall Panel in July 1993 and was completed in November of 1993 (Figure 67).

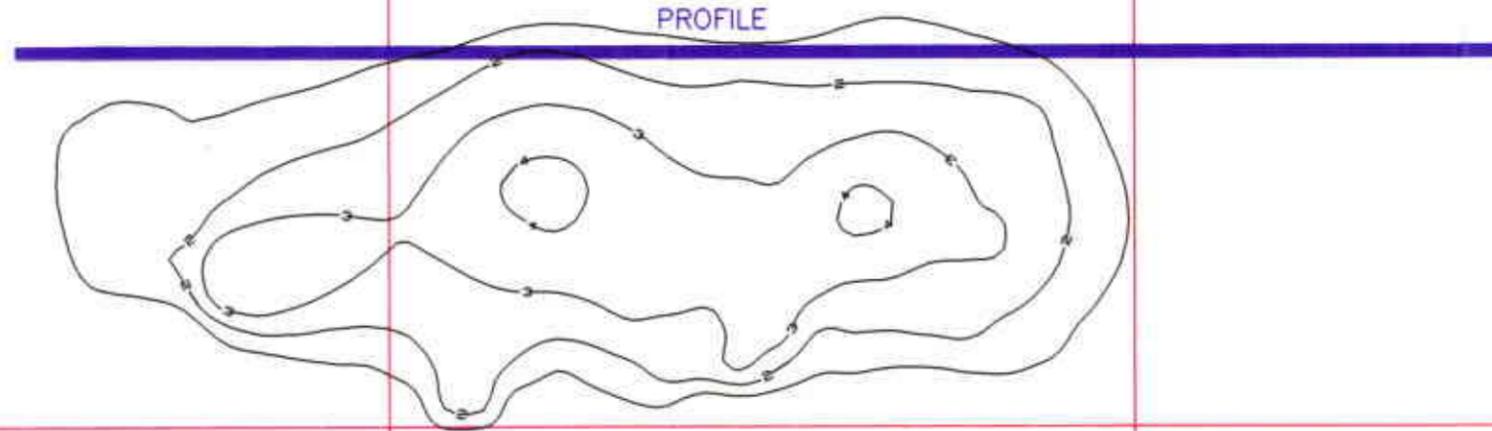
<b>PACIFICORP</b> ONE UTAH CENTER 201 S. MAIN ST. SALT LAKE CITY, UT 84140		
<b>1995 SUBSIDENCE DEER CREEK MINE 1ST &amp; 2ND LEFT LONGWALL PANELS</b>		
DRAWN BY: RODGER C. FRY	<b>FIGURE 68</b>	
SCALE: 1" = 500'	DRAWING #:	
DATE: MARCH 12, 1998	SHEET 1 OF 1	REV.:

The monitoring detected a maximum of slightly over four (4) feet of subsidence above the 2nd Left Longwall Panel. The measurements made in 1995 showed an average of a foot less subsidence than the measurements made in 1994 (Figures 68 and 69). It is believed that subsidence in this area is substantially complete. All of the subsidence detected falls within the bounds of the longwall area. Therefore; the angle of draw in this area is considered to be steeper than 10°.
