## Area 18

### Deer Creek Mine 2nd through 7th Right Longwall Panels

1995 SUBSIDENCE  
 DEER CREEK MINE  
 2ND-7TH RIGHT LONGWALL PANELS

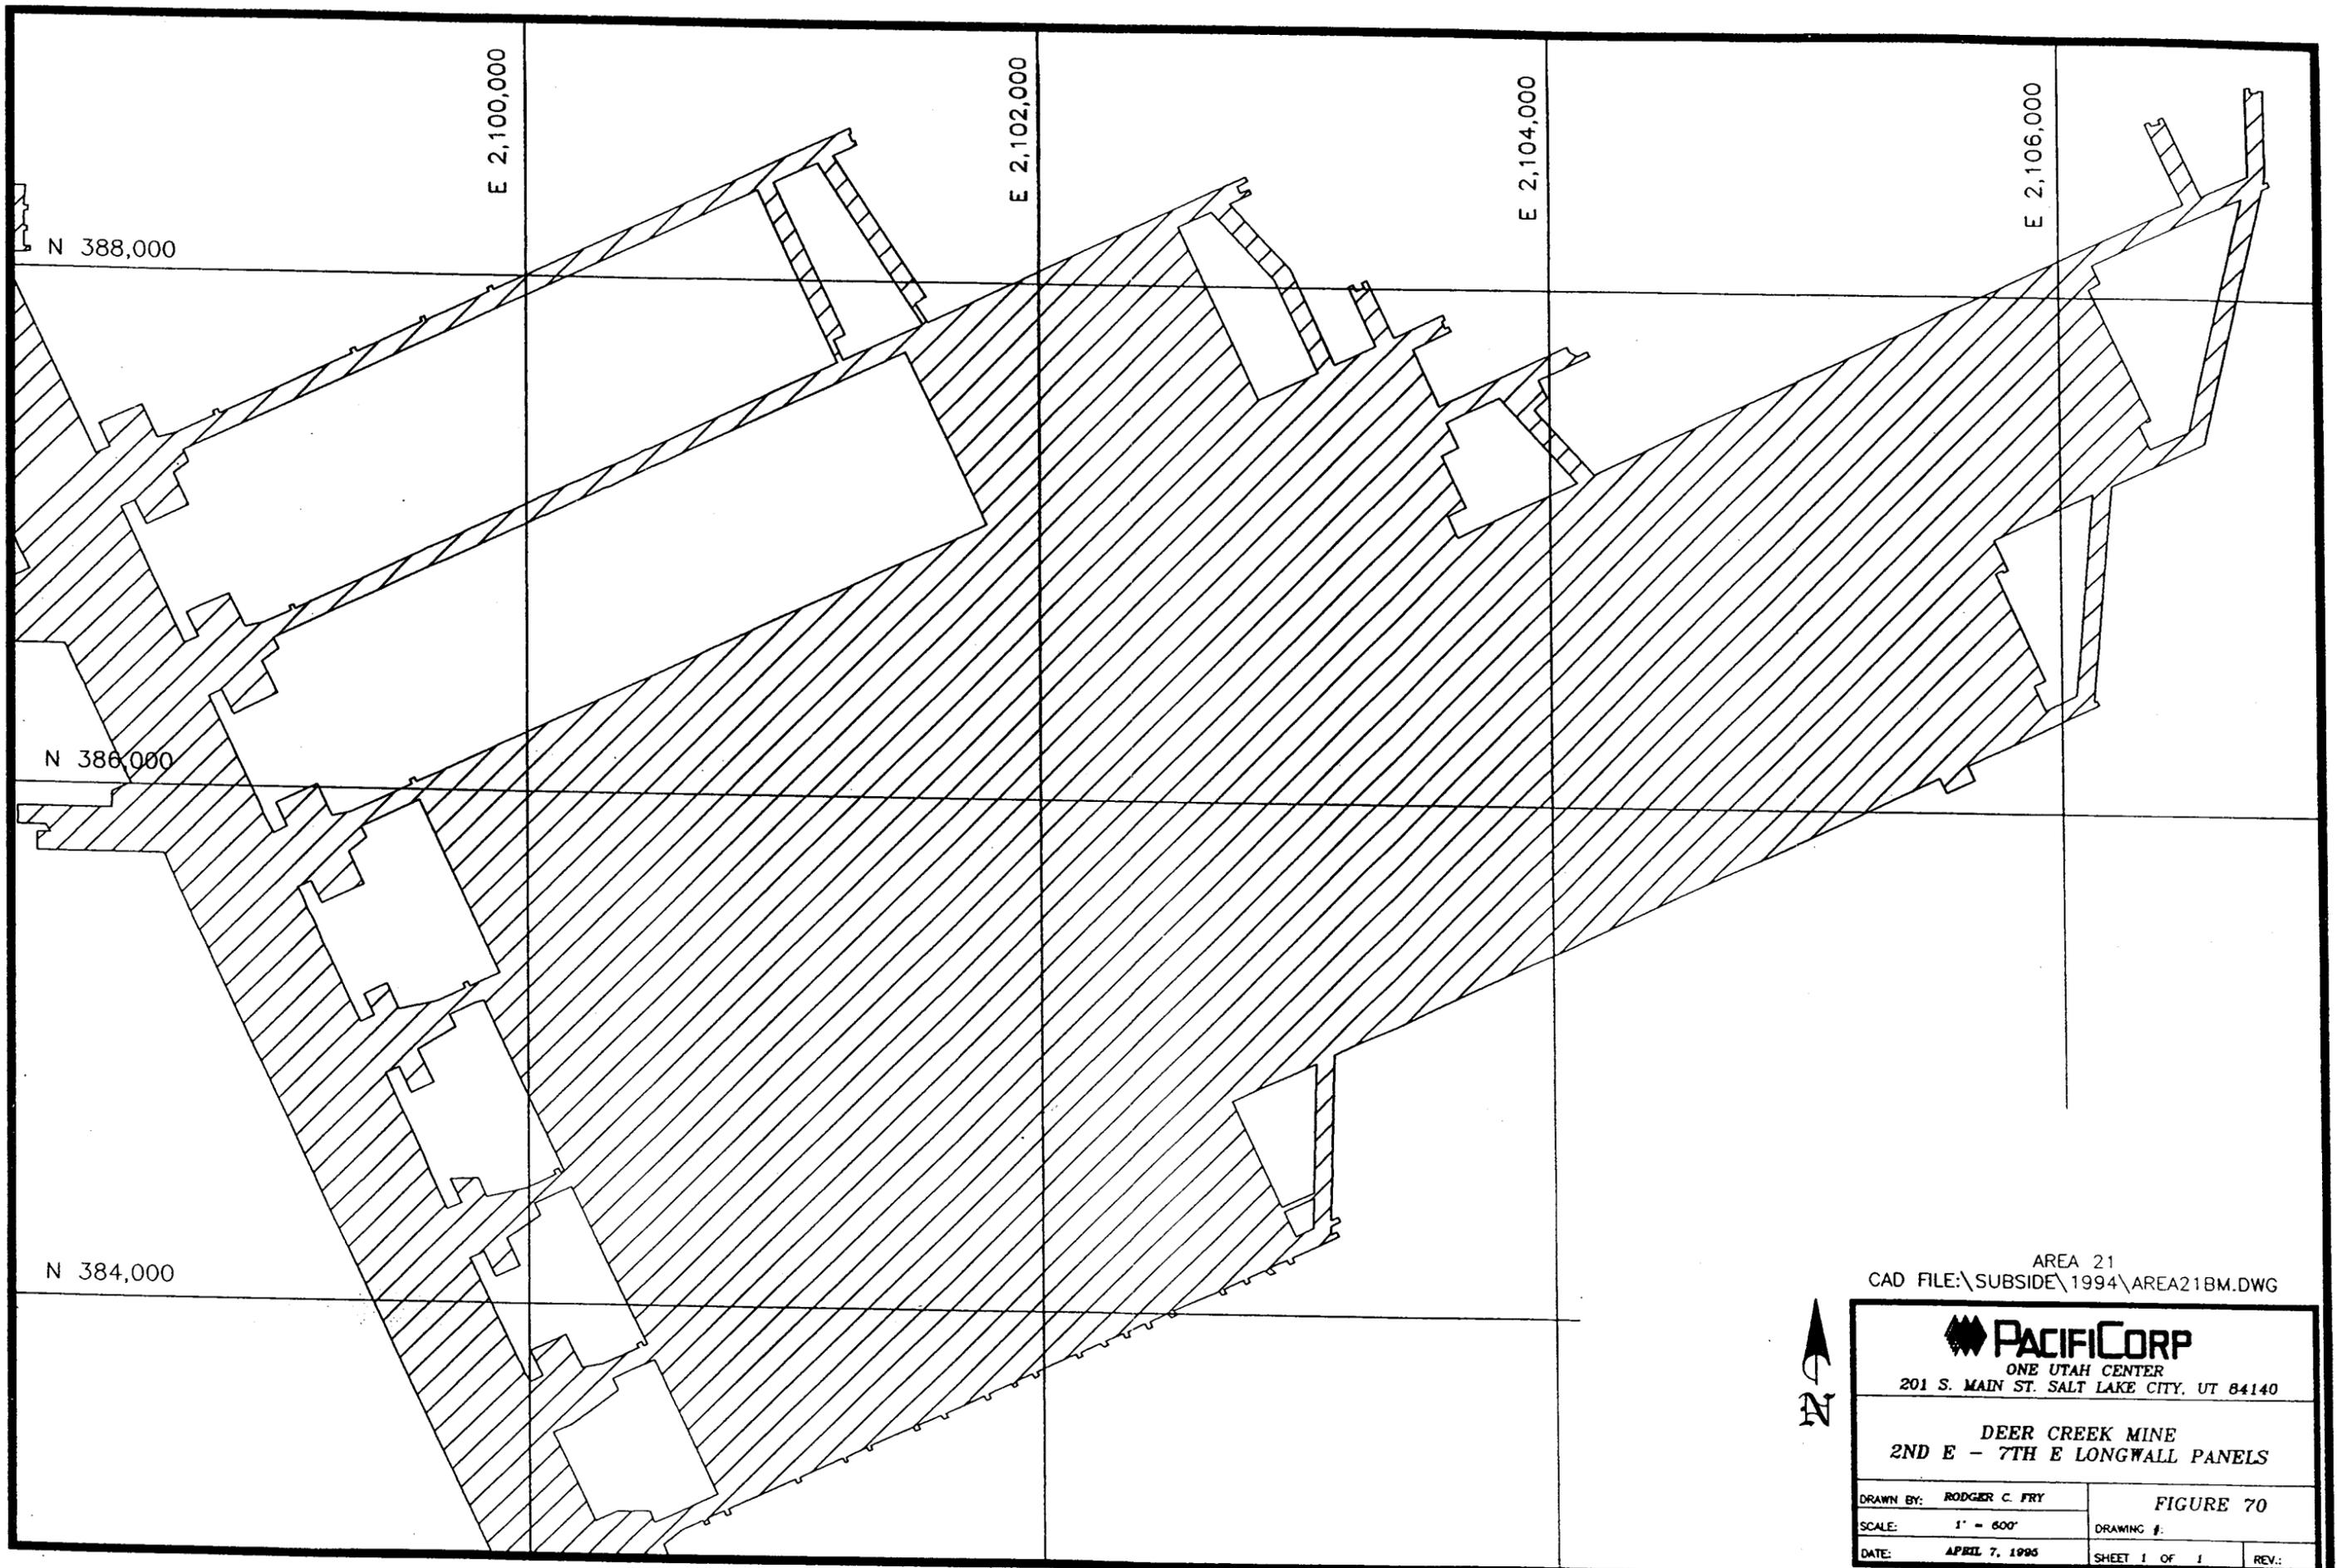
<b>PACIFICORP</b> ONE UTAH CENTER 201 S. MAIN ST. SALT LAKE CITY, UT 84140		
<b>DEER CREEK MINE</b> <b>2ND E - 7TH E LONGWALL PANELS</b>		
DRAWN BY: <b>RODGER C. FRY</b>	<b>FIGURE 70</b>	
SCALE: <b>1" = 600'</b>	DRAWING #	
DATE: <b>APRIL 7, 1995</b>	SHEET 1 OF 1	REV.:

Mining in the 2nd East Longwall panel began in November of 1993 and by the End of August 1995 longwall mining had removed all of the 2nd through 5th East Longwall Panels and the eastern 1,100 feet of the 6th East Longwall Panel (Figure 70). Mining in this area, including the remainder of the 6th East and all of the 7th East Longwall Panels, was completed in January 1996.

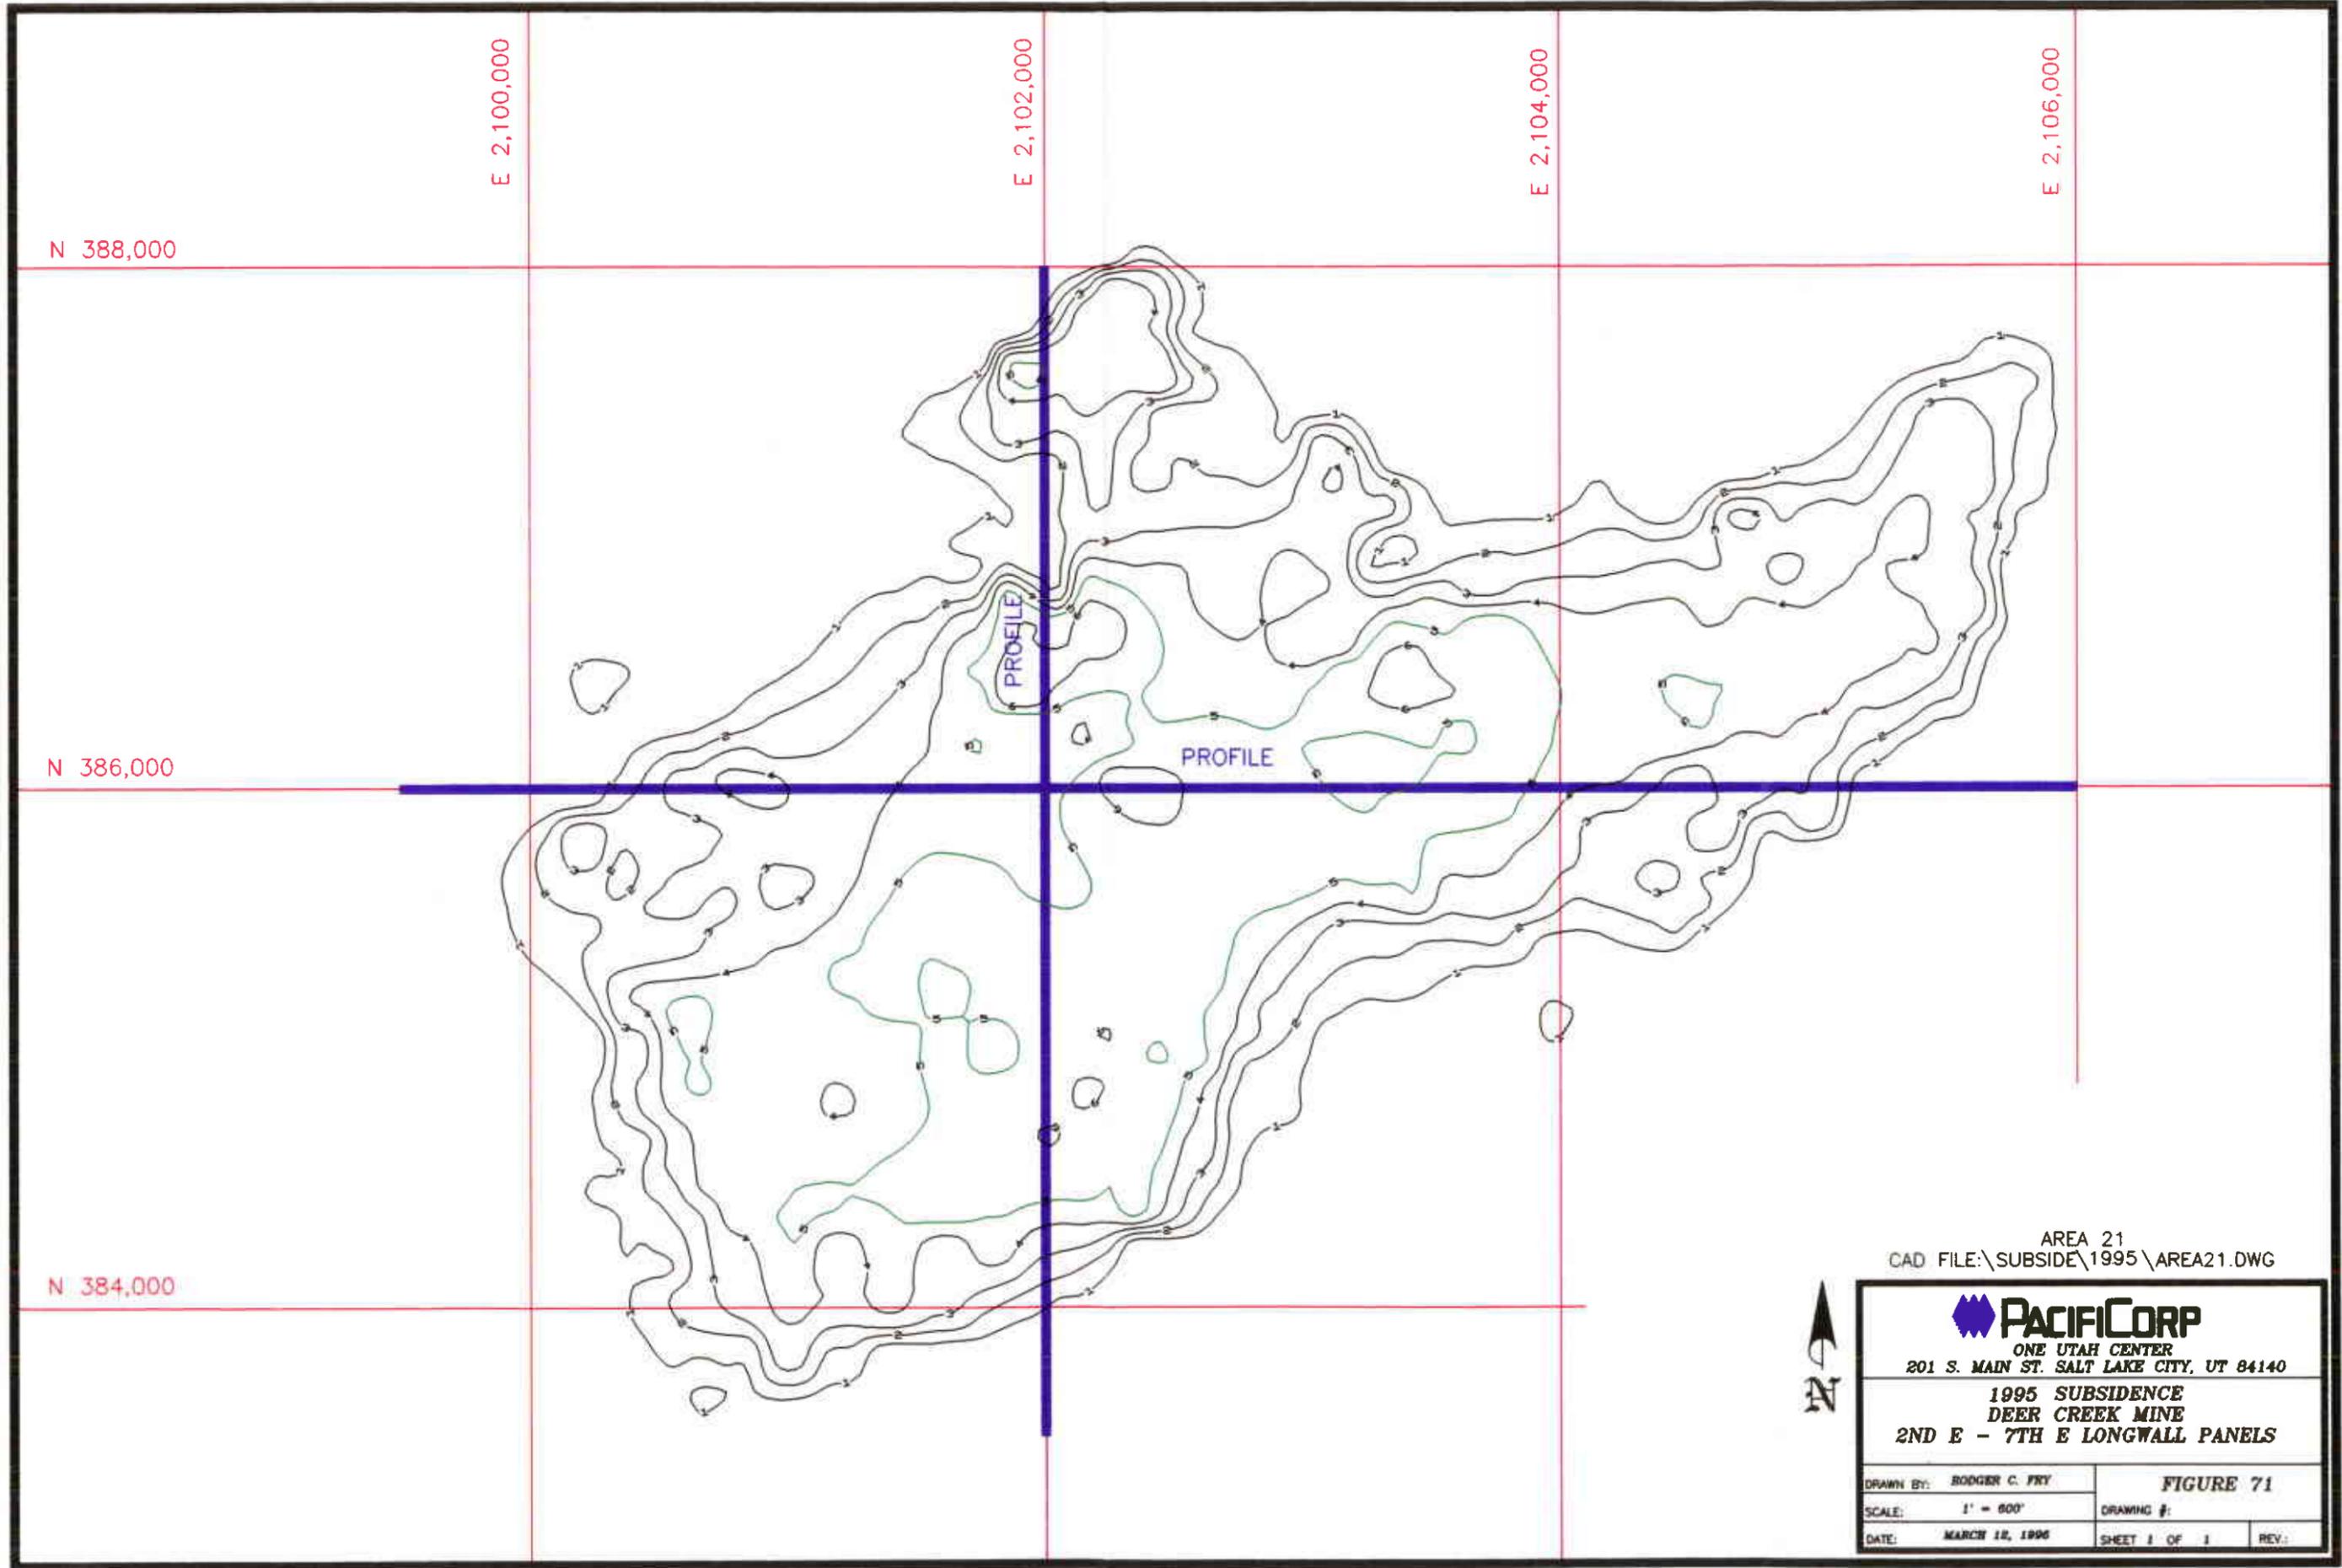
DRAWN BY: RODGER C. FRY	FIGURE 71	
SCALE: 1" = 600'	DRAWING #:	
DATE: MARCH 12, 1996	SHEET 1 OF 1	REV.:

Subsidence detected in 1994 had reached a maximum of over four (4) feet above the 2nd East Longwall Panel (Figures 71, 72 and 73). Subsidence over the 3rd East longwall panel was not detected because this panel is longer than the 2nd East panel and subsidence doesn't usually occur until two panel widths have been mined. In 1995, subsidence had progressed to where most of the areas underlain by the 2nd through 6th East Longwall Panels had subsided between 5 and 6 feet. Because subsidence is not complete in this area, no angle of draw was calculated.
