ANNUAL SUBSIDENCE MONITORING REPORT
EAST /TRAIL MOUNTAIN PROPERTIES
1997

PACIFICORP
SUBSIDENCE MONITORING PROGRAM
ANNUAL REPORT FOR 1997

April, 1998

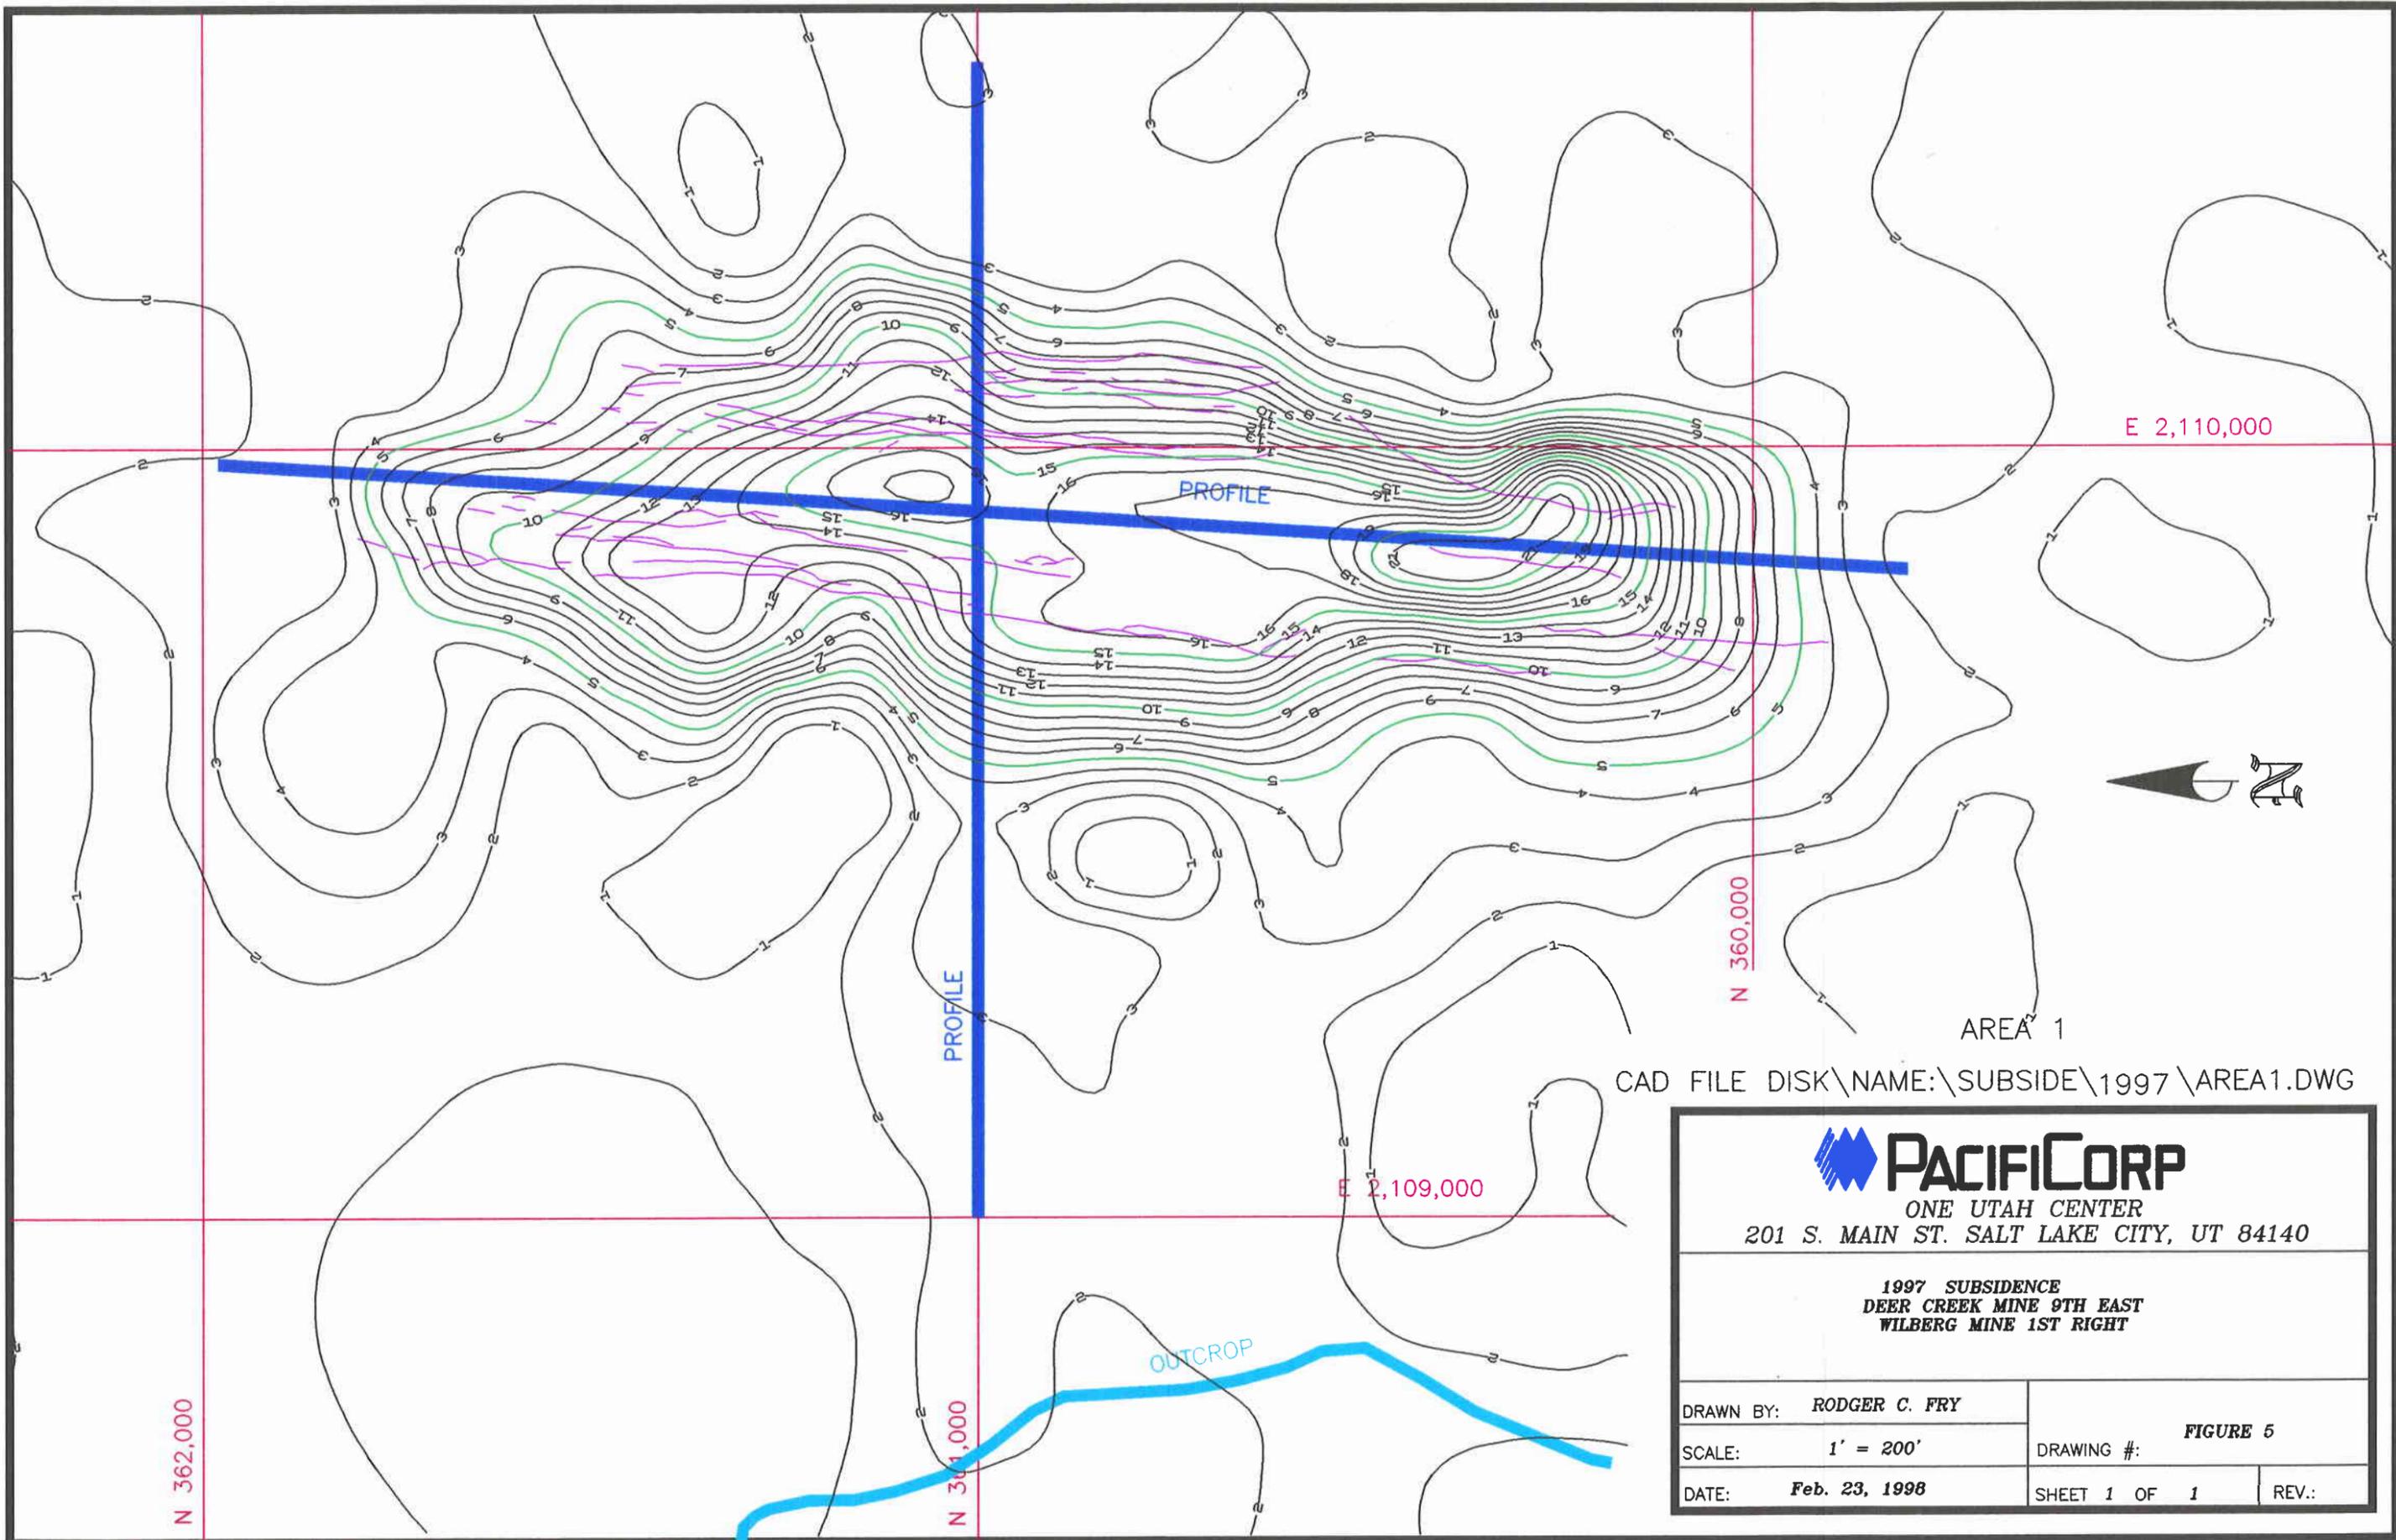
DRAWN BY: RODGER C. FRY	DRAWING #: FIGURE 5	
SCALE: 1' = 200'	SHEET 1 OF 1	
DATE: Feb. 23, 1998	REV.:

Figures 6 and 7 are north to south and west to east profiles showing the amount of subsidence in this area during the past fourteen years. The location of each line is shown on Figure 5. The area has seen little change since 1985 and appears to have totally stabilized. Maximum subsidence remains at about twenty-eight (28) feet. A detailed look from a helicopter revealed that the subsidence maximum is located on a steep slope, about 200 feet south of the southernmost mining, where a good-sized rotational slump has occurred. The workings here are also surrounded by burned coal. It is probable that the combination of steep slopes and crushing of clinker beds has allowed subsidence to occur well outside the area of mine workings. An inspection of the area from the ground indicates that many of the open fractures forming the graben-like structure have begun to heal and fill in with soil.

In the summer of 1997, some of the fractures in this area were reclaimed per the U. S. Forest Service recommendations. This reclamation consisted of knocking down the abrupt escarpments and filling in the fractures in accessible areas. The top soil was then evenly distributed and the area re-seeded. This reclamation was completed by September 1, 1997 and encompassed 1.5 acres.

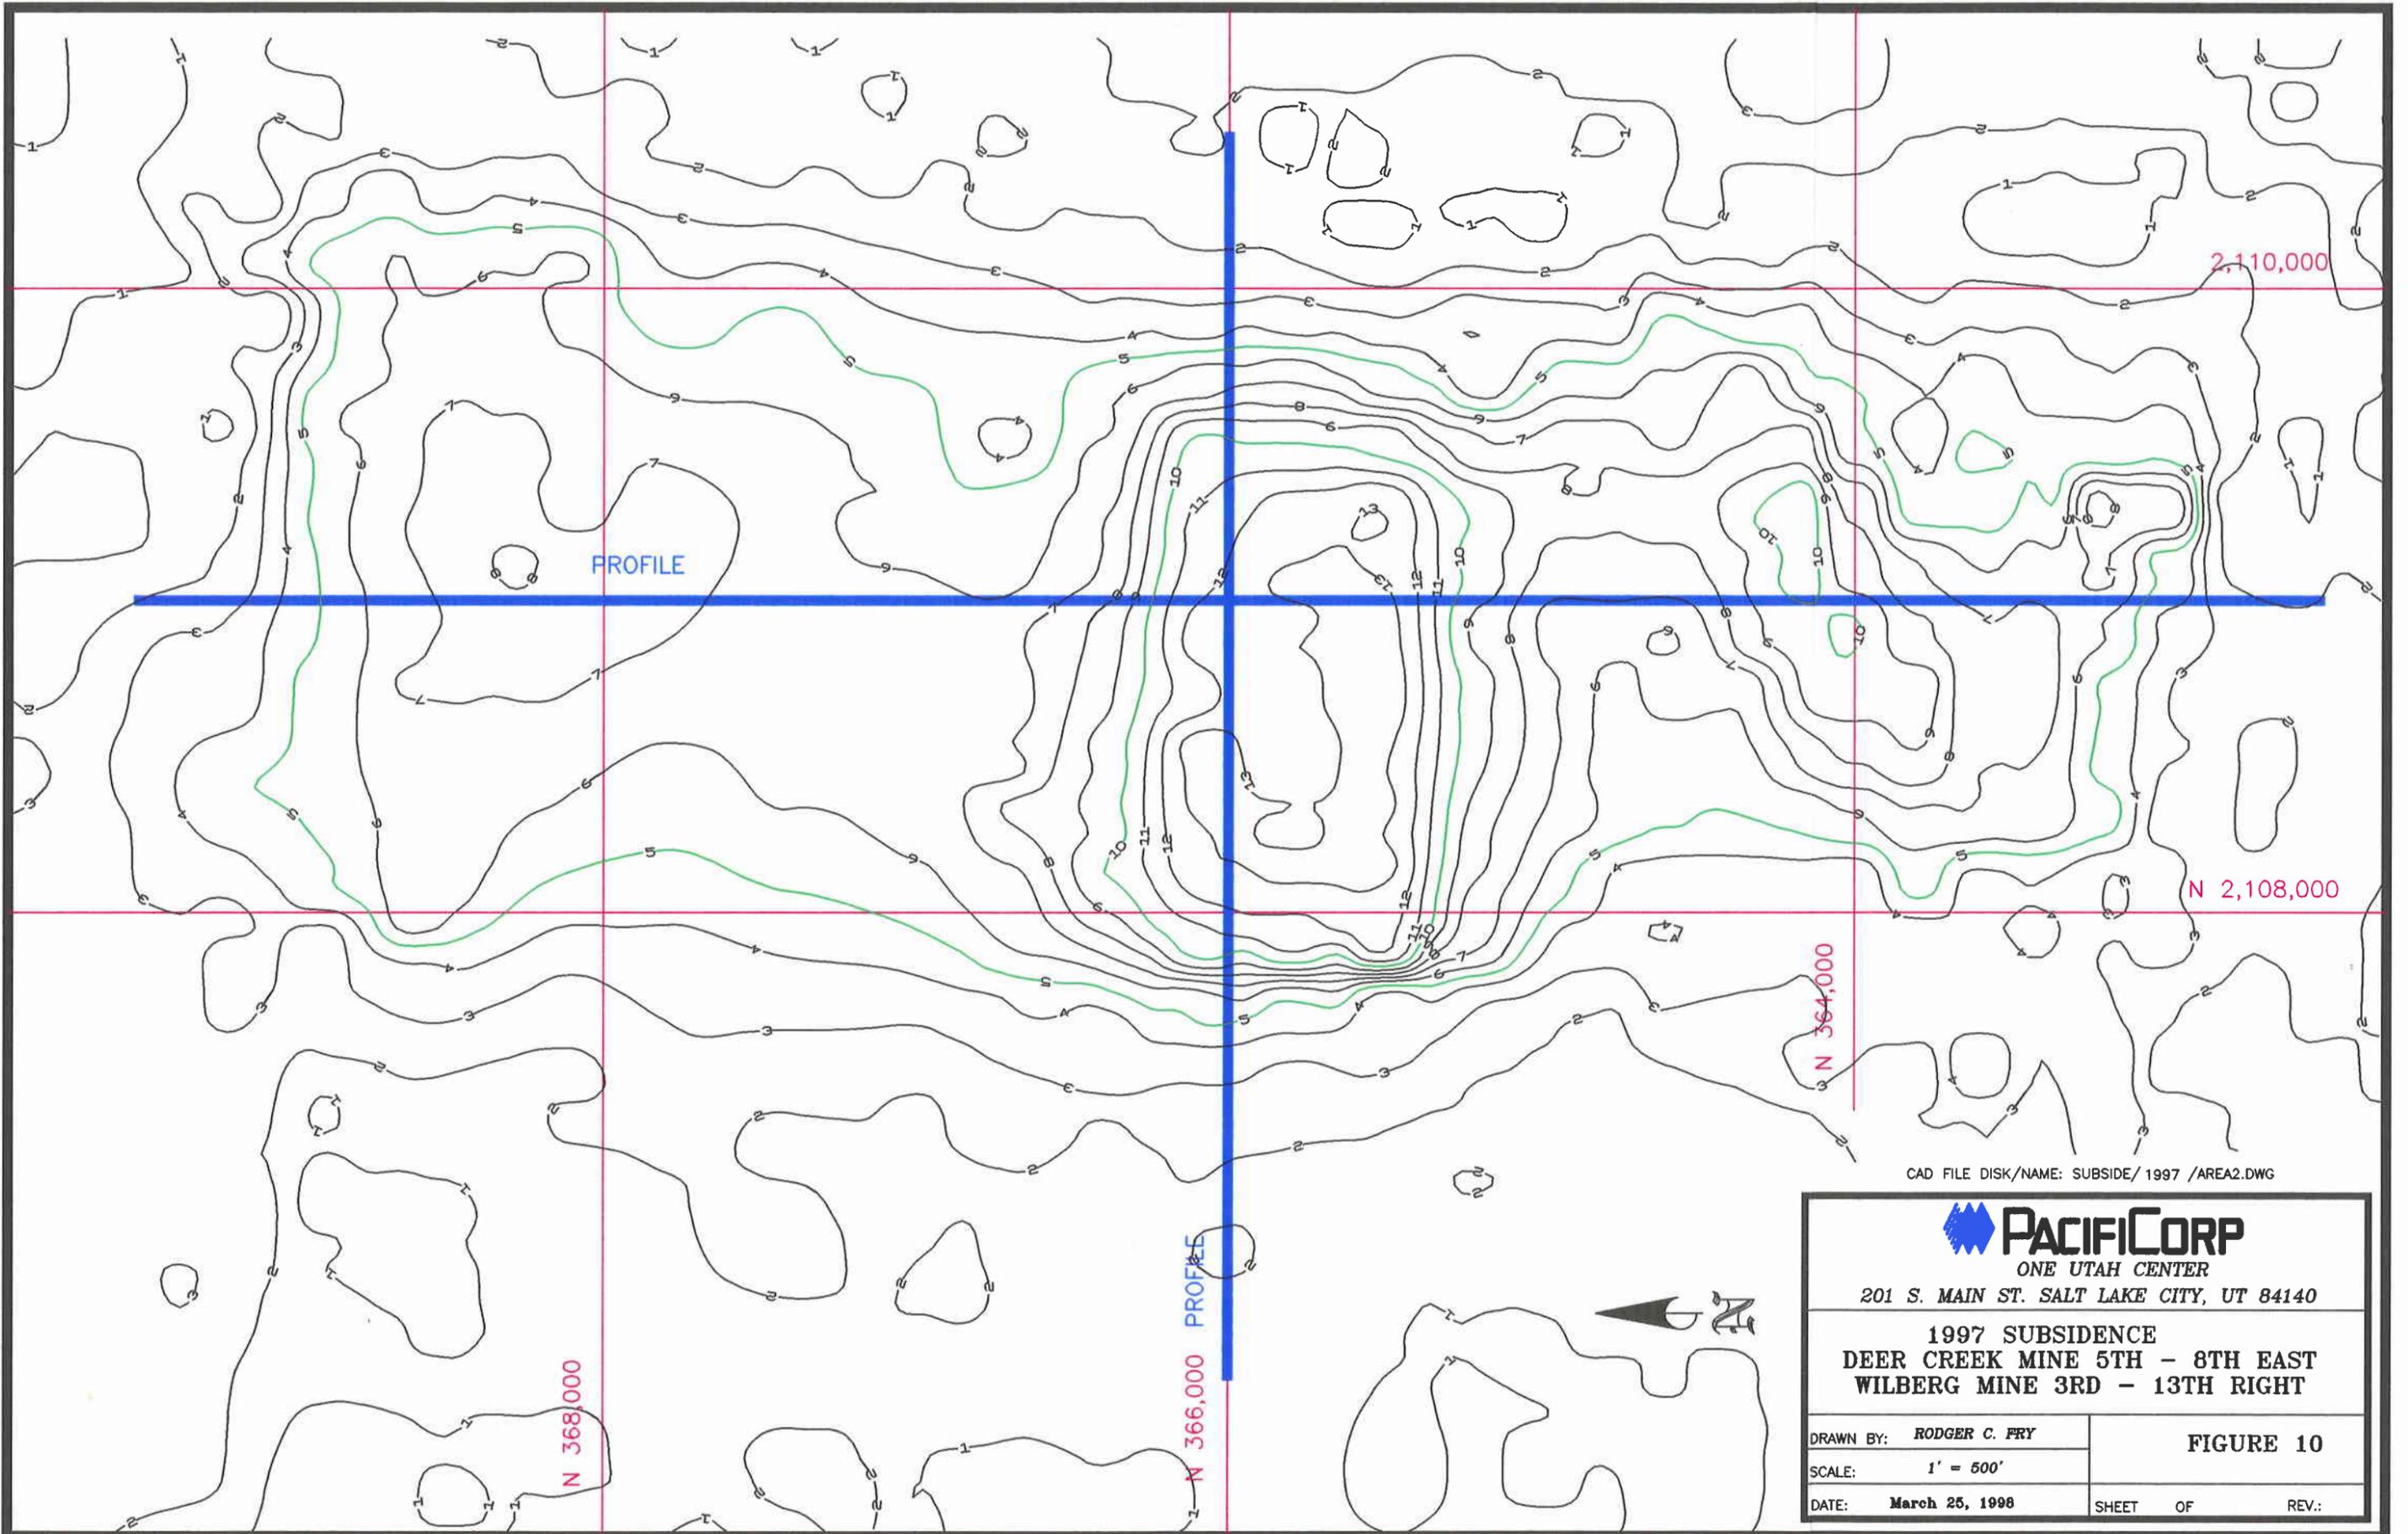
PACIFICORP ONE UTAH CENTER 201 S. MAIN ST. SALT LAKE CITY, UT 84140	
1997 SUBSIDENCE DEER CREEK MINE 5TH - 8TH EAST WILBERG MINE 3RD - 13TH RIGHT	
DRAWN BY: RODGER C. FRY	FIGURE 10
SCALE: 1" = 500'	SHEET OF REV.:
DATE: March 25, 1998

Maximum subsidence in Area 2 has stabilized at 13 feet in one area above the center of the multiple seam mining area (Figure 10). The subsidence profiles (Figures 11 and 12) indicate that the subsidence has been stable for the past 5 years or more. Neither PacifiCorp nor other contracted personnel have detected any surface fissures or other visible disturbance in the area.

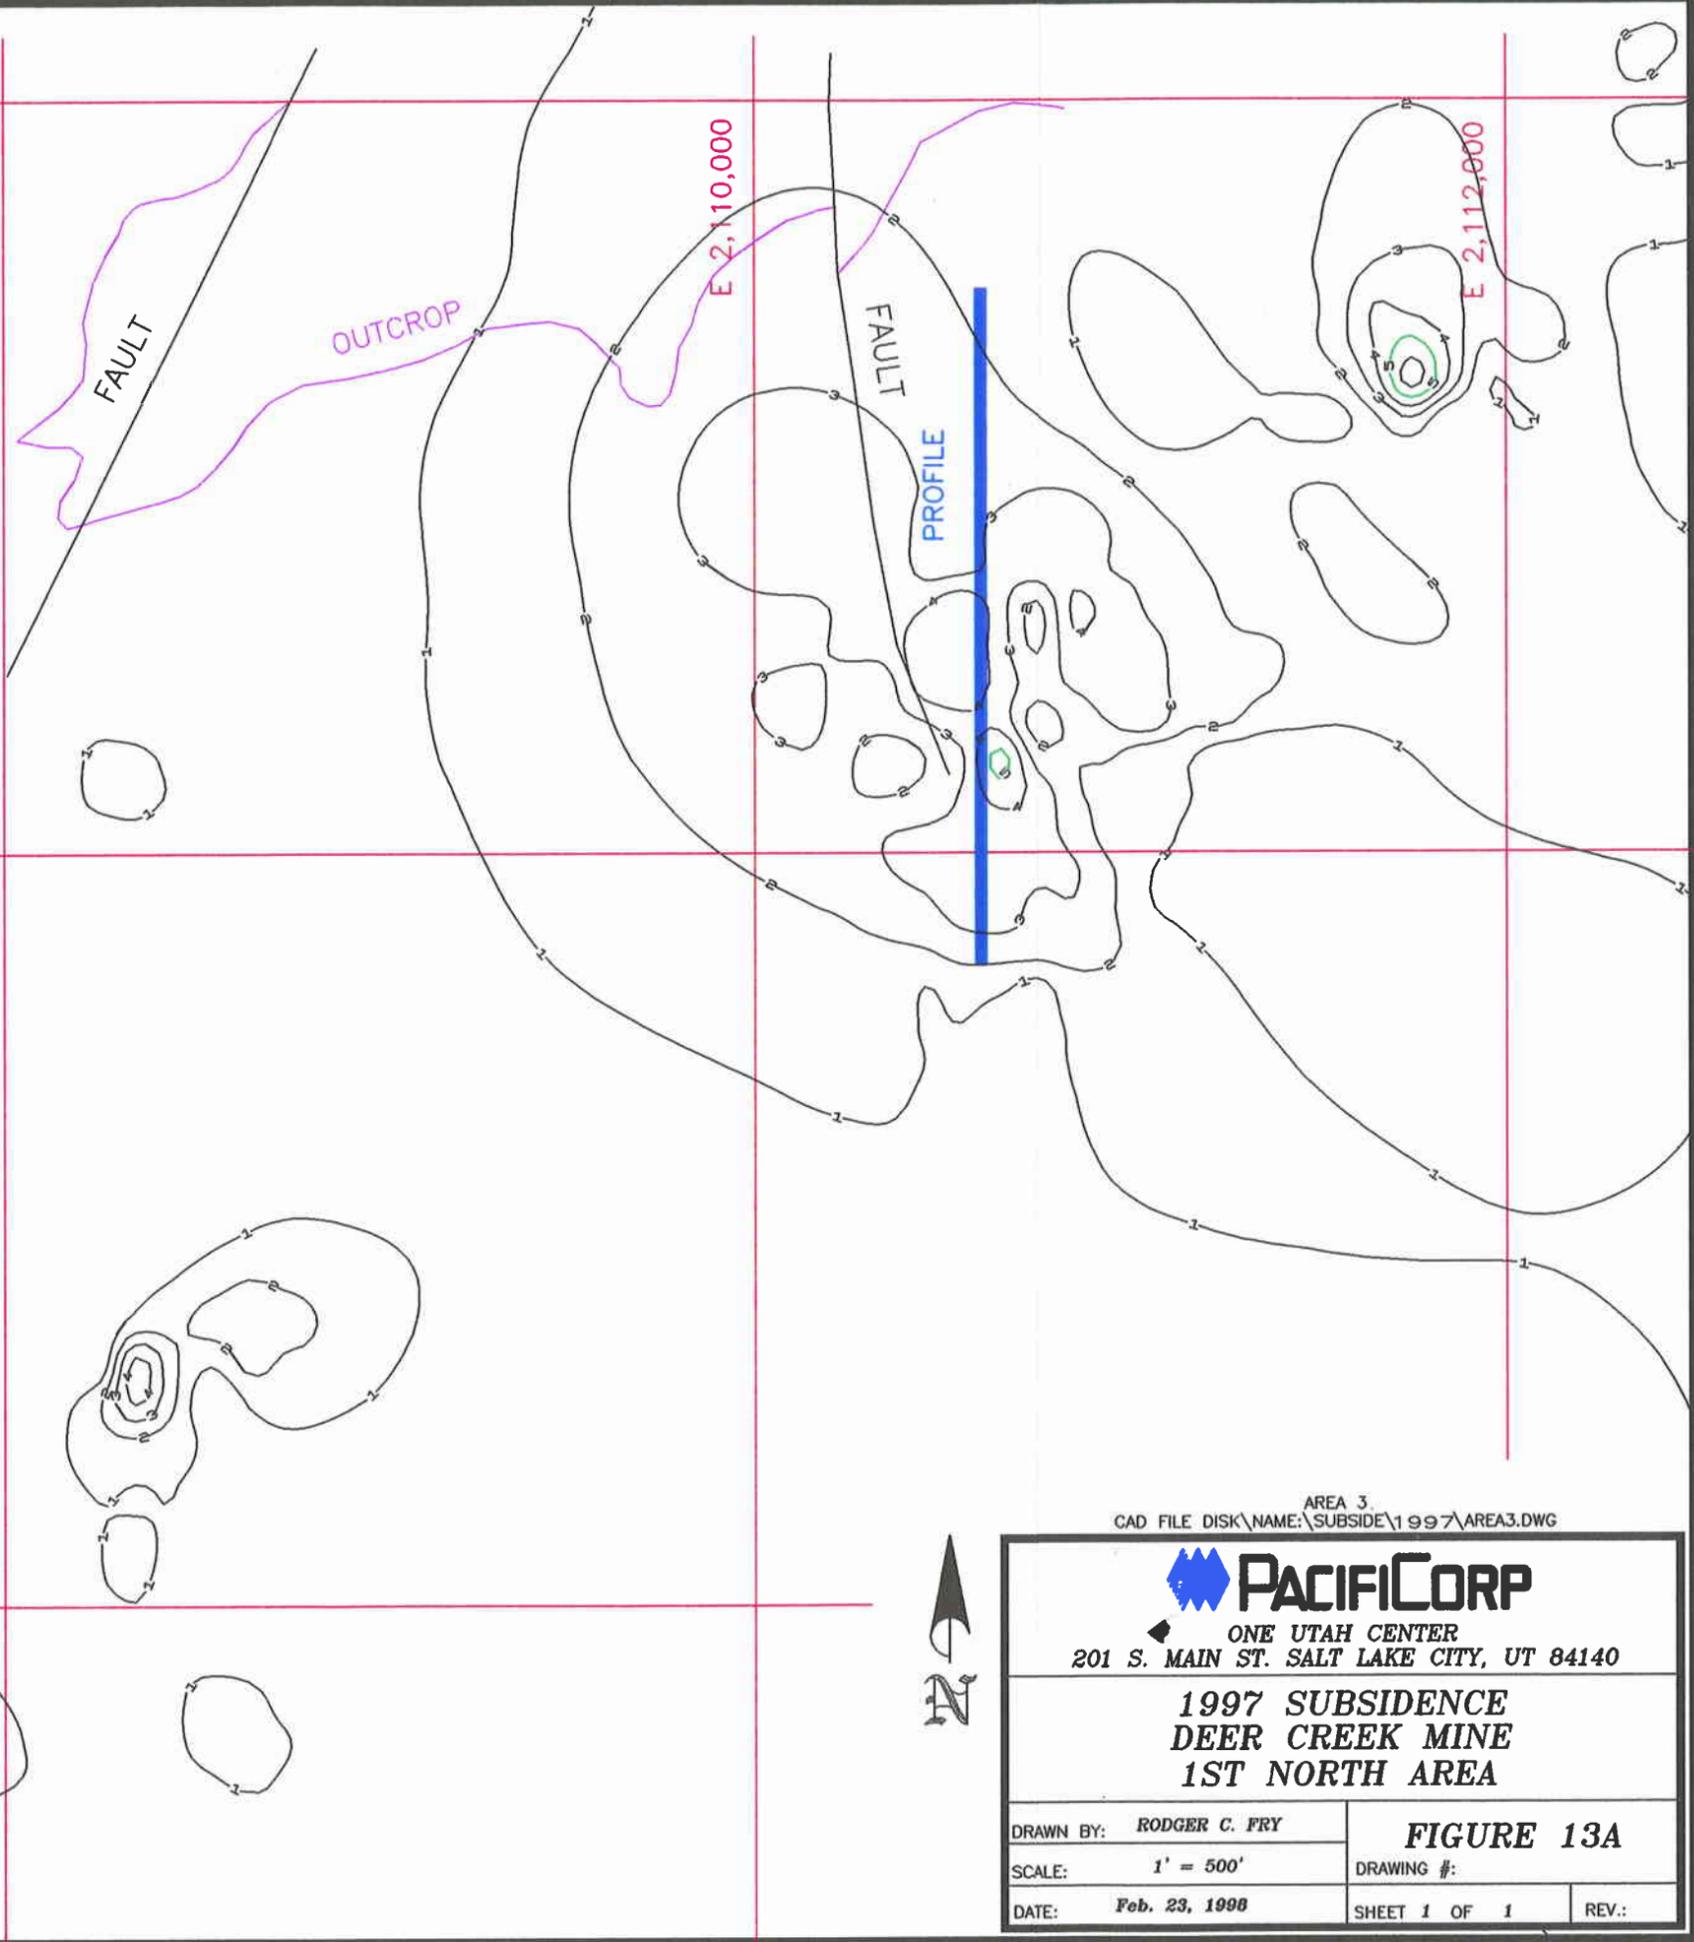
FIGURE 13A

The subsidence above 1st North occurs on a narrow ridge capped by a highly fractured sandstone. The subsidence measured is depicted in Figure 13A. Figure 14 is a profile of total subsidence as it occurred along a line of points above the workings. The subsidence in area 3 has shown no significant change in the past 4 years.

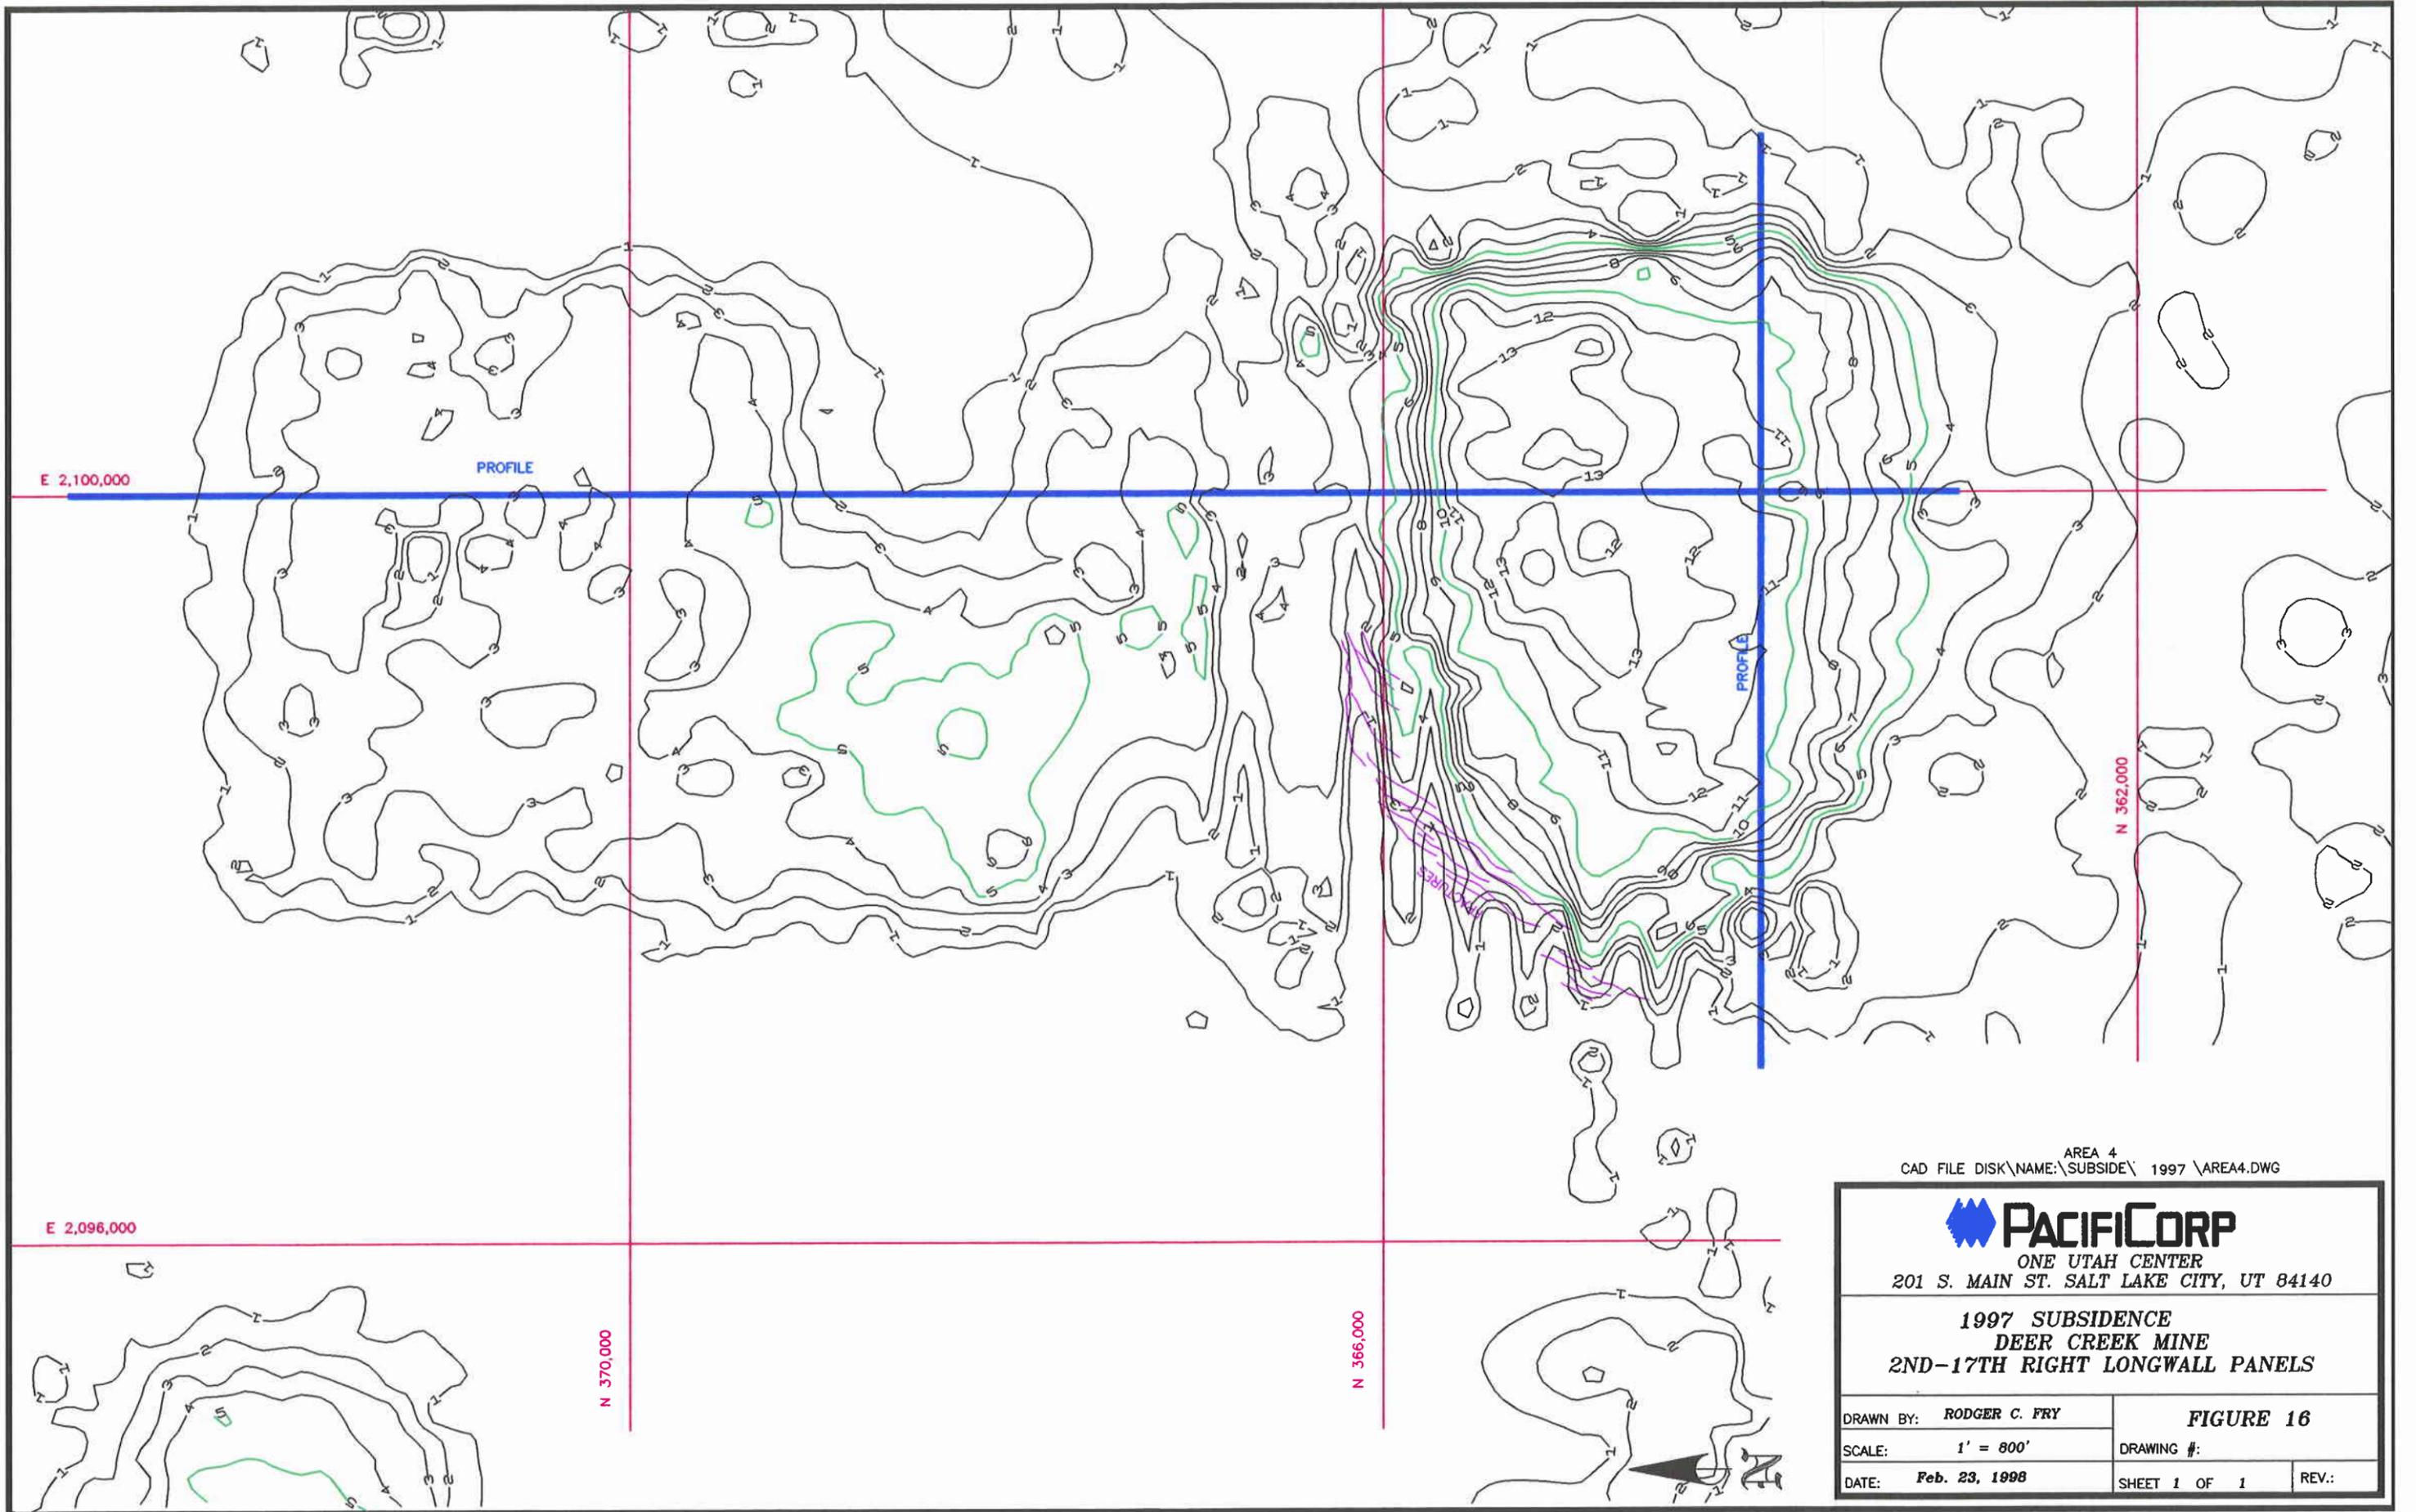
FIGURE 16

Maximum subsidence increased dramatically between 1994 and 1995 (8) feet to over thirteen (13) feet (Figure 16) due to the mining which occurred in the Hiawatha seam. The subsidence was virtually unchanged between 1995 and 1997 as shown in the profiles, Figures 17 and 18.

Surface fractures were identified in the field in late May of 1995. These fractures were located on Fee surface land and PacifiCorp filled in the fractures with a motor grader and reseeded the area. The location of the fractures are shown on figure 16. The revegetation in these areas is now established and no further fracturing has been identified.

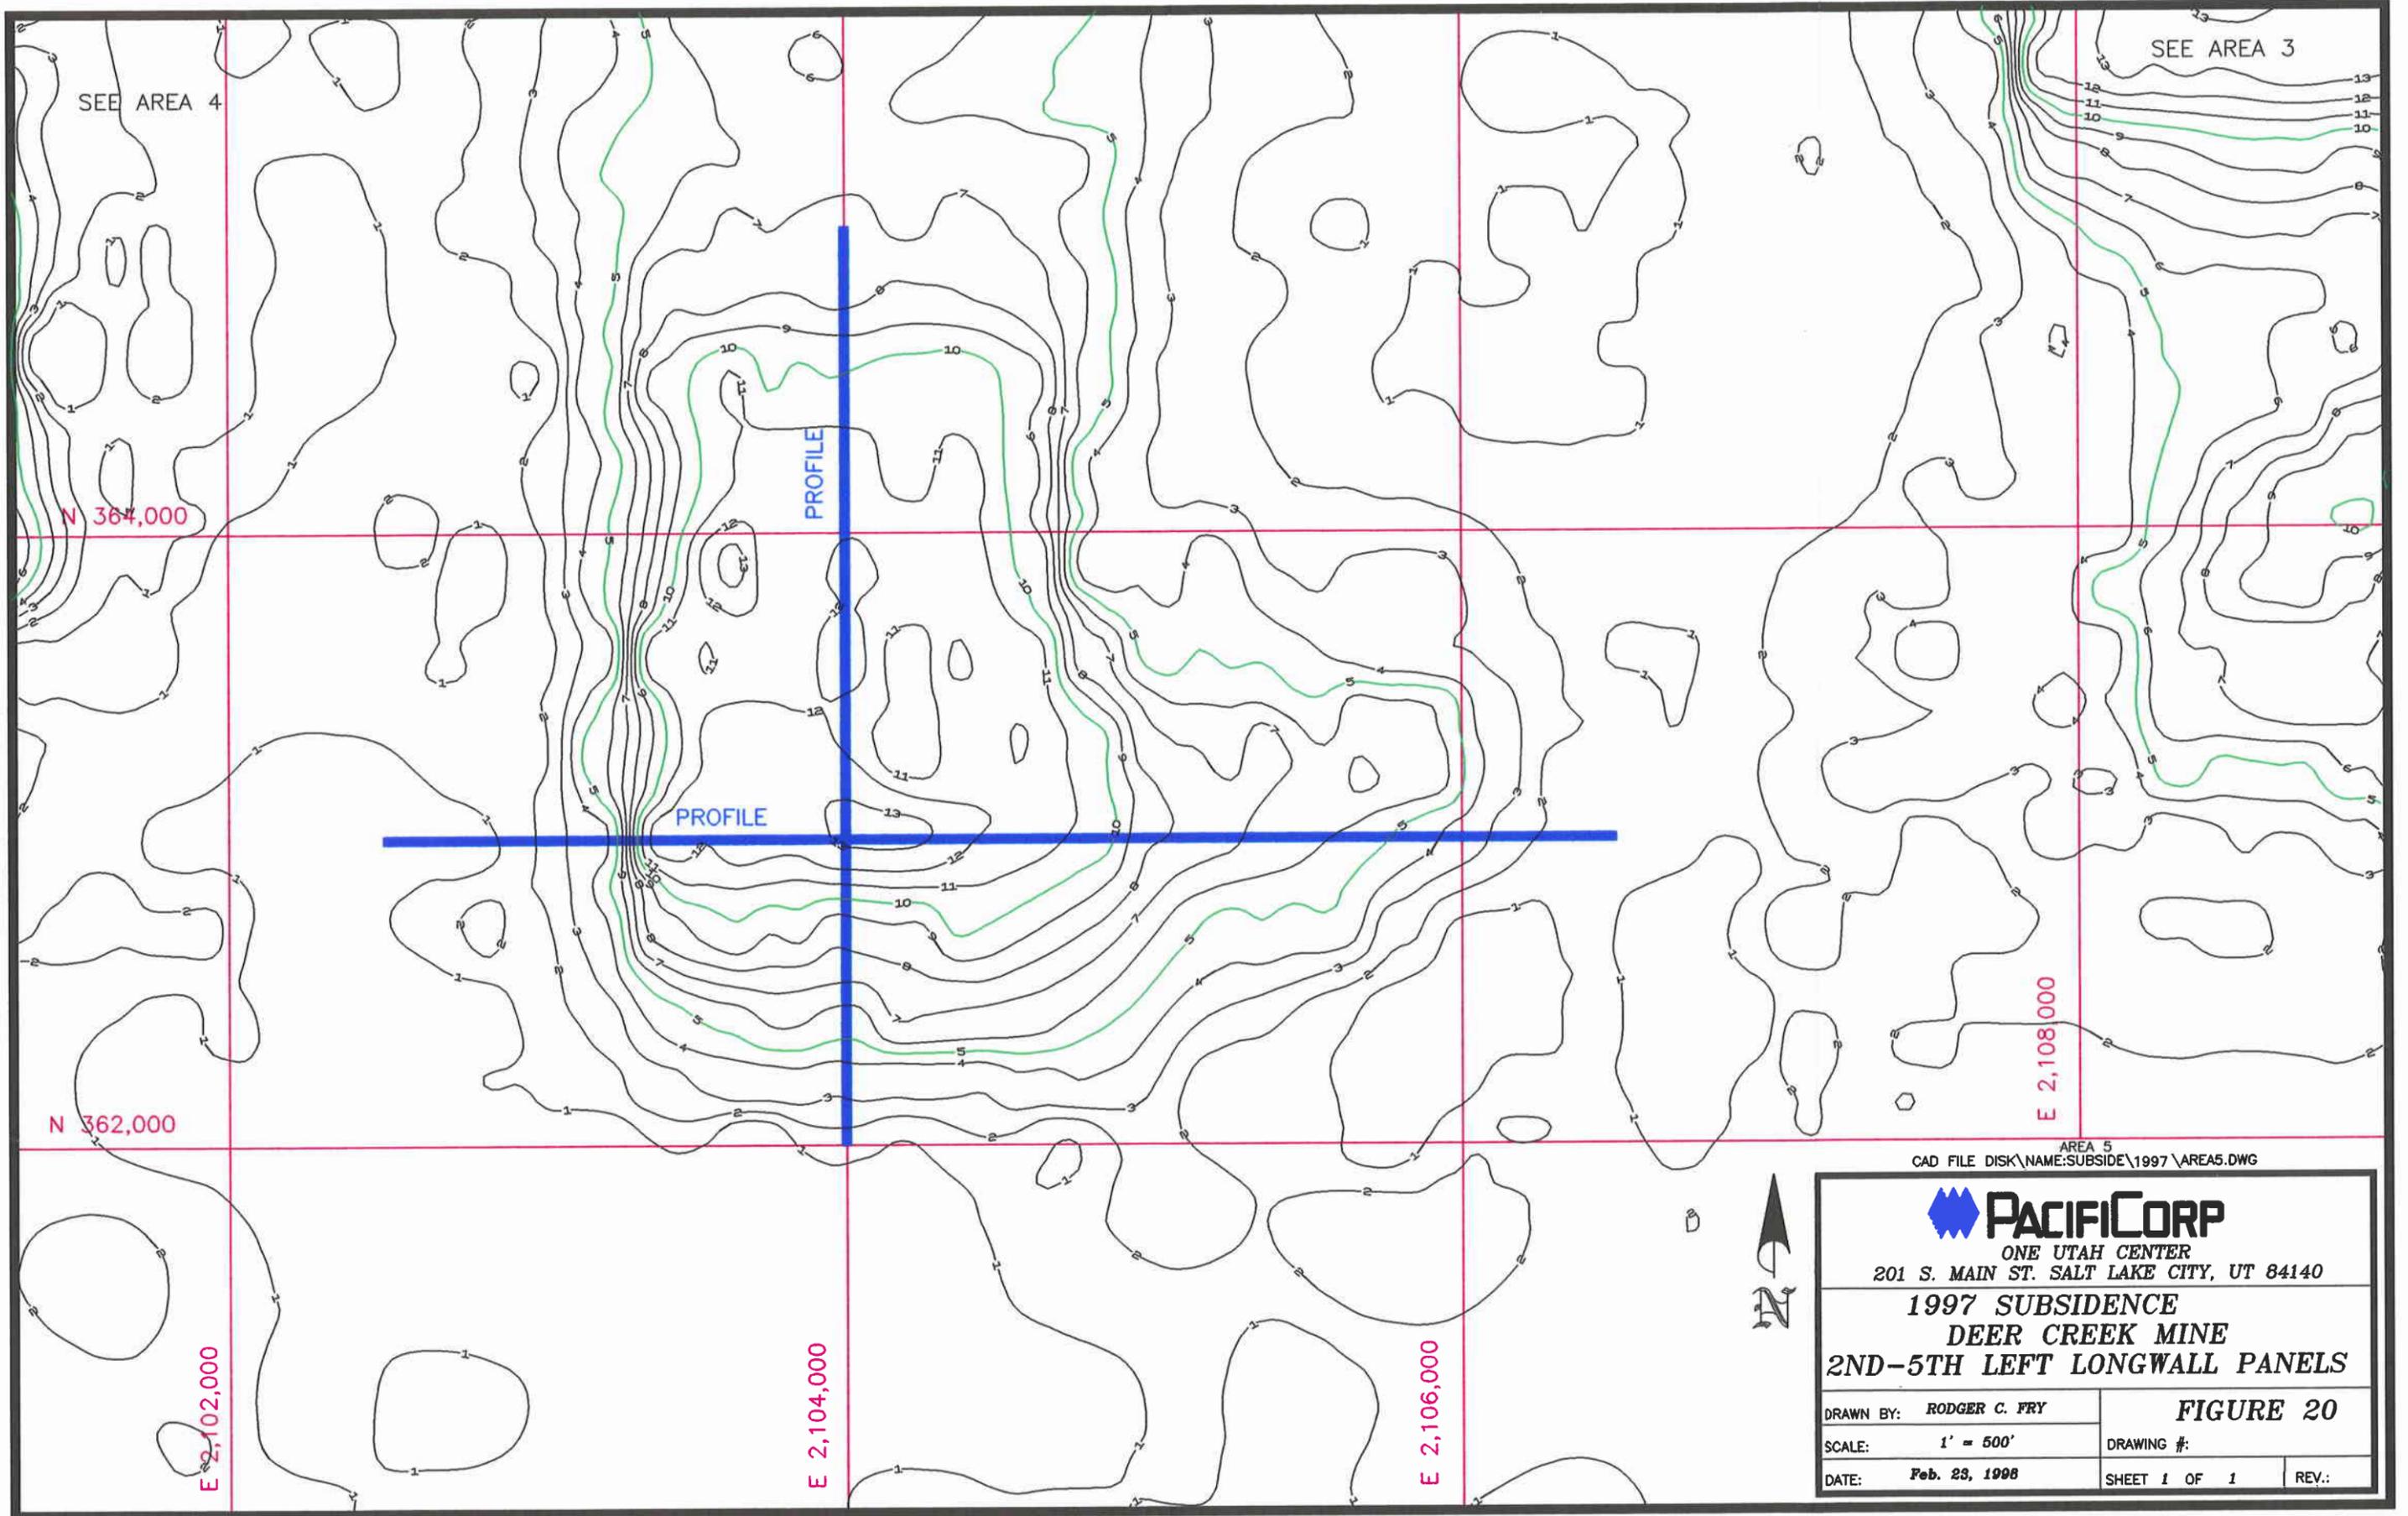
FIGURE 20
DRAWING #:
SHEET 1 OF 1 REV.:

Maximum subsidence over the panels is slightly greater than thirteen (13) feet where both seams have been mined (Figure 20). The maximum subsidence showed a substantial increase between 1993 and 1994 but showed slight change between 1994 and 1997. It is important to point out that the subsidence measurements in 1997 between the 1,500 foot and 2,500 foot marks on the North-South profile show about 1 foot greater subsidence in 1997 than was measured in 1996. This could be due to measuring error or continuing subsidence. Future monitoring should identify which case exists. No surface disturbance has been identified over the panels.

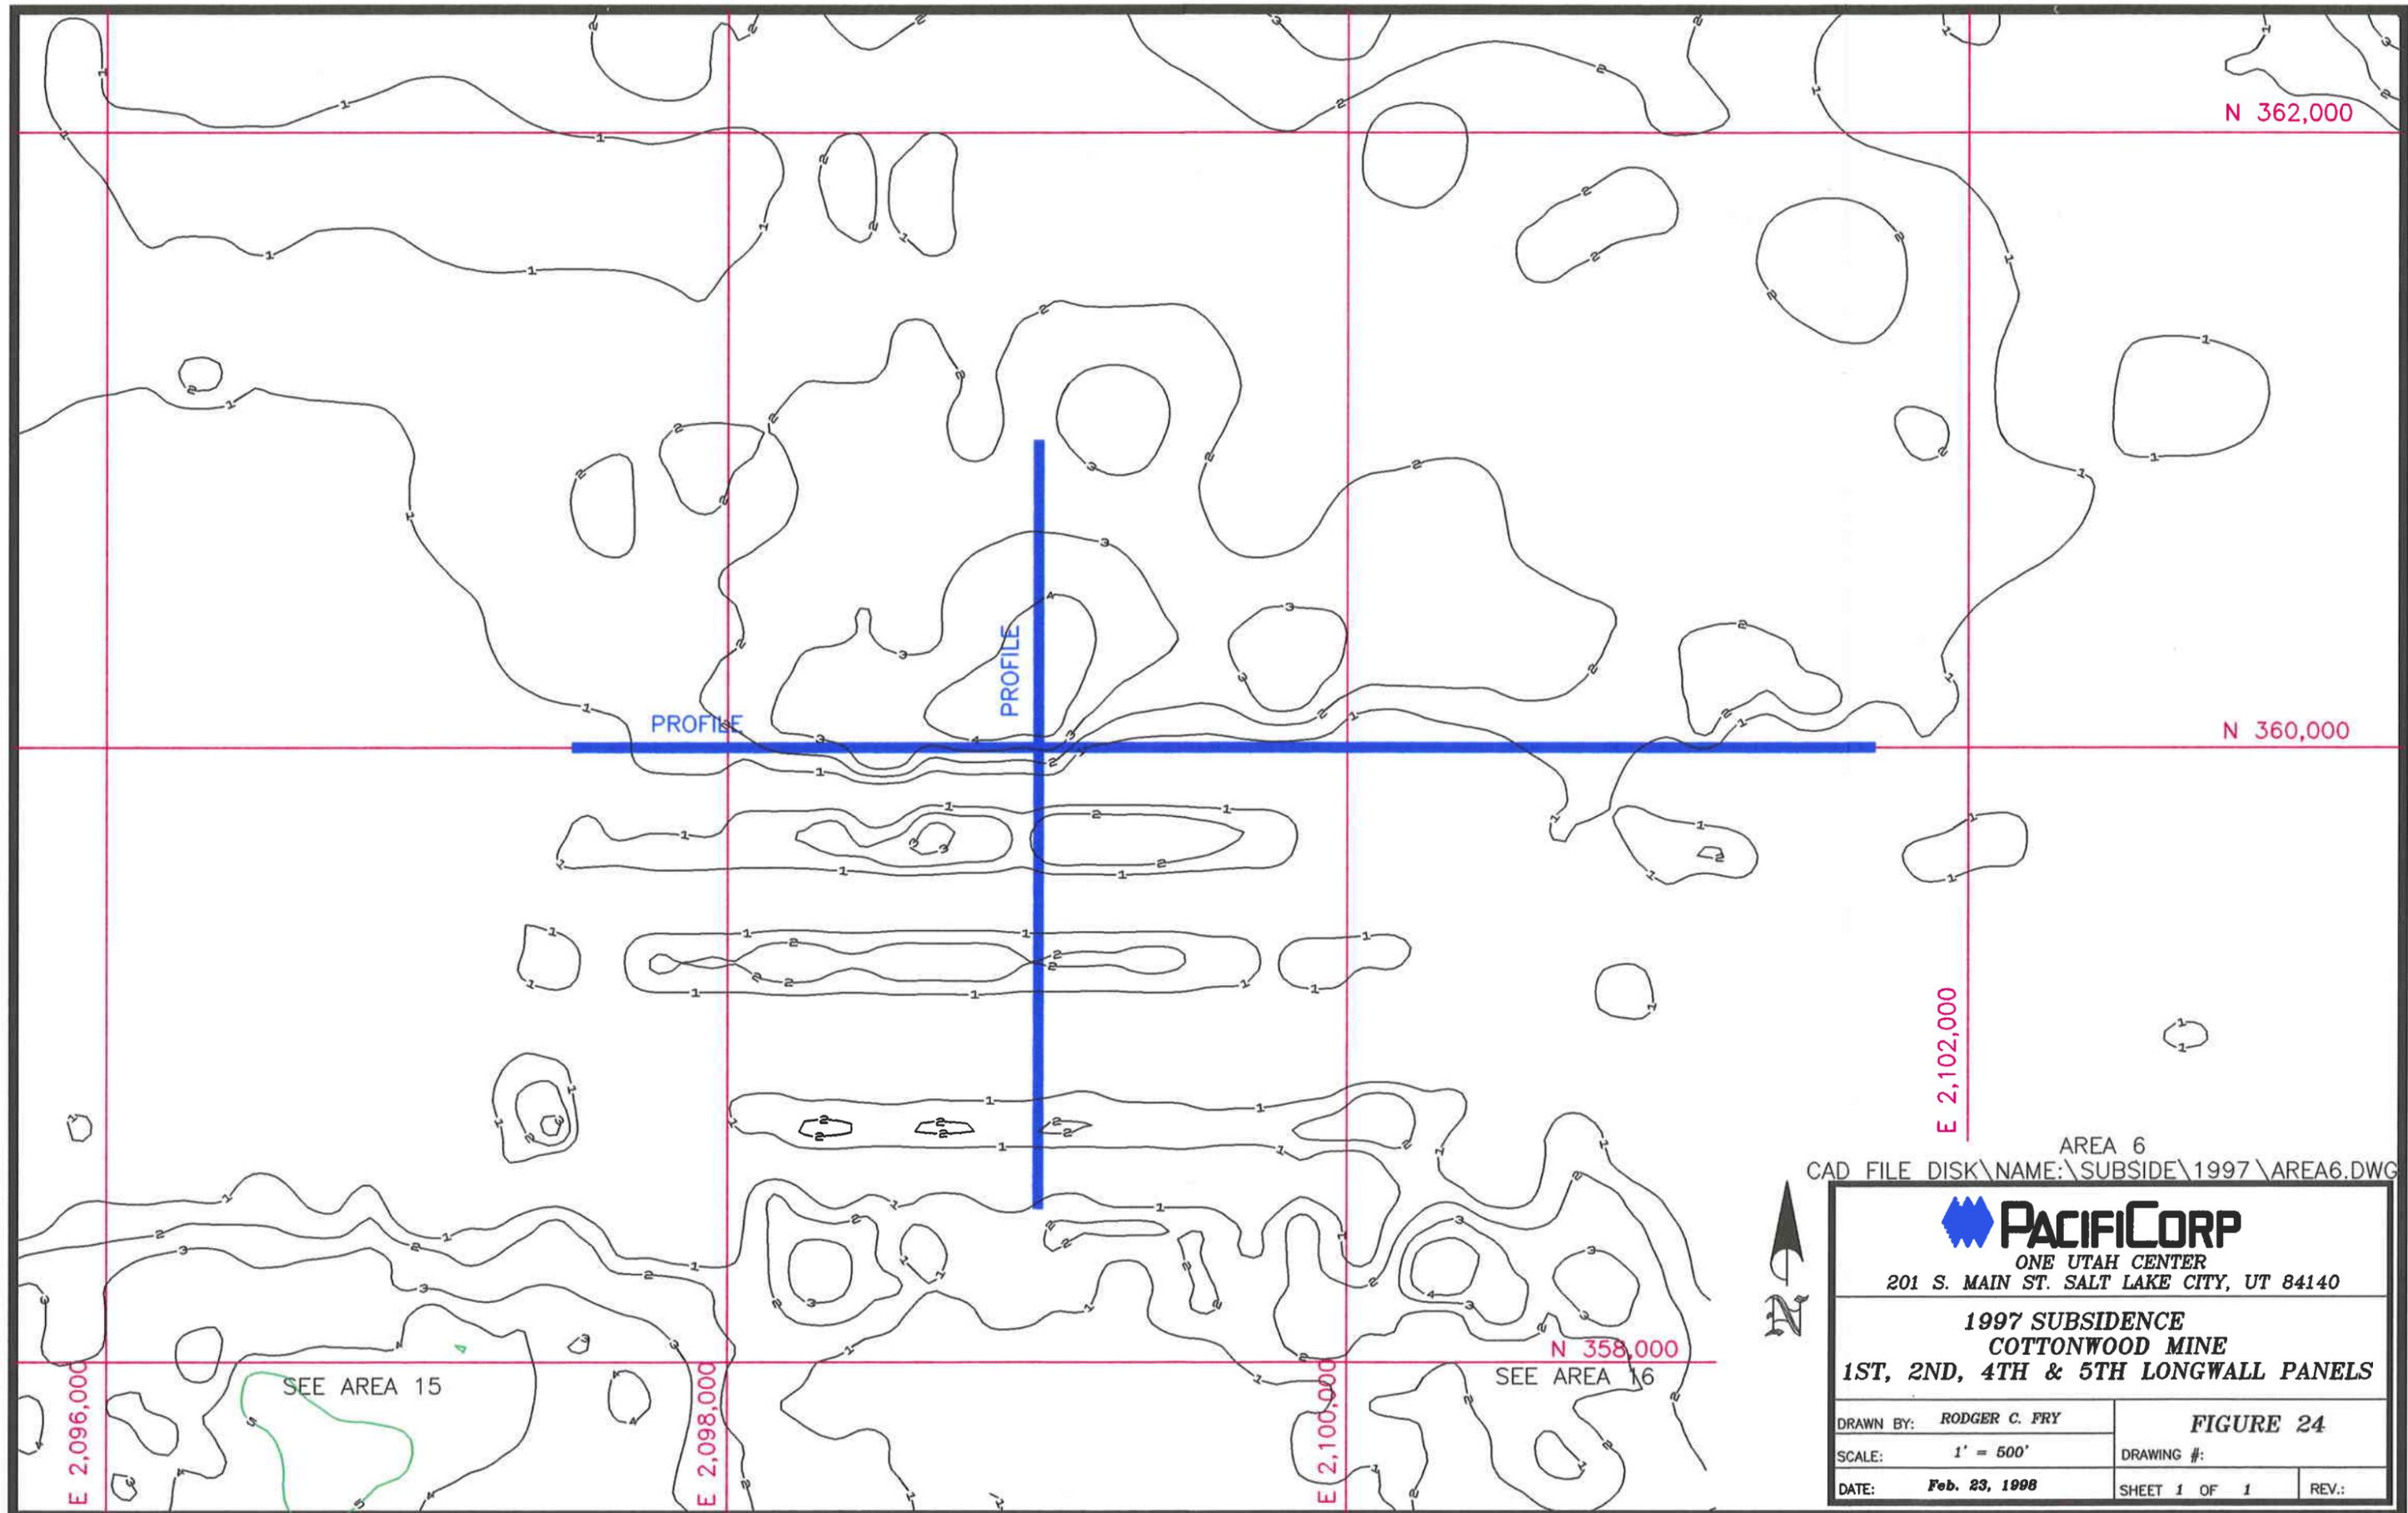
DRAWN BY: RODGER C. FRY		FIGURE 24	
SCALE: 1' = 500'		DRAWING #:	
DATE: Feb. 23, 1998	SHEET 1 OF 1	REV.:

Mining in the Wilberg 1st and 2nd West longwall panels was completed in June 1983 (Figure 23). This area of subsidence has now reached a maximum of between four and five feet over the Second West Longwall Panel (Figure 24). The subsidence in this area has been stable for the past four years. The subsidence profiles (Figures 25 and 26) show the change in subsidence since 1983.
