ANNUAL SUBSIDENCE MONITORING REPORT
EAST /TRAIL MOUNTAIN PROPERTIES
1997

PACIFICORP
SUBSIDENCE MONITORING PROGRAM
ANNUAL REPORT FOR 1997

April, 1998

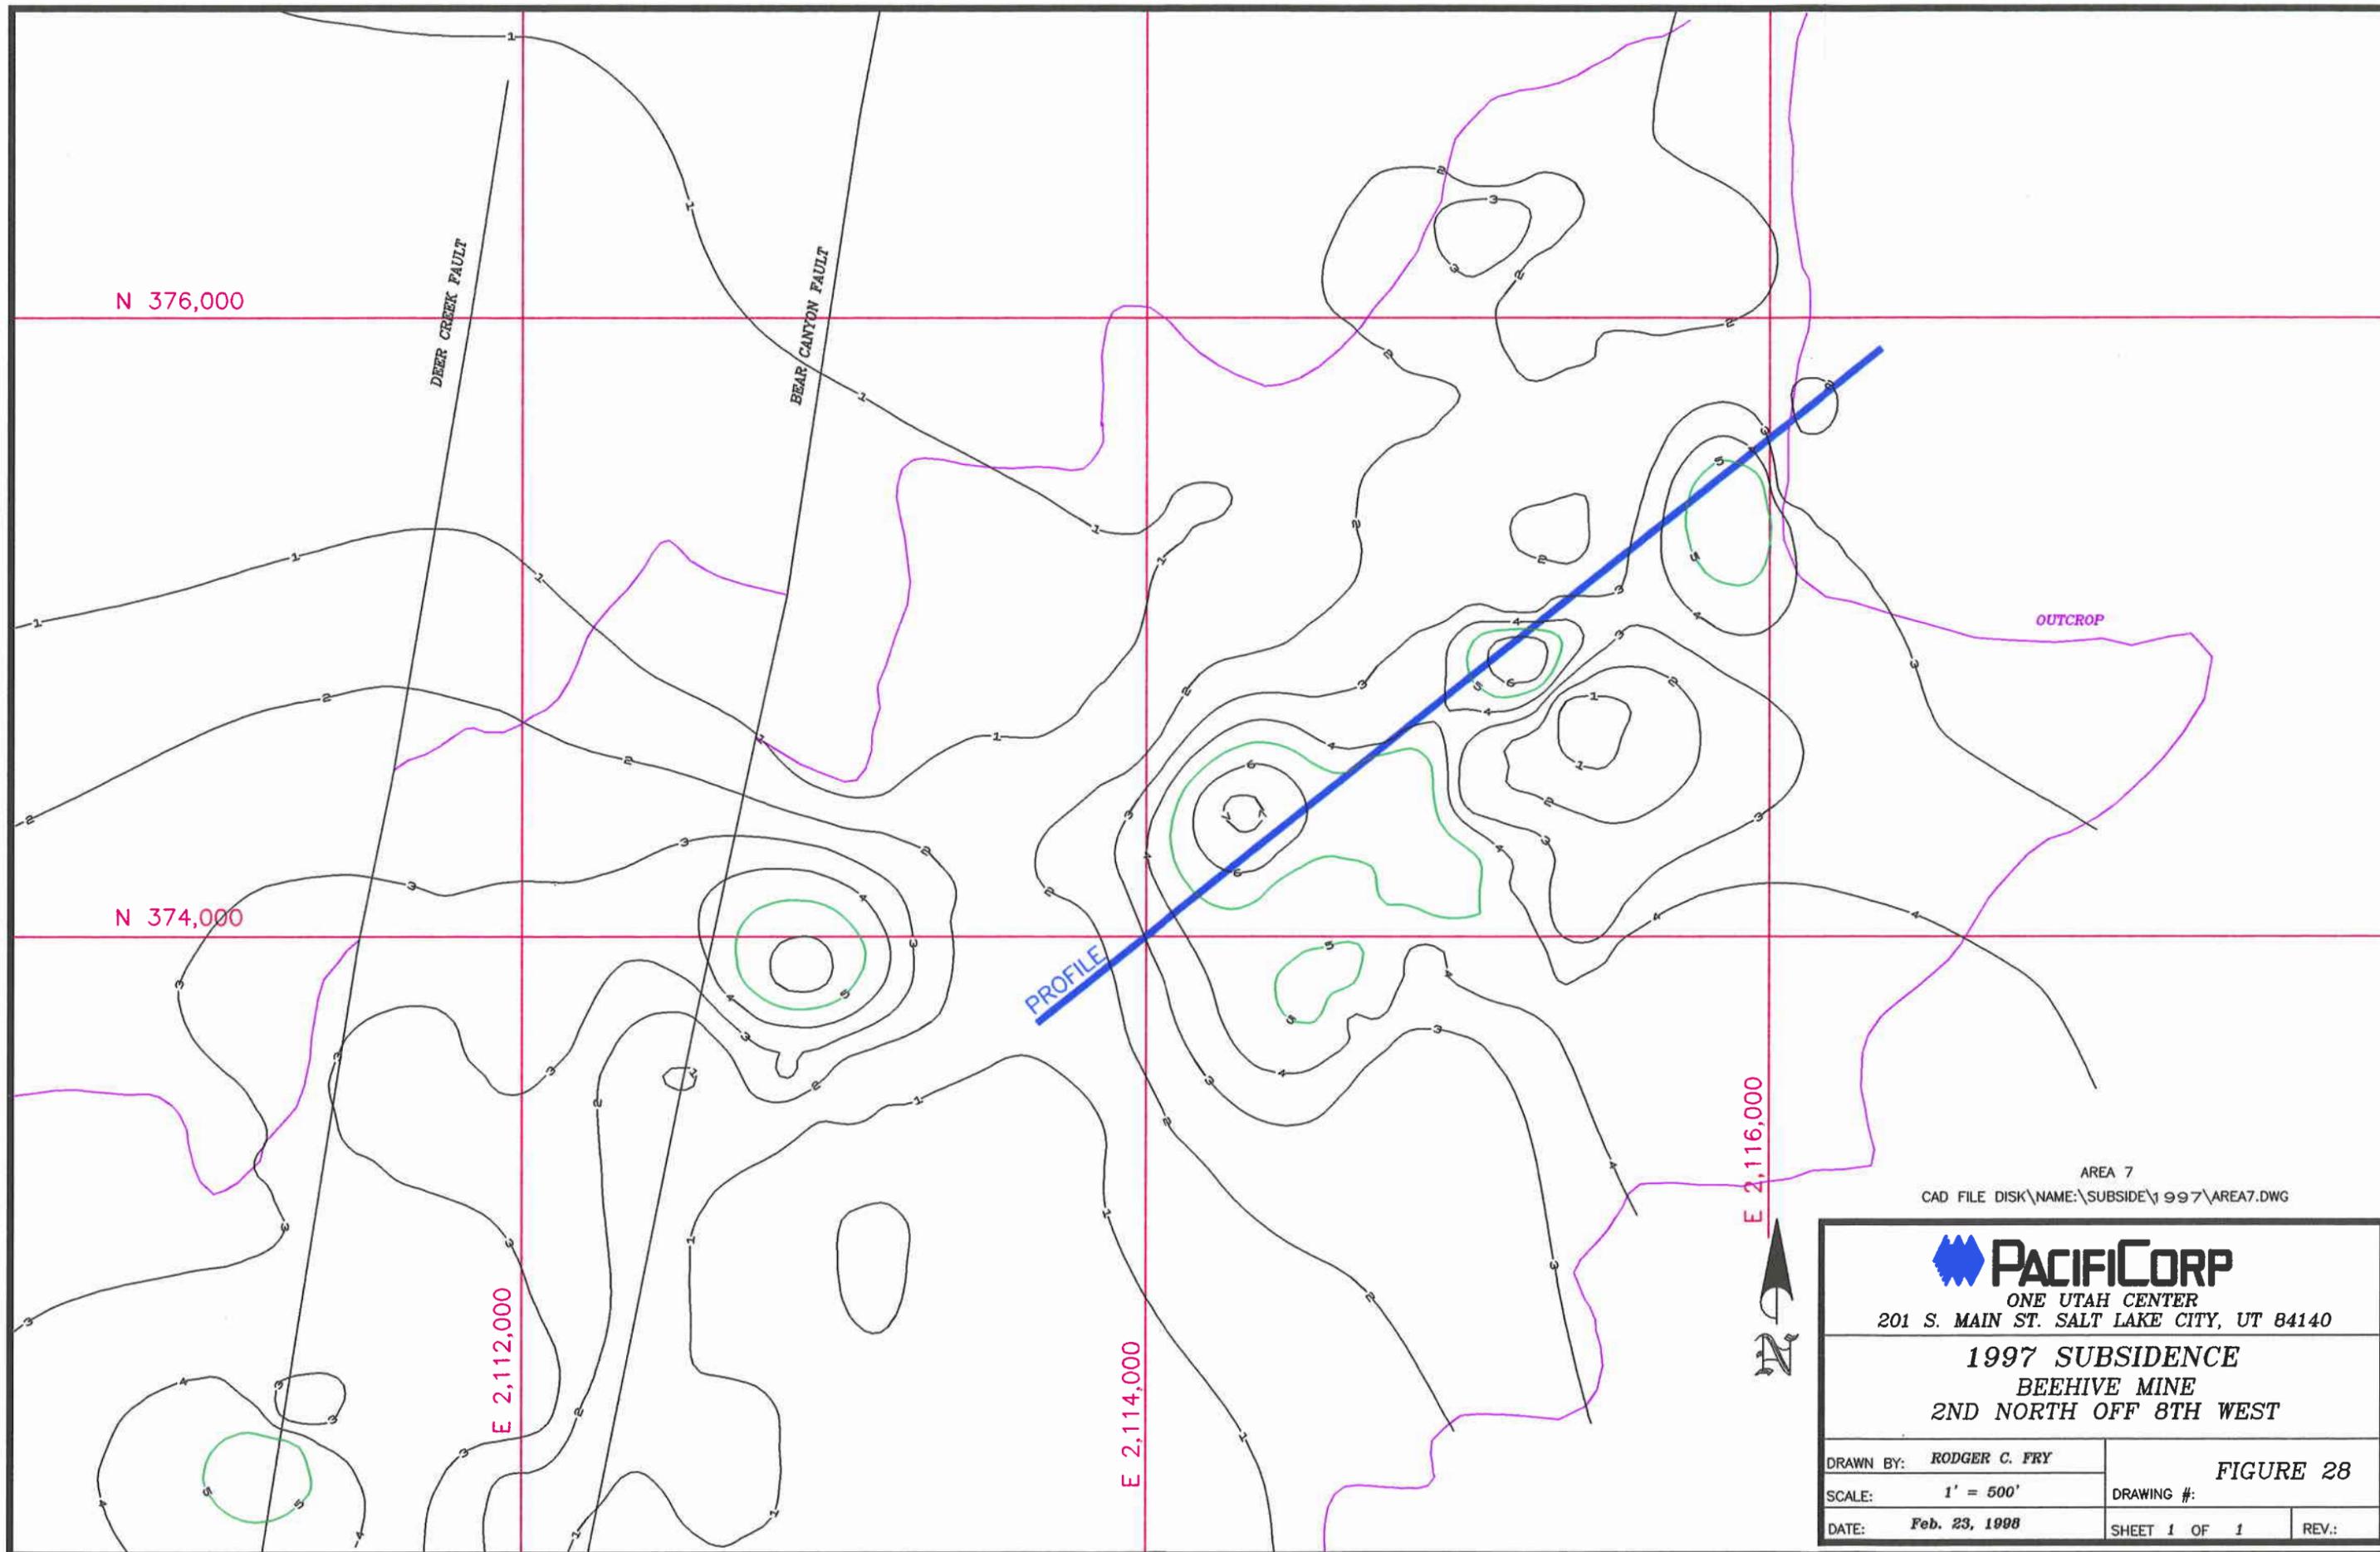
PACIFICORP ONE UTAH CENTER 201 S. MAIN ST. SALT LAKE CITY, UT 84140		
1997 SUBSIDENCE BEEHIVE MINE 2ND NORTH OFF 8TH WEST		
DRAWN BY: RODGER C. FRY	FIGURE 28	
SCALE: 1' = 500'	DRAWING #:	
DATE: Feb. 23, 1998	SHEET 1 OF 1	REV.:

Pillar extraction mining in 2nd North was completed in 1983 and, as shown in Figures 27, 28, and 29, little additional subsidence has occurred over the workings since 1984. The workings are surrounded by burned coal.

Maximum subsidence is as much as seven (7) feet. In examining the area by helicopter and aerial photography, it is apparent that much of the elevation change measured was due to cliff failure and mass wasting on the steep slopes above the workings, where the rocks were highly fractured prior to mining. The profile, Figure 29, shows no measurable subsidence since 1991, this area is however, steep and rugged limiting the accuracy of the photogrammetric monitoring. Hence, the fluctuations in the reading are experienced from year to year.
