August 26, 2003

RE: 2003 Second Quarter Water Monitoring, Energy West Mining Company, Trail Mountain Mine, C0150009-WQ03-2, Task ID #168

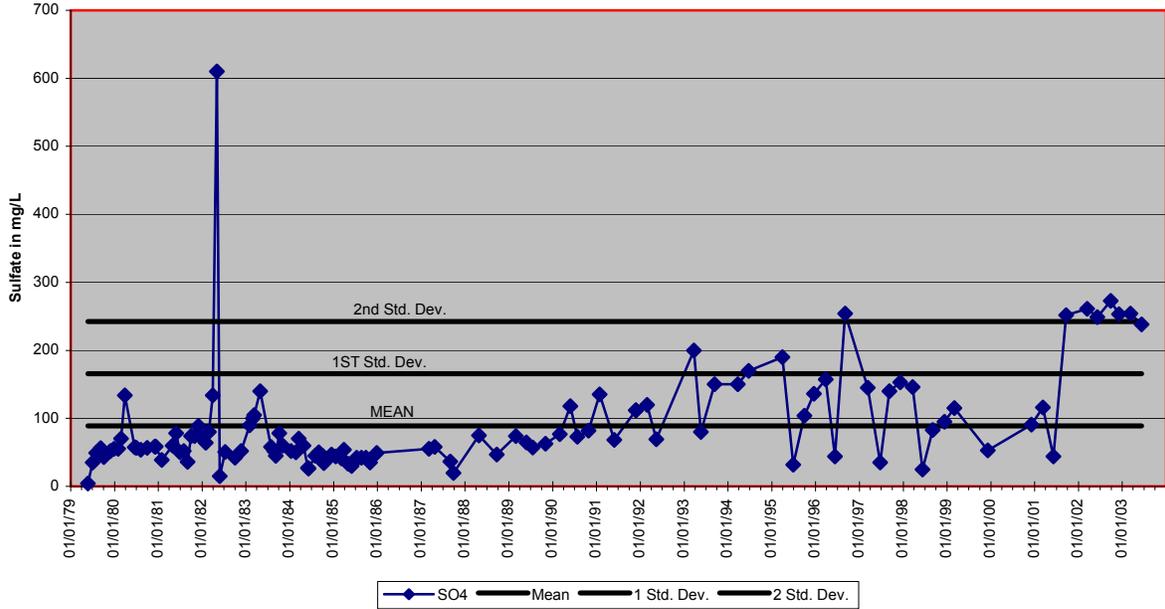
SW-2 Sulfate

Sulfate values at SW-2 have returned to within two standard deviations of the mean value (see the attached chart); however, sulfate is still elevated and the Permittee needs to identify the source of this increase in sulfate in the stream.
