WATER QUALITY MEMORANDUM

Utah Coal Regulatory Program

RE: 2003 Fourth Quarter Water Monitoring, Energy West Mining Company, Trail Mountain Mine, C/015/0009-WQ03-4, Task ID #1795

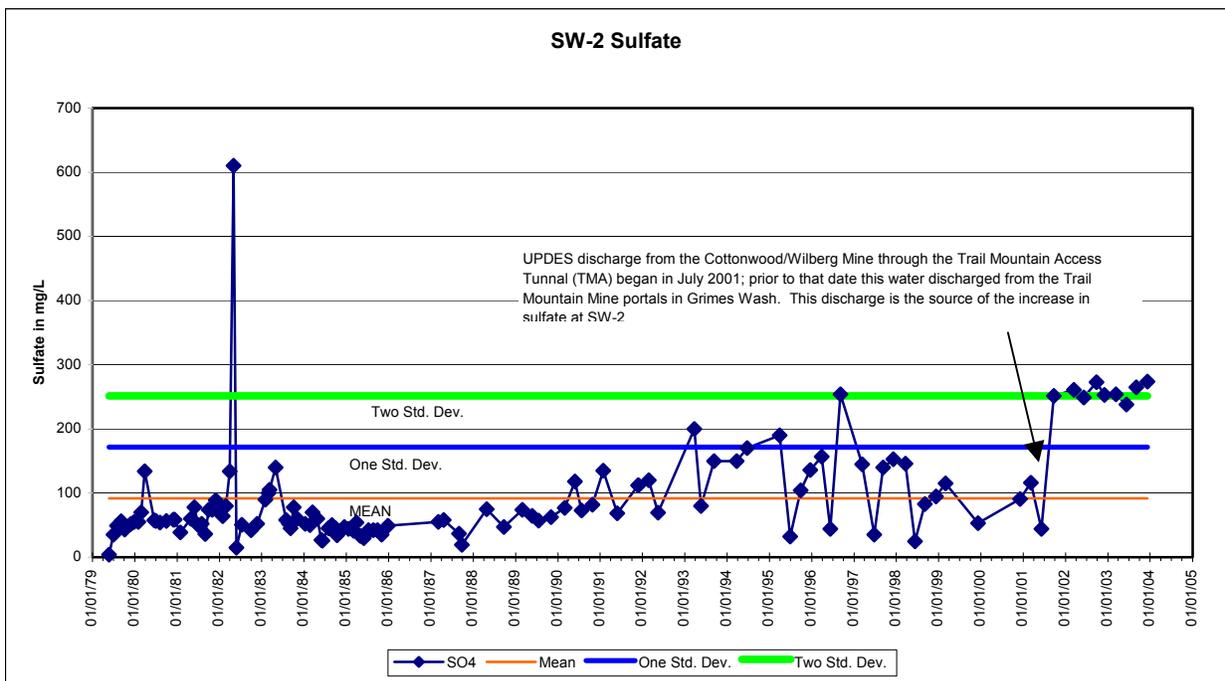
SW-2 December: SO₄ (n = 117) was outside the two standard deviation range. (See the chart at the end of this report.)

SW-2: the Permittee has identified the UPDES discharge from the Cottonwood/Wilberg Mine through the Trail Mountain Access Tunnel (TMA) as the source of the sulfate: prior to July 2001 this water discharged from the Trail Mountain Mine portals in Grimes Wash. No action is needed at this time.

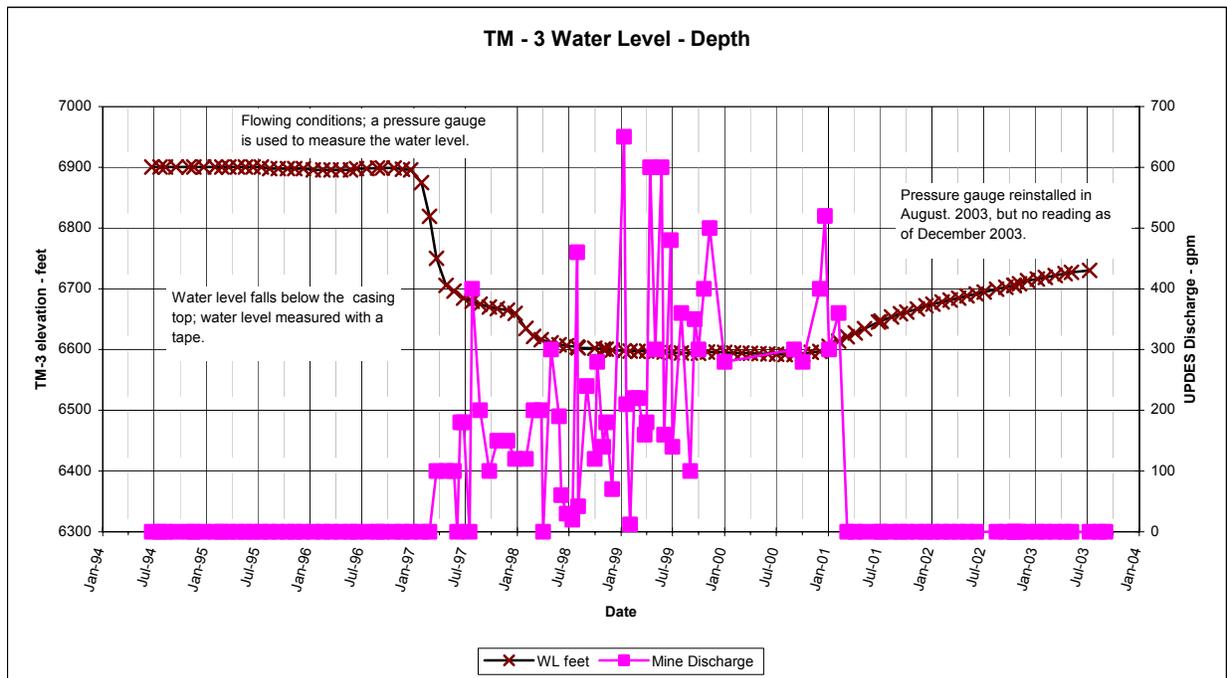
TM-3: water level in this piezometer has been recovering since mine operations ceased, and the pressure gauge was reinstalled in August 2003 because the water level was approaching the top of the casing; however, so far no pressure readings have been reported. (See the chart at the end of this report.)

TM-3: water level in this piezometer has been recovering and the gauge was reinstalled in August 2003 because the water level was approaching the top of the casing, but so far no pressure readings have been reported. Chuck Semborski suspects trapped air is interfering with the gauge, and the gauge will be serviced as soon as the site is accessible with the equipment needed to open the wellhead.
